# Post Completion Defect Inspection Report

**Example, VICTORIA, 3024**

Report/Agreement #              0807210944395

Inspection Date:                  08 Jul 2021

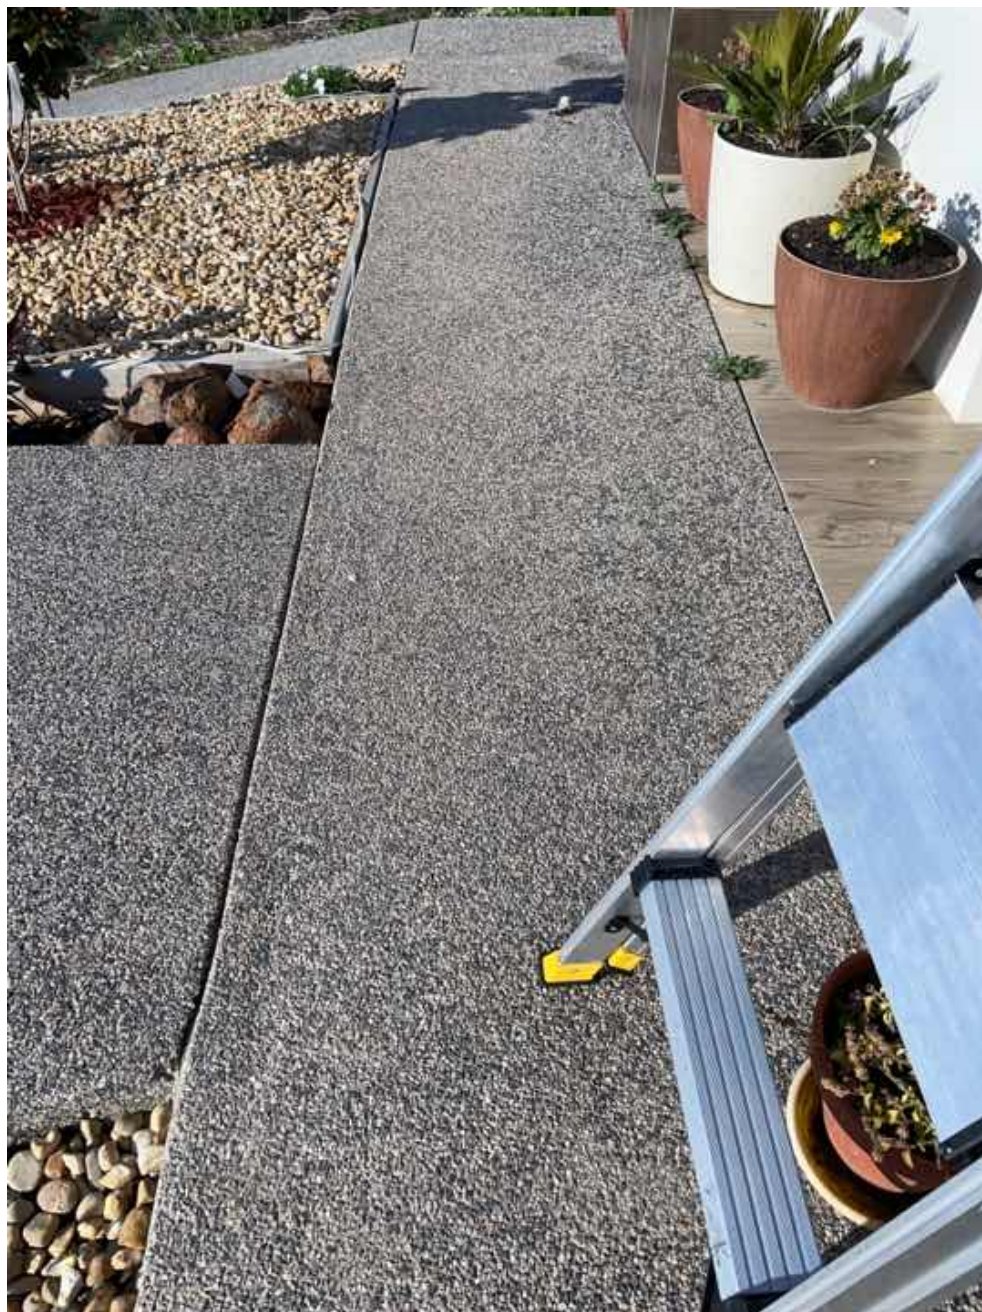
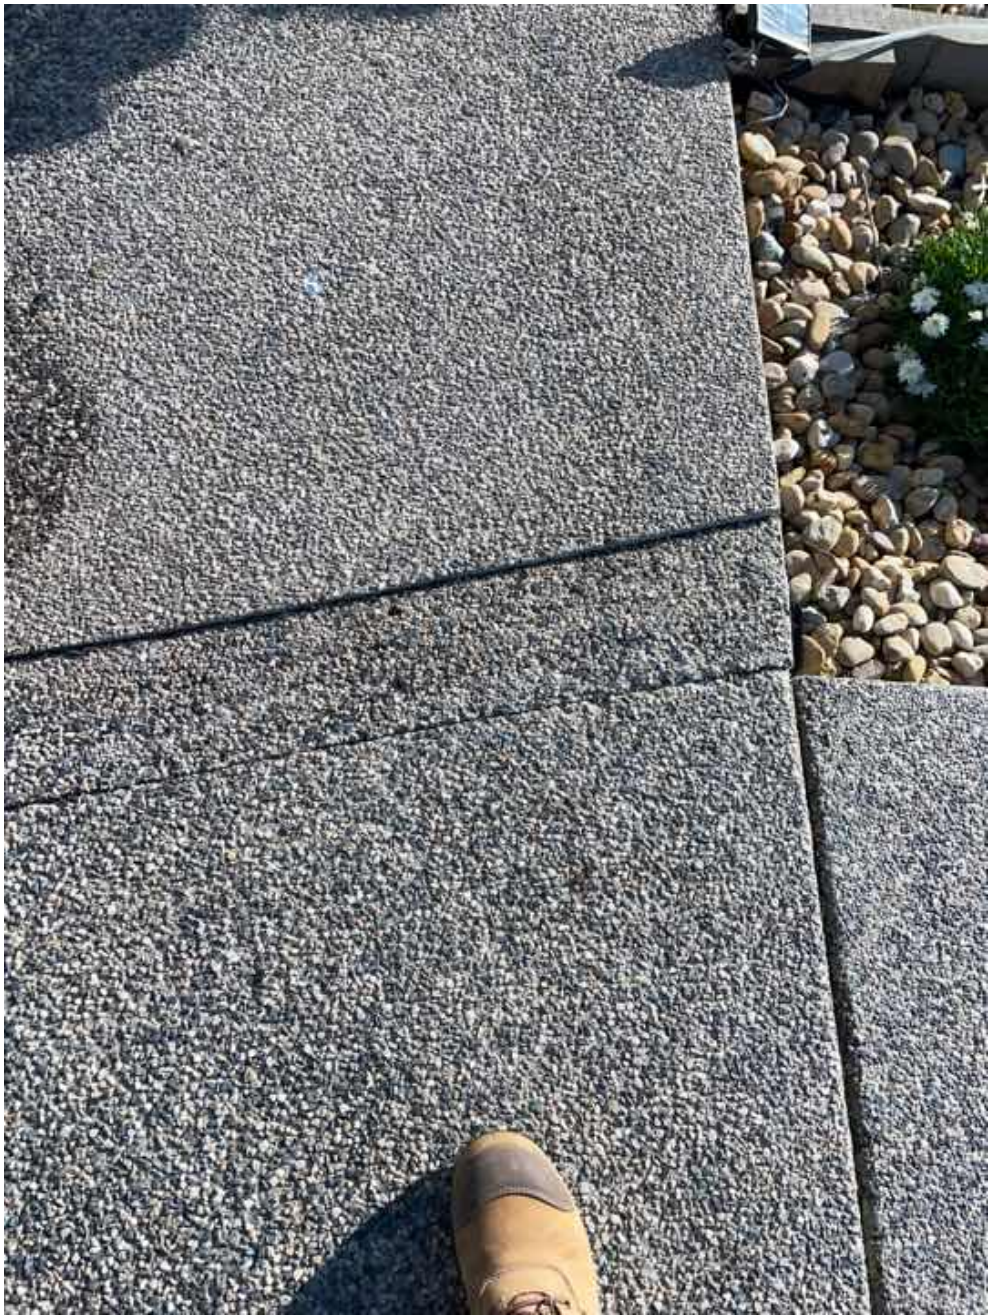
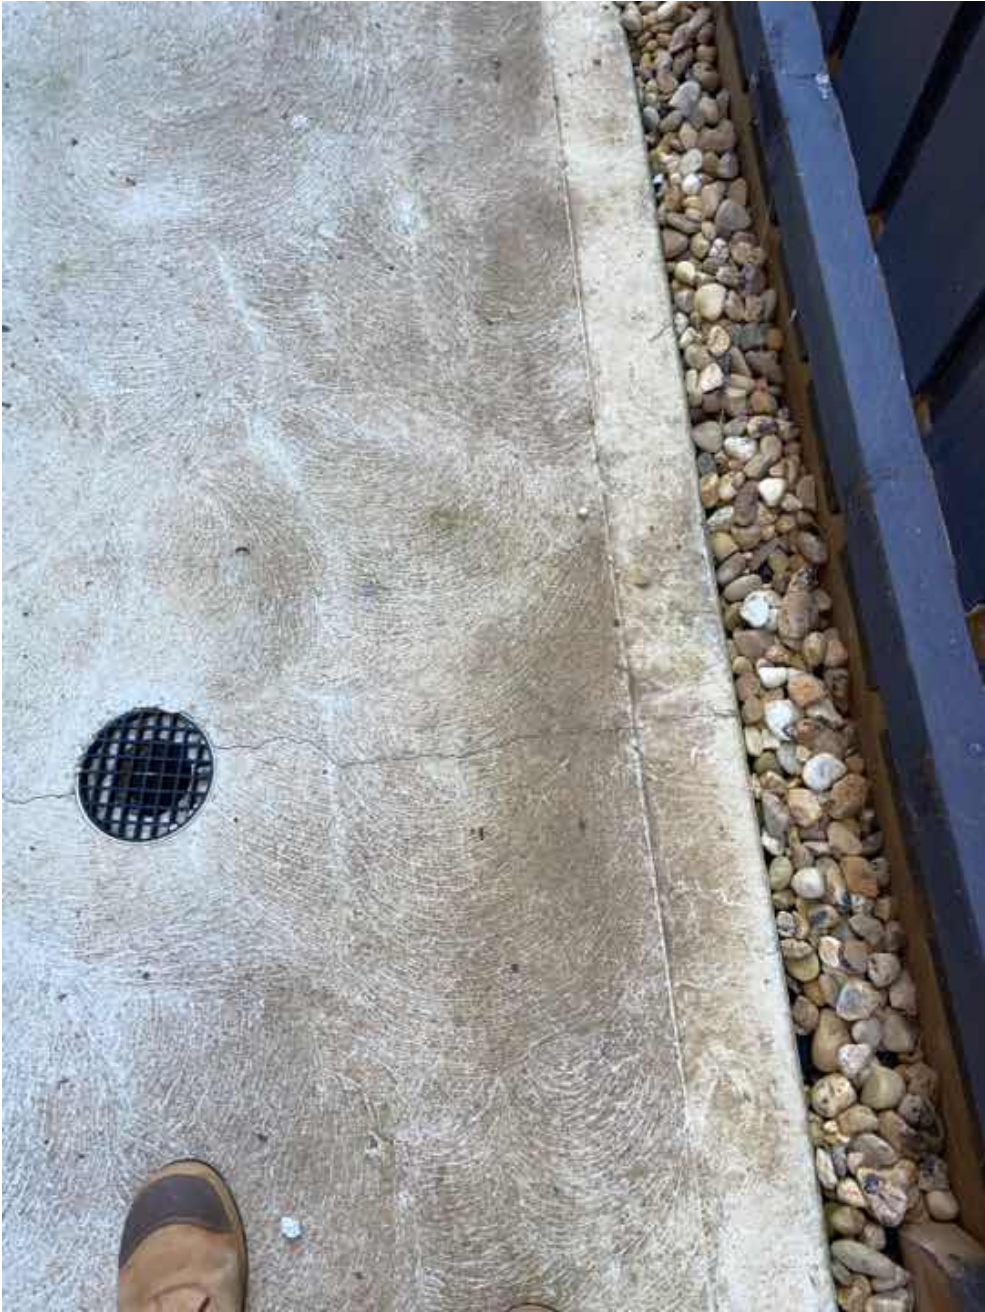
Common cracks and settlement were observed on paths. This may not have any effect on the actual structural integrity of the dwelling itself. Maintenance is recommended. Note: Whilst these cracks appeared to be minor at the time of inspection, we strongly recommend you monitor these cracks and if worsening occurs contact a concreter for further advice.

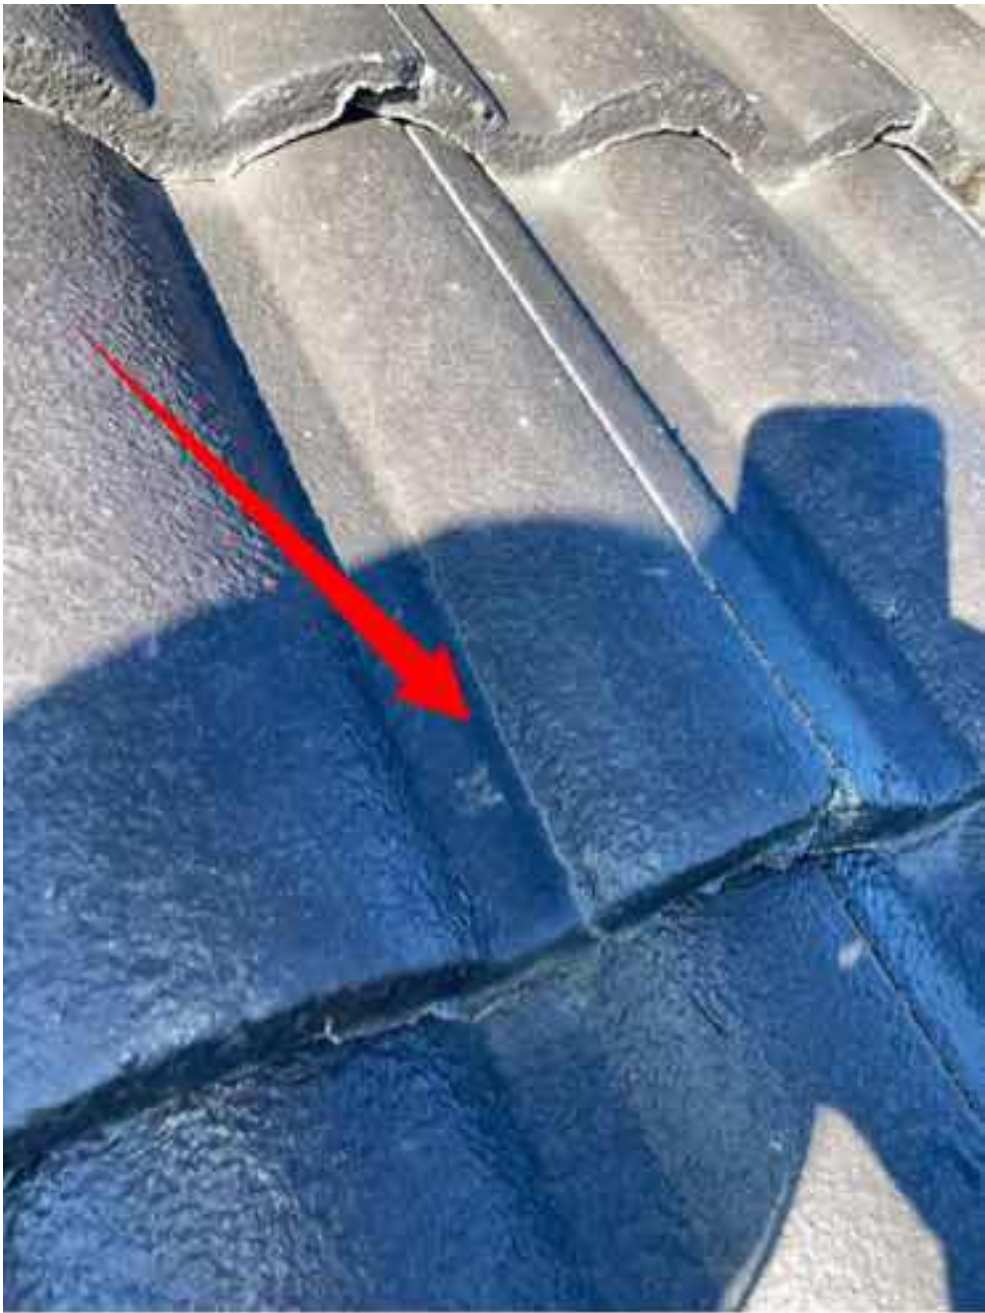
Cracked tiles visible - Recommendations: Contact a roof tiler for repairs. This has potential to become a serious issue if repairs aren't carried out due to water ingress into the roof cavity

Tile lift/unevenness visible - Recommendations: Have roofer re-fix. Considered a minor defect but has the potential to become a Major defect if repairs aren't carried out immediately due to water ingress into the roof cavity

Roof line unevenness visible - Recommendations: May be related to some gaining or loosening of the burrup truss. See a carpenter for advice and recommendations. Considered a Minor Defect, however has the potential to be a costly repair.

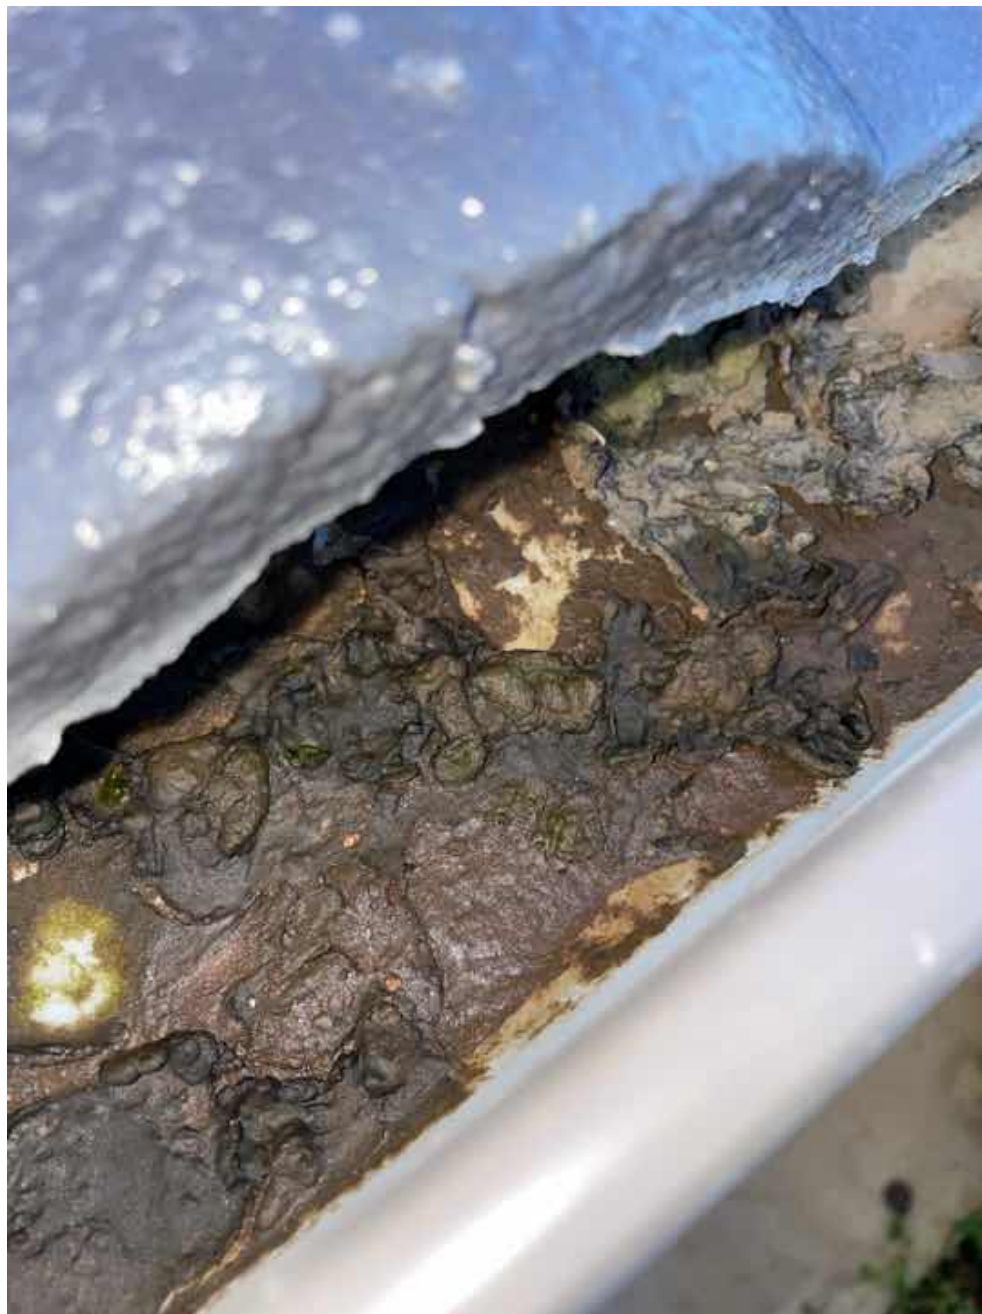
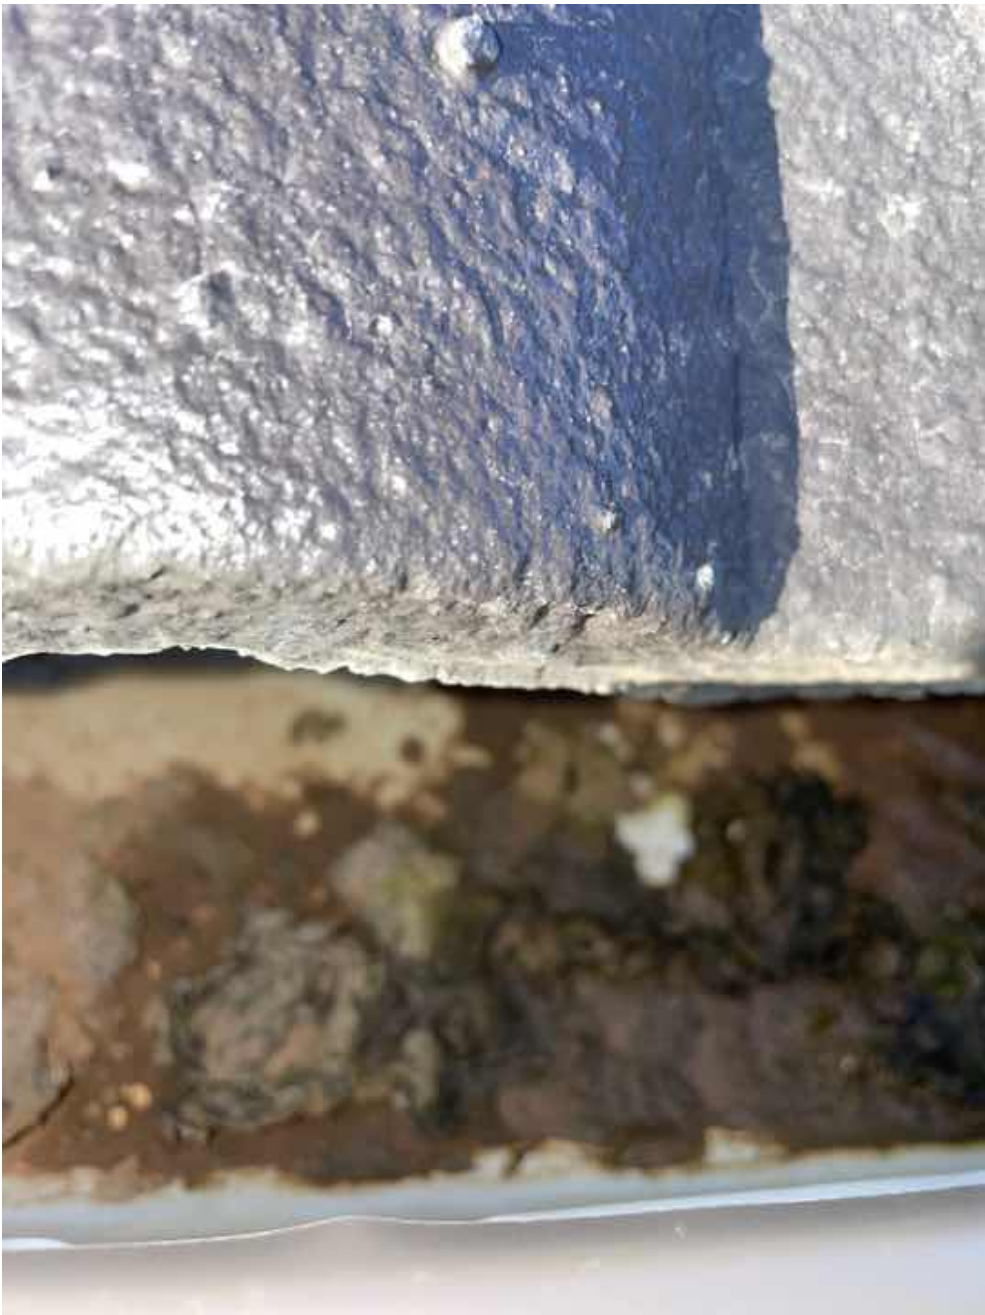
Debris in guttering areas- this requires cleaning out to prevent blocking of down pipes and leaking into eaves and fascia. Recommendations: Have gutters cleaned and assessed by a plumber for adequate fall. Also regularly clean to prevent ponding. Ponding water will contribute to rust.

The gutter fall appears inadequate in areas - Recommendations: A qualified roof plumber should be engaged for repairs and recommendations.

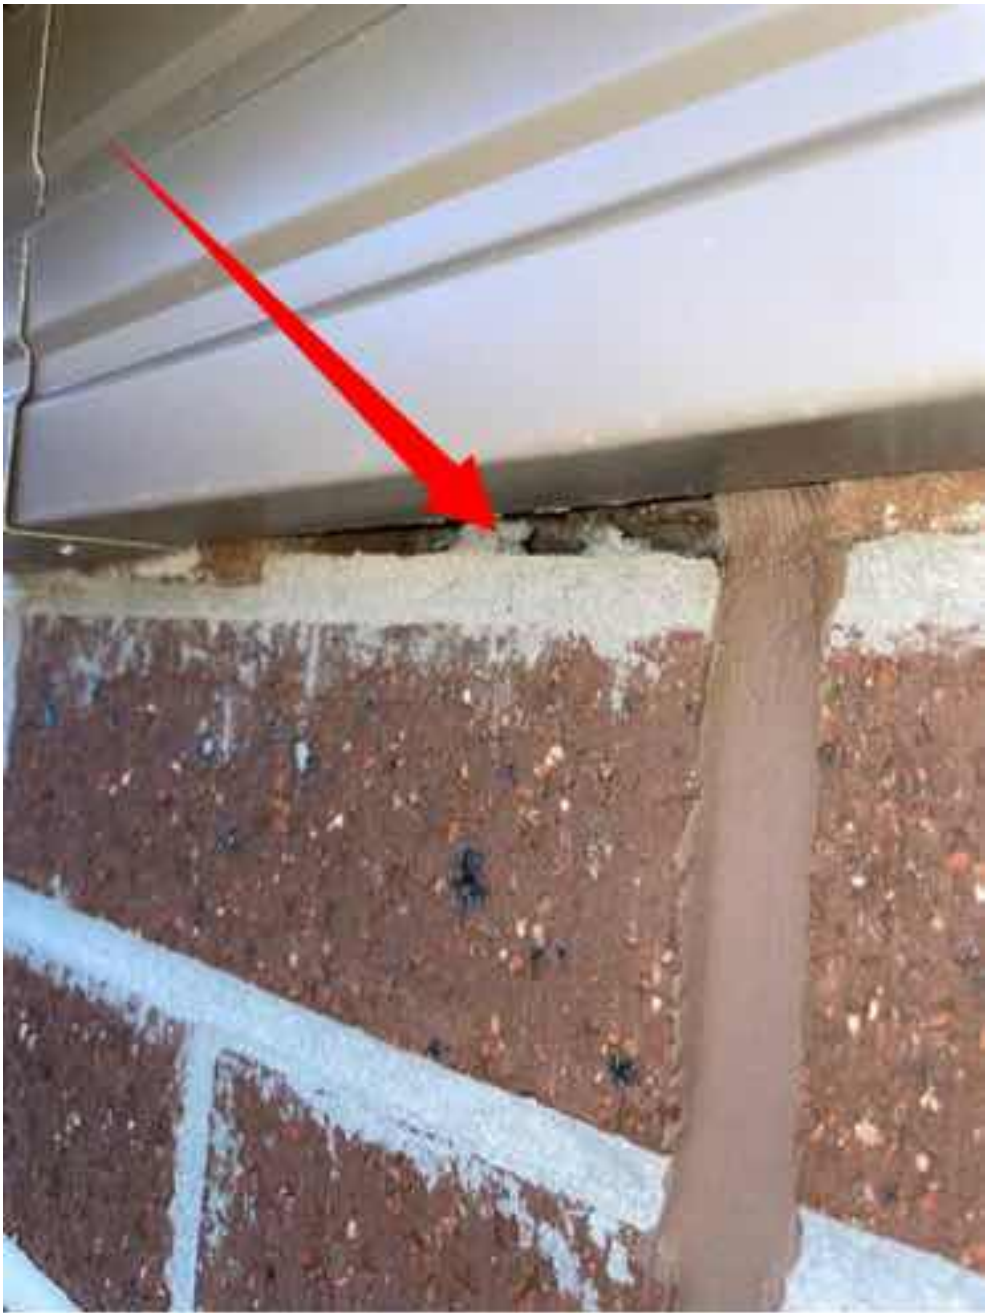
### Cracks noted (Damage Category 3 to 4)

Possible causes may be foundation movement. Support structure deflection. Thermal movement and moisture uptake or loss, failure under external loads. In the inspectors opinion these cracks require further assessment. A structural engineer should be consulted for further evaluation and advice.

Mortar between the brickwork is eroded. Contact a licensed bricklayer for repairs.

Minor brick damage observed to the brickwork. Have repaired by a licensed brick layer.

Penetration openings observed. I recommend sealing these off so as to avoid vermin and other pest infestation.

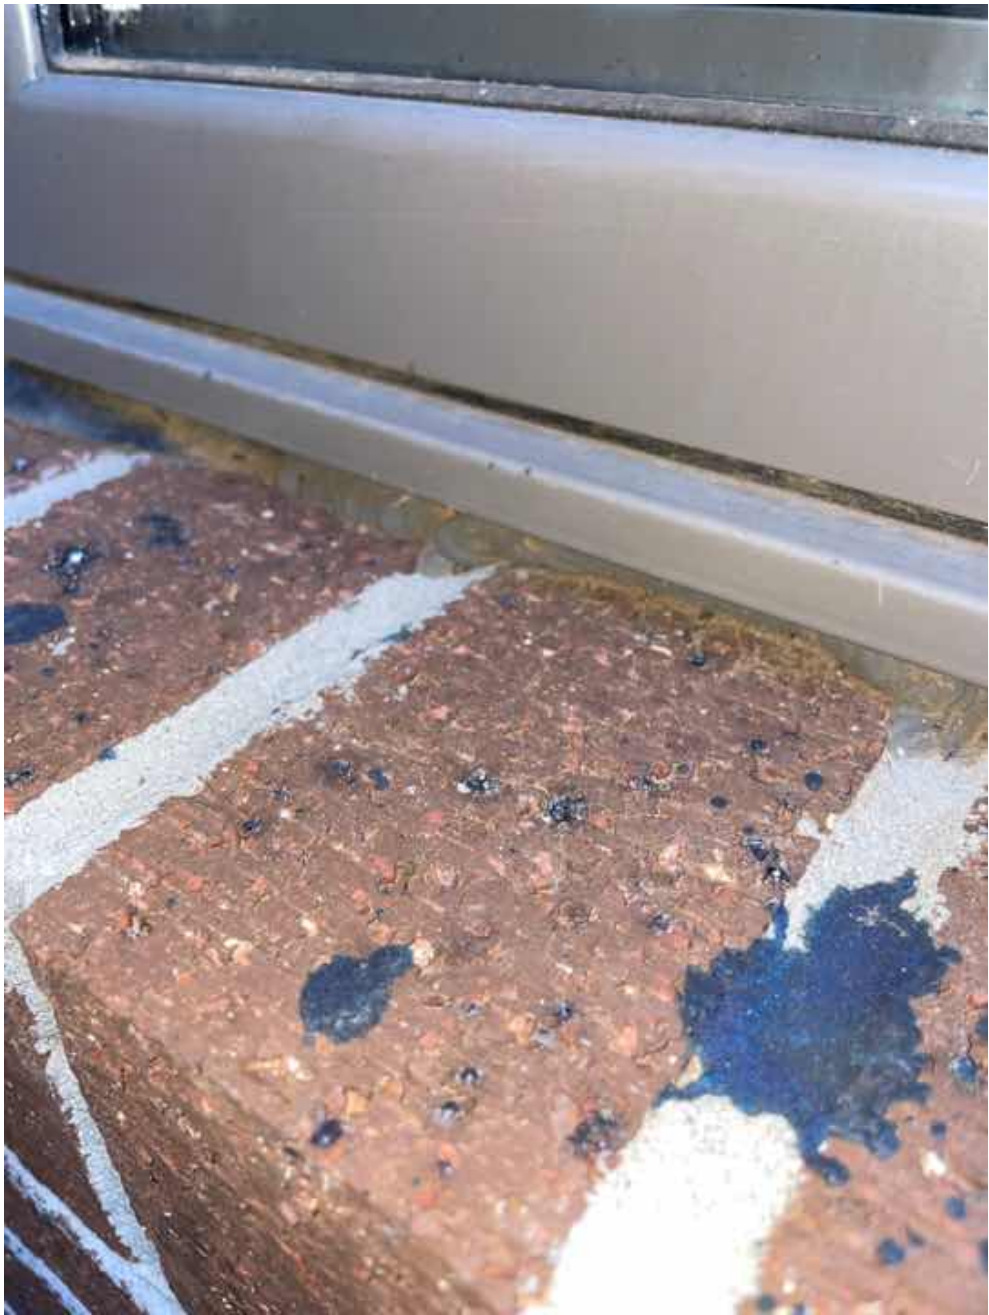
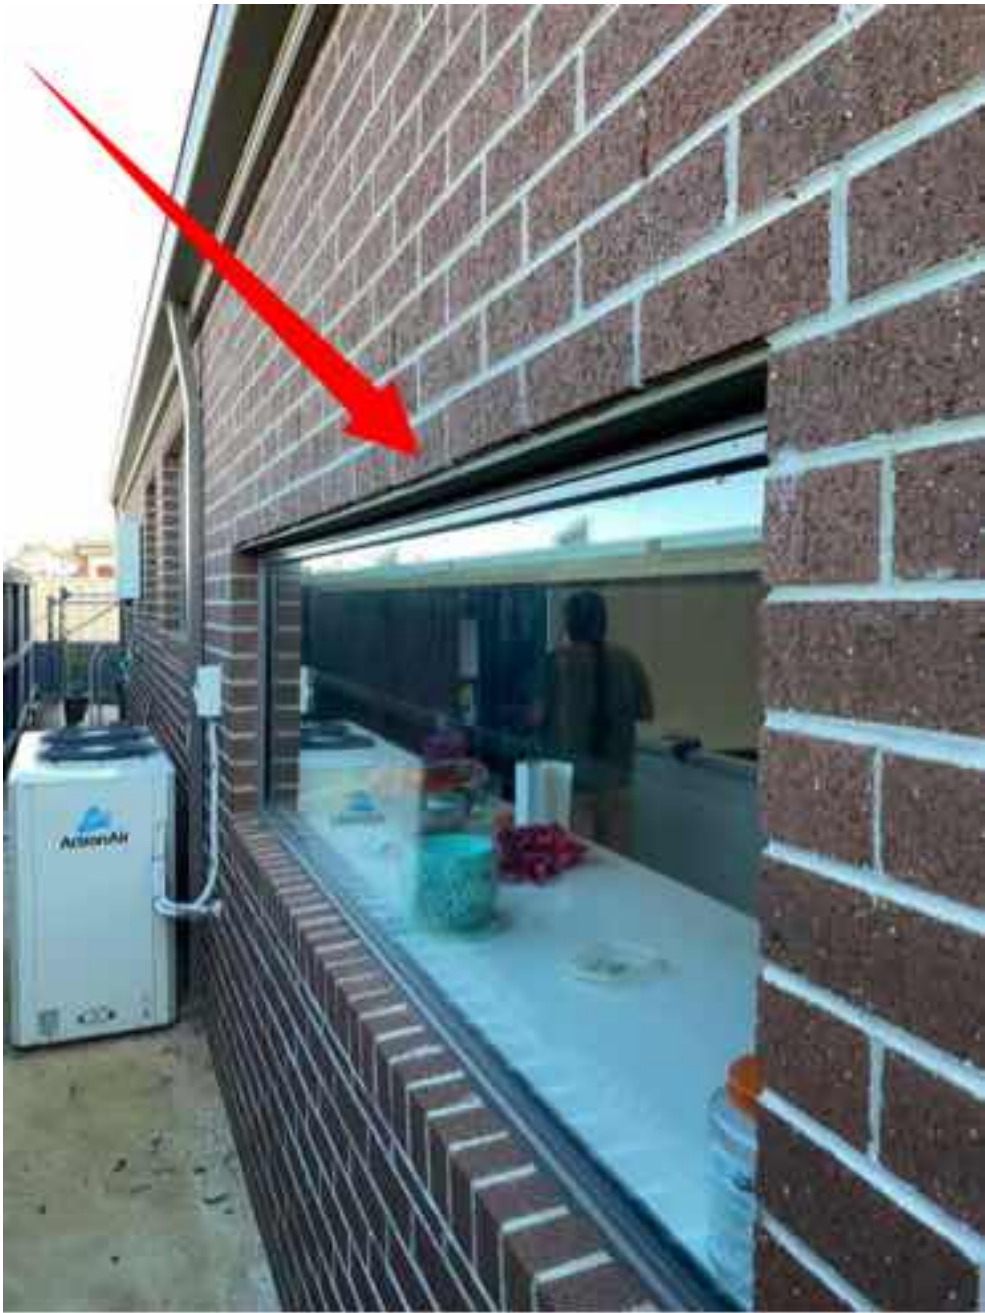
Gaps between window frame and wall cladding evident - This can be due to poor workmanship, wall movement, footings settlement. Recommendations: A qualified carpenter should be engaged for advice and recommendations.

Lintel sagging in sections. This may cause cracking in wall linings above the window - Recommendations: A qualified brick layer should be engaged for repairs and recommendations.

Deterioration of sections of window rubber seals was observed - Recommendations: A qualified glazier should be engaged for advice and recommendations.

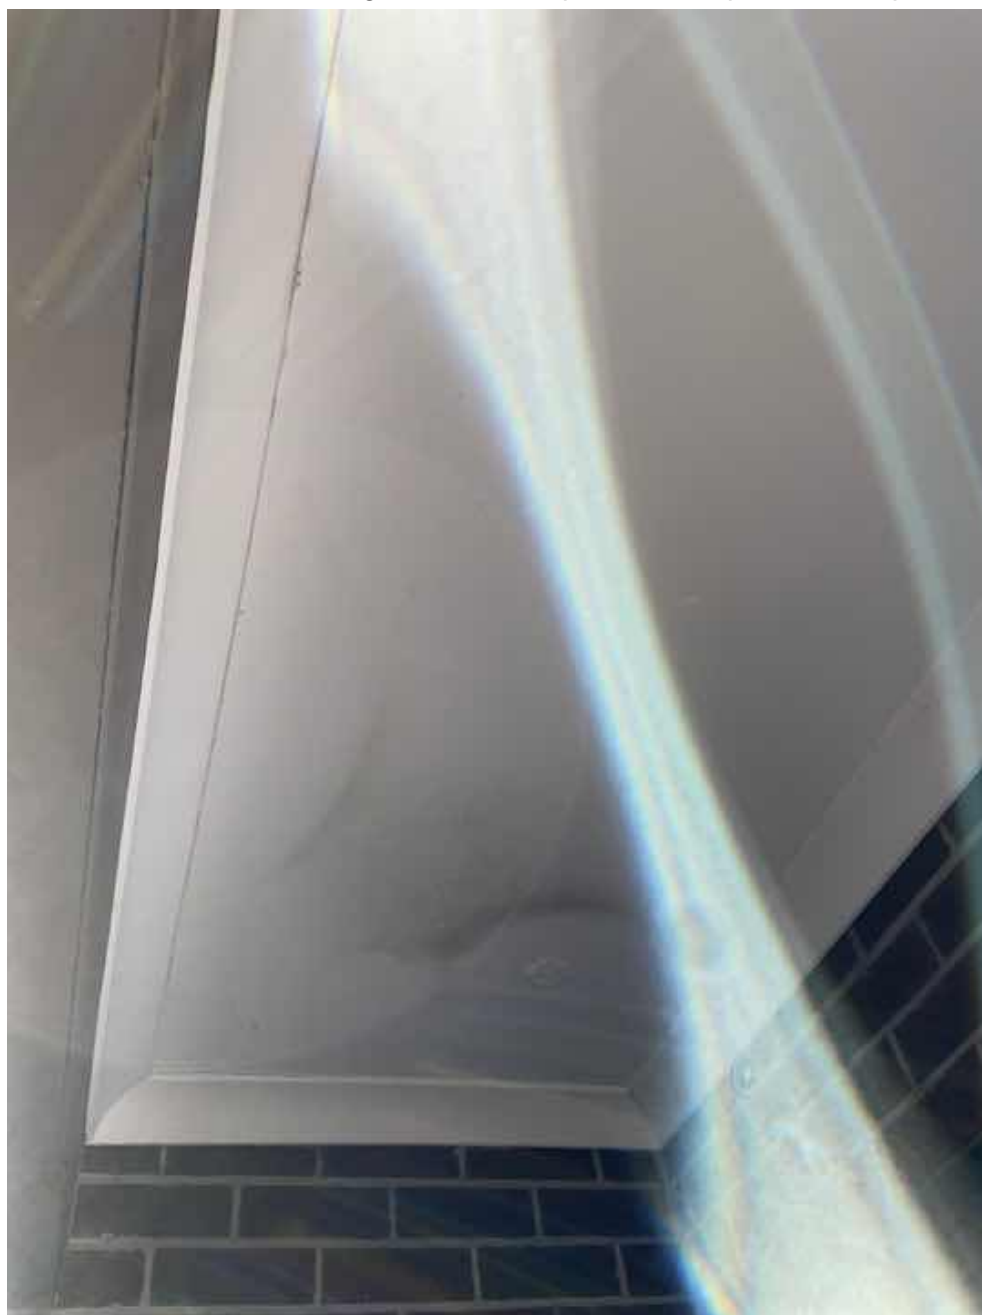
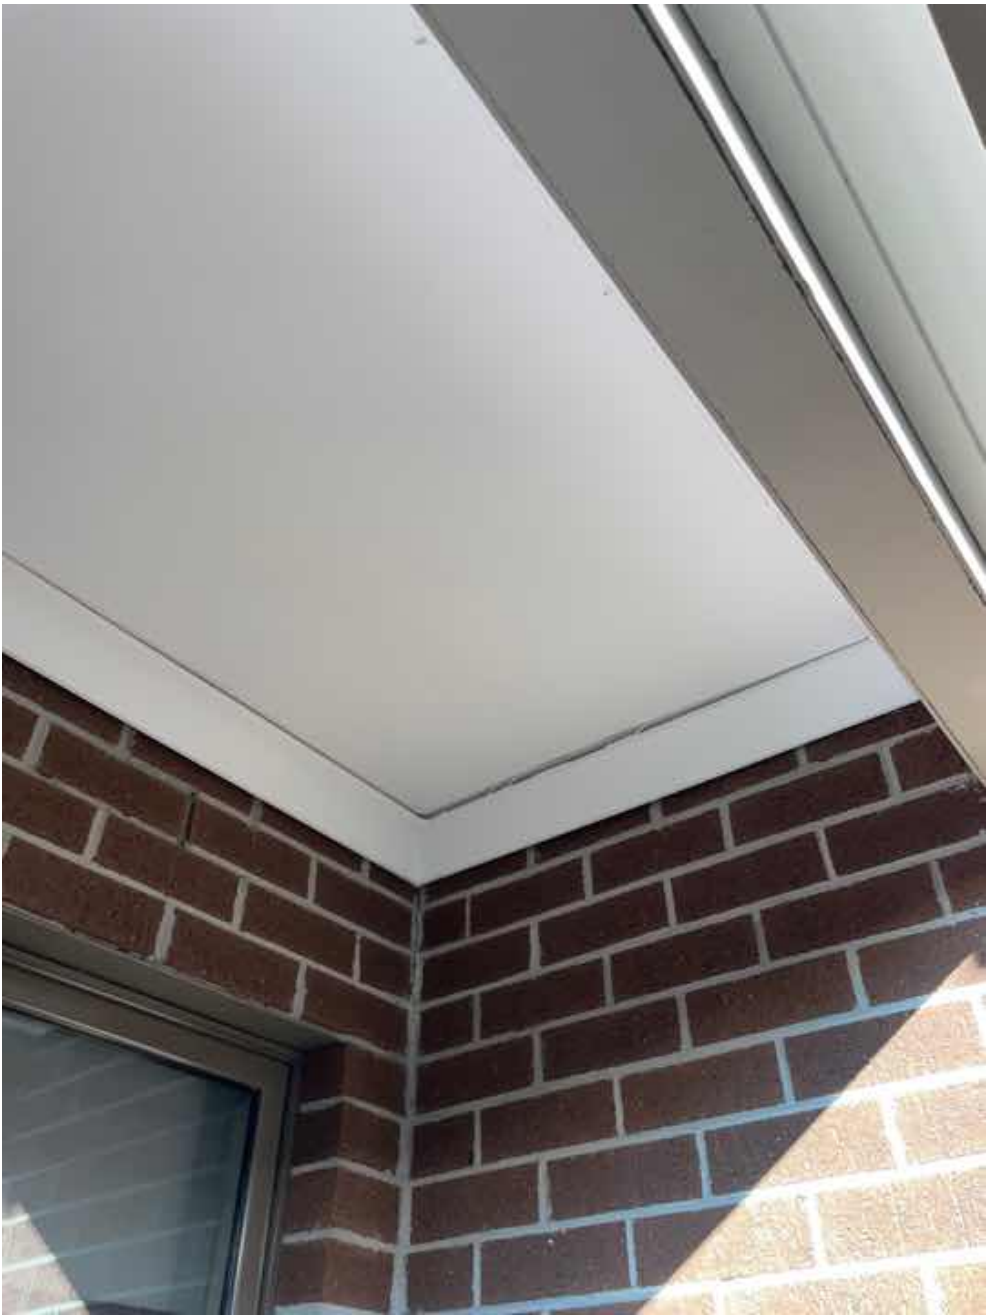
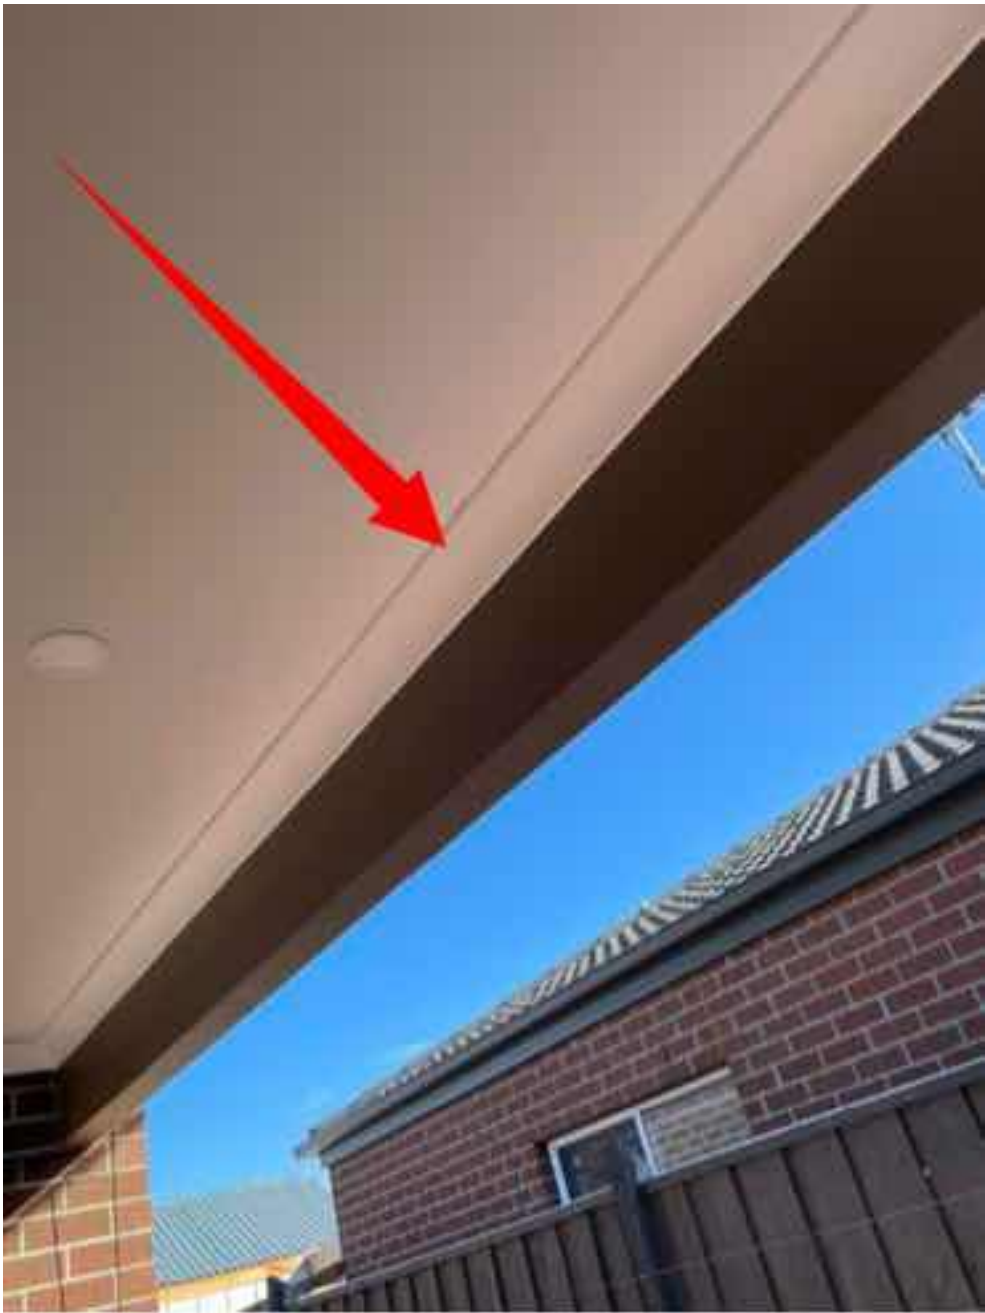
Eave lining damage visible. Recommendations: A qualified carpenter should be engaged for repairs.

We strongly recommend you re-finish and paint the eaves and timber trim to preserve same.

Eave lining stains observed. Normally this occurs due to overflow in blocked gutters. Recommendations. Gutters should be kept clear of debris and eave linings can then be painted or repaired as required.

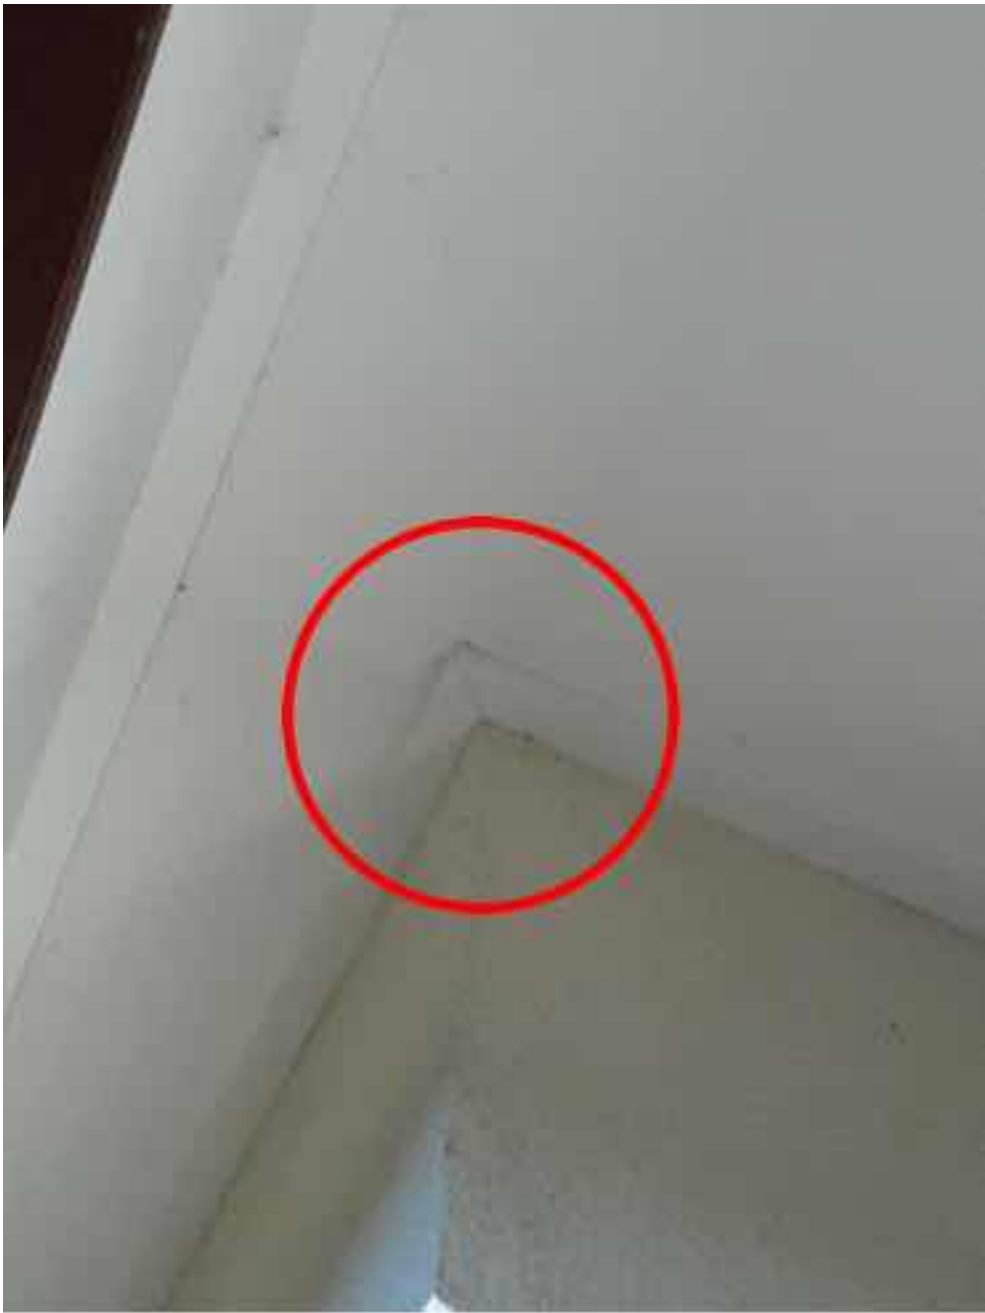
Ceiling lining join cracks. Contact a licensed plasterer for repairs.

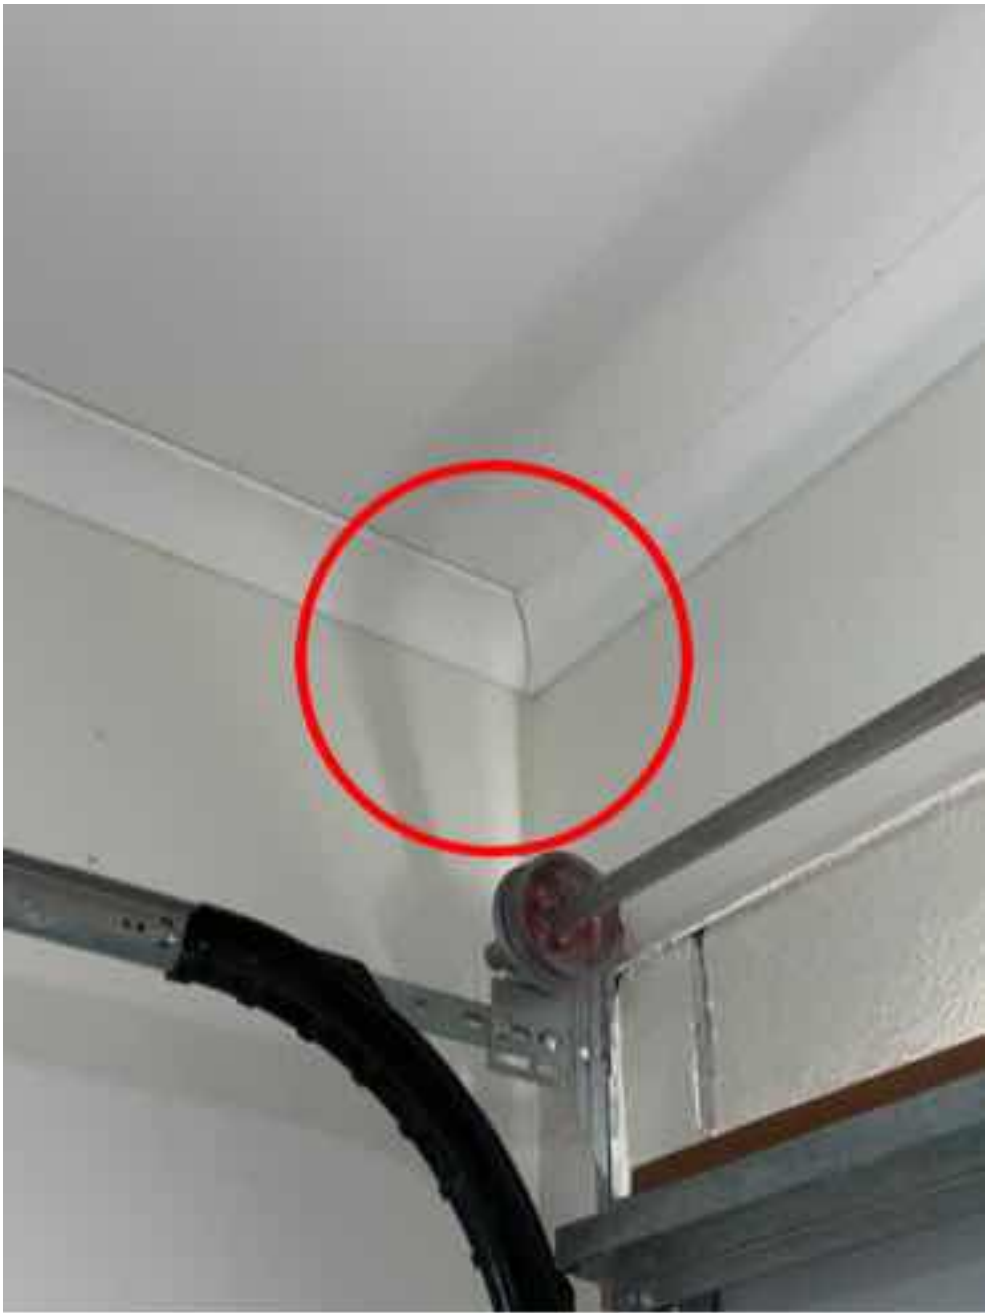
Cornice separation - I recommend you contact a licensed plasterer for repairs.

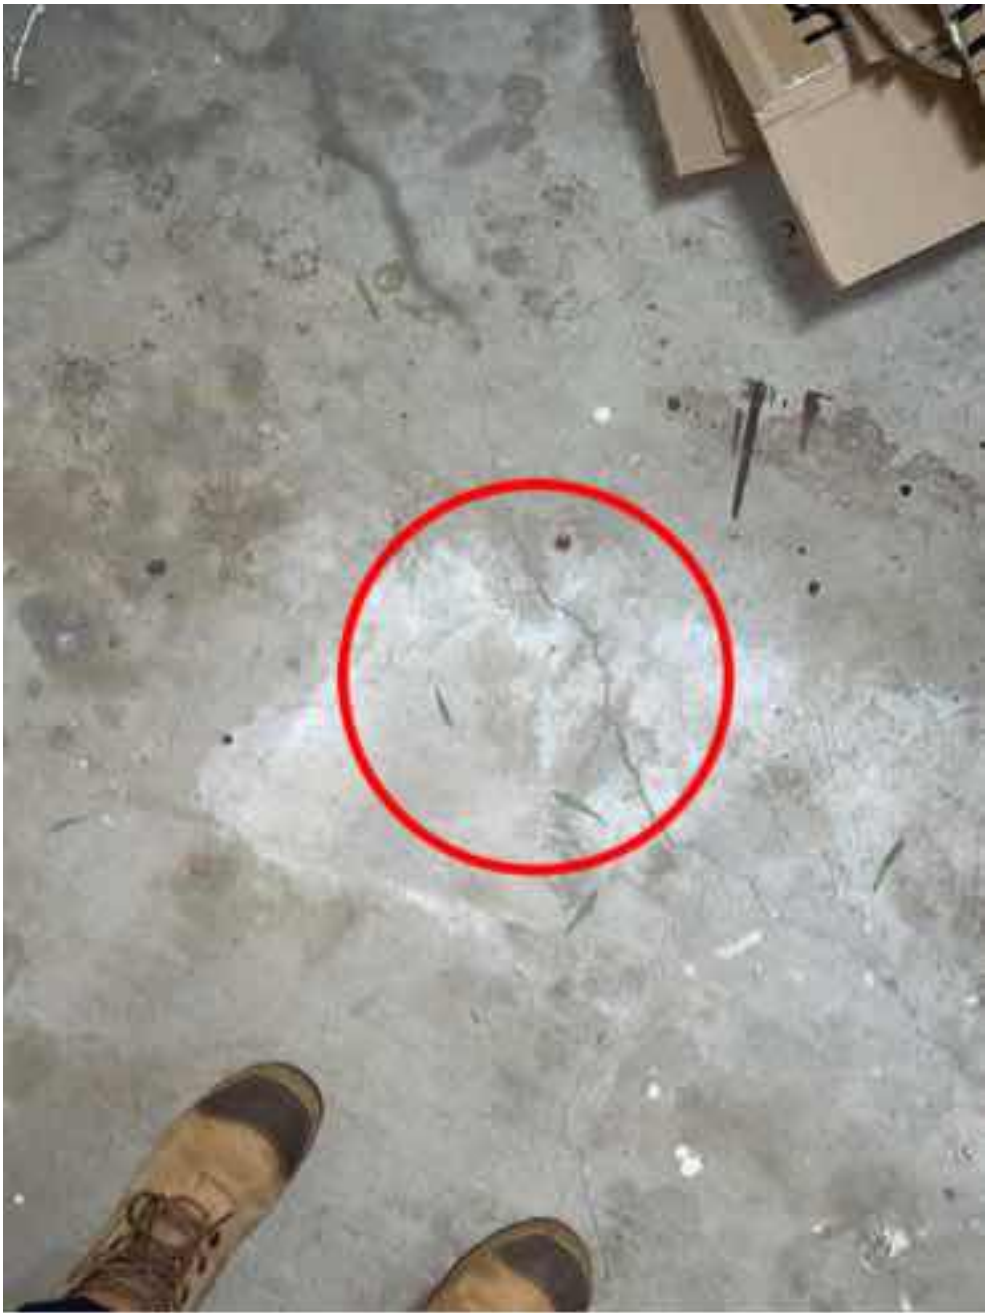
Minor hairline slab cracks - Note. Whilst these cracks appeared to be minor at the time of inspection, we strongly recommend you monitor these cracks and if worsening occurs contact a qualified concreter for further advice.
