# Post Completion Defect Inspection Report

**Example, VICTORIA, 3024**

Report/Agreement #              0807210944395

Inspection Date:                  08 Jul 2021

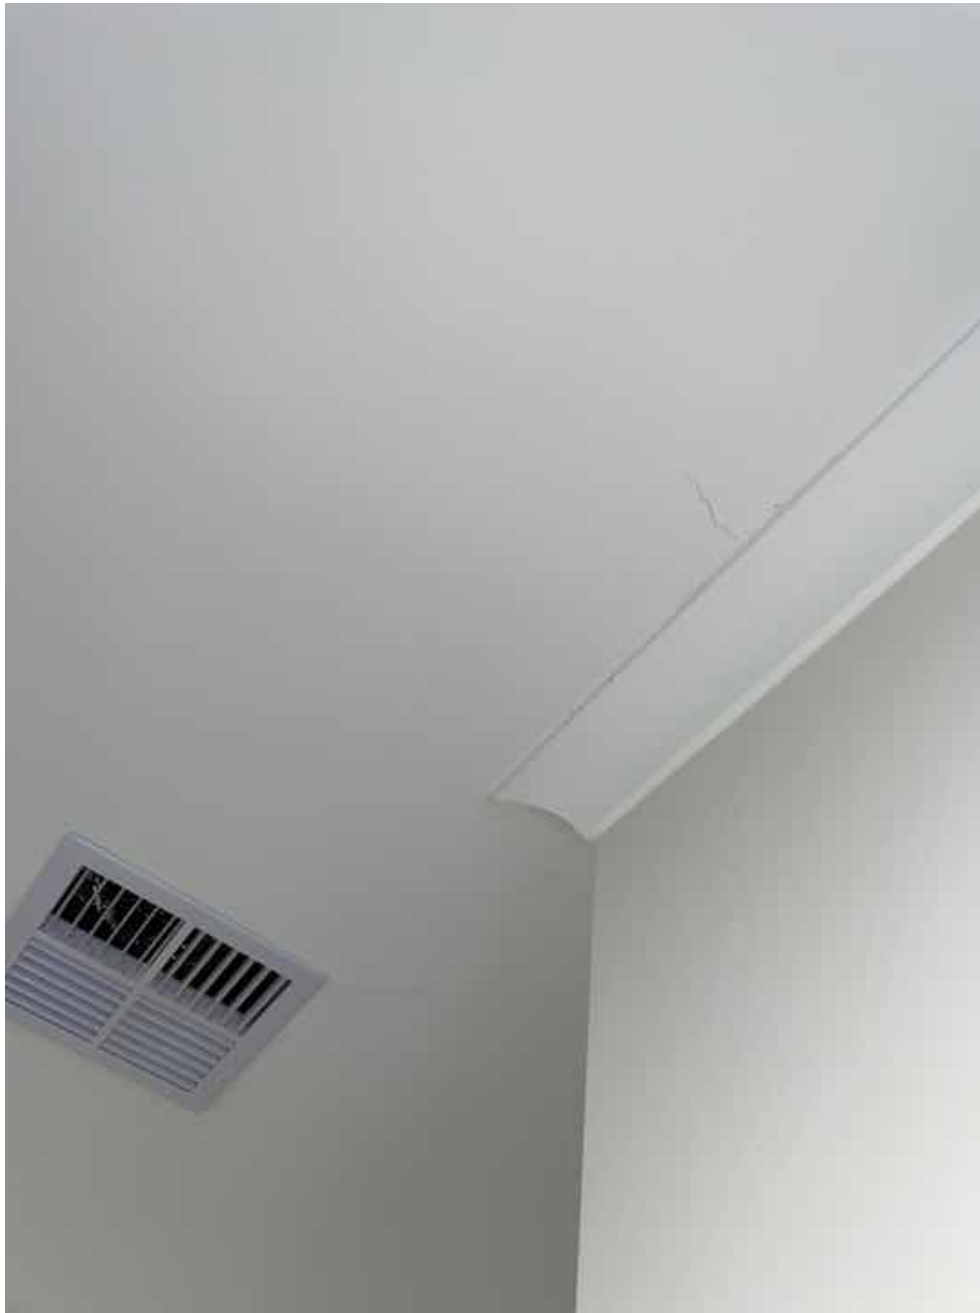
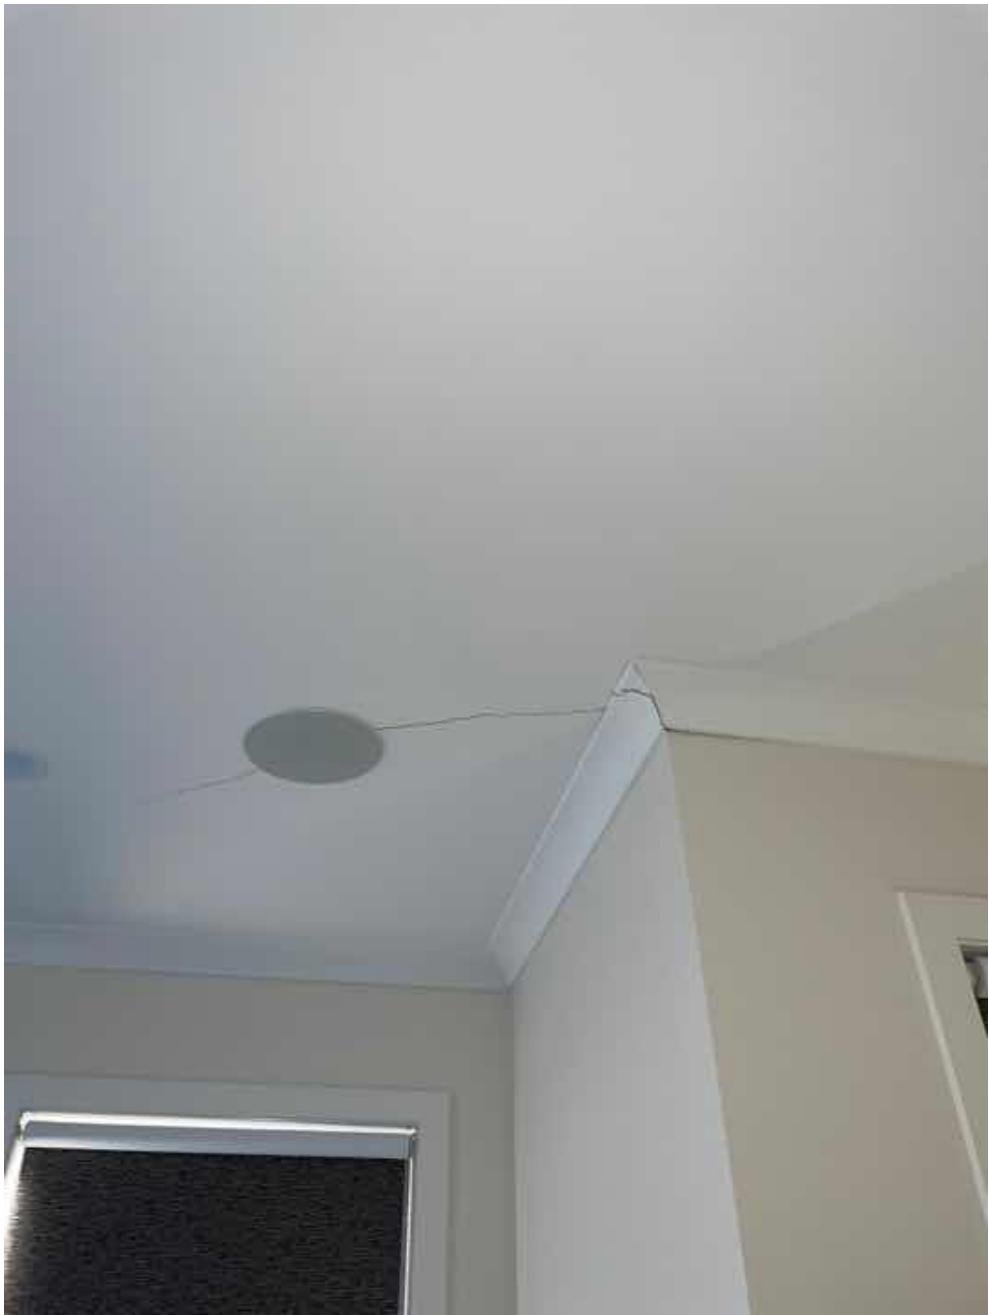
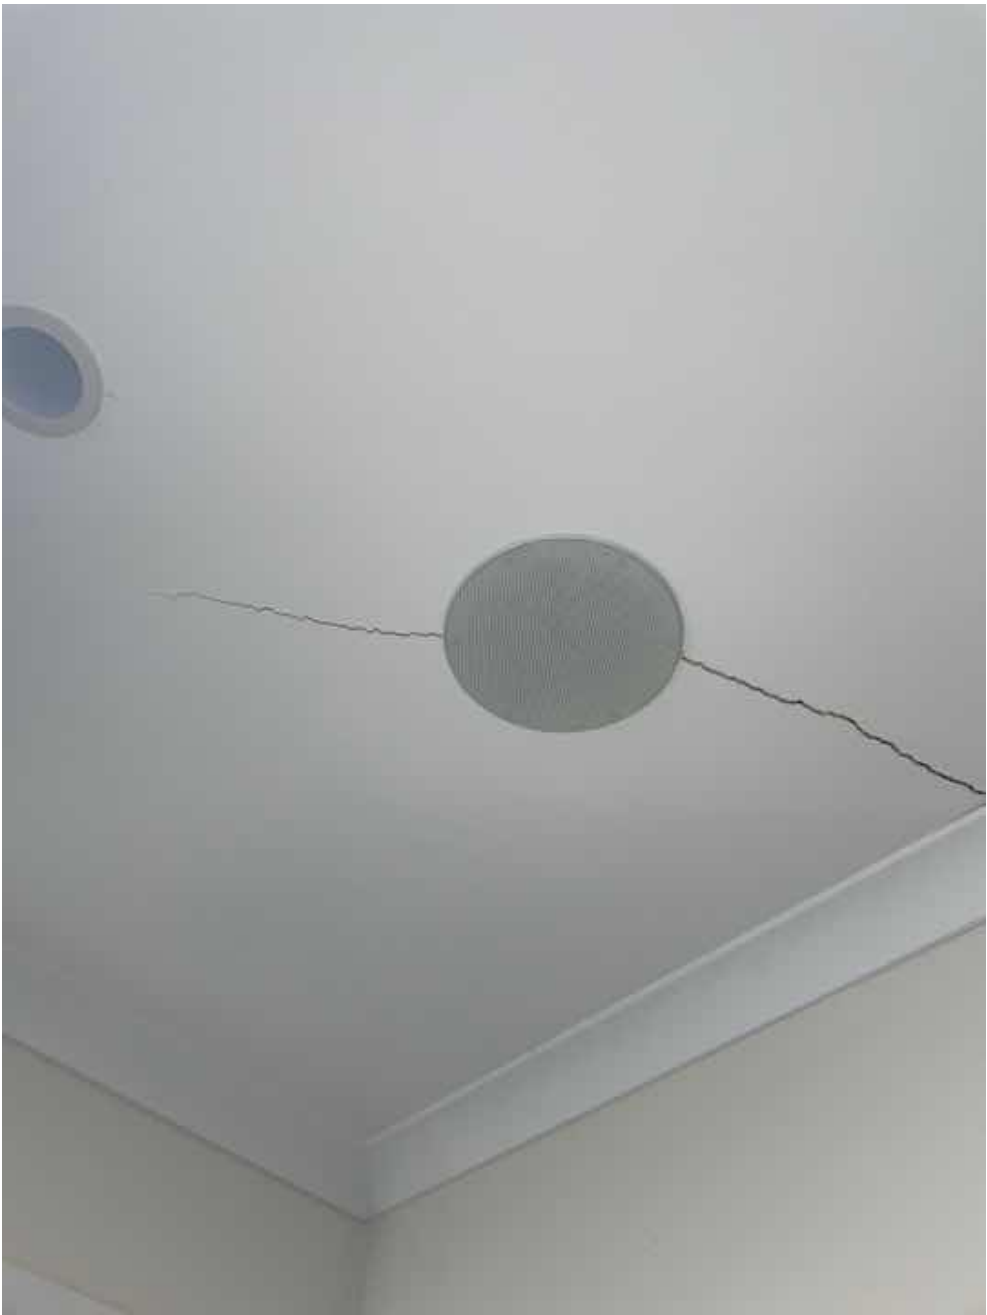
Settlement Cracks Noted . These are typical and generally patch and paint will suffice, however Monitoring these cracks advised for 12 months and if become wider or longer, you will need to contact a structural engineers to assess.

Major Cracks - Excessive, multiple or wide cracking visible. Recommendations: Contact a qualified structural engineer for further advice and recommendations.

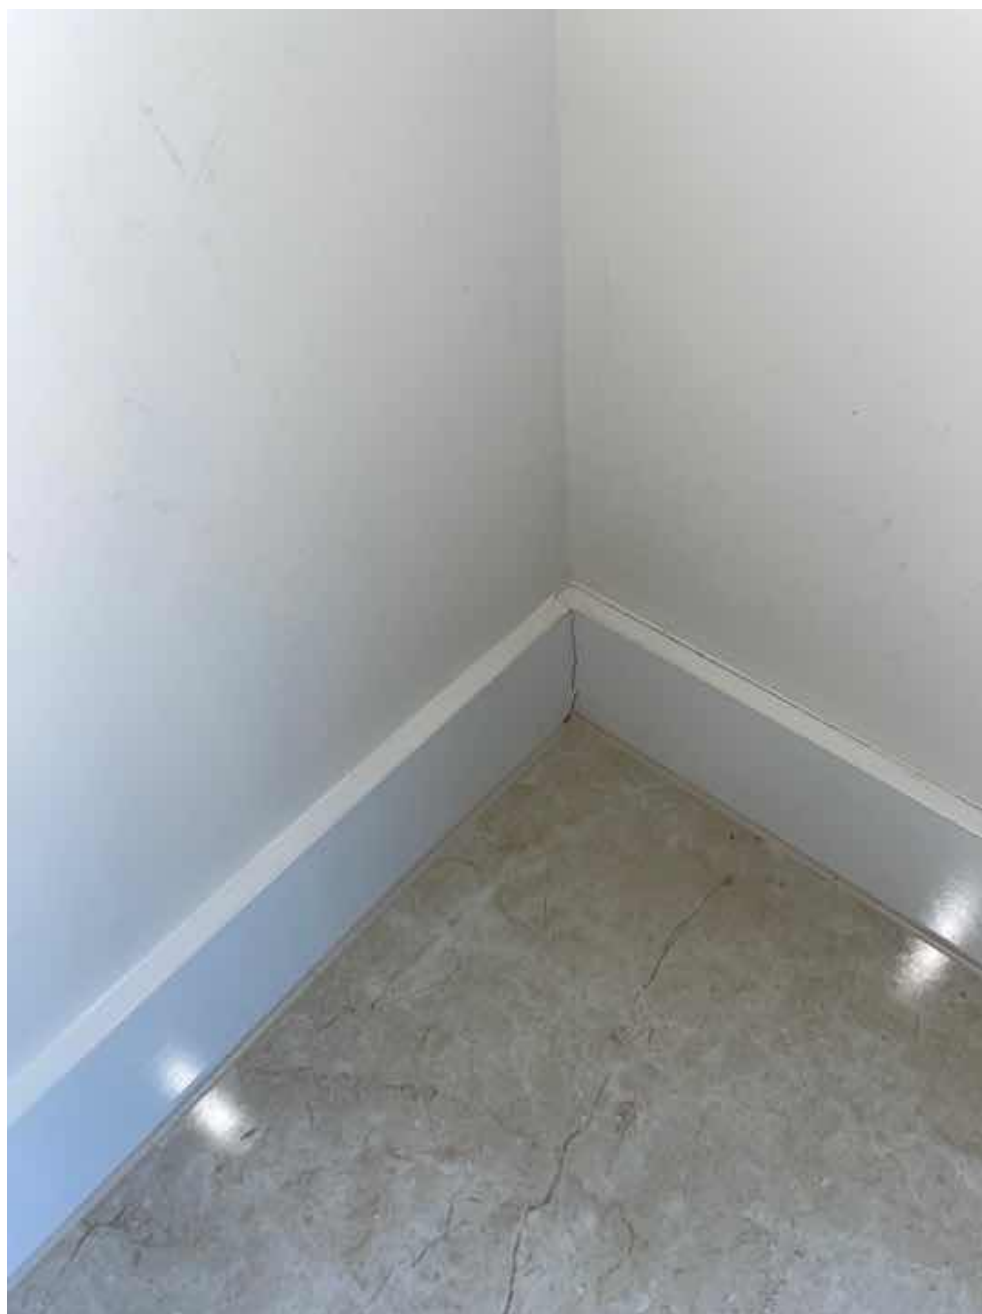
Settlement Cracks Noted. These are typical and generally patch and paint will suffice, however we recommend monitor these cracks and if become wider or longer, you will need to contact a structural engineers to assess.

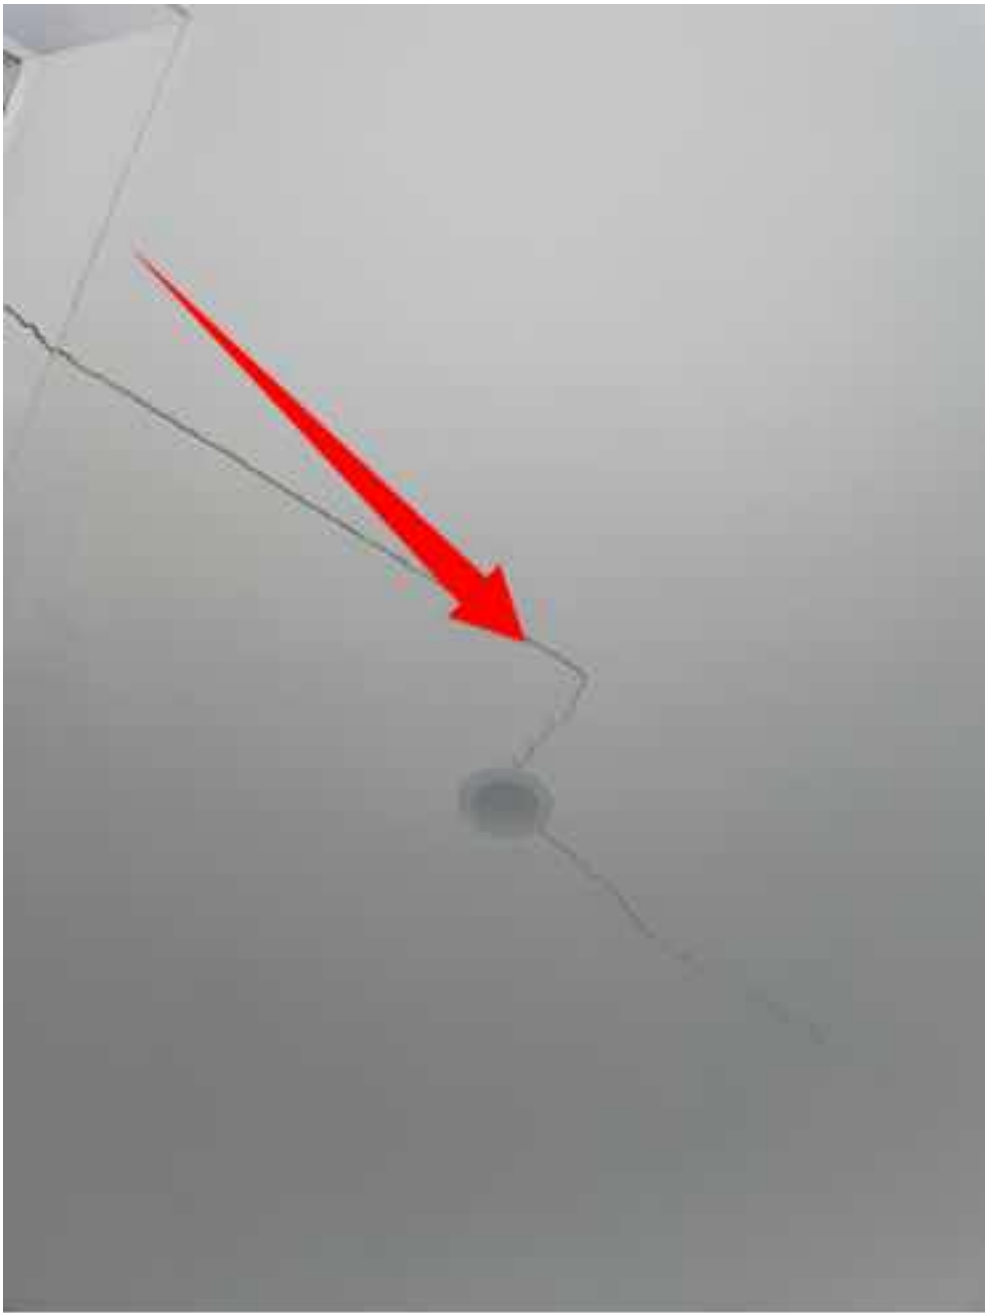
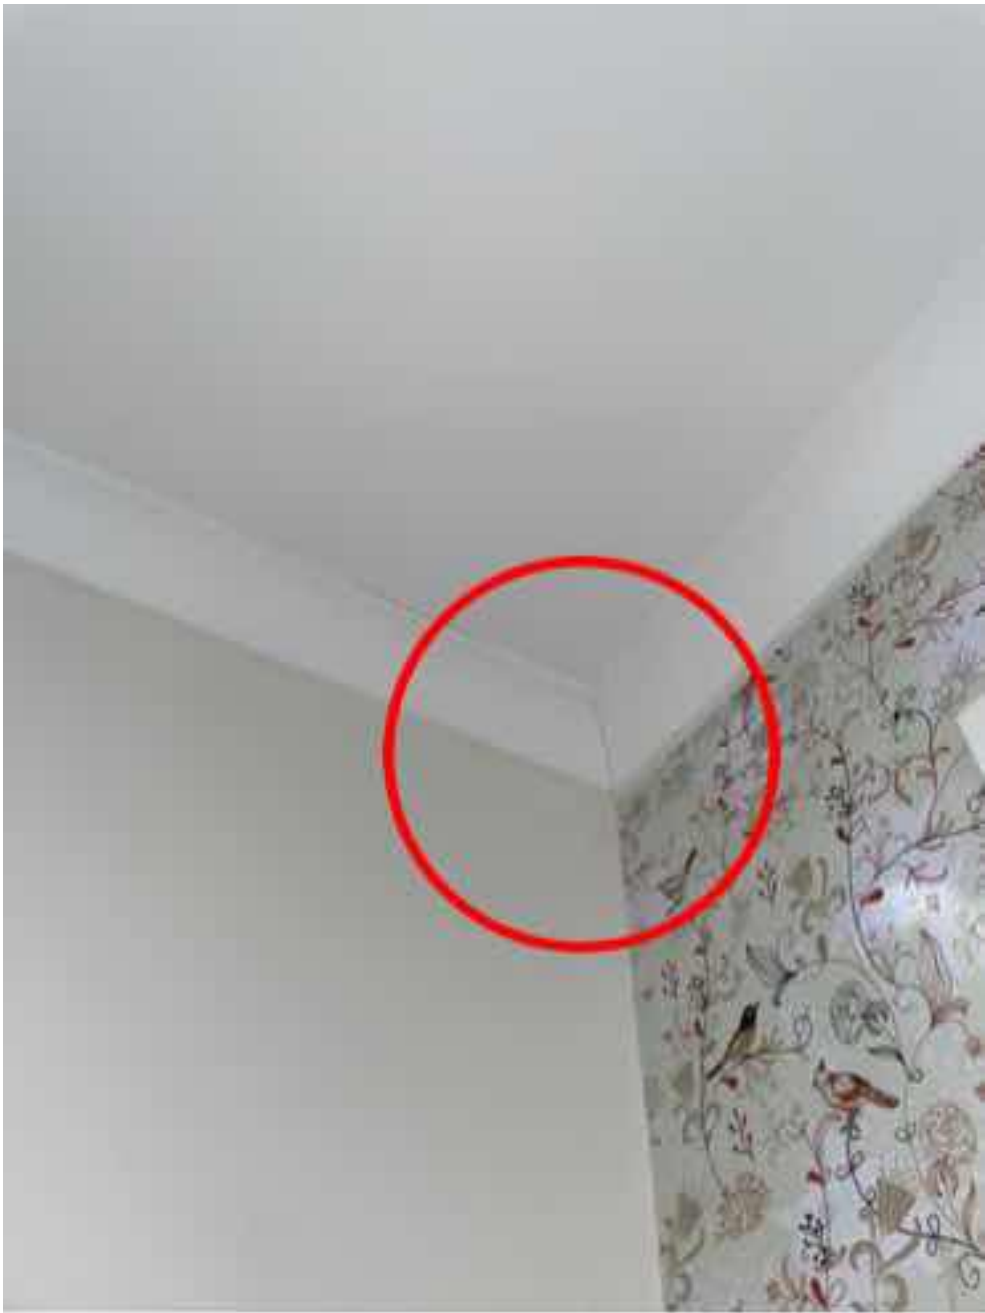
INTERIORS	Combo Lounge & Dining Room	Ceiling	Major Cracks - Excessive, multiple or wide cracking visible. Recommendations: Contact a qualified structural engineer for further advice and recommendations.
INTERIORS	Combo Lounge & Dining Room	Flooring	Cracked floor tiles noted - Recommendations: A qualified tiler should be engaged for repairs.
INTERIORS	Combo Lounge & Dining Room	Flooring	Unevenness visible in floor - Recommendations: A qualified carpenter should be engaged for advice and recommendations re levelling.
INTERIORS	Bedroom 1	Windows	Moisture damage and high moisture readings recorded. Possible water ingress. Or condensation. Contact a glazier for repairs.
INTERIORS	Bedroom 2	Walls	Major Cracks - Excessive, multiple or wide cracking visible. Recommendations: Contact a qualified structural engineer for further advice and recommendations. It appears the property has had significant sagging to the slab where the external walls and load points are supported. Underpinning of the exterior walls is highly recommended to prevent further deterioration. Once Underpinning has been carried out, remedial works will need to be carried out to repair the damage.

Settlement Cracks Noted . These are typical and generally patch and paint will suffice, however Monitoring these cracks advised for 12 months and if become wider or longer, you will need to contact a structural engineers to assess.

Major Cracks - Excessive, multiple or wide cracking visible. Recommendations: Contact a qualified structural engineer for further advice and recommendations.

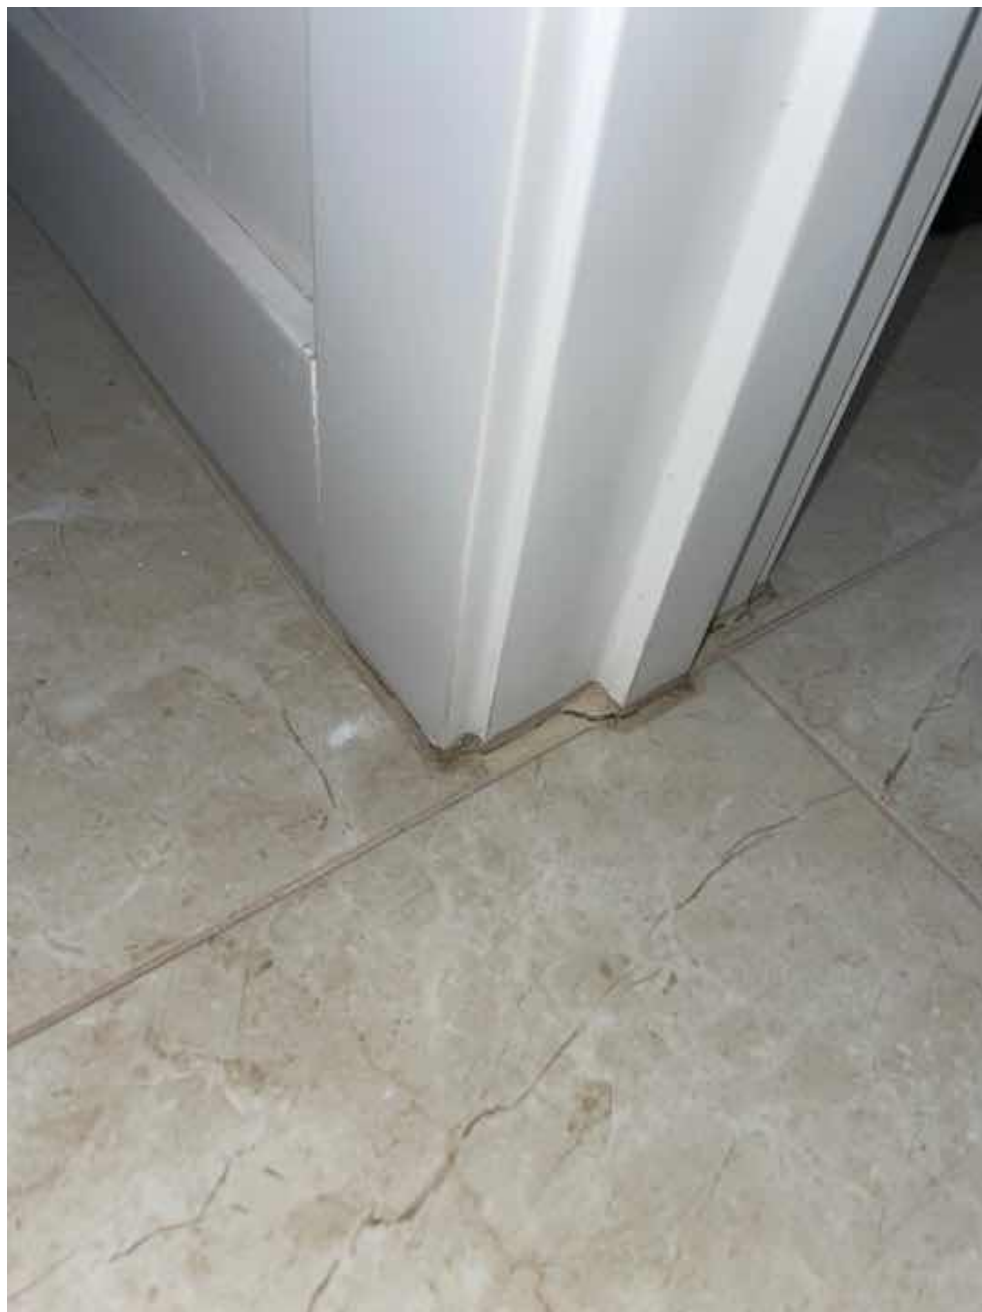
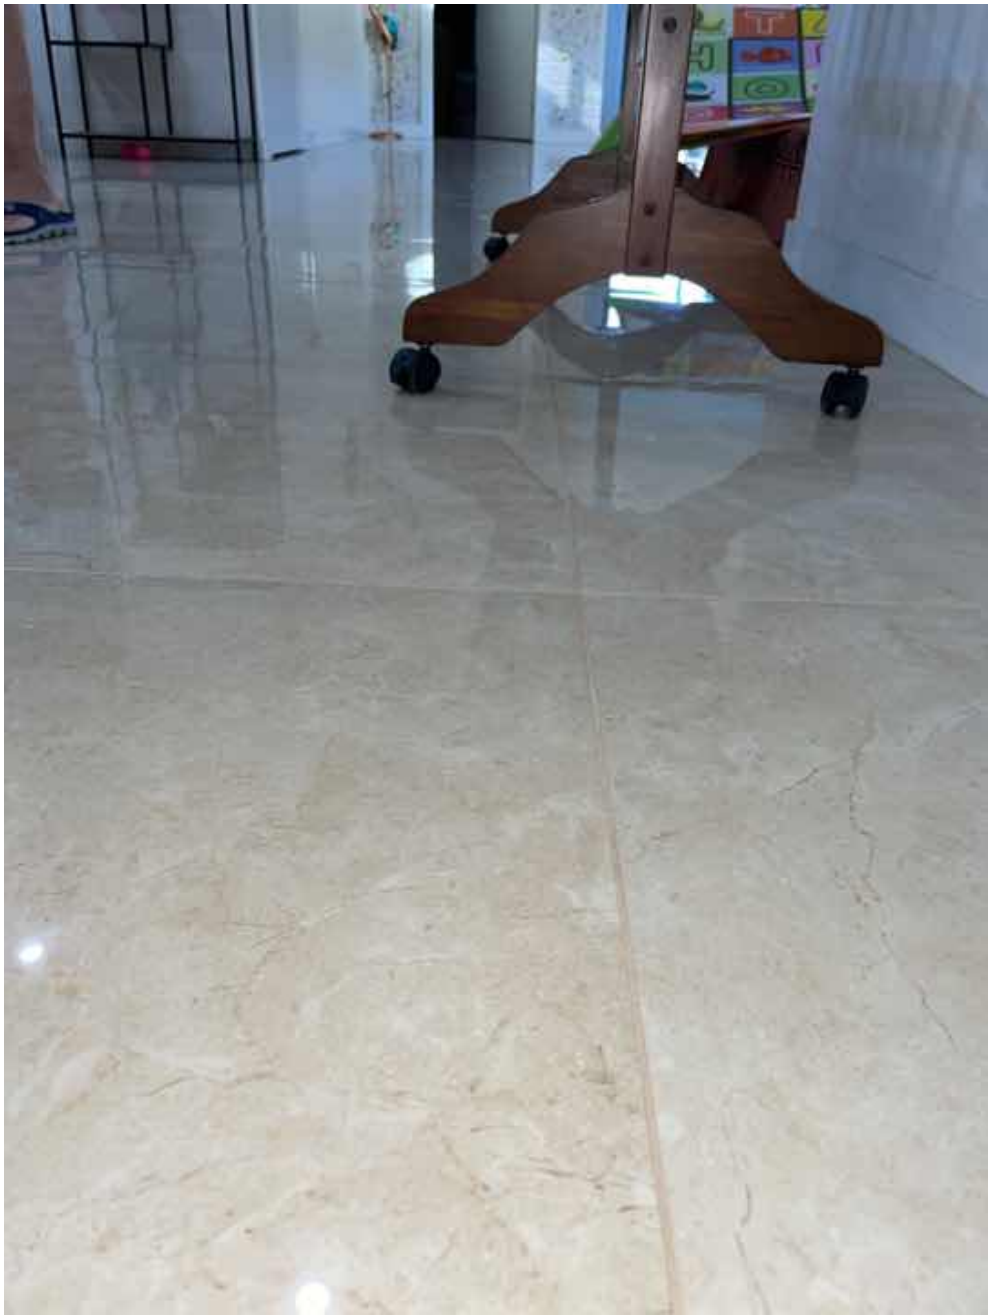
Cracked floor tiles noted - Recommendations: A qualified tiler should be engaged for repairs.

Unevenness visible in floor - Recommendations: A qualified carpenter should be engaged for advice and recommendations re levelling.

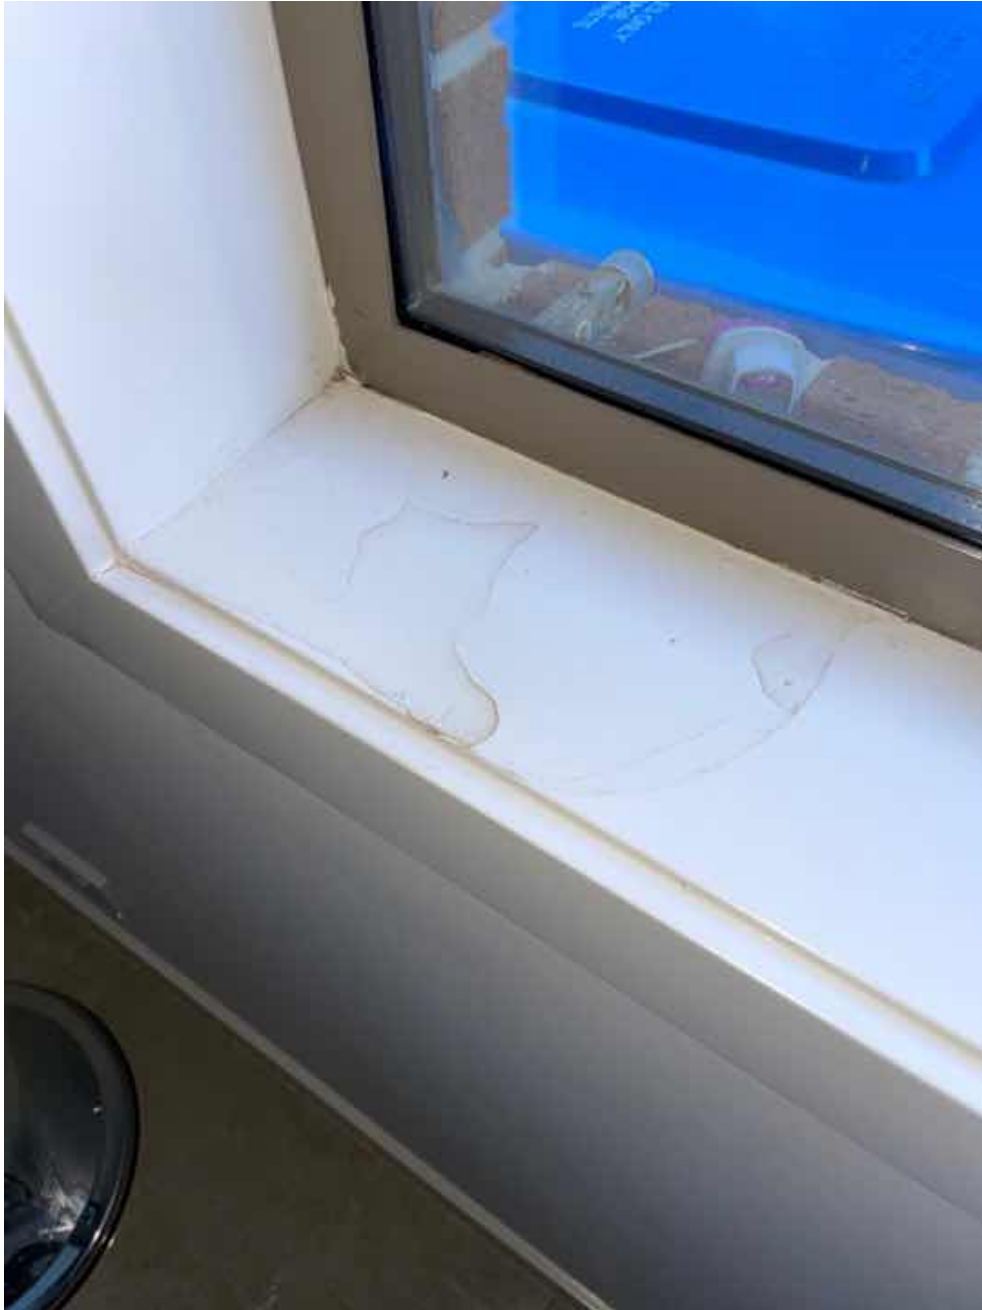
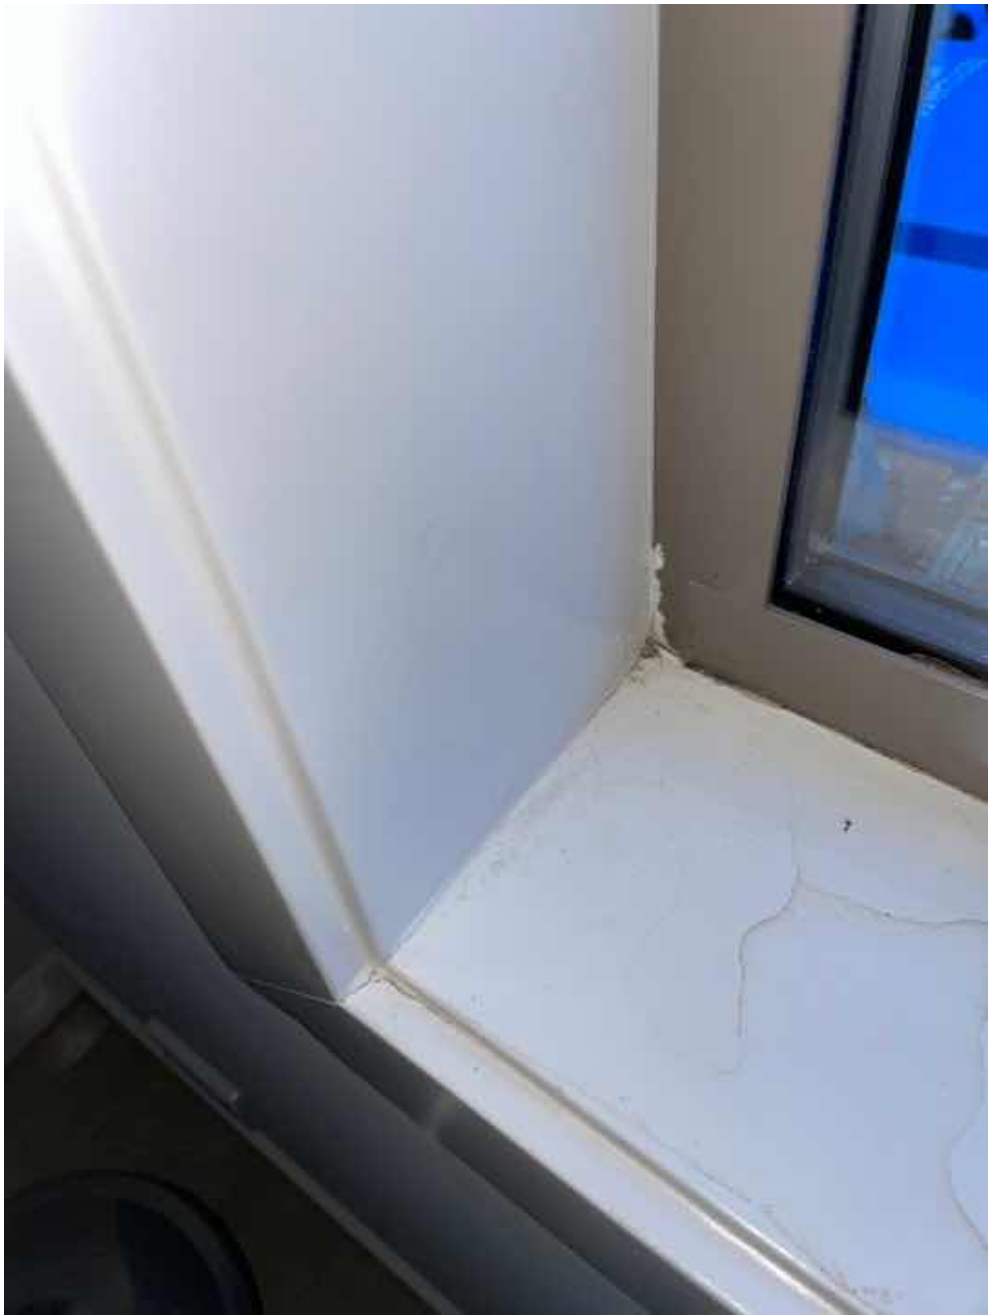
Moisture damage and high moisture readings recorded. Possible water ingress. Or condensation. Contact a glazier for repairs.

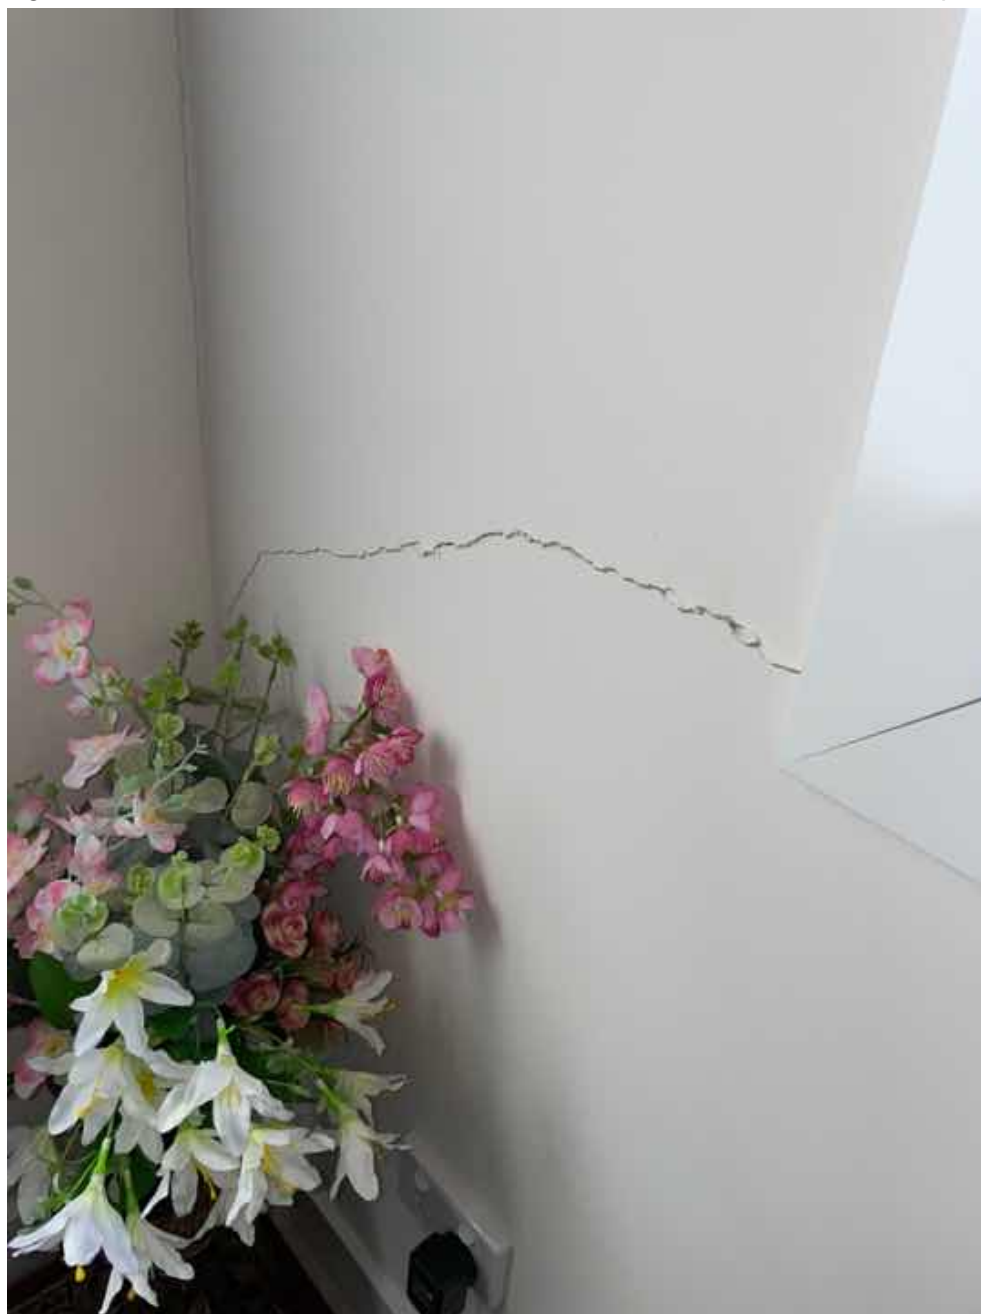
Major Cracks - Excessive, multiple or wide cracking visible. Recommendations: Contact a qualified structural engineer for further advice and recommendations.

Underpinning of the exterior walls is highly recommended to prevent further deterioration.

Once Underpinning has been carried out, remedial works will need to be carried out to repair the damage.

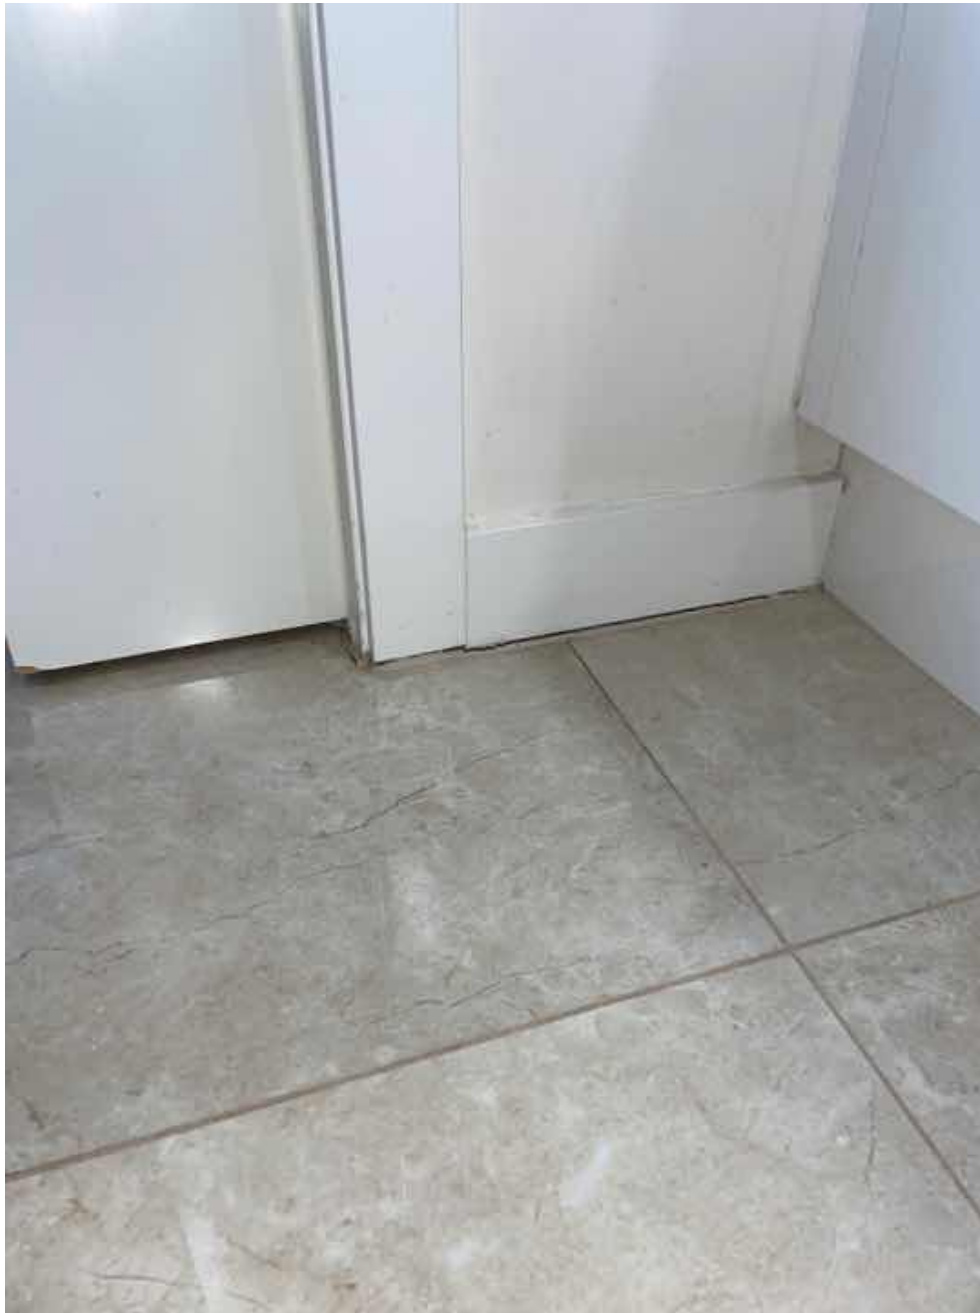
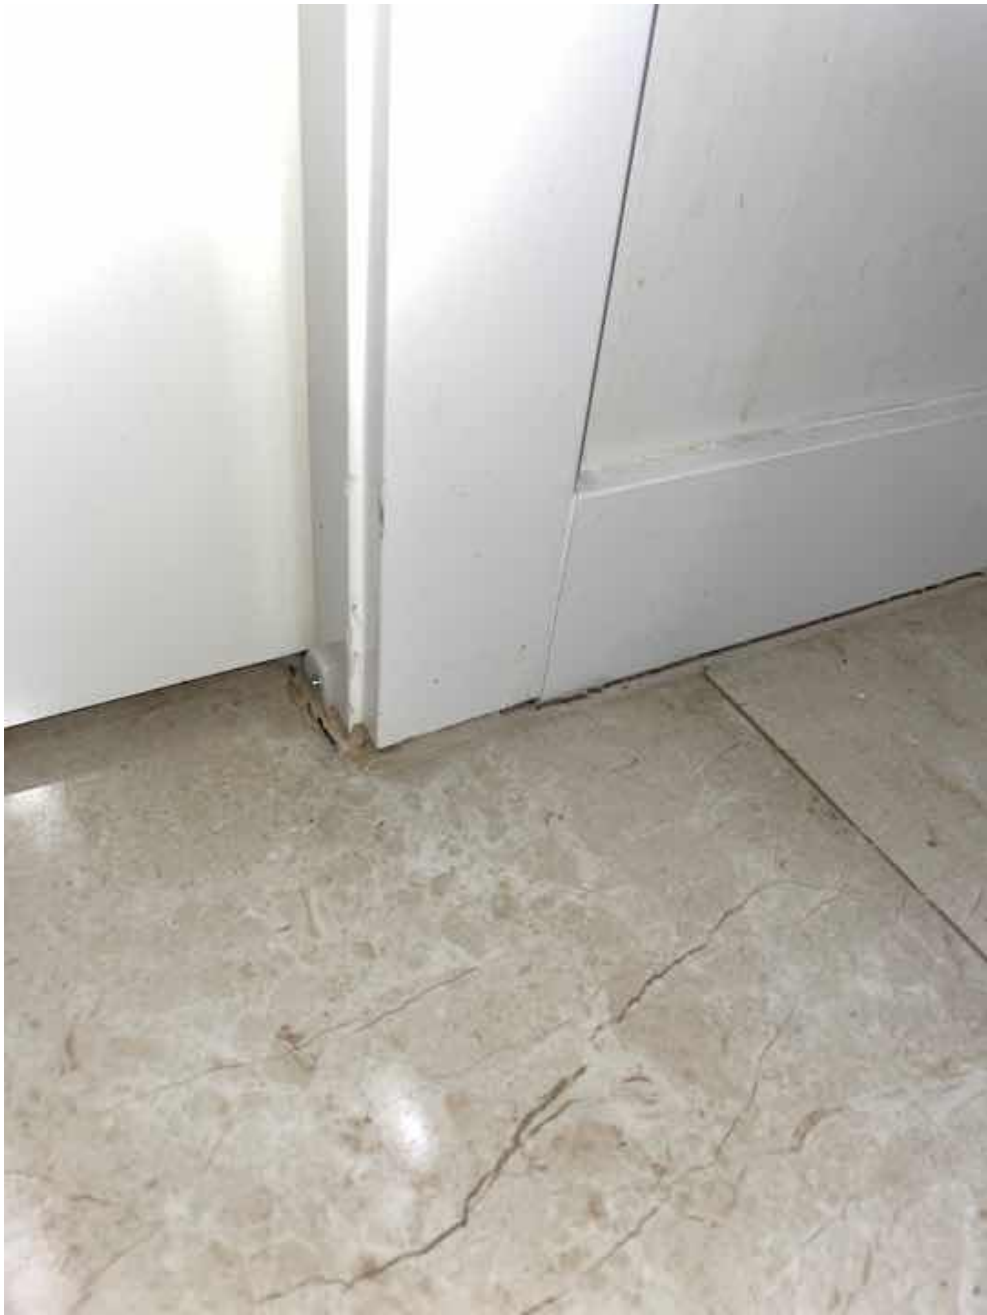
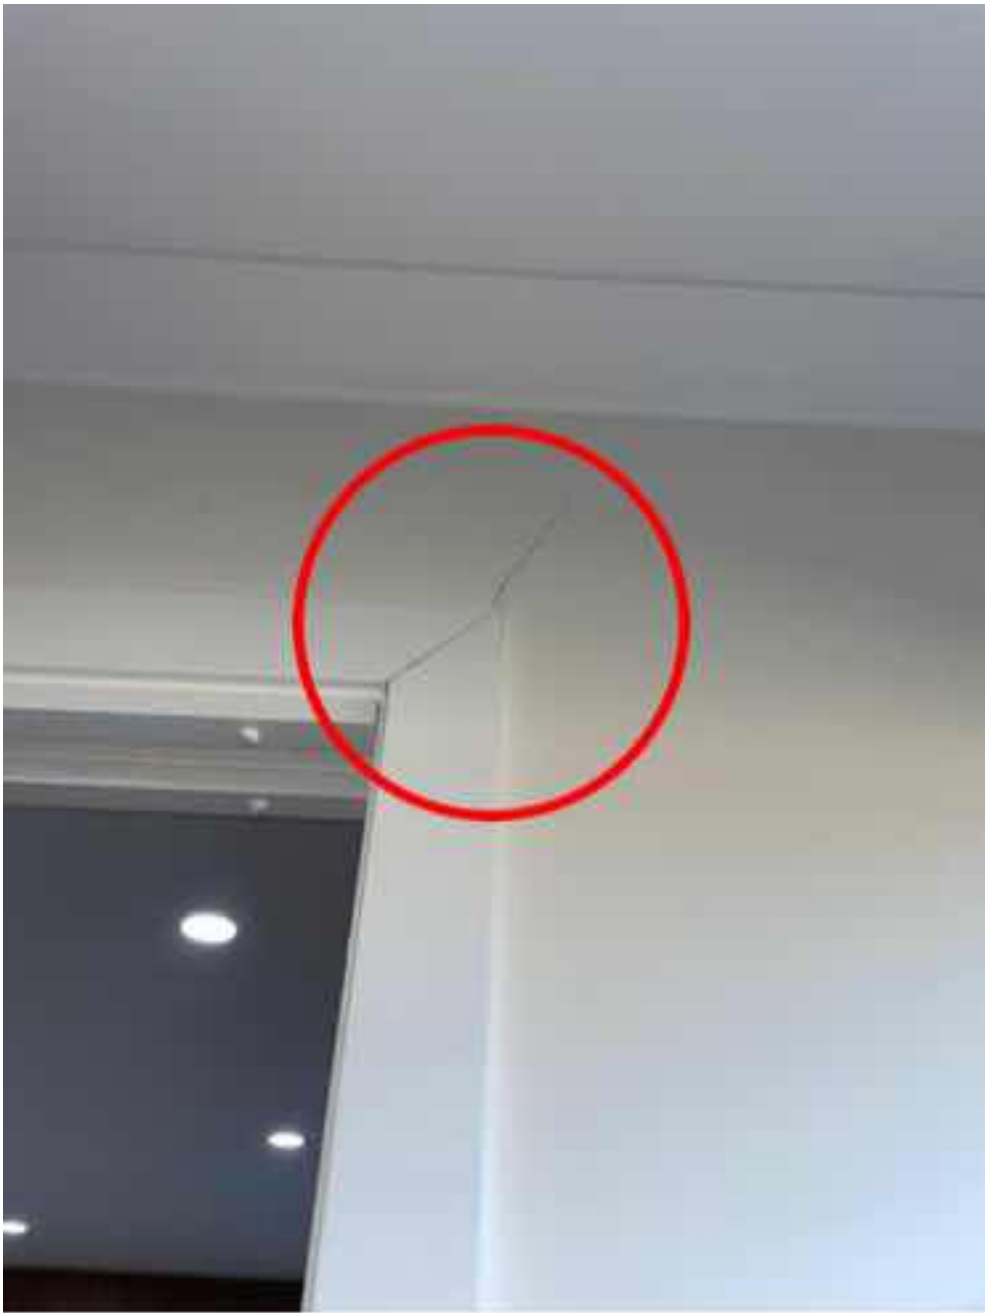
KITCHEN & LAUNDRY	Kitchen and Meals Area	Walls	Major Cracks - Excessive, multiple or wide cracking visible. Recommendations: Contact a qualified structural engineer for further advice and recommendations.

Major Cracks - Excessive, multiple or wide cracking visible. Recommendations: Contact a qualified structural engineer for further advice and recommendations.

Settlement Cracks Noted . These are typical and generally patch and paint will suffice, however Monitoring these cracks advised for 12 months and if become wider or longer, you will need to contact a structural engineers to assess.

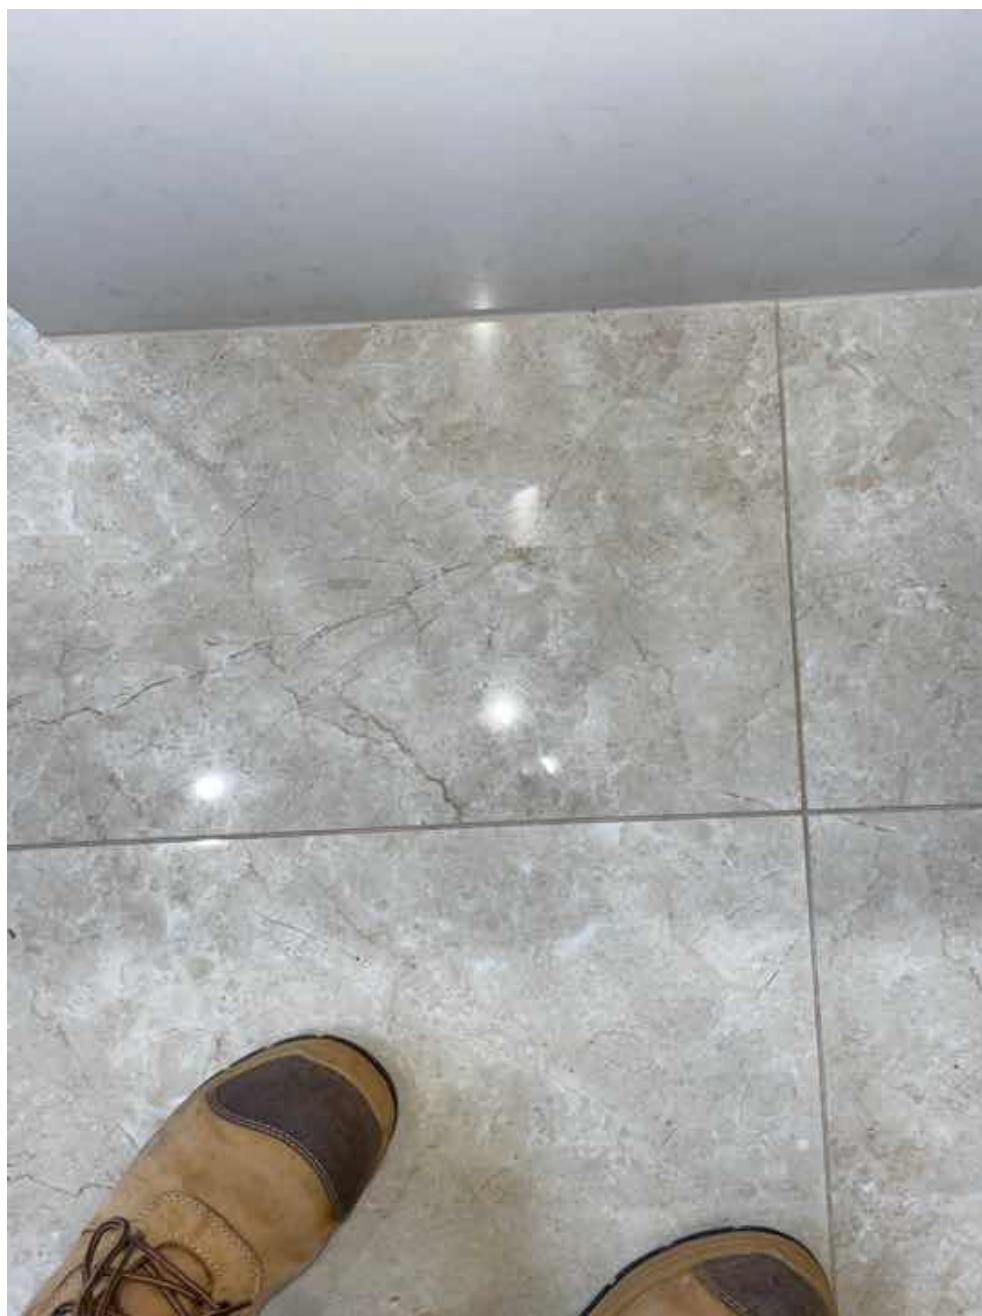
KITCHEN & LAUNDRY	Kitchen and Meals Area	Floor	Cracked floor tiles - Recommendations: A qualified tiler should be engaged for advice and recommendations. This needs to be repaired at the earliest as this has the potential to lead to many related issues such as damp, water ingress to other areas and cracked tiles. Contact a licensed tiler for repairs and recommendation
ROOF VOID	Roof Void Findings	Roof Cladding	Cracked tile section visible. Recommendations: A qualified roof tiler should be engaged for advice and recommendations.
ROOF VOID	Roof Void Findings	Roof Cladding	Gable end flashing gaps visible. Recommendations: A qualified roofer should be engaged for advice and recommendations.
CONCLUSION	Condition Of Inspected Structure	The incidence of Major Defects	The incidence of major defects in this residential building as compared with similar buildings is considered HIGH

Cracked floor tiles - Recommendations: A qualified tiler should be engaged for advice and recommendations. This needs to be repaired at the earliest as this has the potential to lead to many related issues such as damp, water ingress to other areas and cracked tiles. Contact a licensed tiler for repairs and recommendation
