# Post Completion Defect Inspection Report

**Example, VICTORIA, 3024**

Report/Agreement #              0807210944395

Inspection Date:                  08 Jul 2021

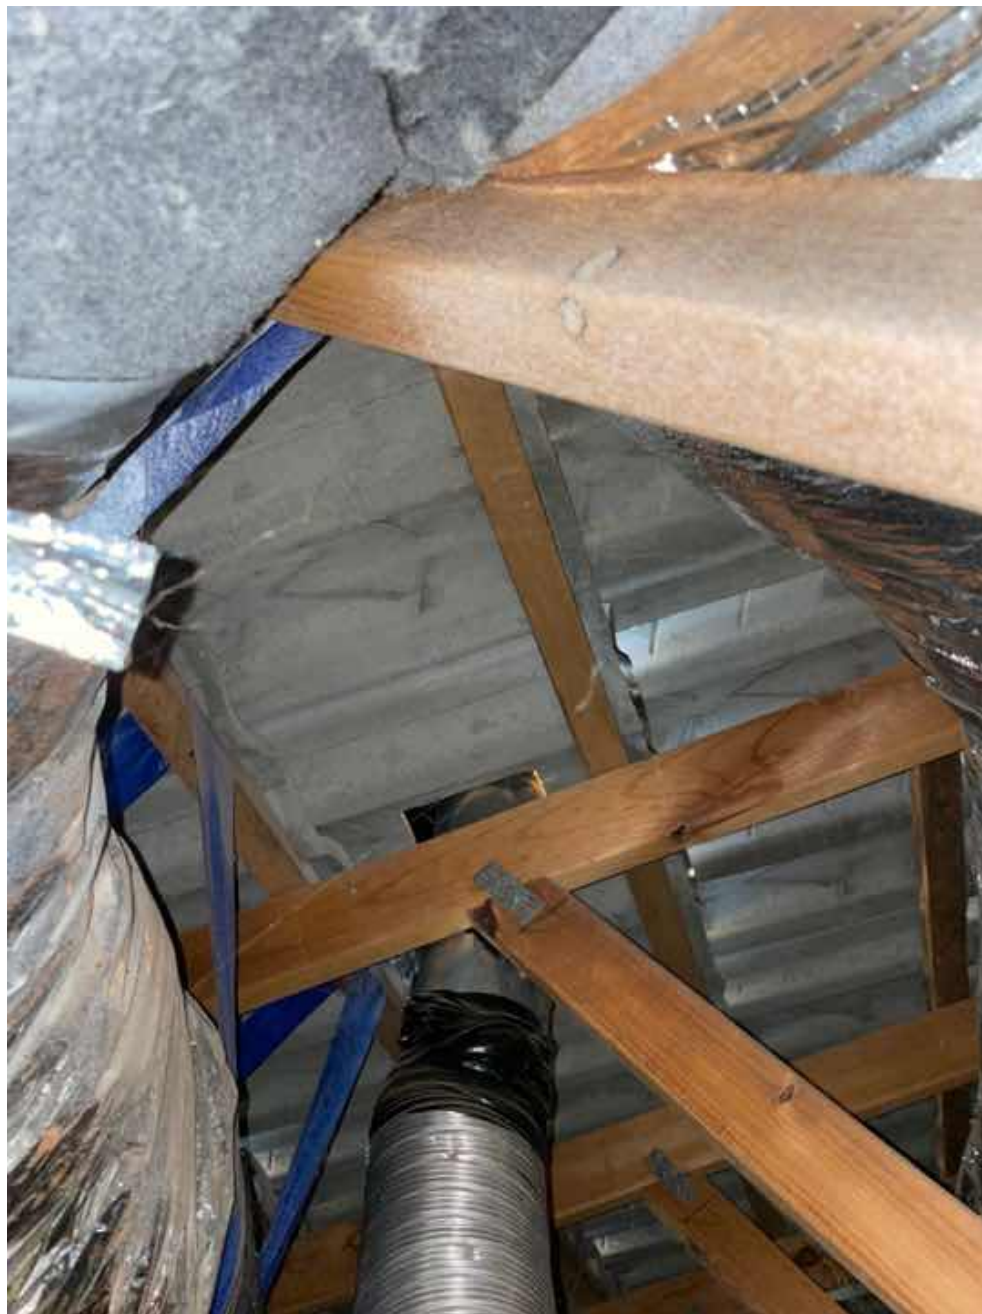
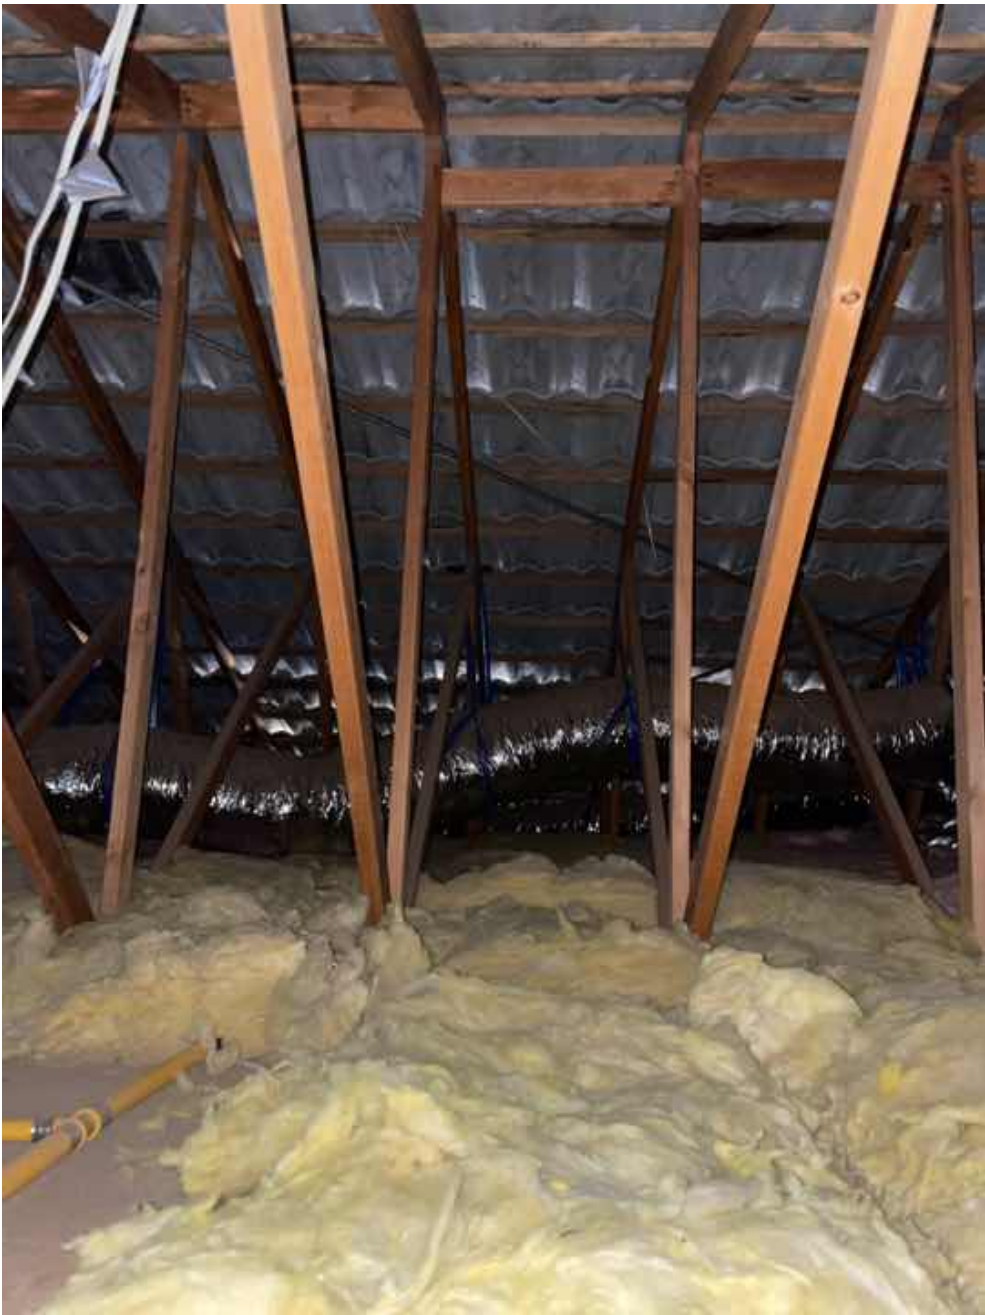
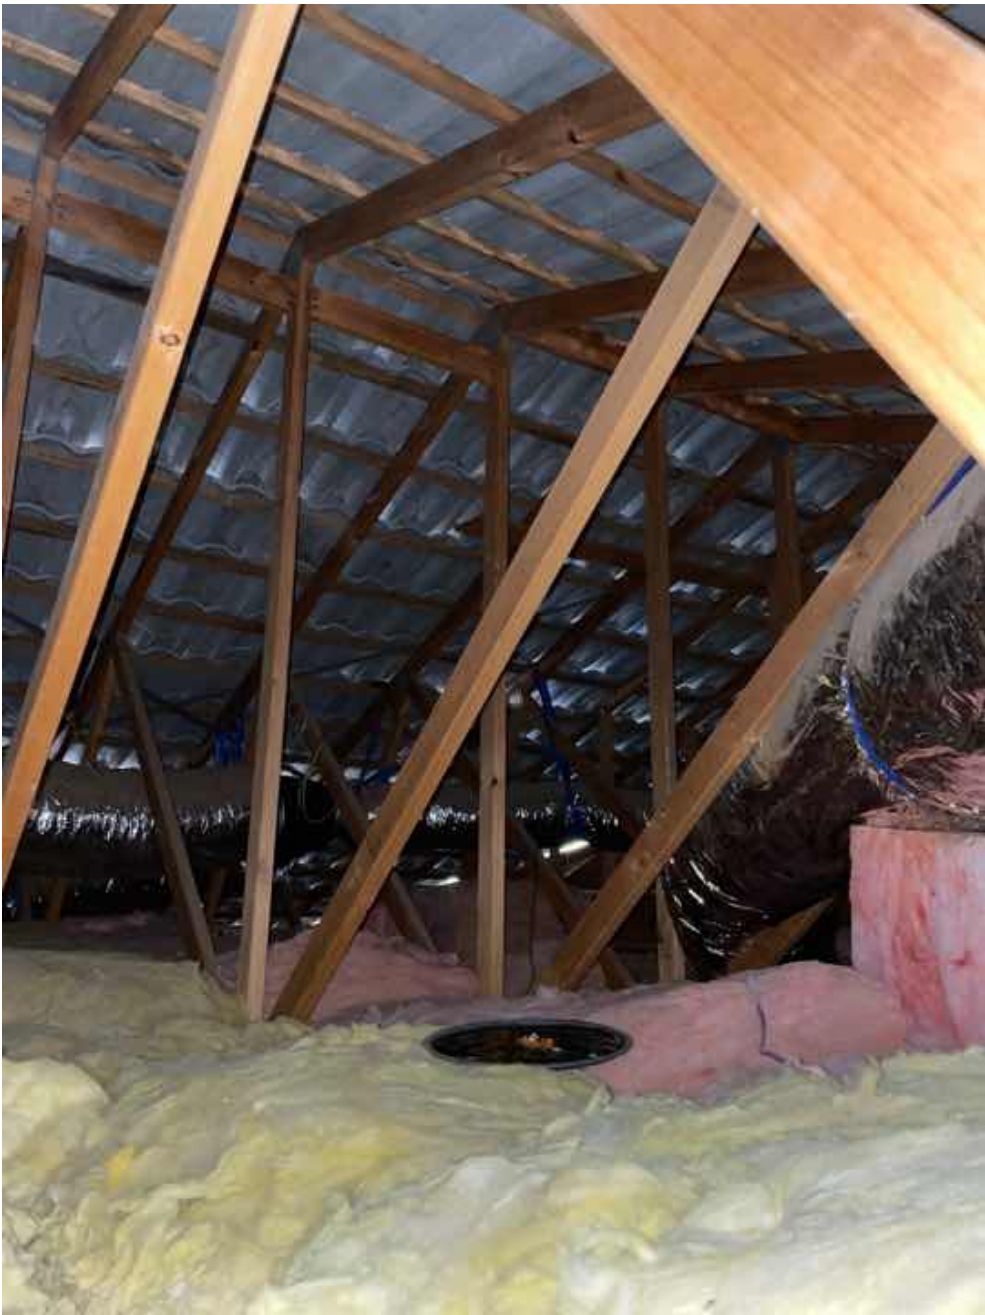
There is evidence to suggest that there is some leakage into the roof void. In the absence of rain it is difficult to determine if this is an old leak or it's active. Monitoring during periods of rain should reveal and leaks, if leakvis indeed active contact a licensed roofing contractor for repairs.

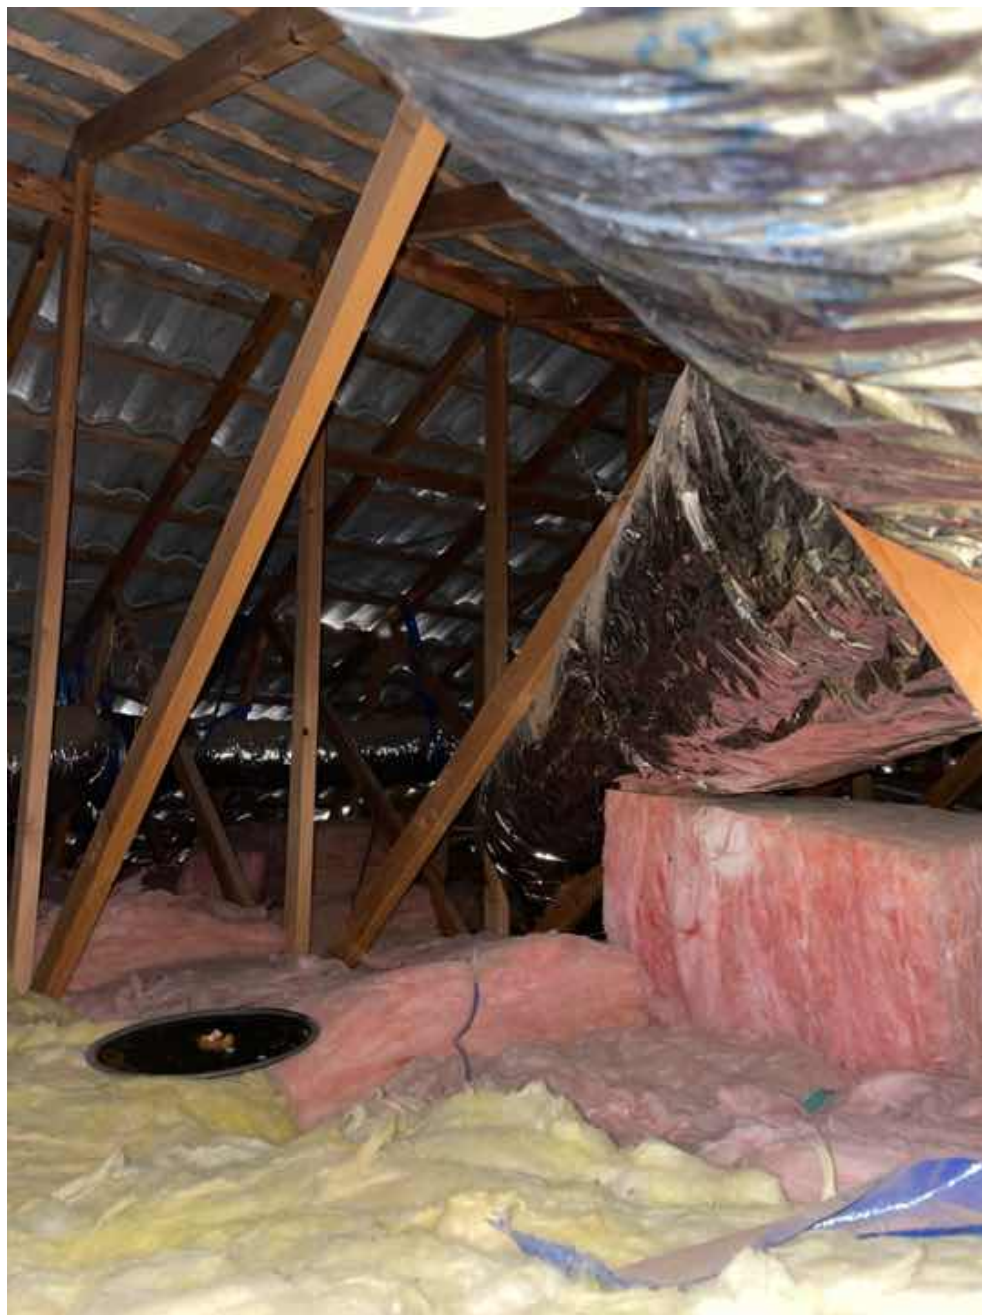
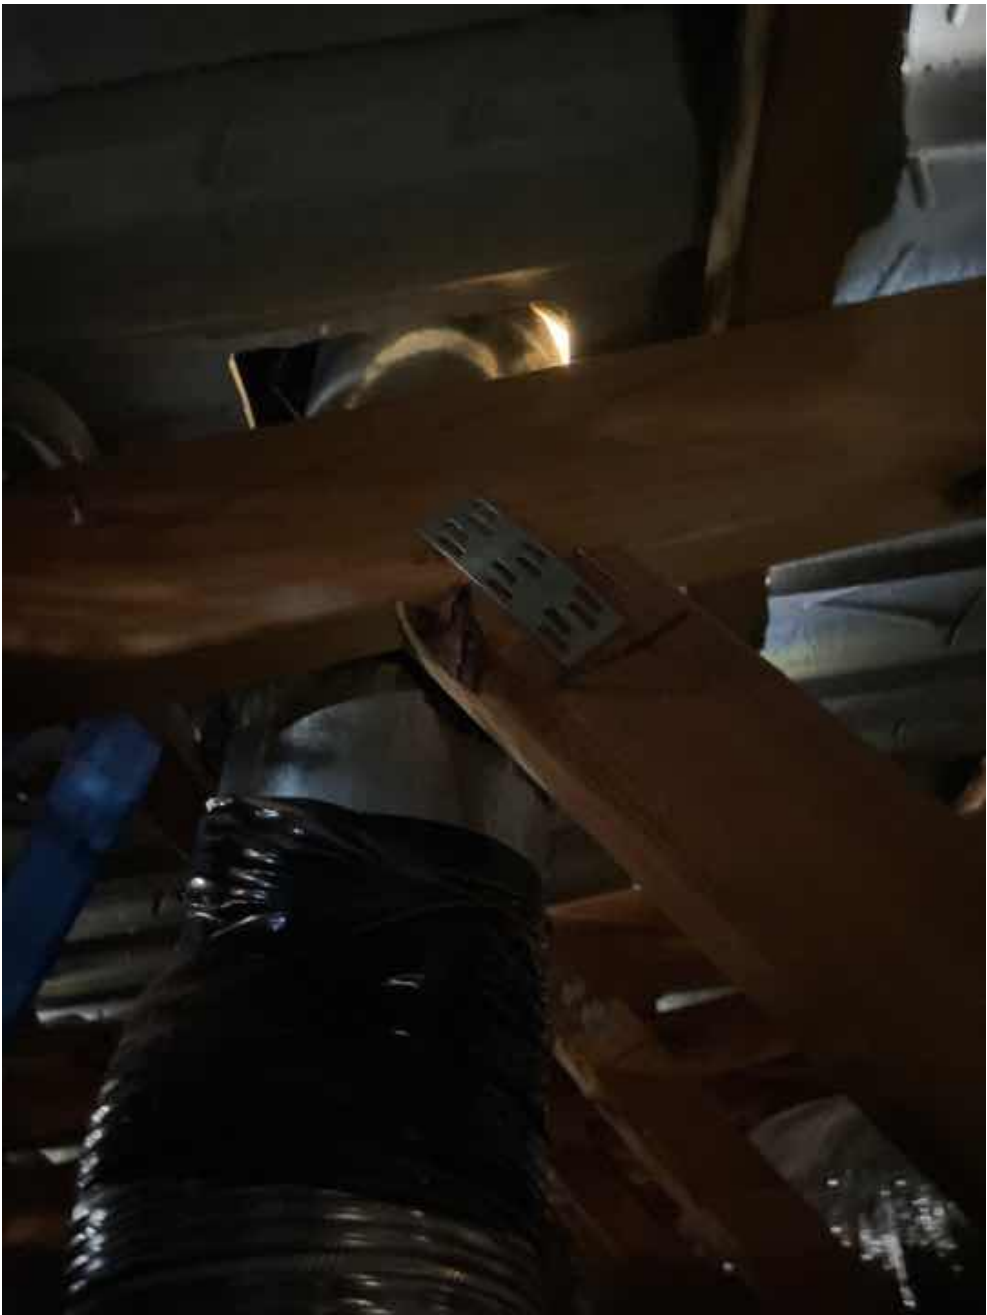
Cracked tile section visible. Recommendations: A qualified roof tiler should be engaged for advice and recommendations.

Gable end flashing gaps visible. Recommendations: A qualified roofer should be engaged for advice and recommendations.

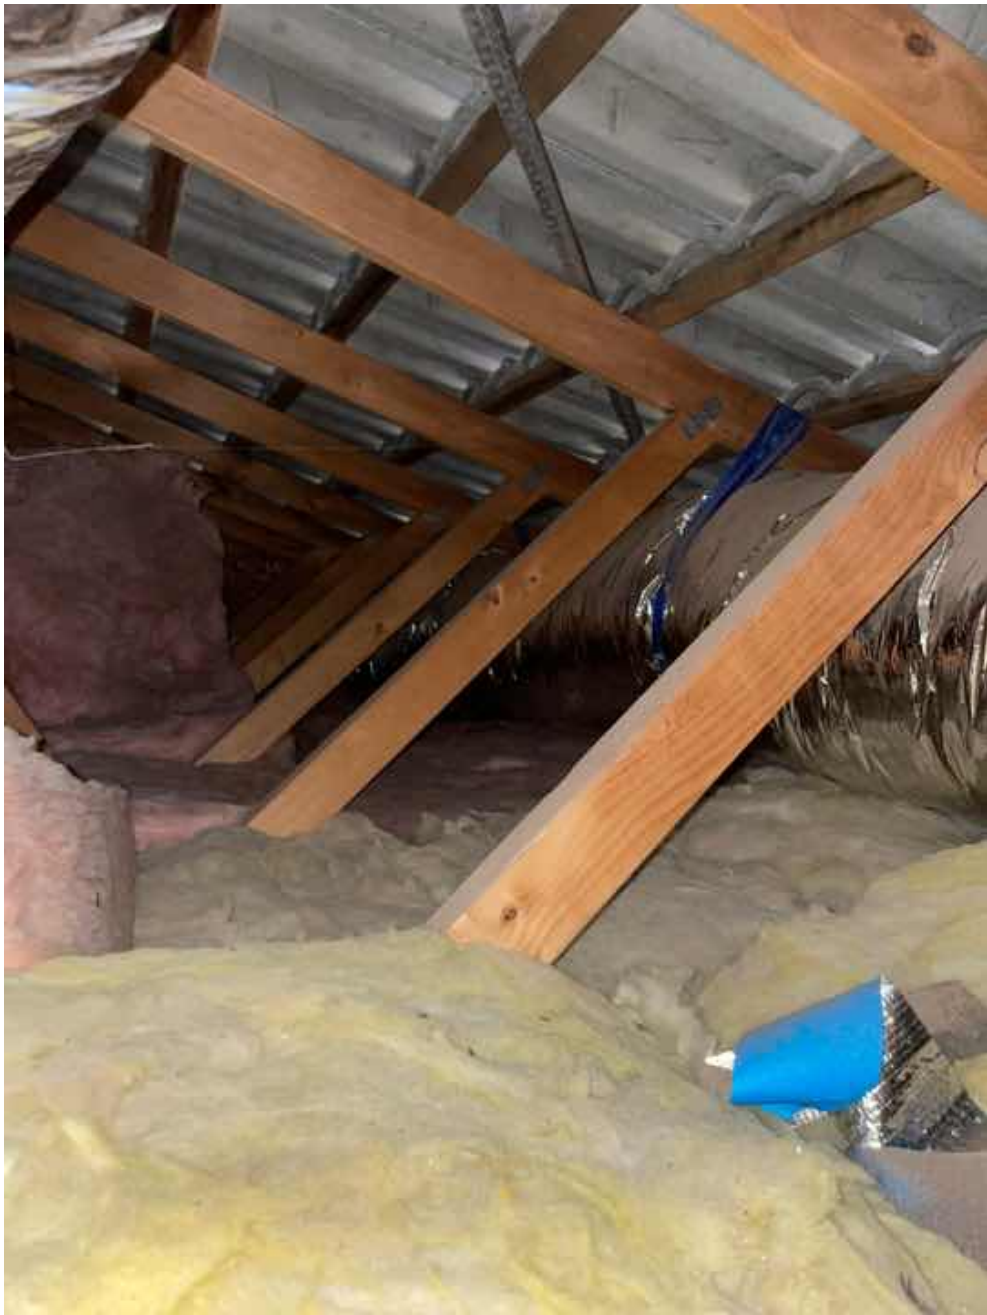
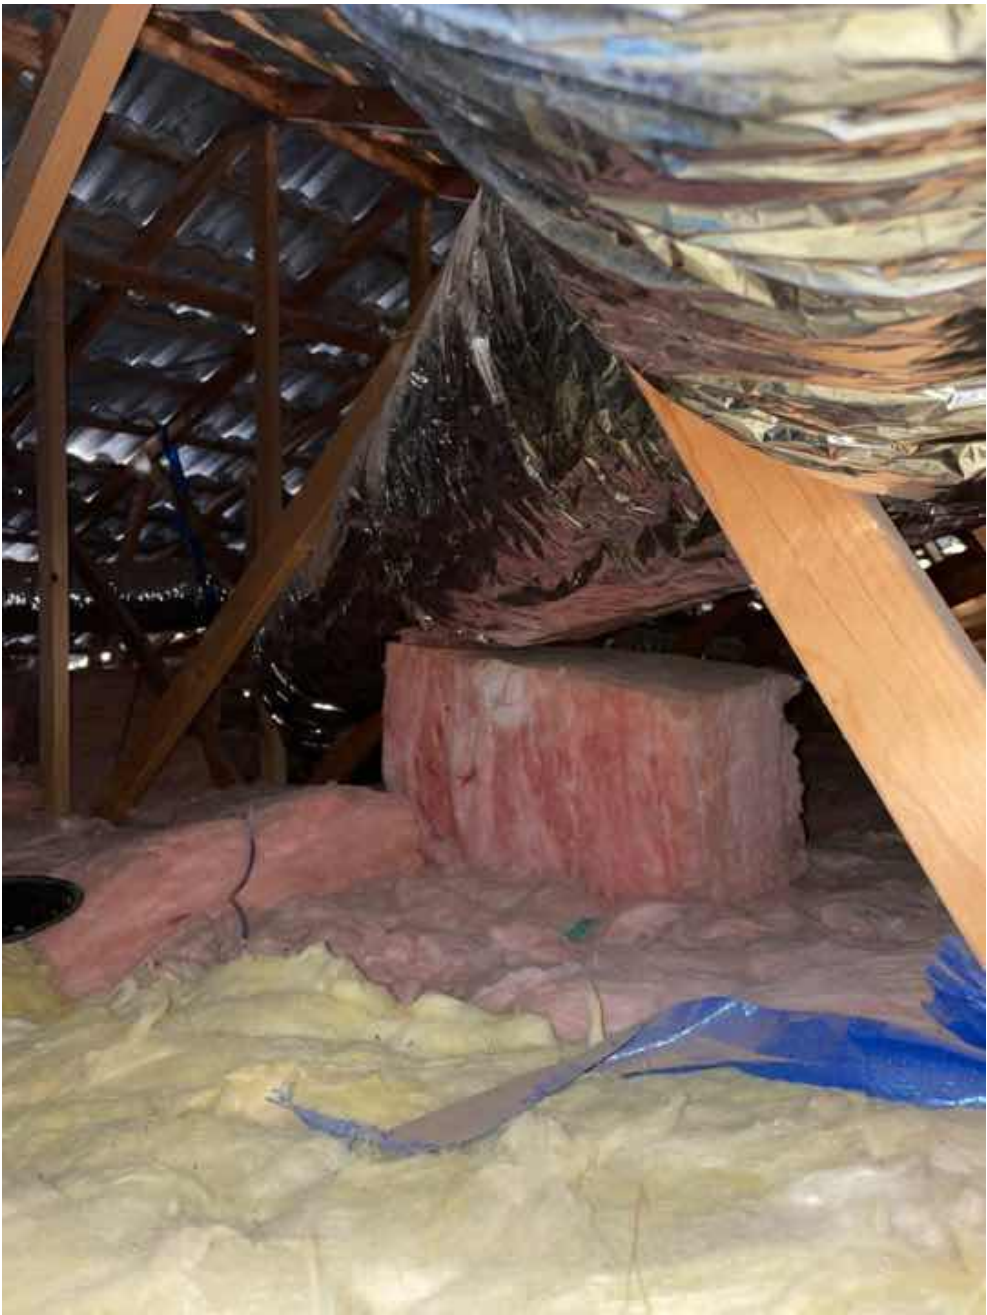
Sections of the insulation were poorly installed / laid with gaps visible in sections. Recommendations: Engage insulation contractor to assess.
