Dilapidation Survey Inspection Report

Report/Agreement # 0202210849412

Inspection Date: 02 Feb 2021

Dilapidation Inspection Report

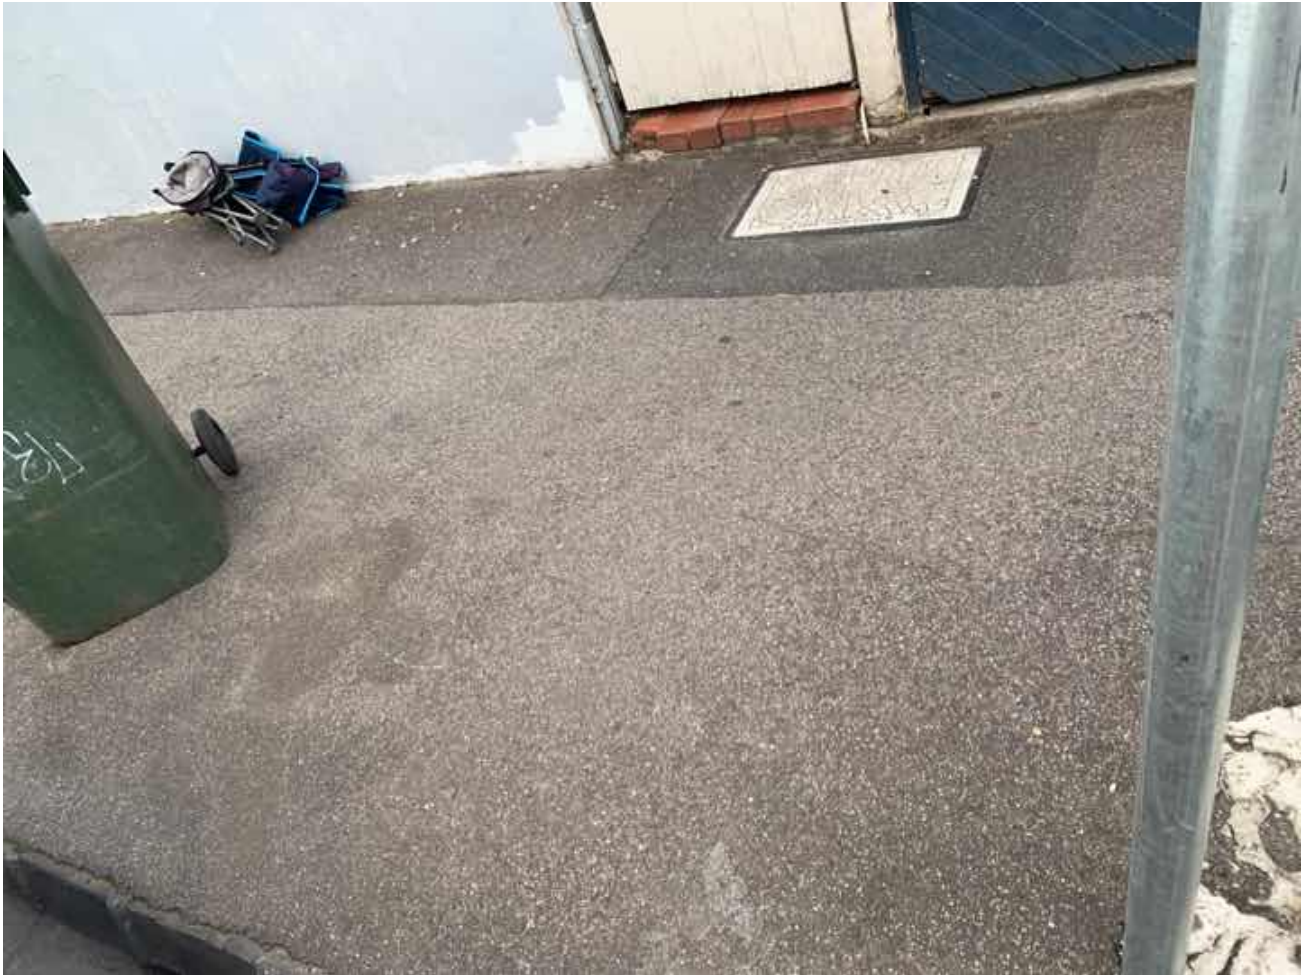
Crossover

No Defects Noted

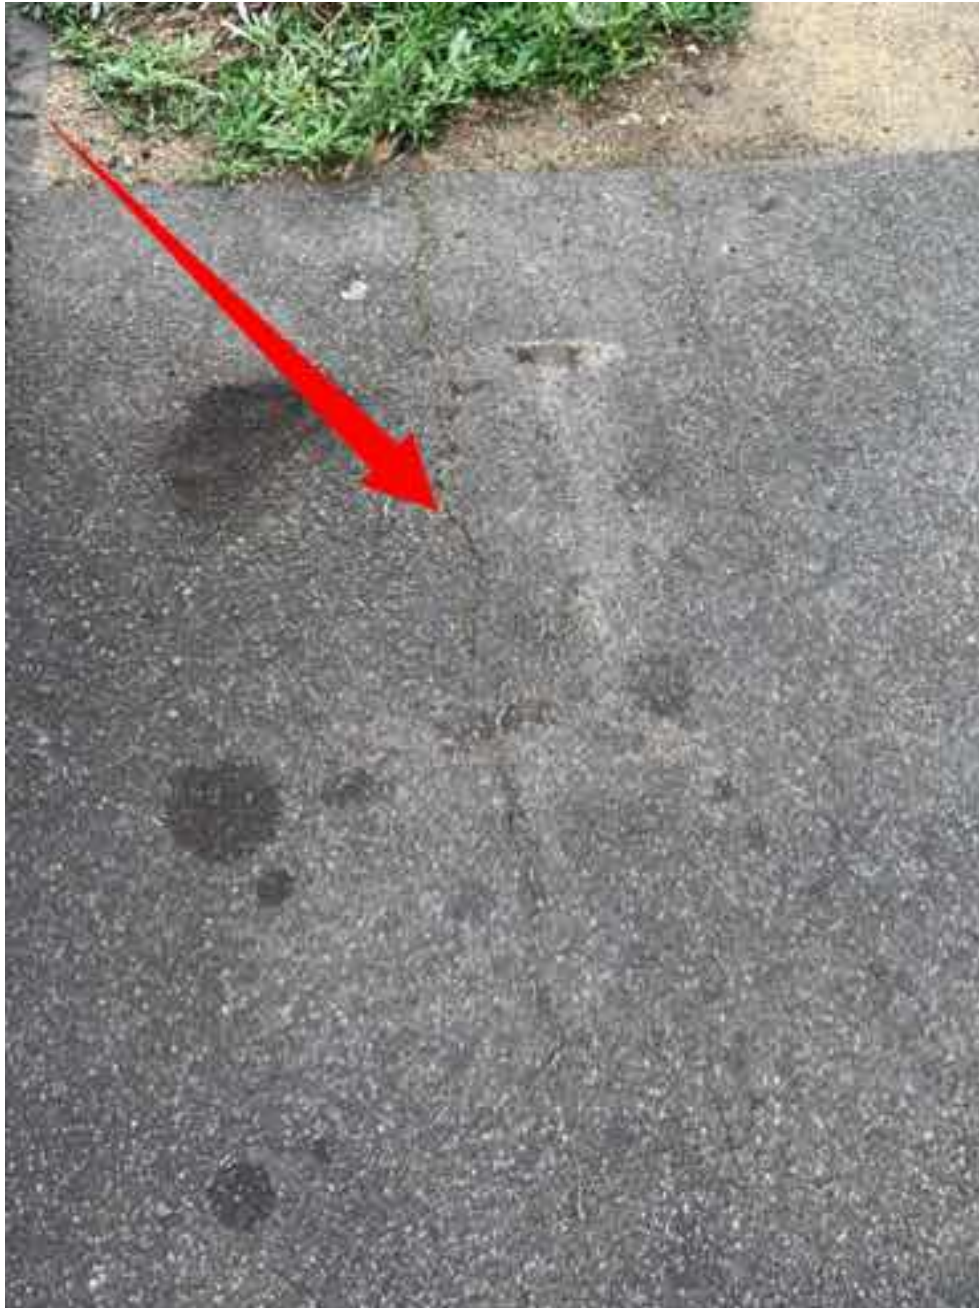
Path/Kerb

Small Appearance Crack Present.

Pre existing Defect

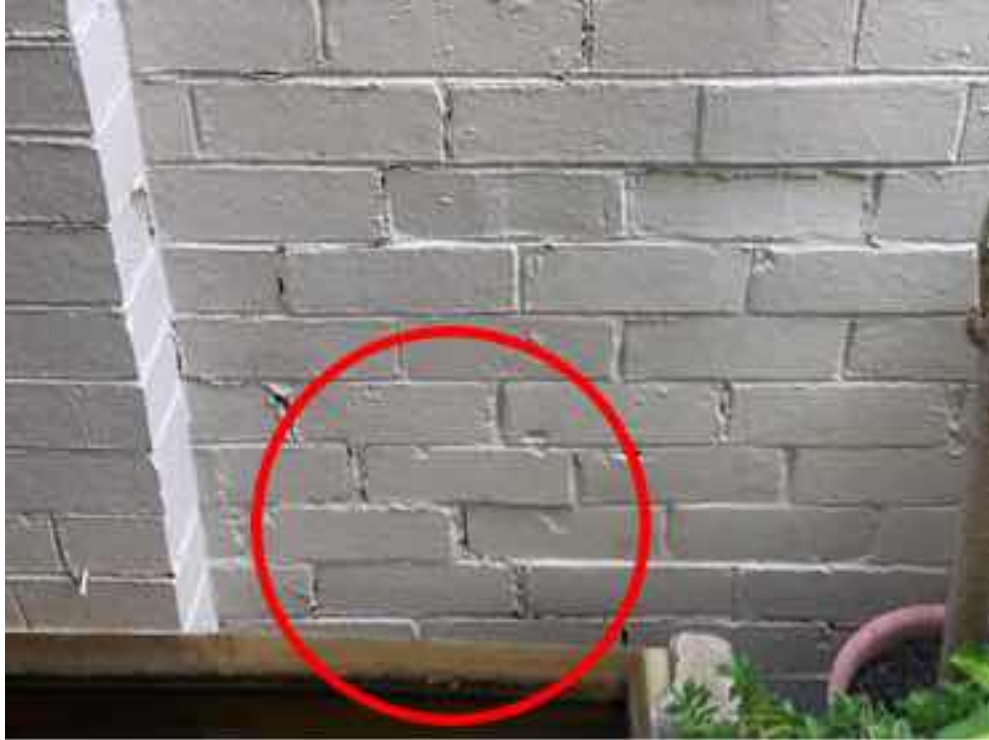
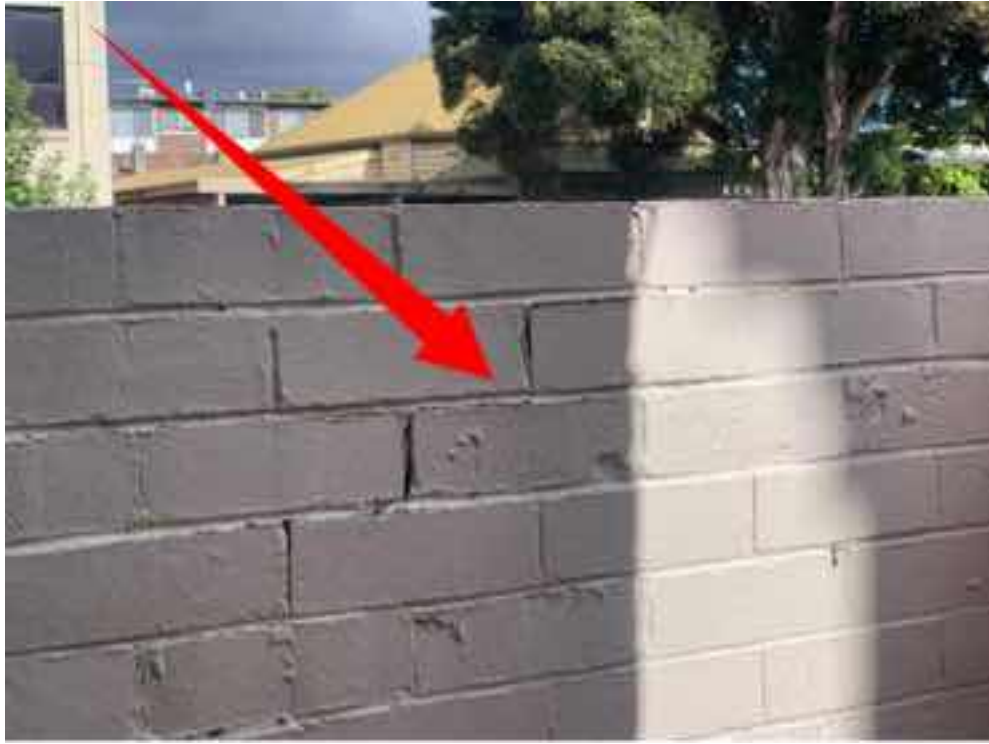
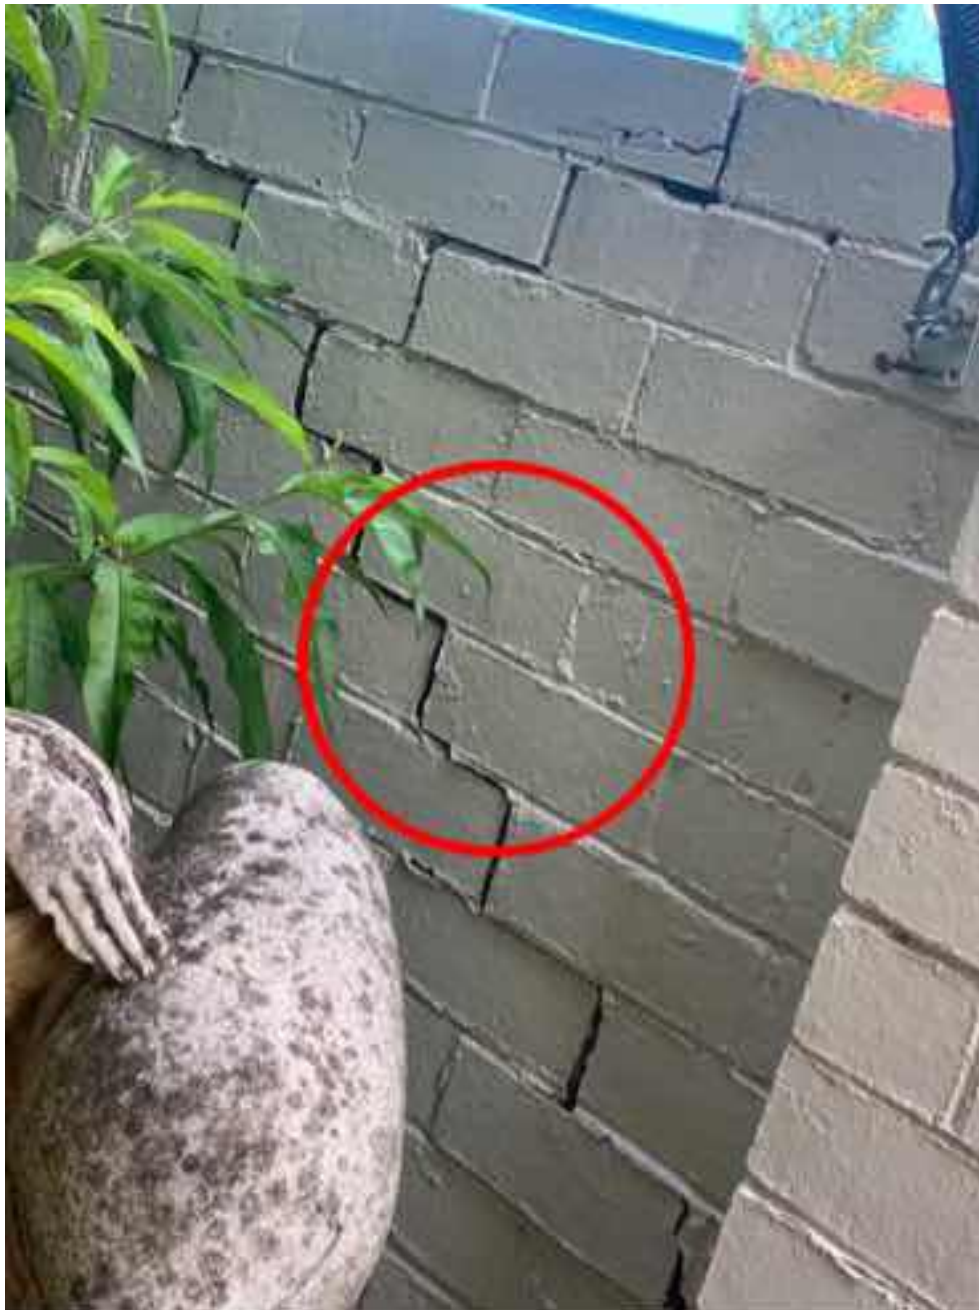
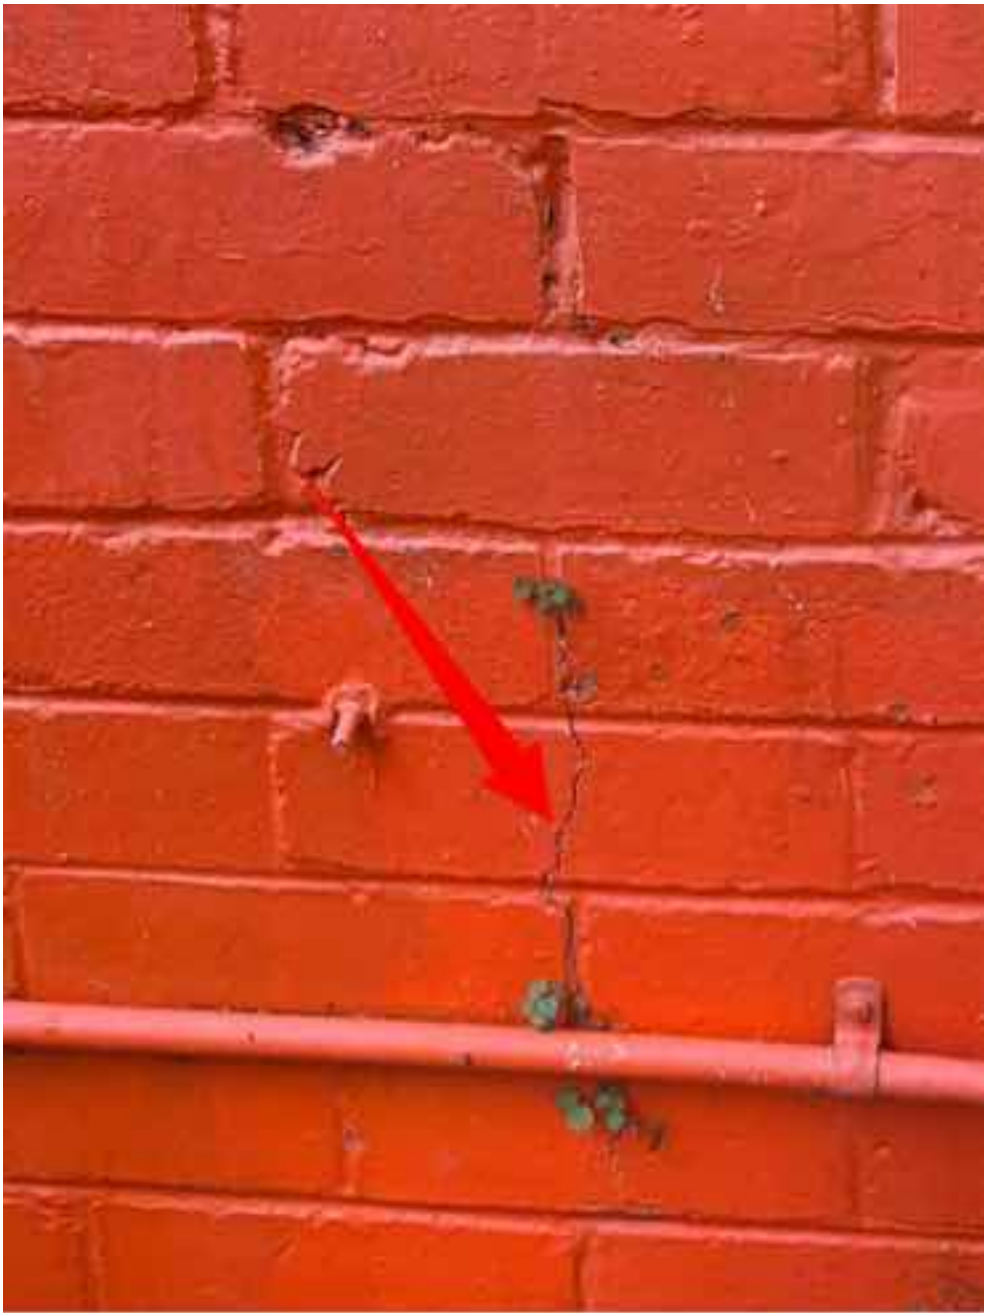
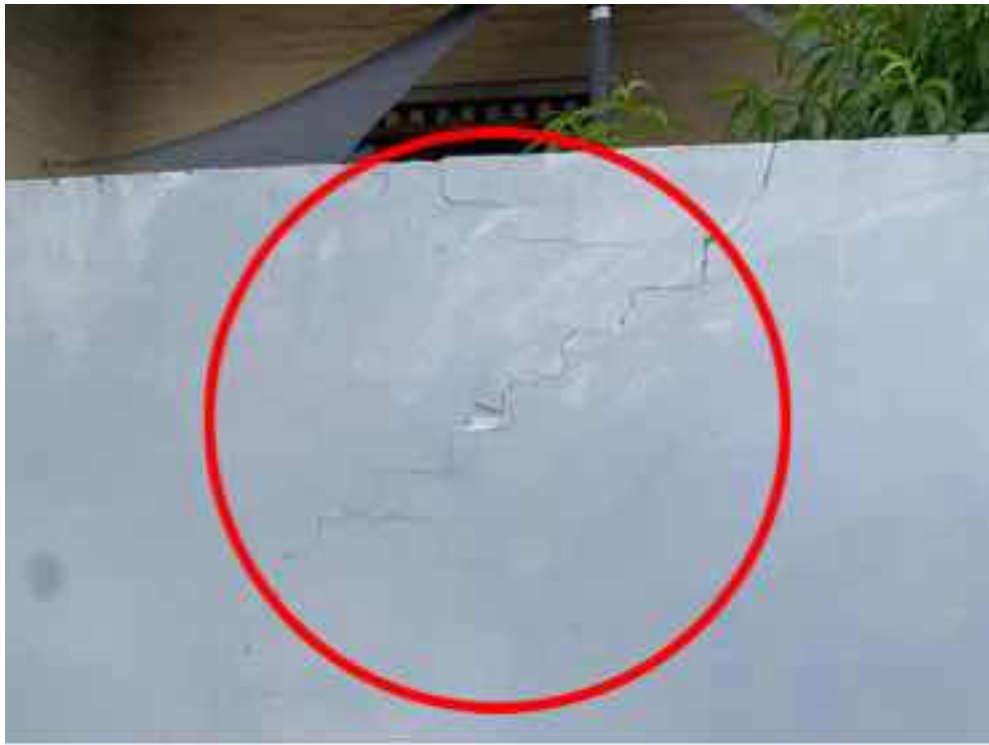
Fence

Settlement Cracks Present.

Pre Existing Damage

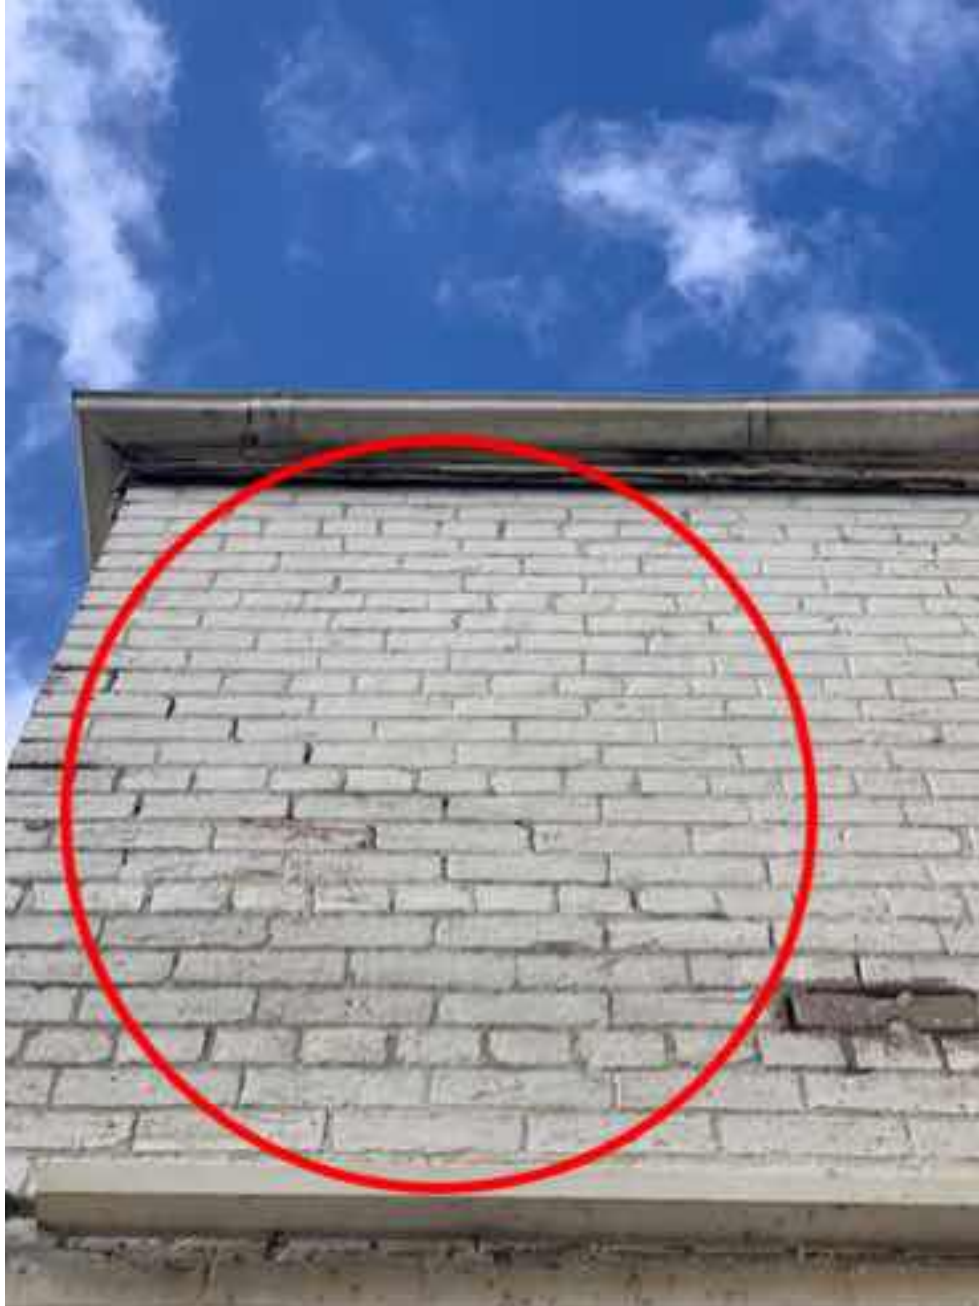
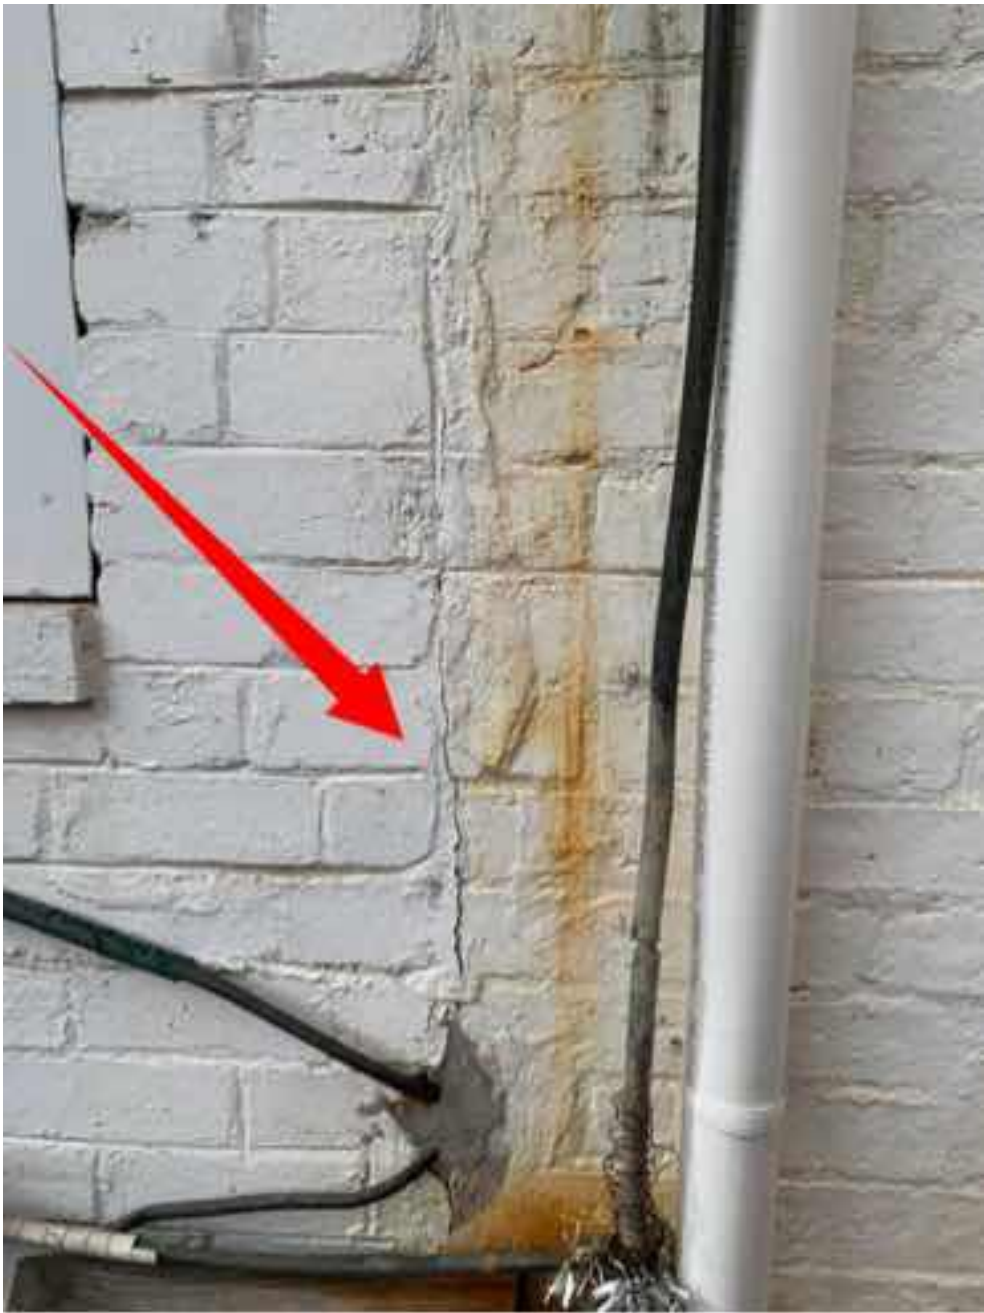
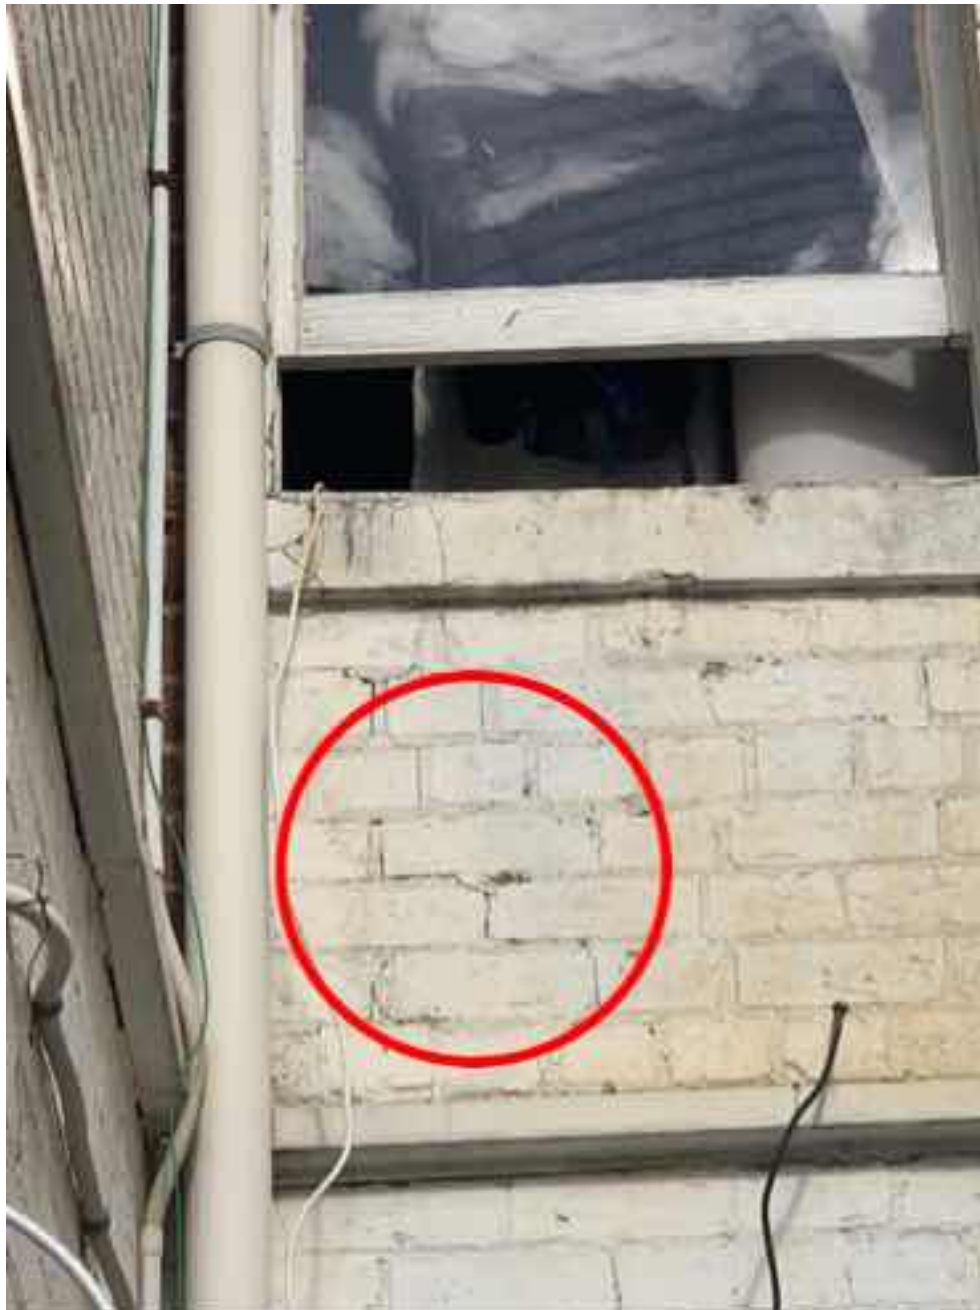
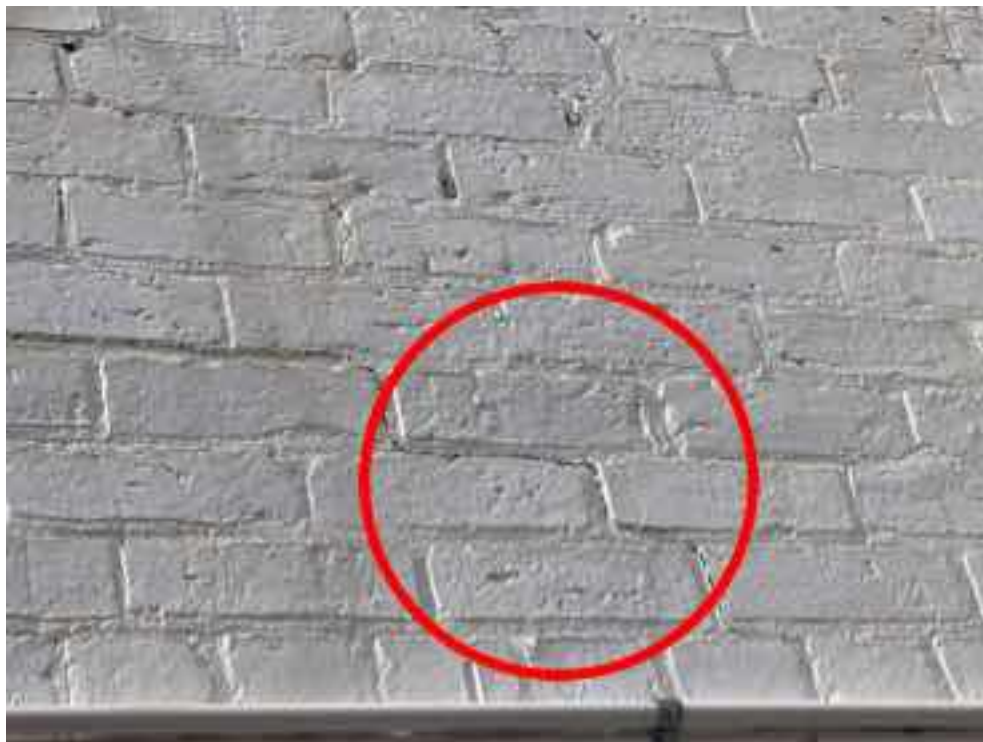
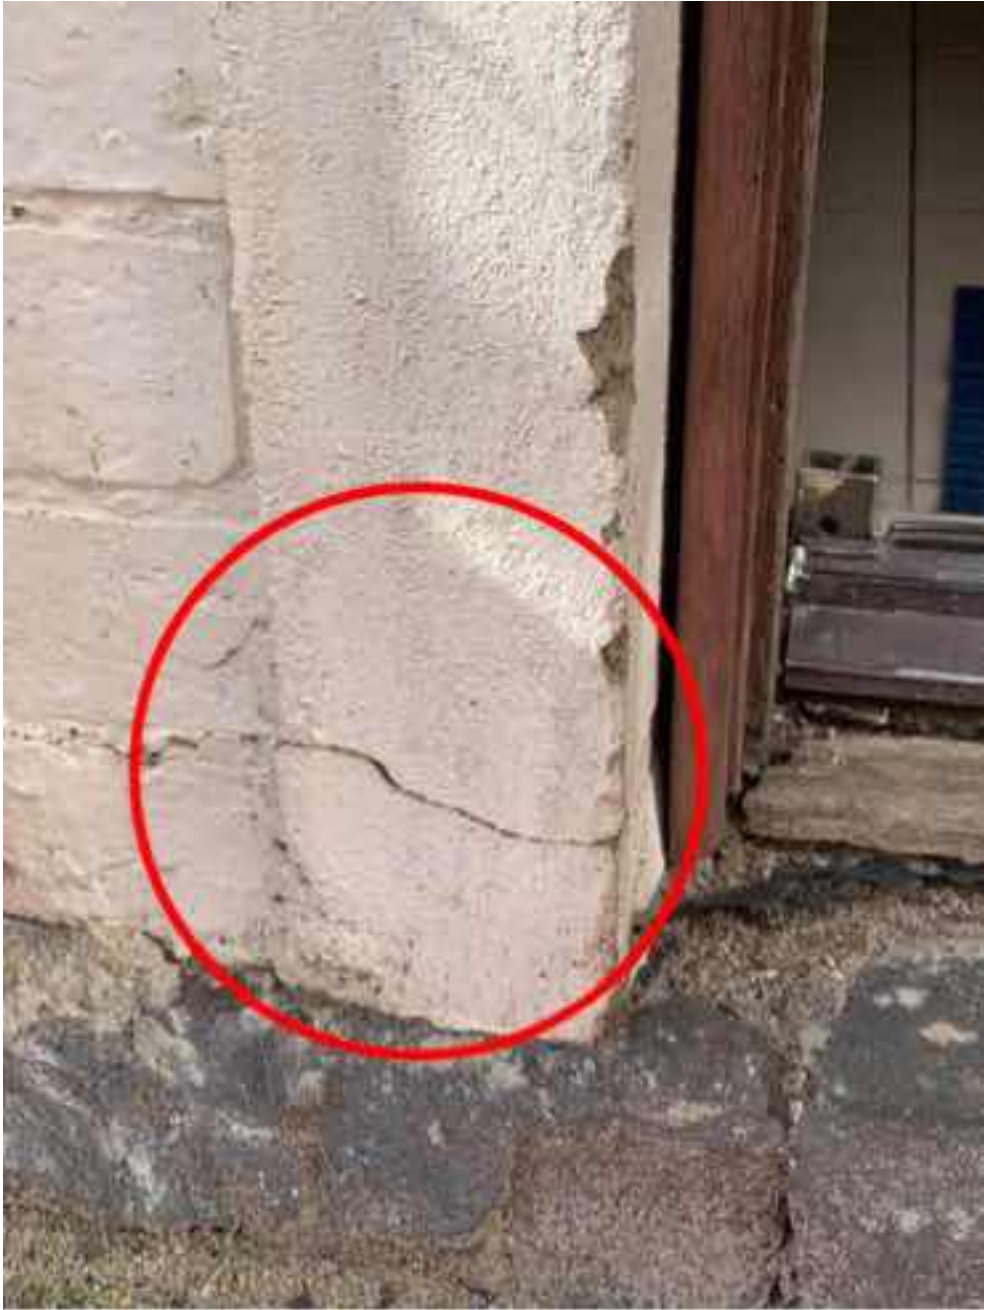
North Elevation

Settlement Cracks Present

Pre Existing Damage

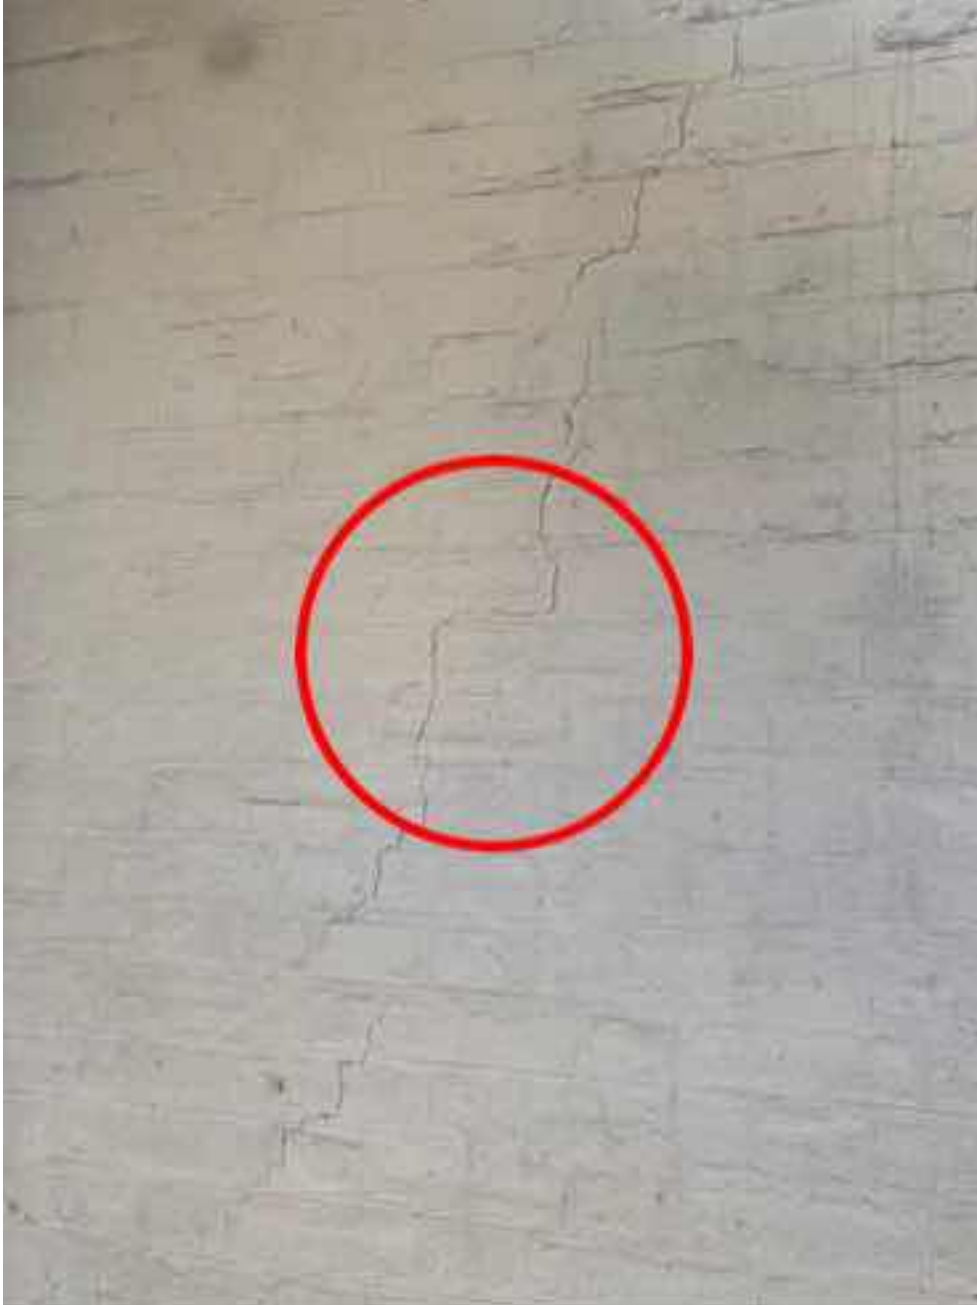
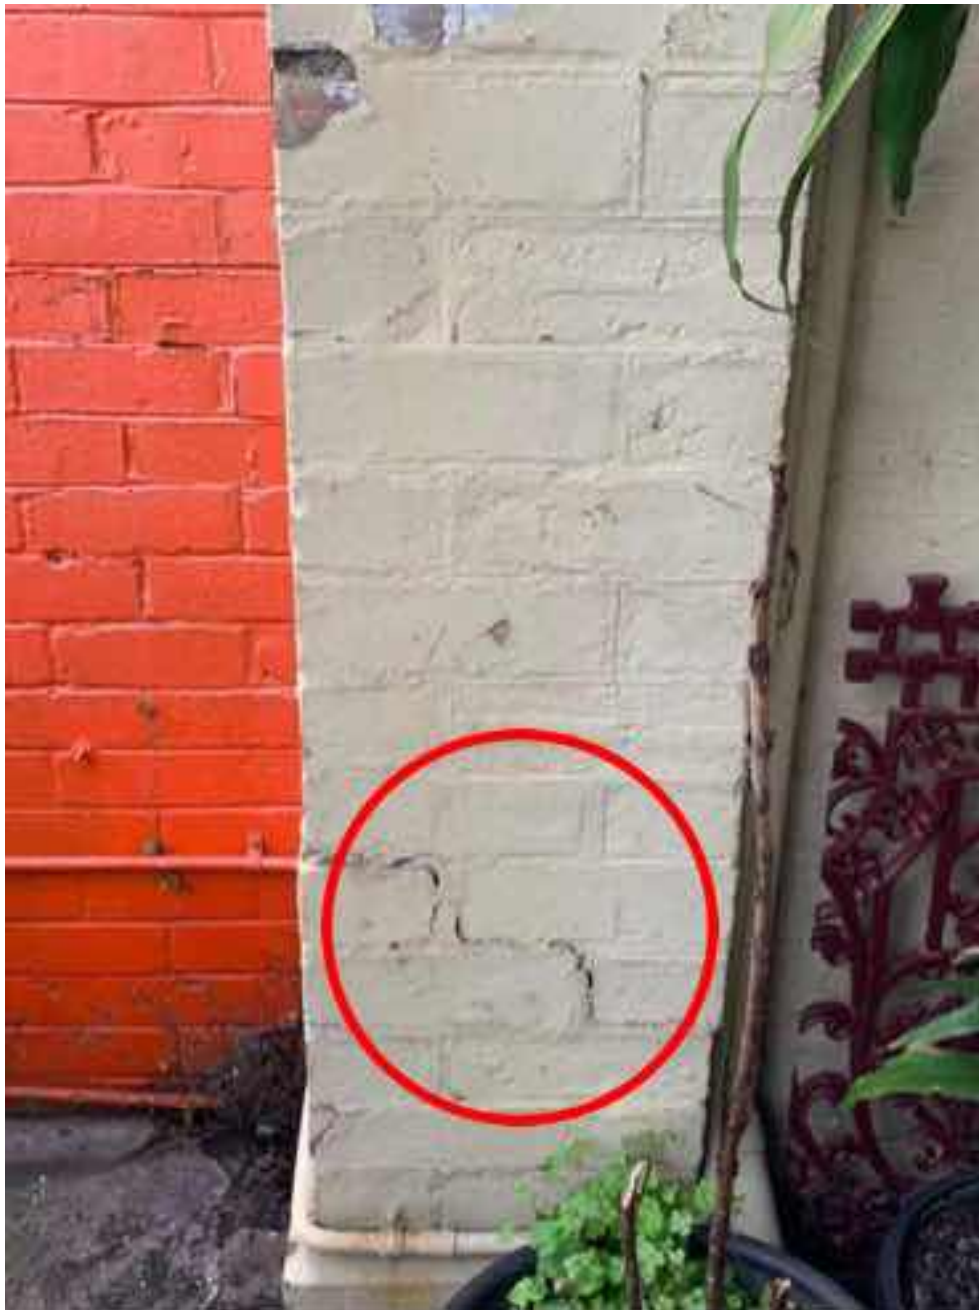
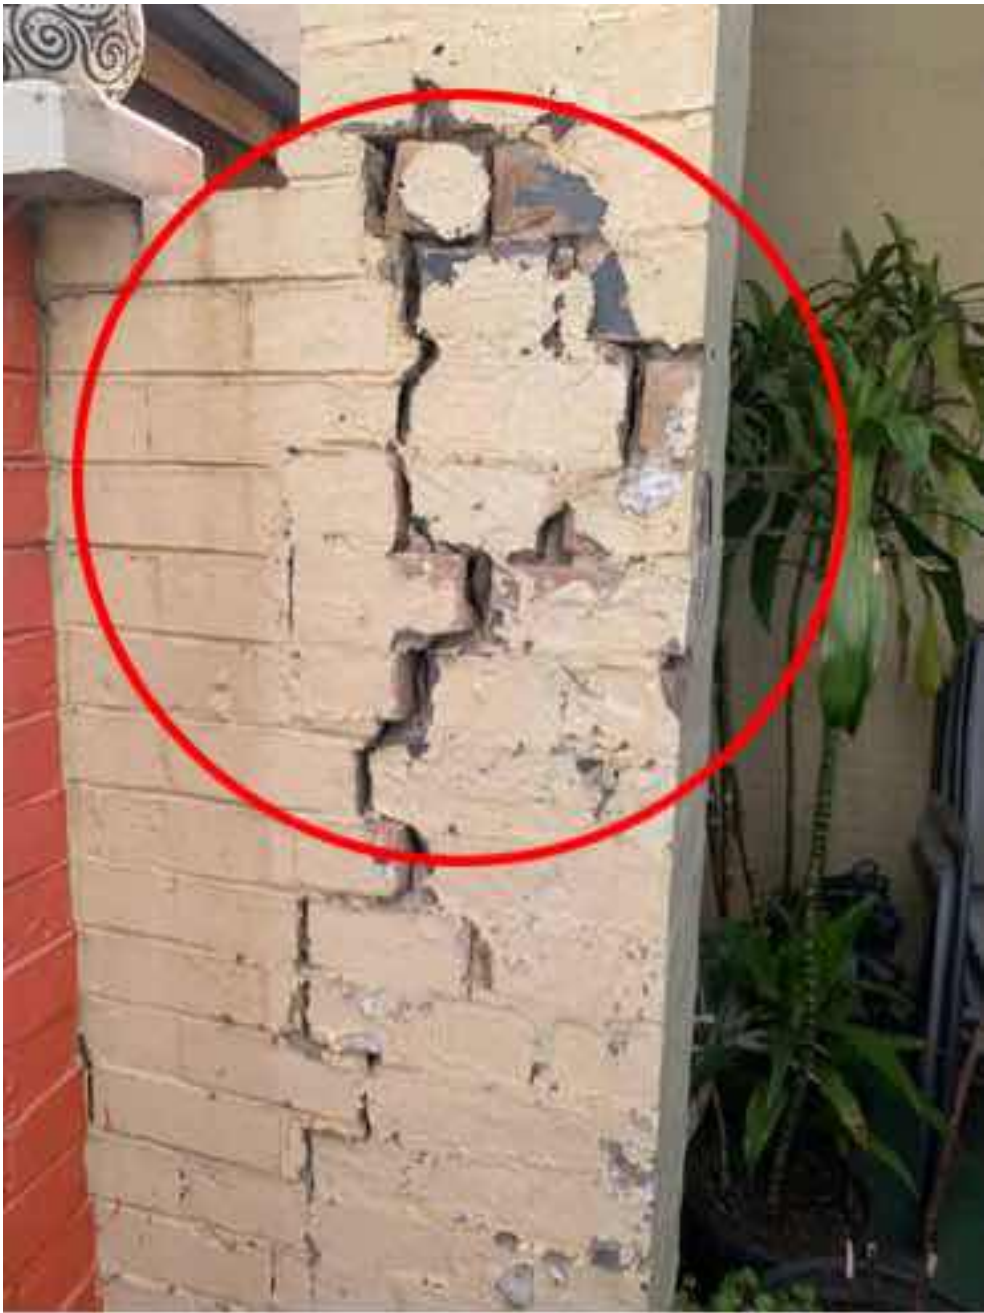
West Elevation

Settlement Cracks Present

Pre Existing Damage
Structural Crack Present

Pre Existing Damage

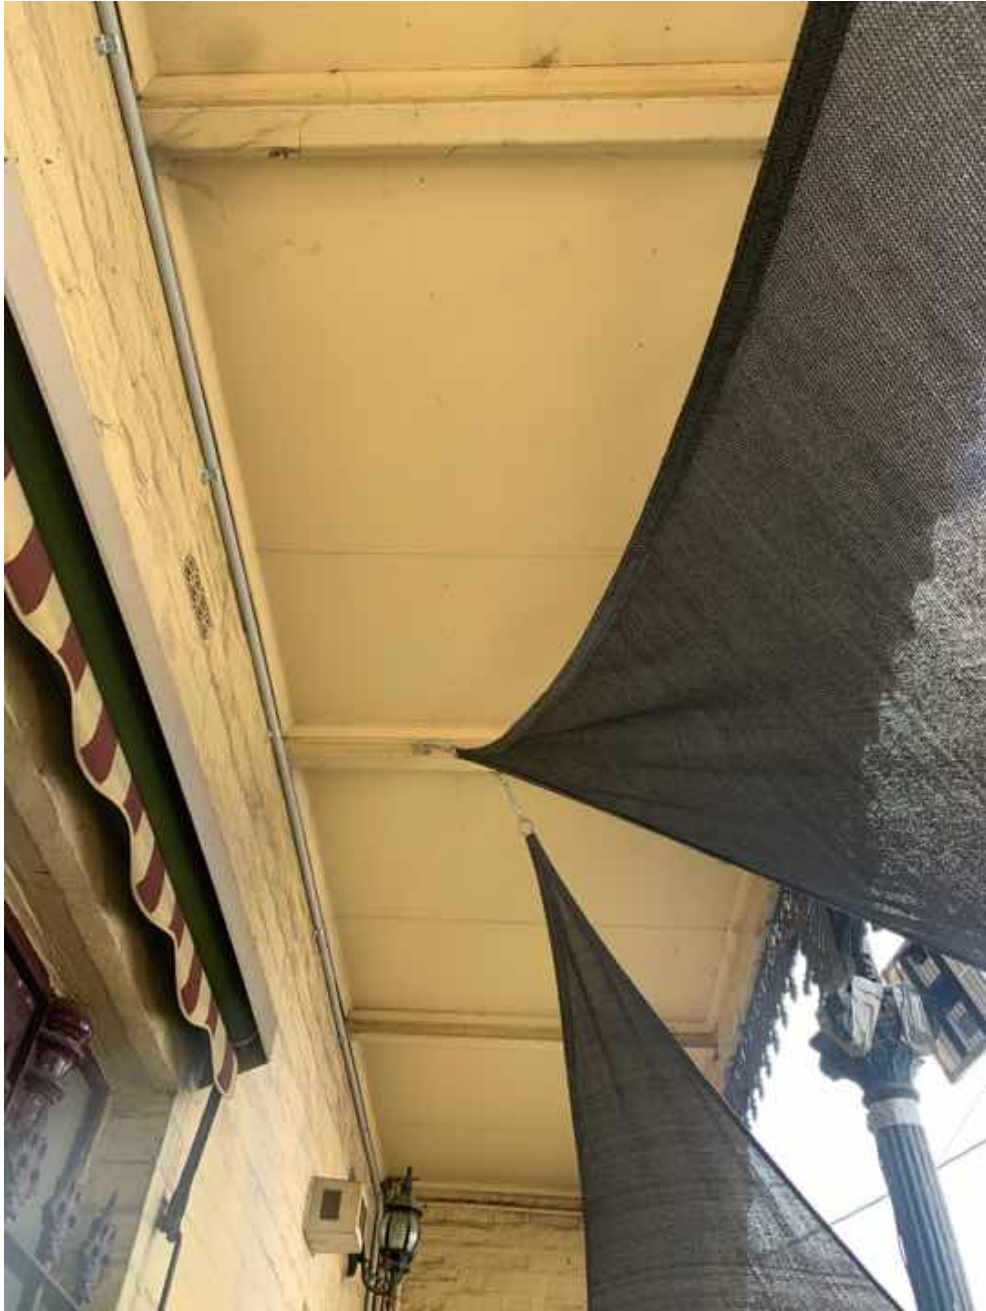
Eaves/lining

No Defects Noted

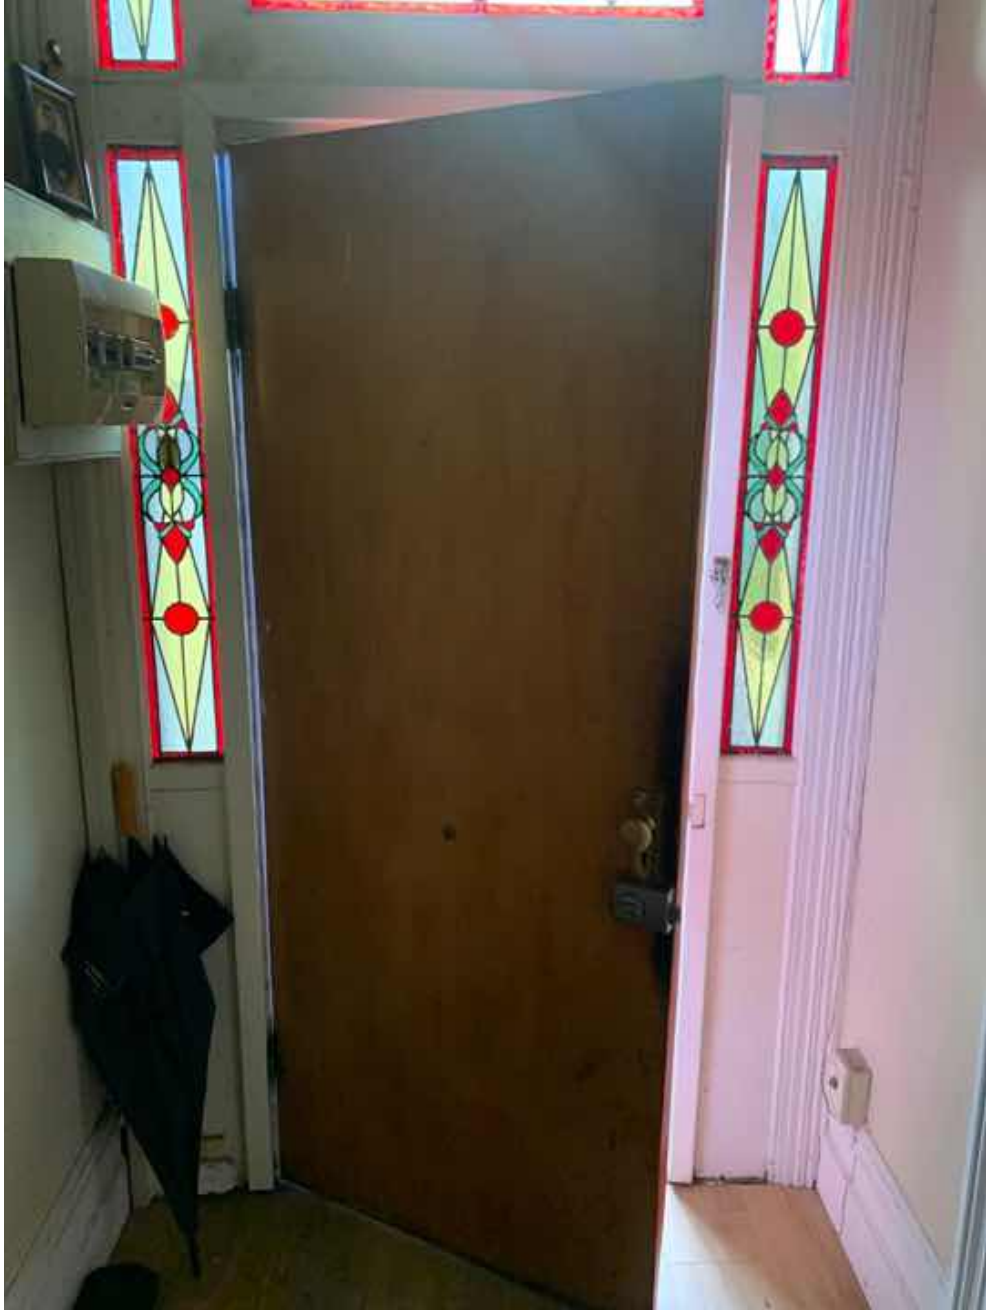
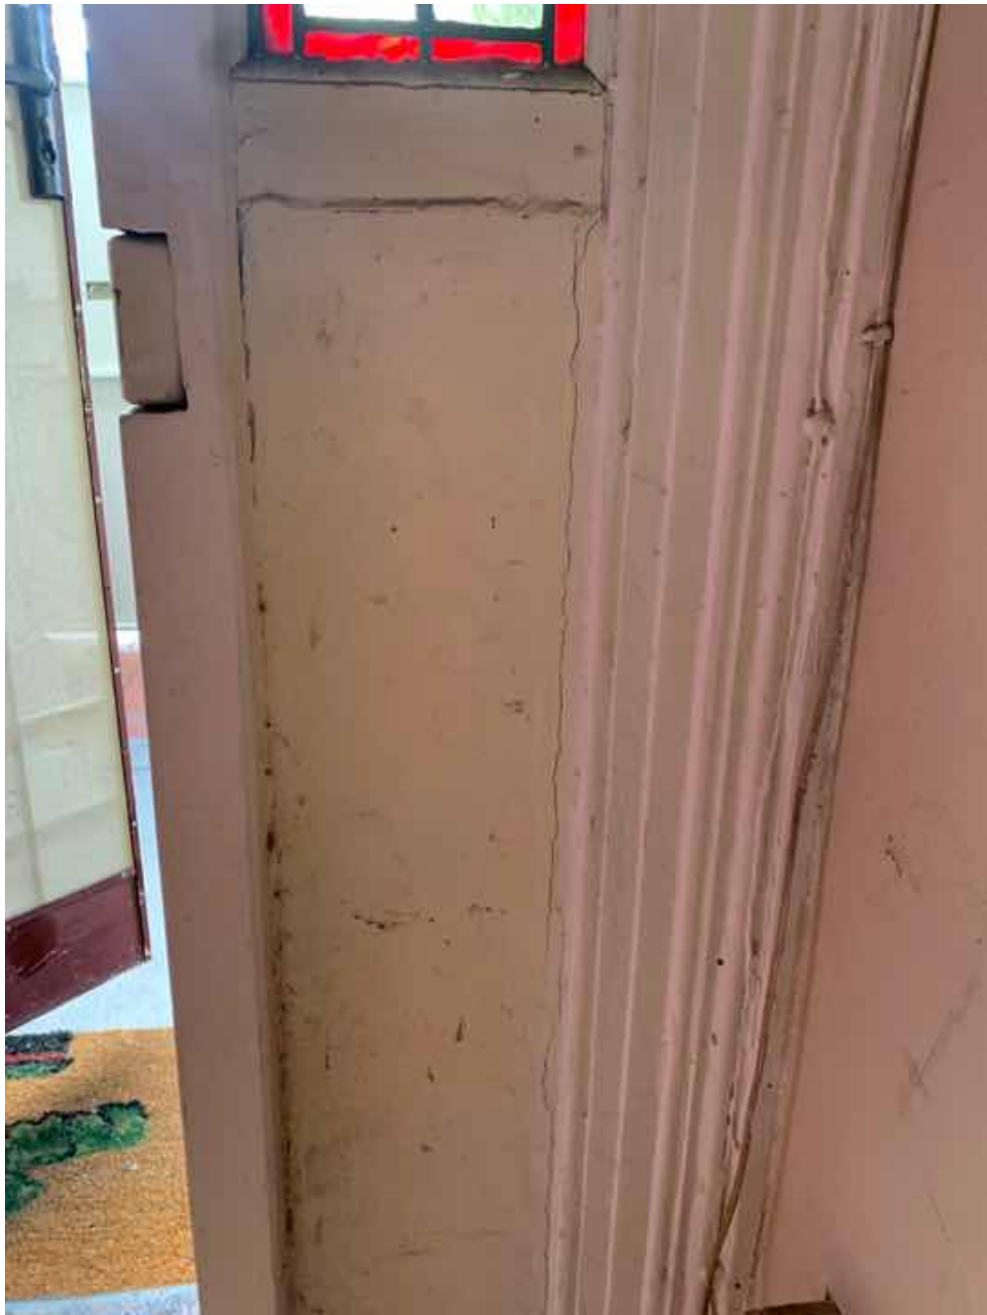
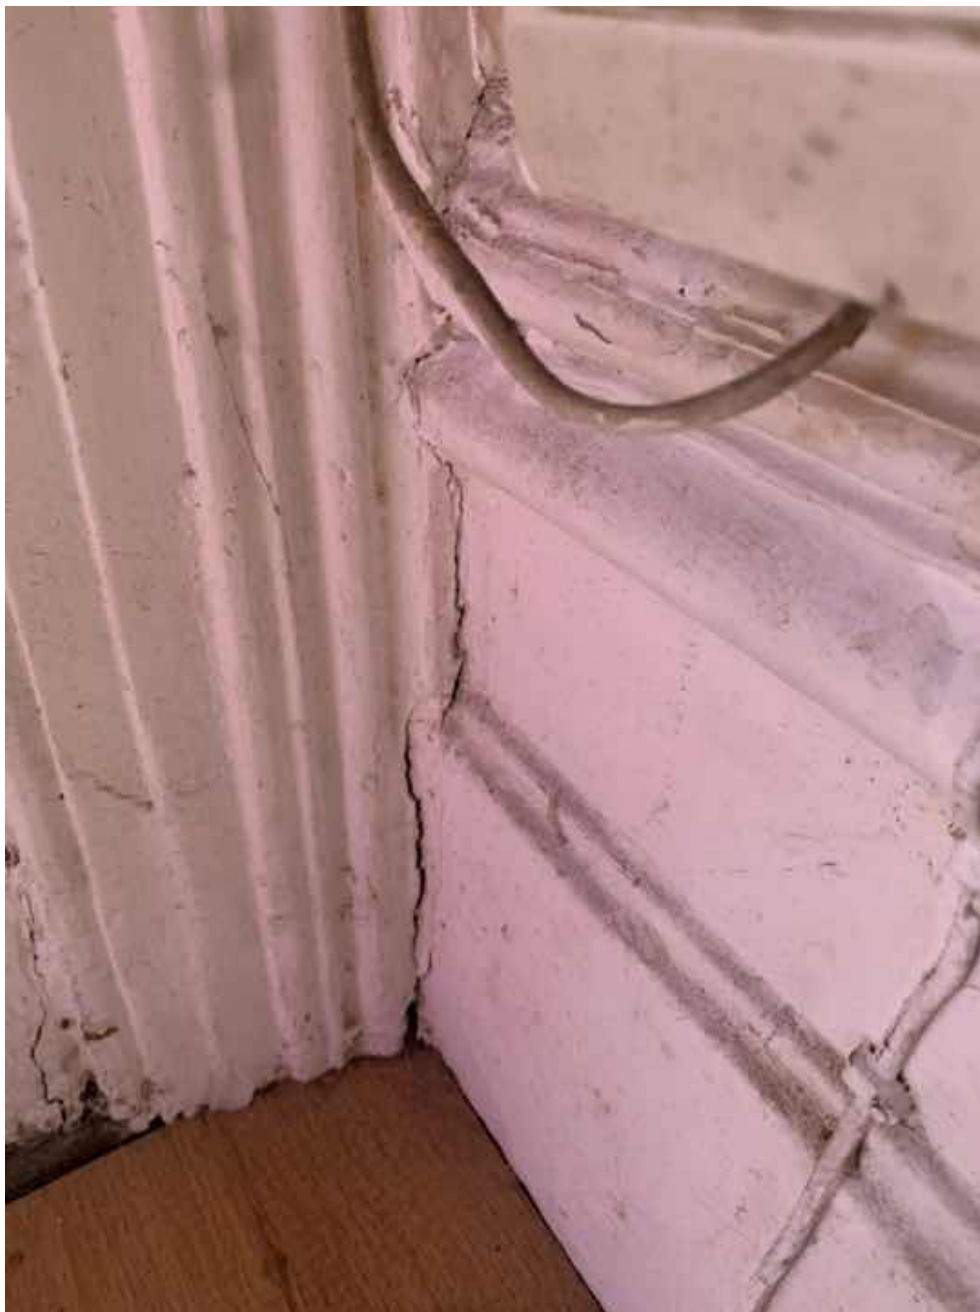
Front Door & Frame

Settlement Cracks Present

Pre Existing Damage
