Dilapidation Survey Inspection Report

Report/Agreement # 0202210849412

Inspection Date: 02 Feb 2021

Dilapidation Inspection Report

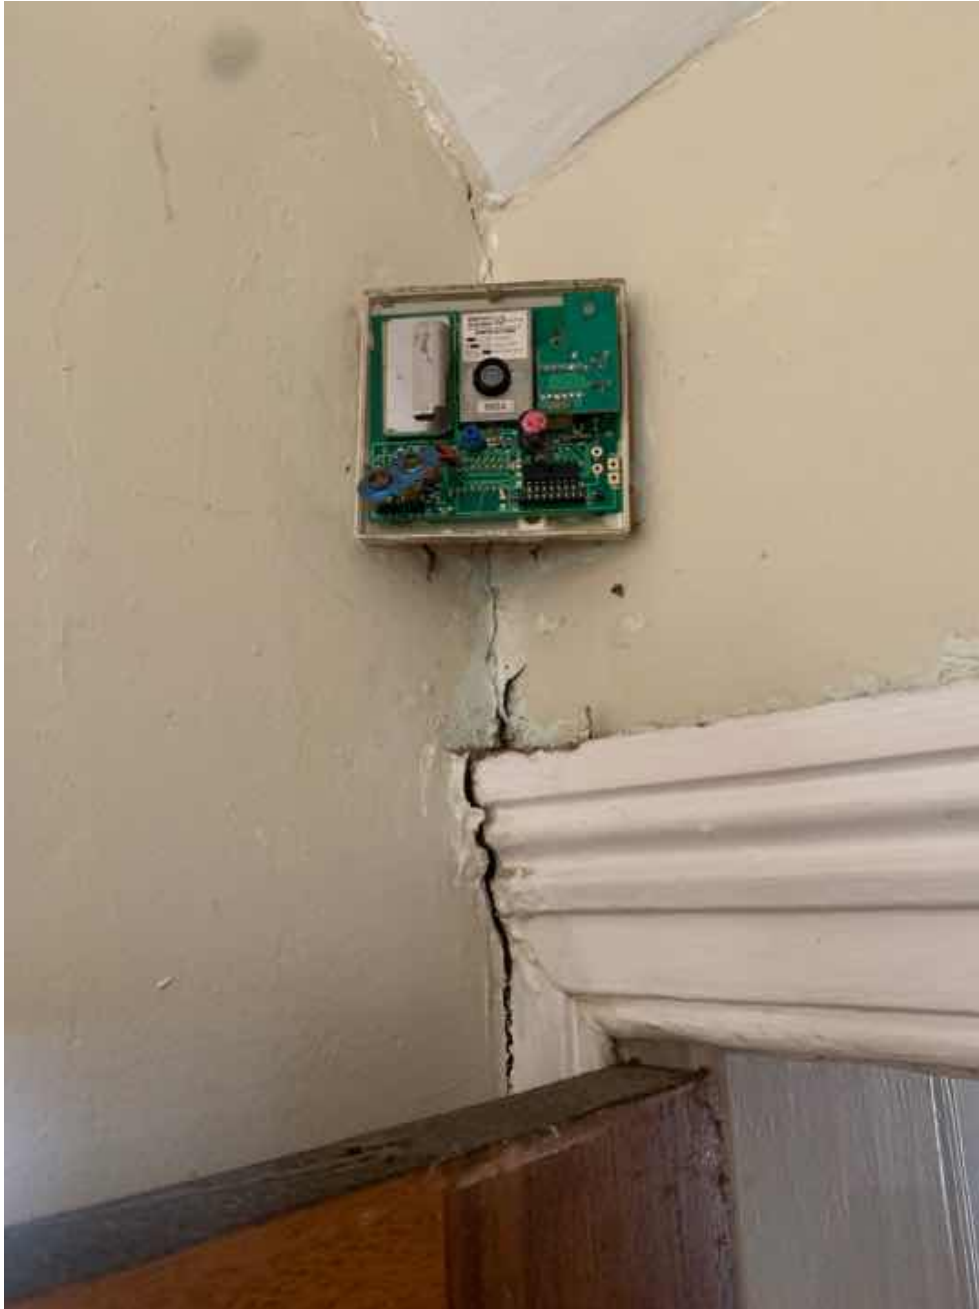
Door & Frame

Settlement Cracks Present

Pre Existing Damage

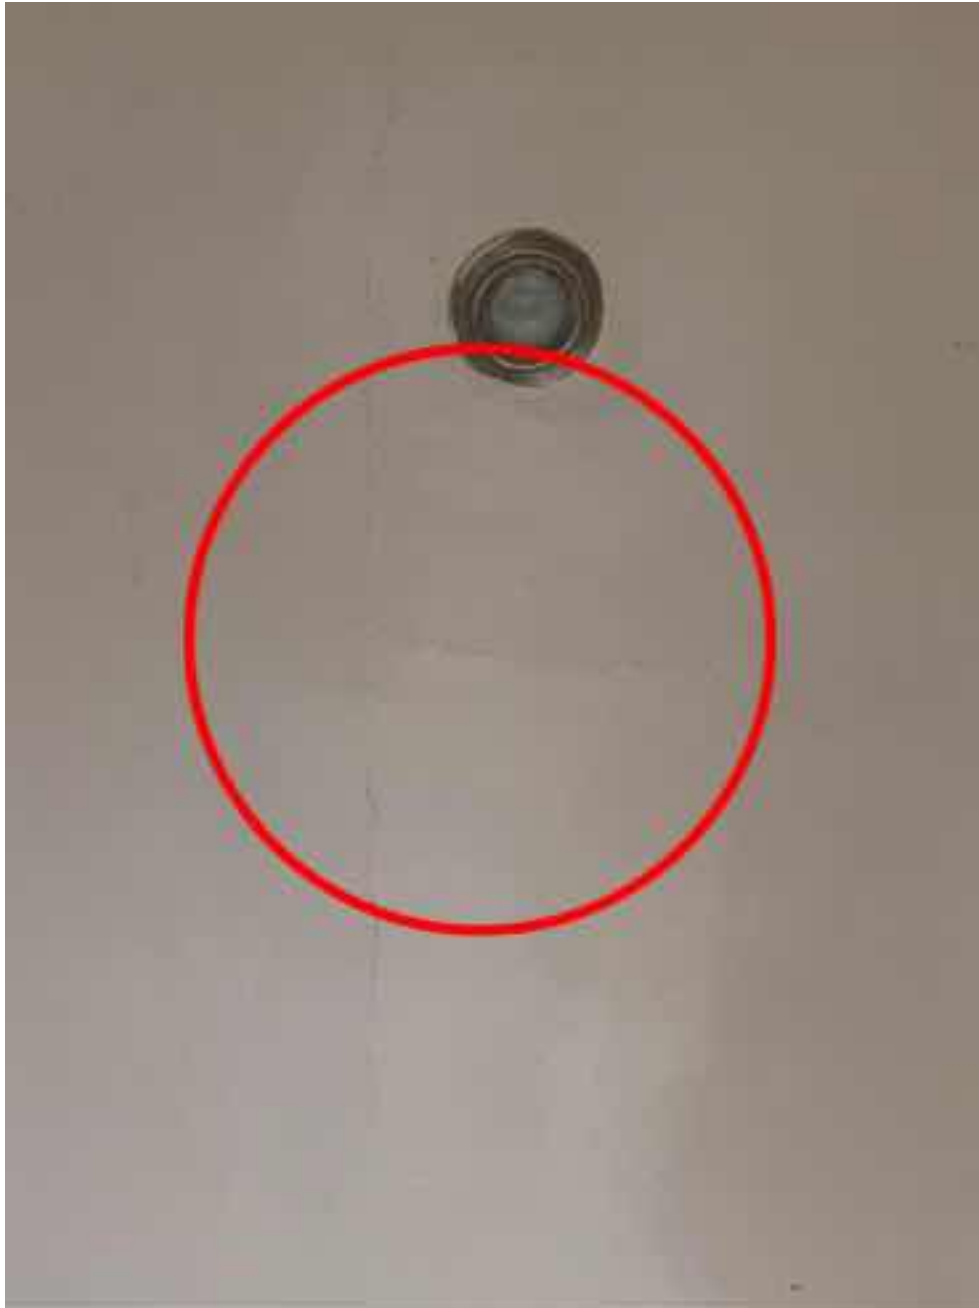
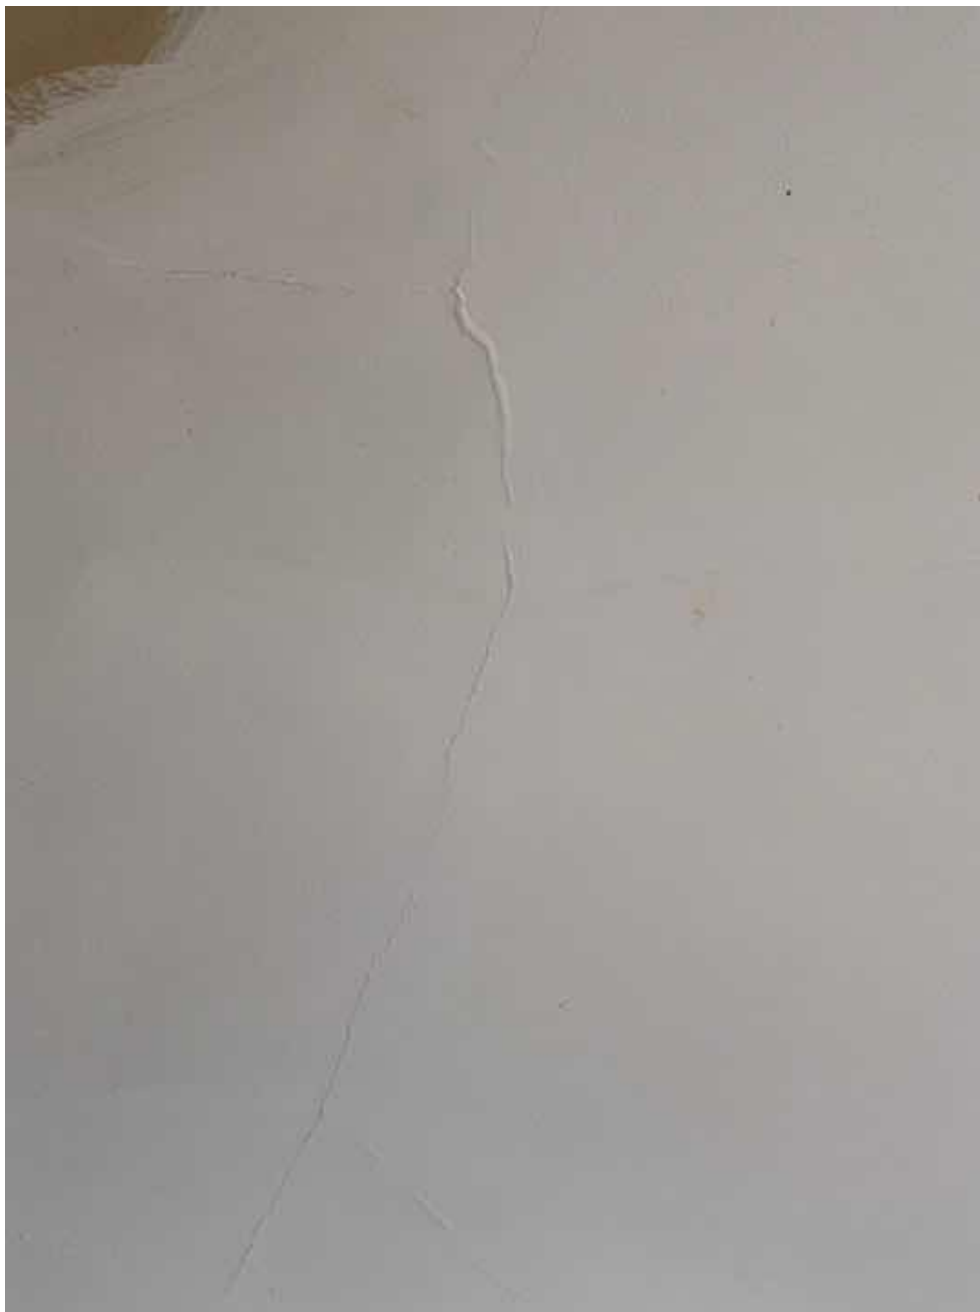
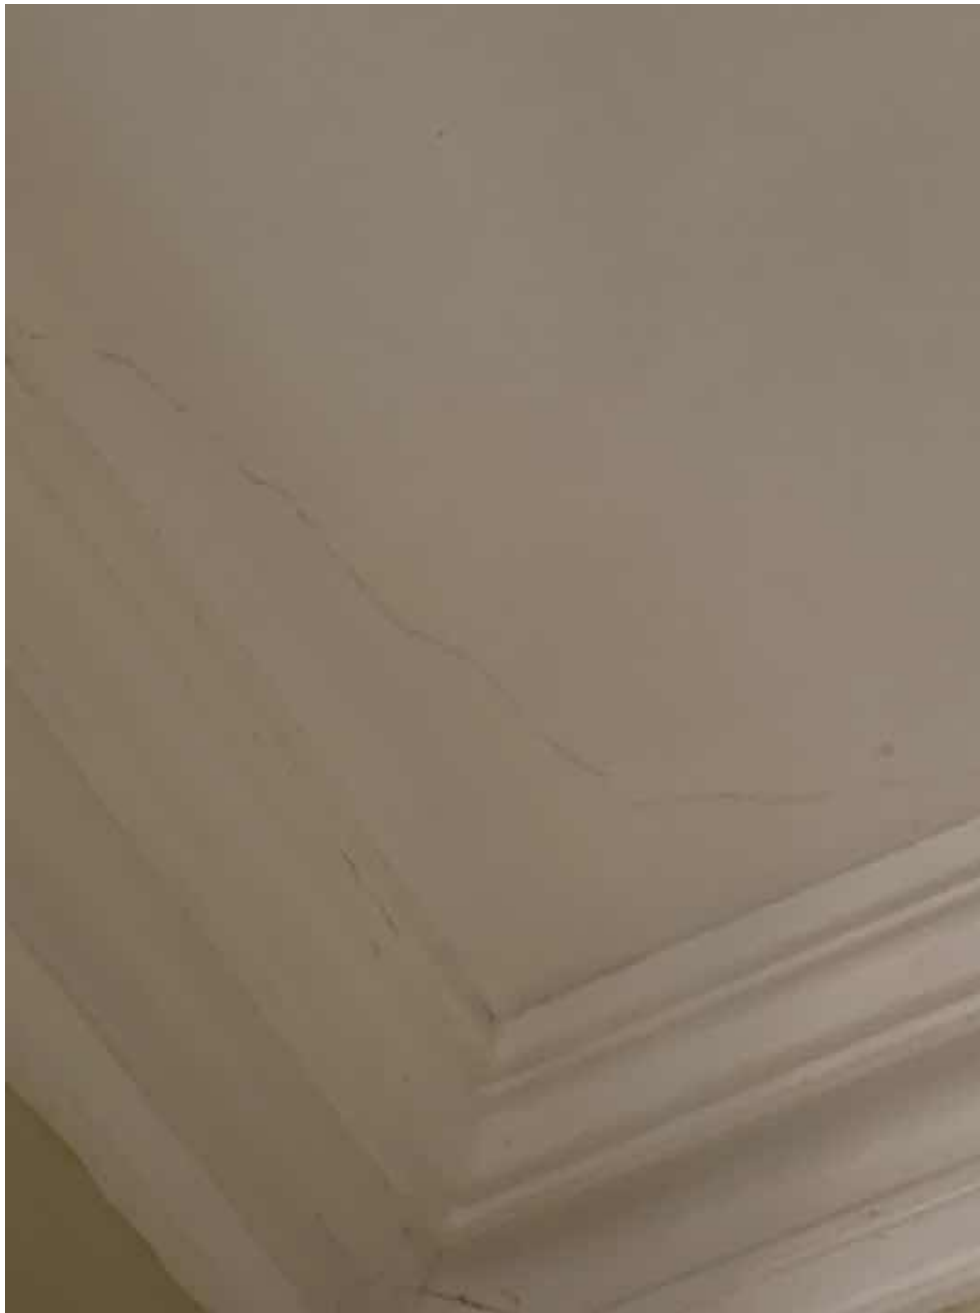
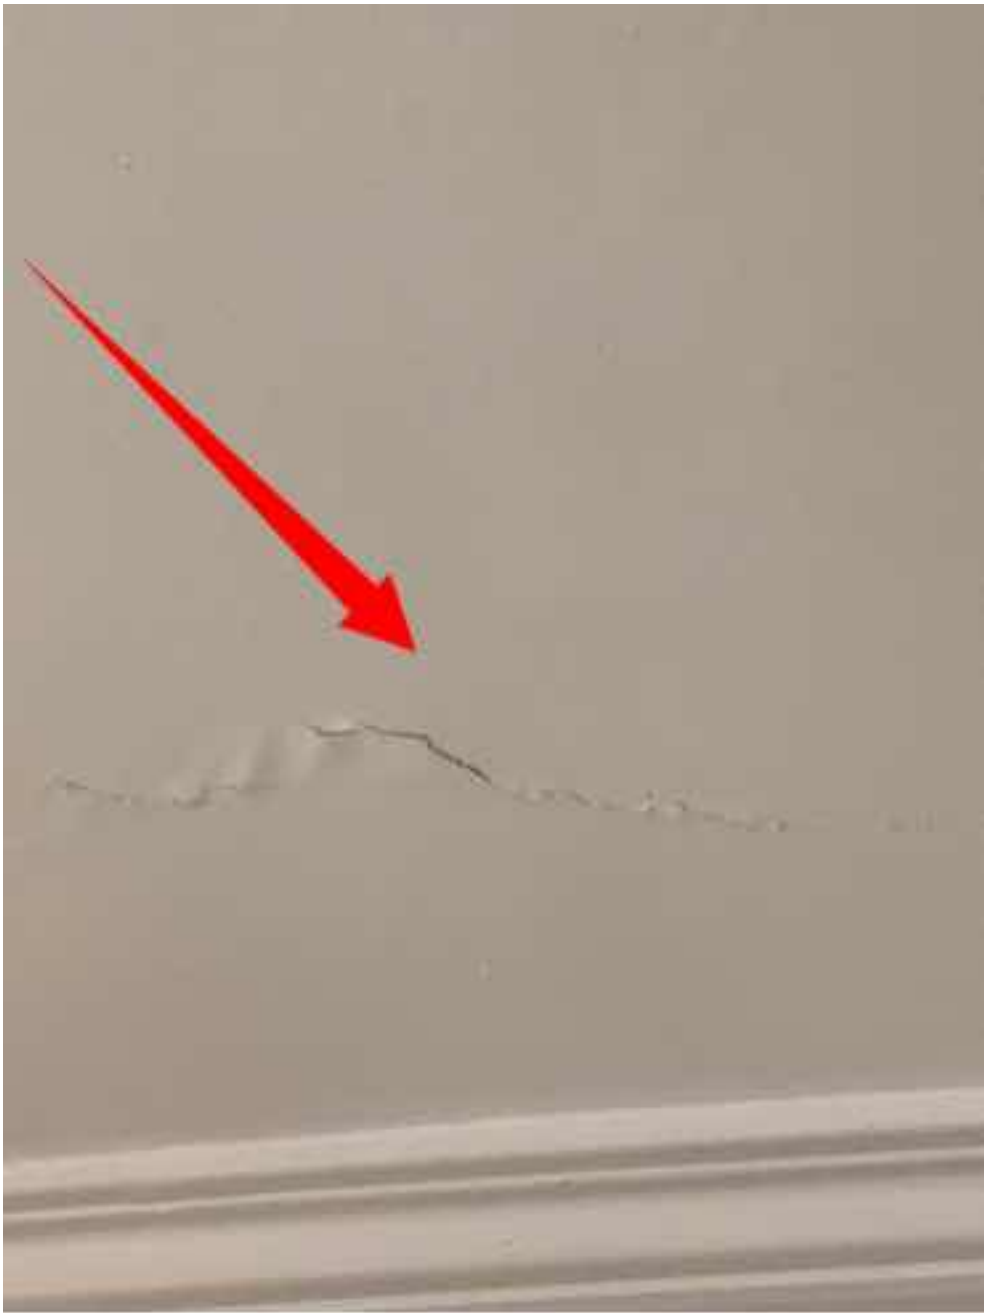
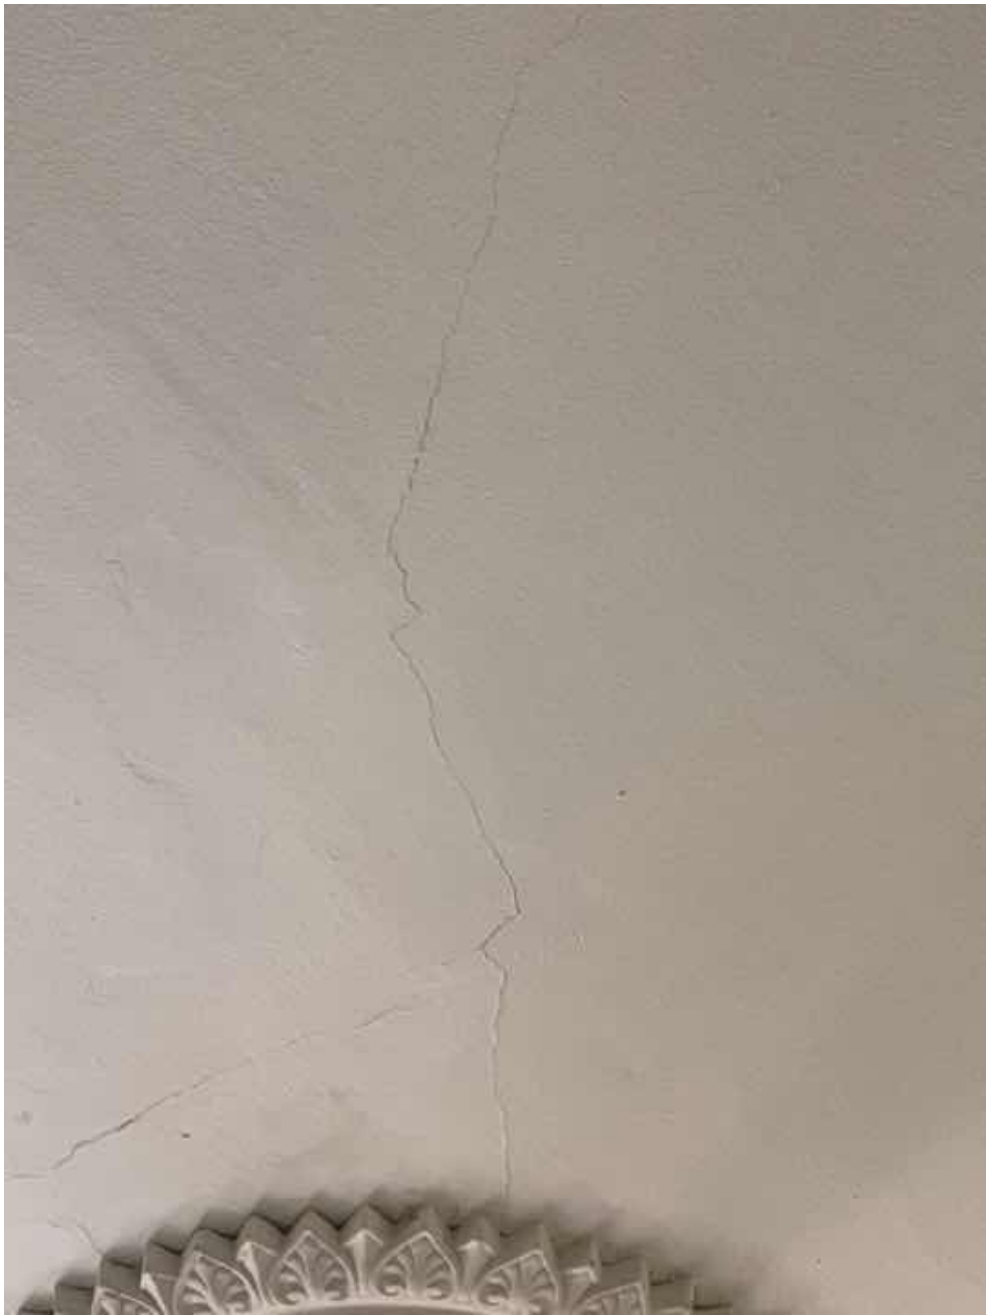
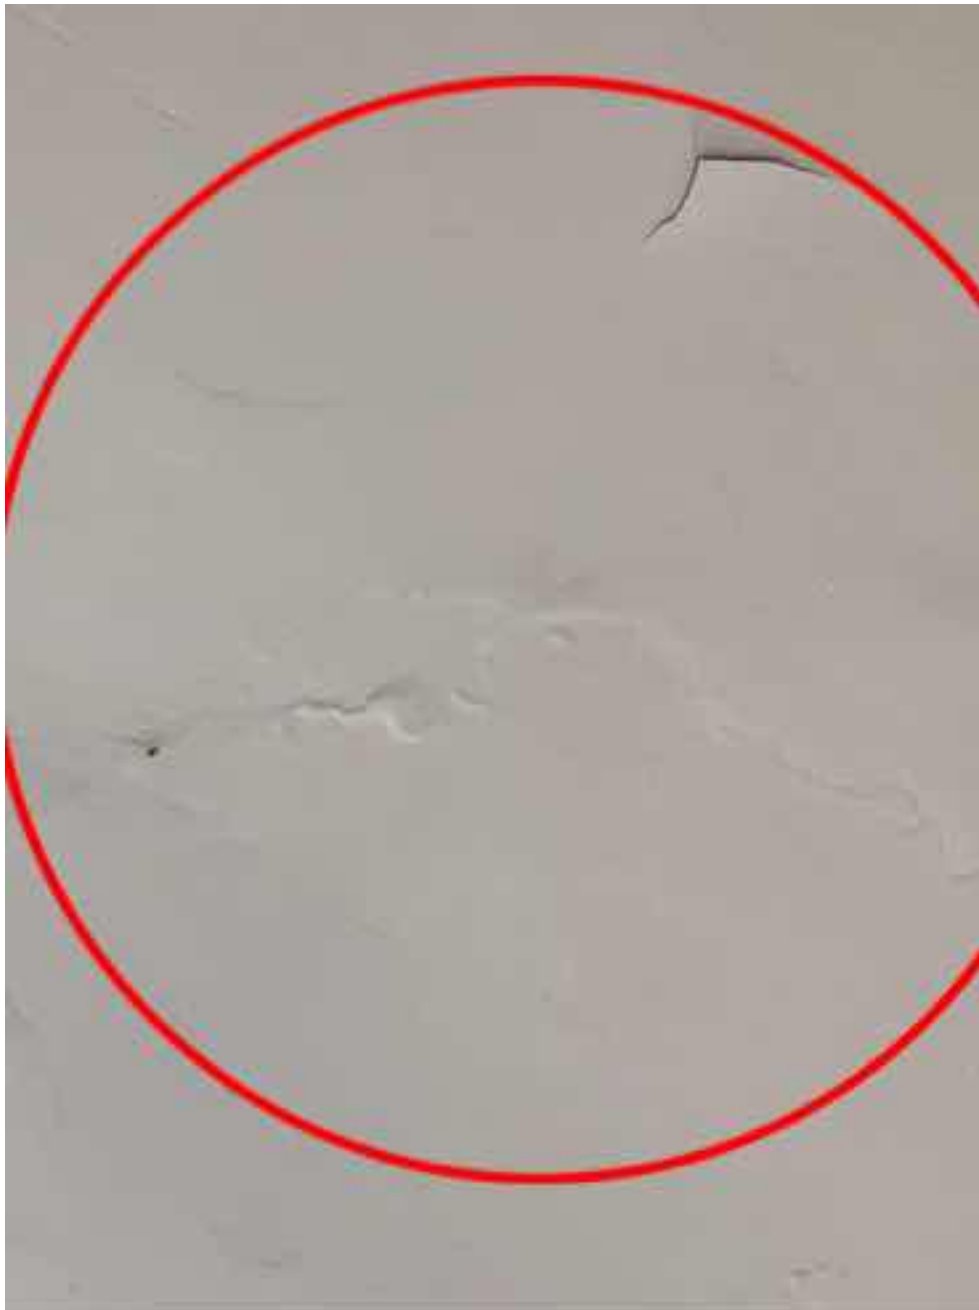
Ceiling

Settlement Cracks Present

Pre Existing Damage

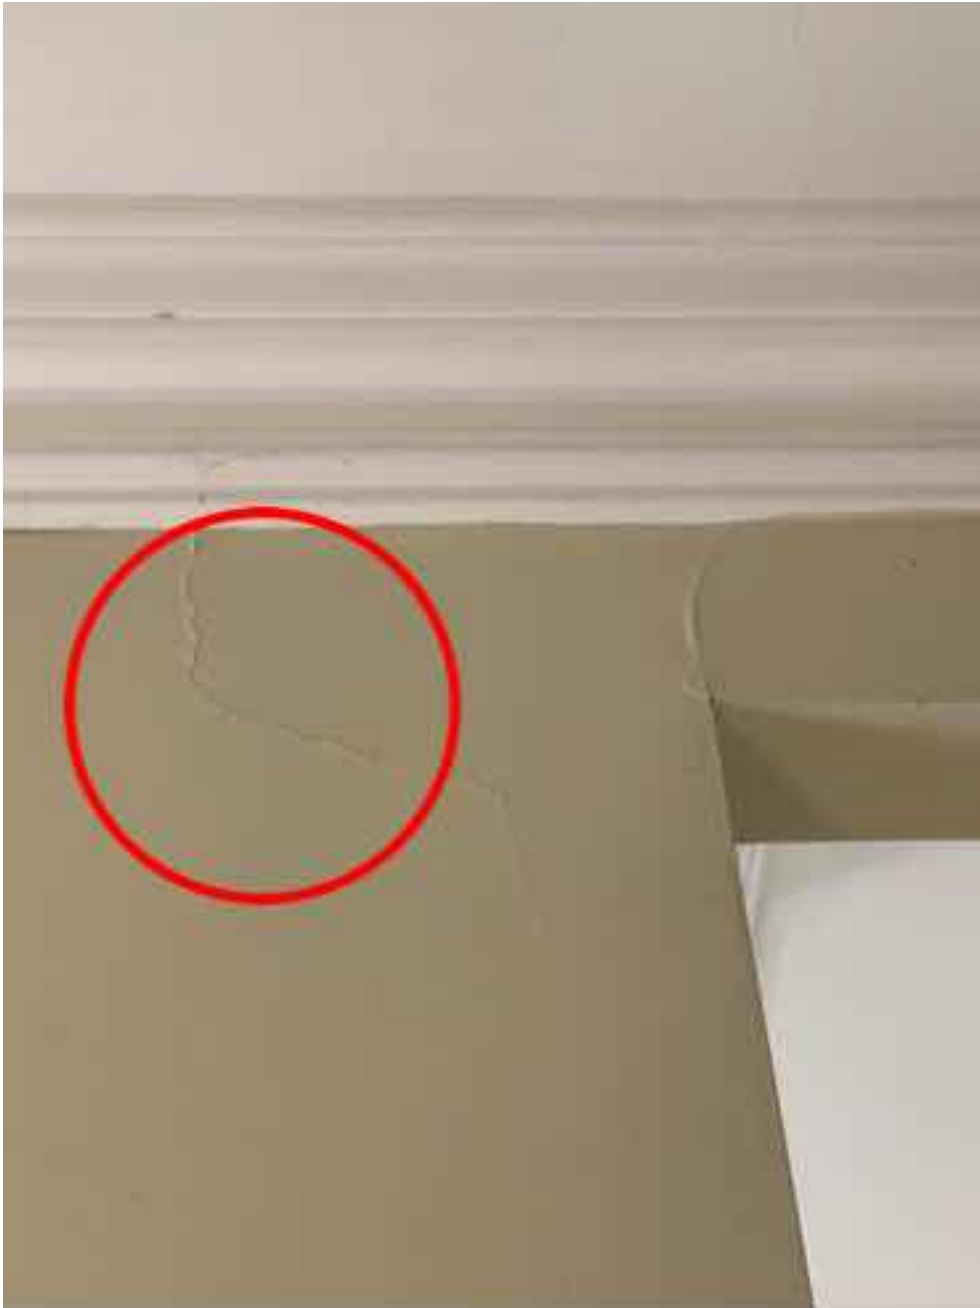
Eastern Wall

Settlement Crack Present

Pre Existing Damage

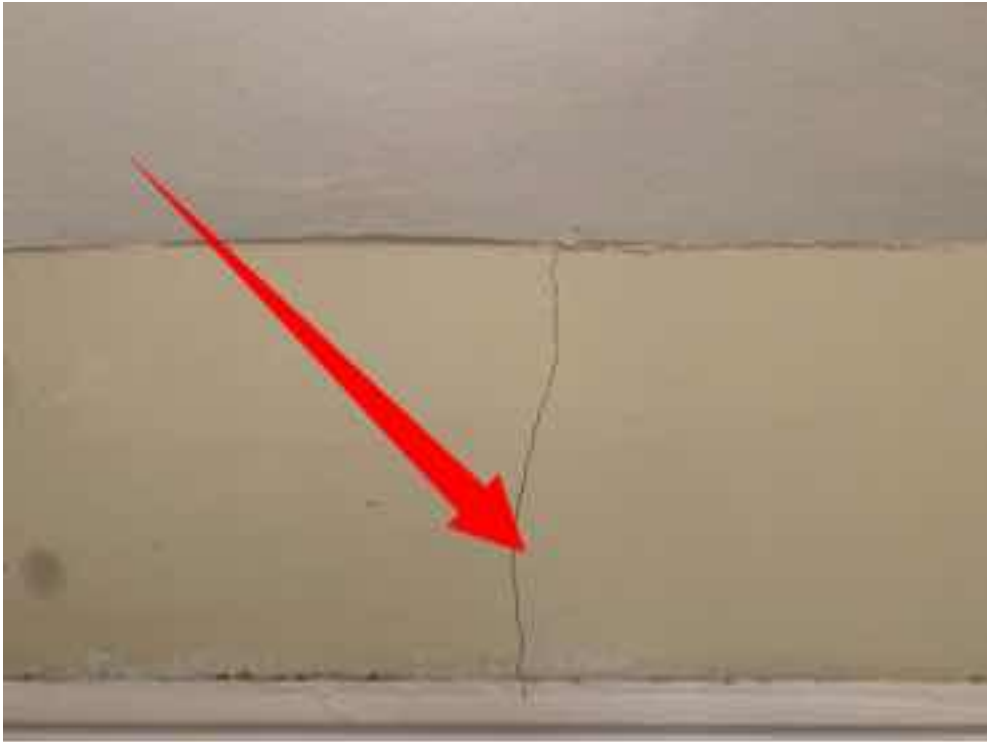
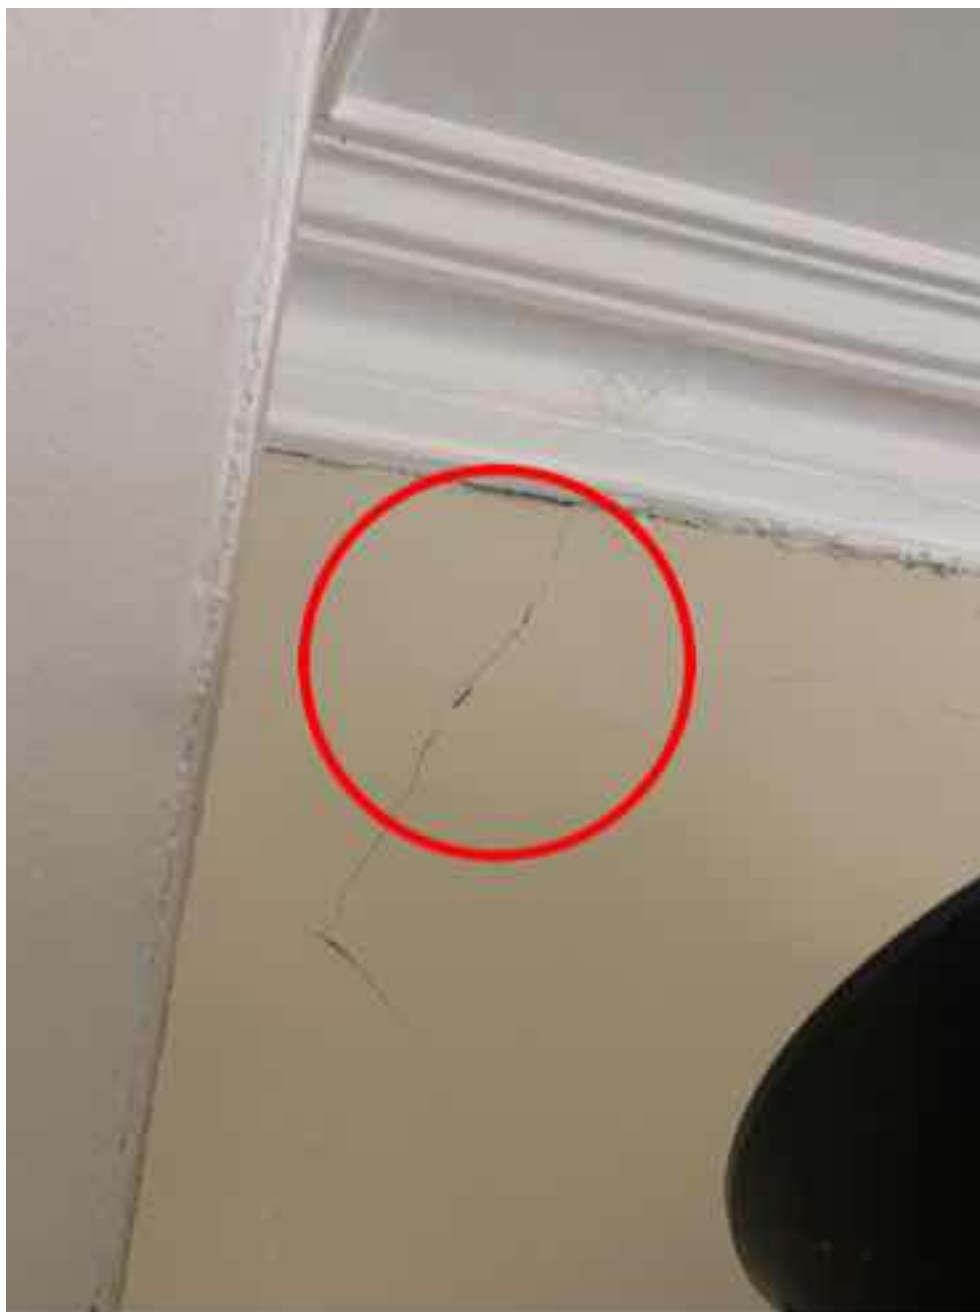
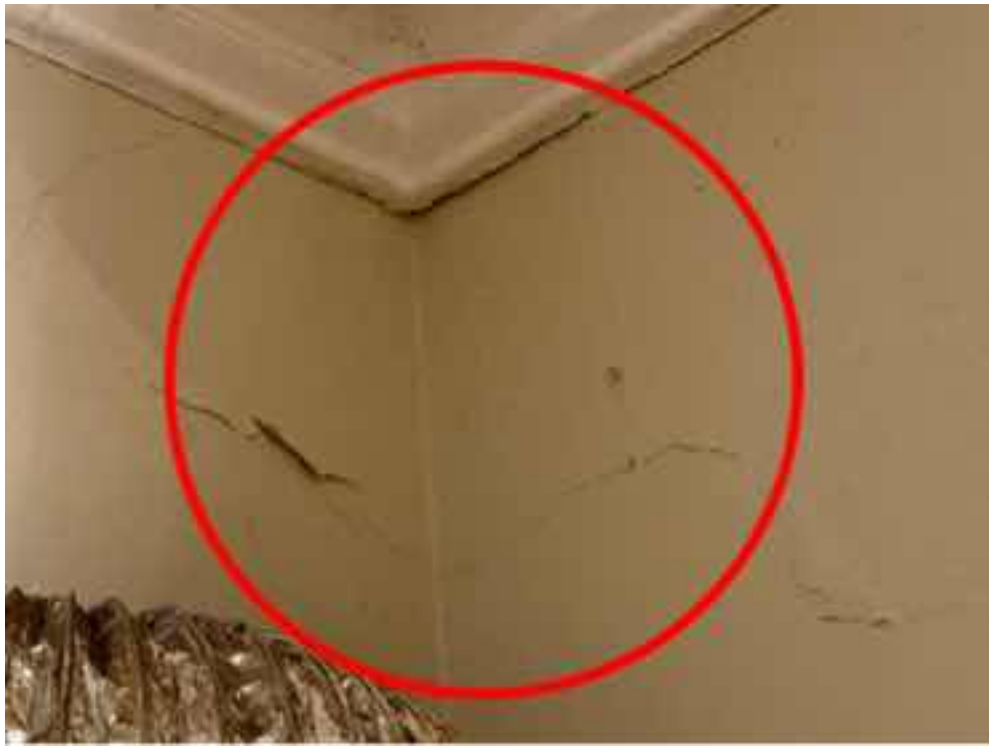
Western wall

Settlement Cracks Present

Pre Existing Damage

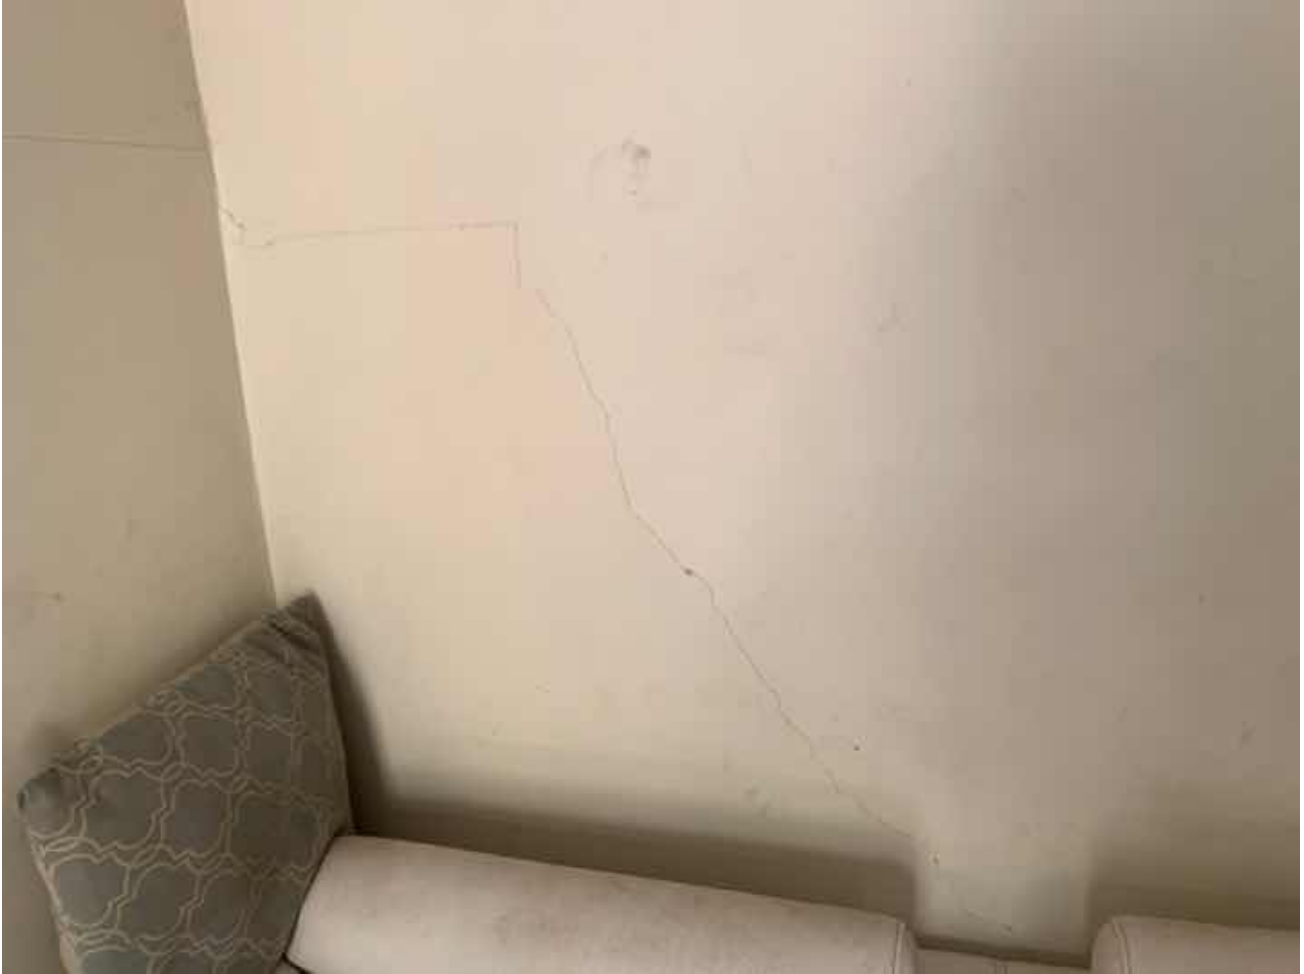
Southern Wall

Settlement Cracks Present

Pre Existing Damage

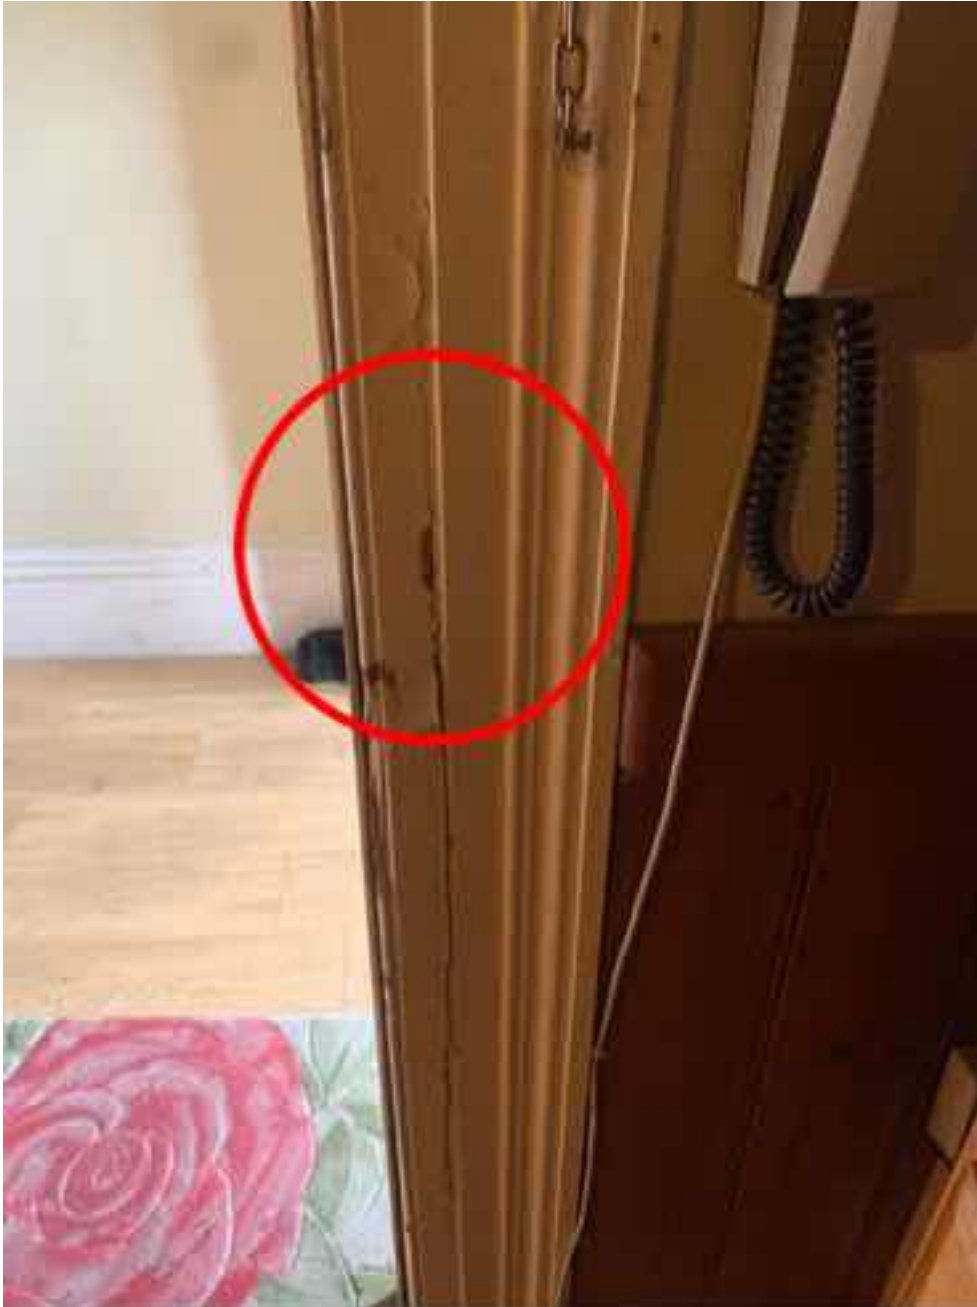
Door & Frame

Settlement Cracks Present

Pre Existing Damage

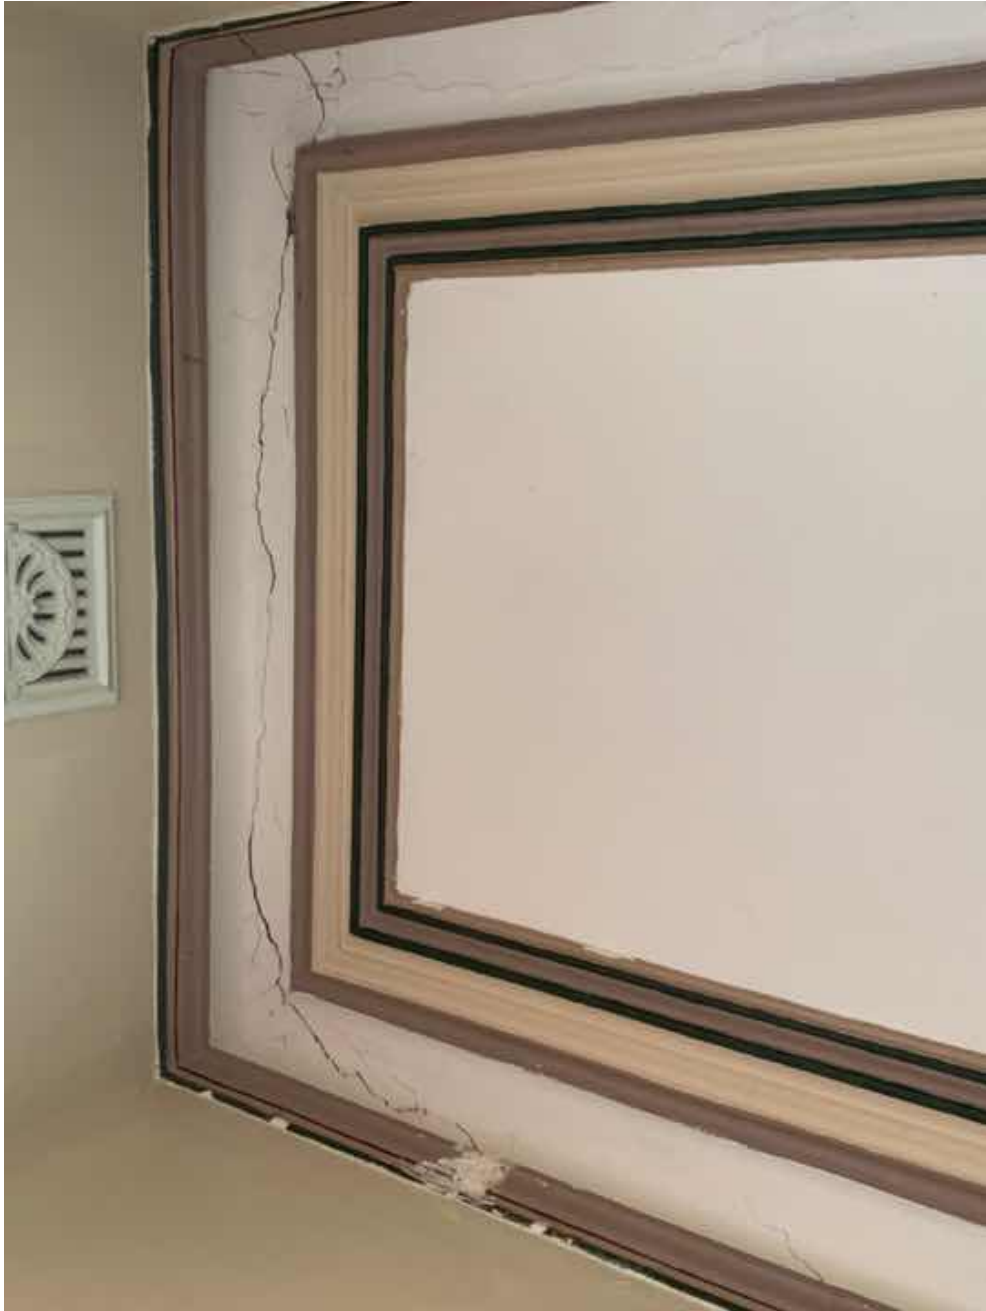
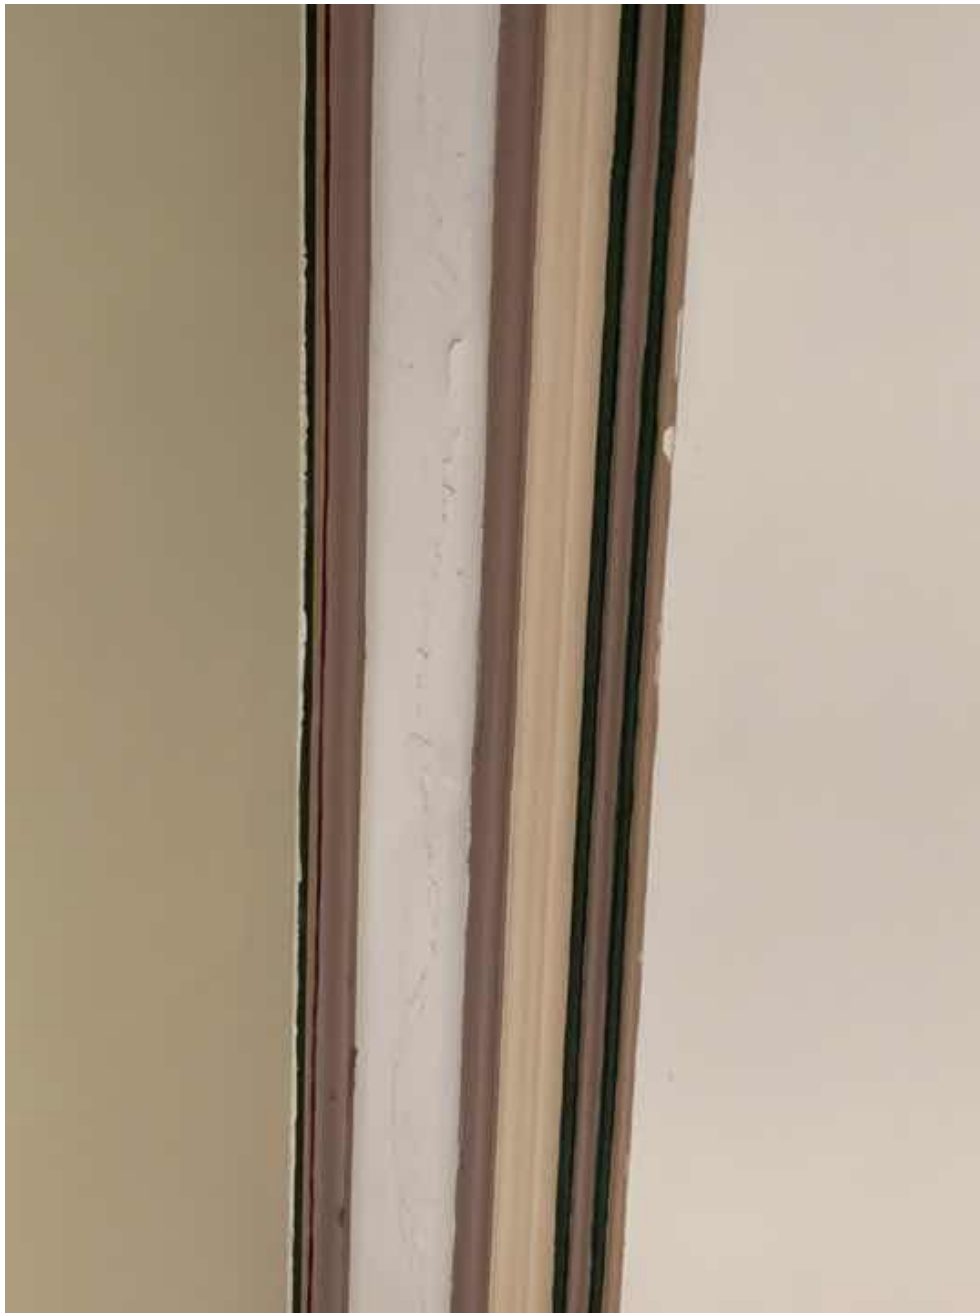
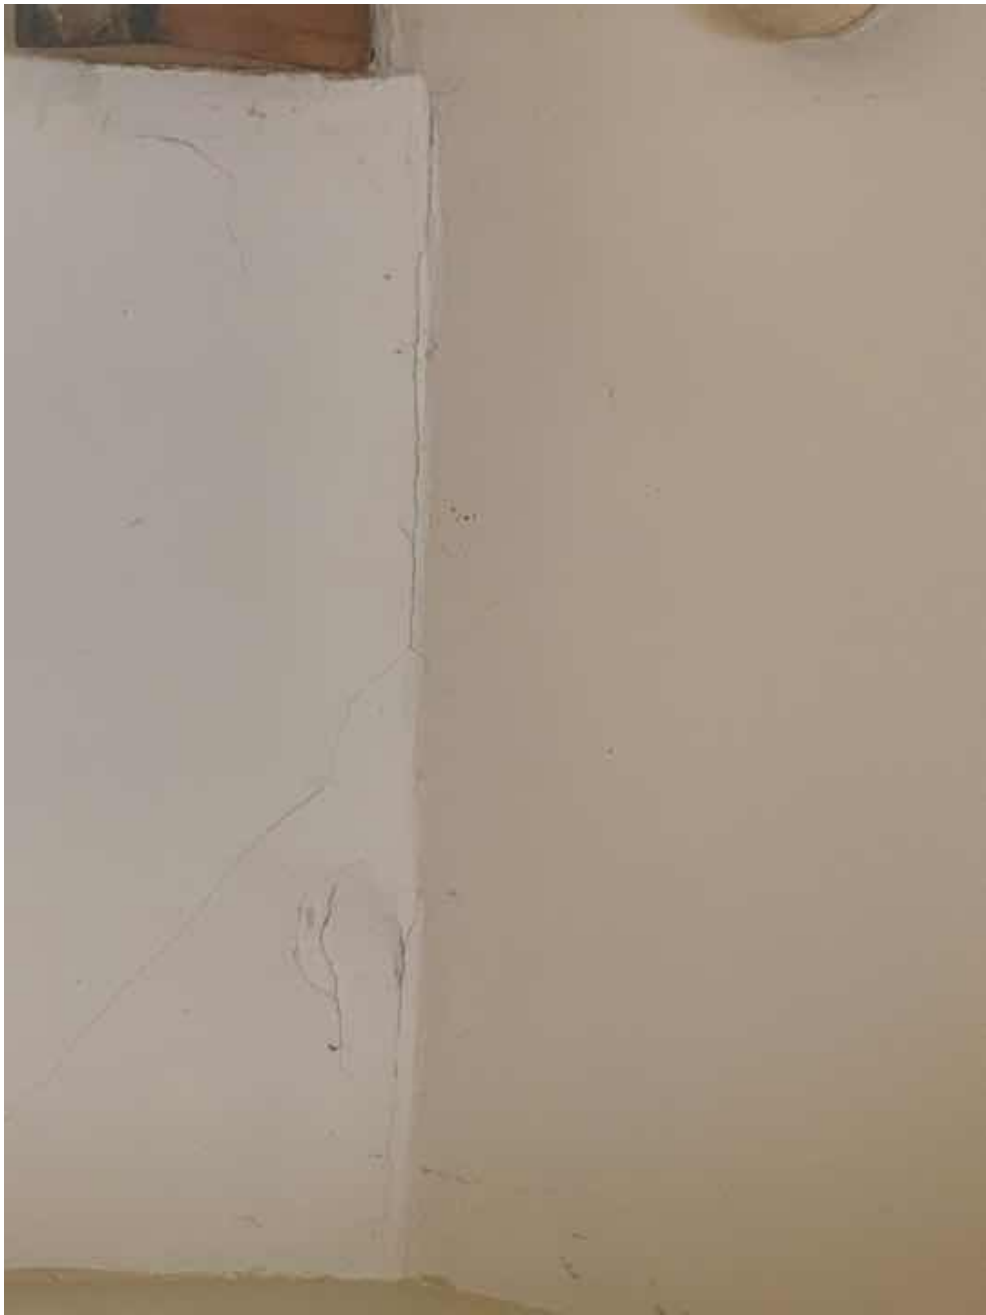
Ceiling

Settlement Cracks Present

Pre Existing Damage

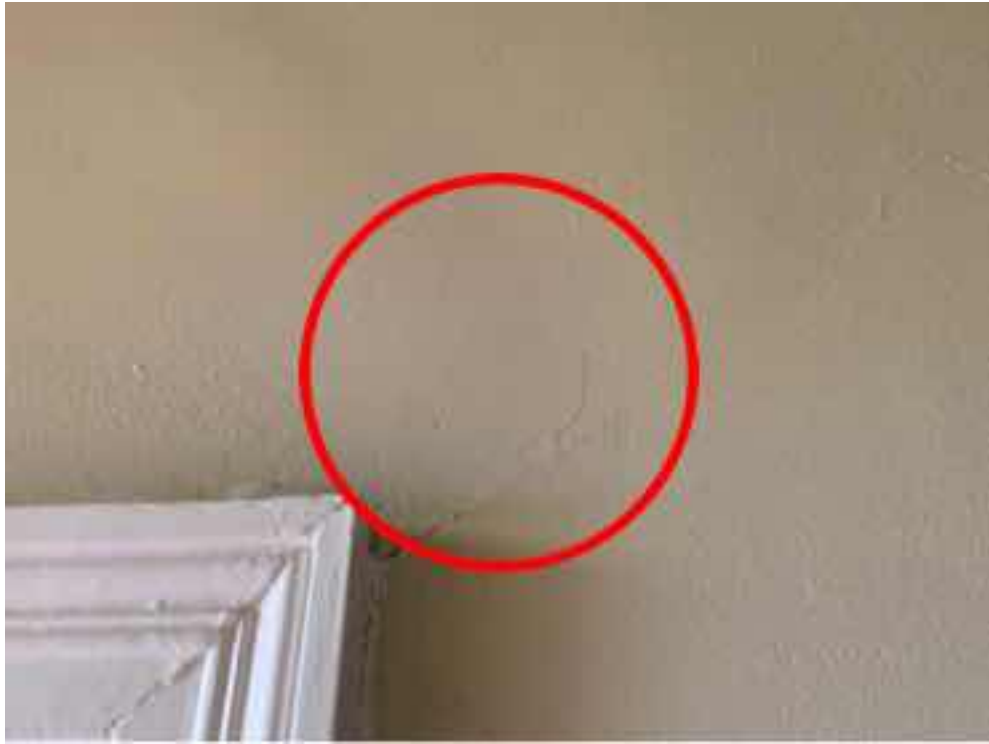
Northern Wall

Settlement Cracks Present

Pre Existing Damage

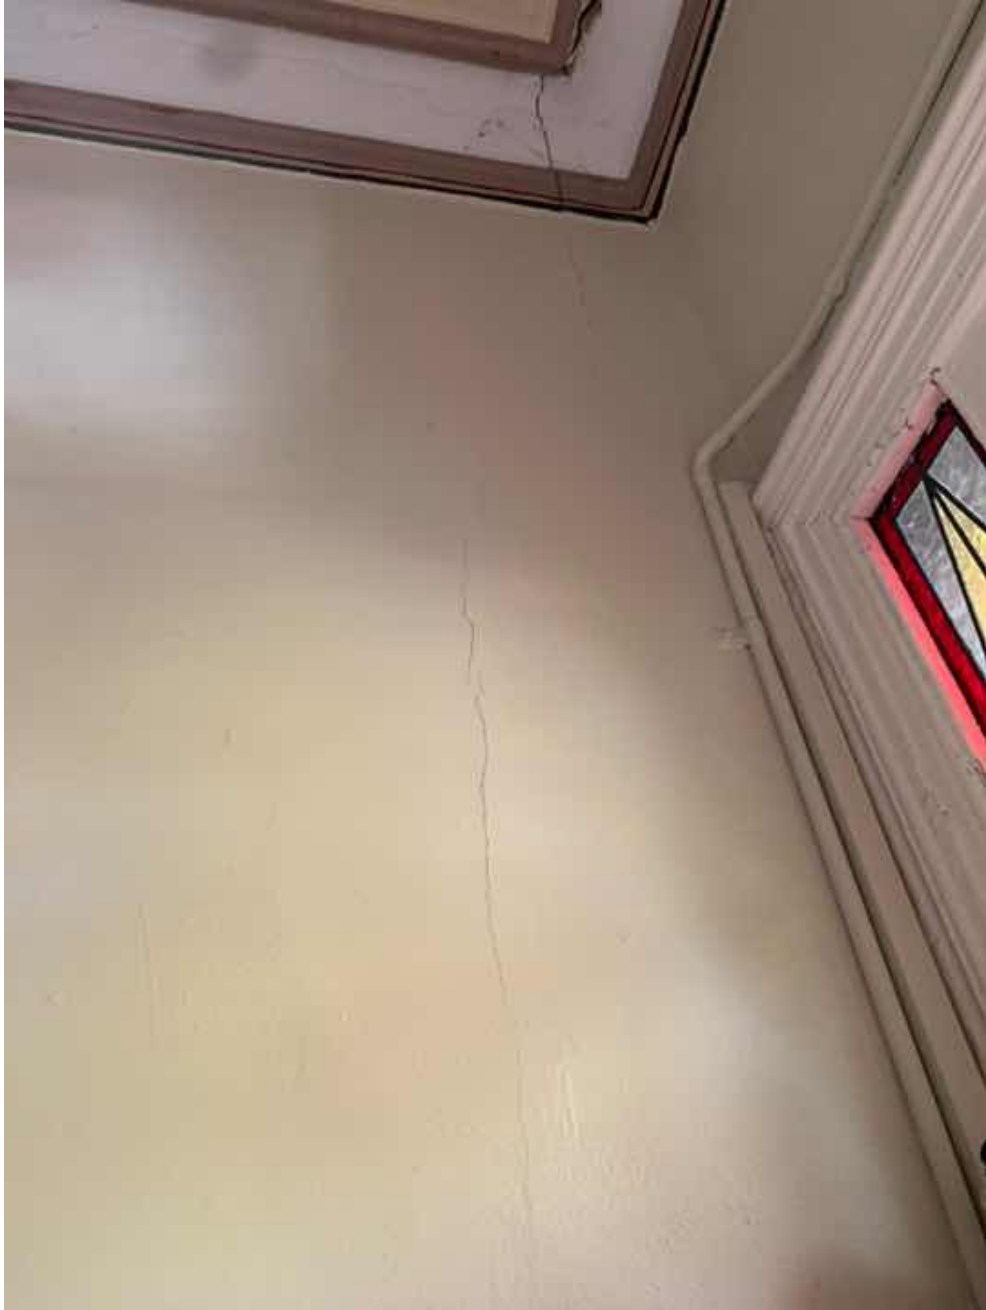
Southern Wall

Settlement Cracks Present

Pre Existing Damage

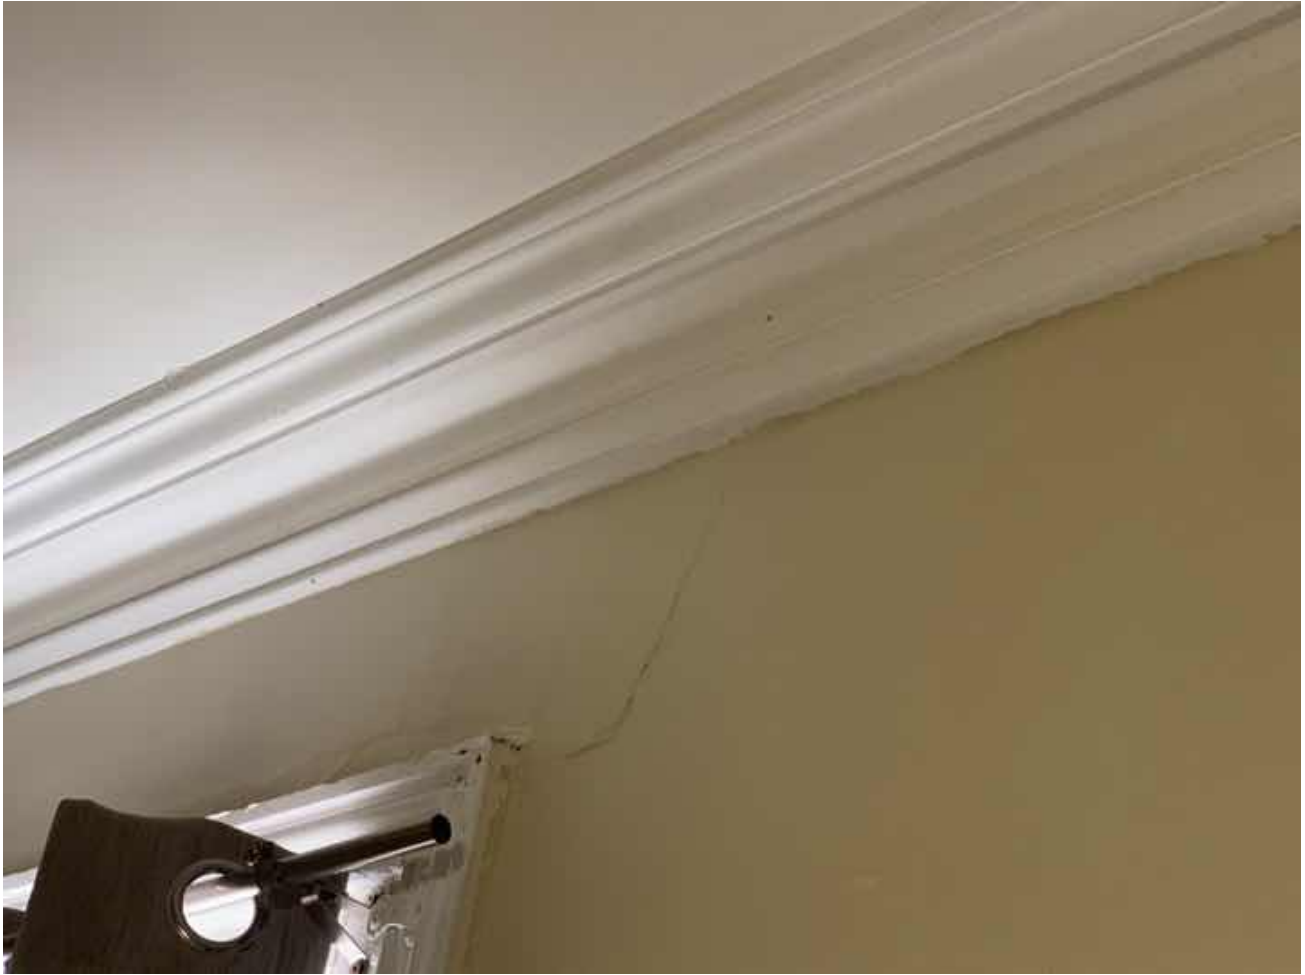
Eastern Wall

Settlement Cracks Present

Pre Existing Damage
