Dilapidation Survey Inspection Report

Report/Agreement # 0202210849412

Inspection Date: 02 Feb 2021

Dilapidation Inspection Report

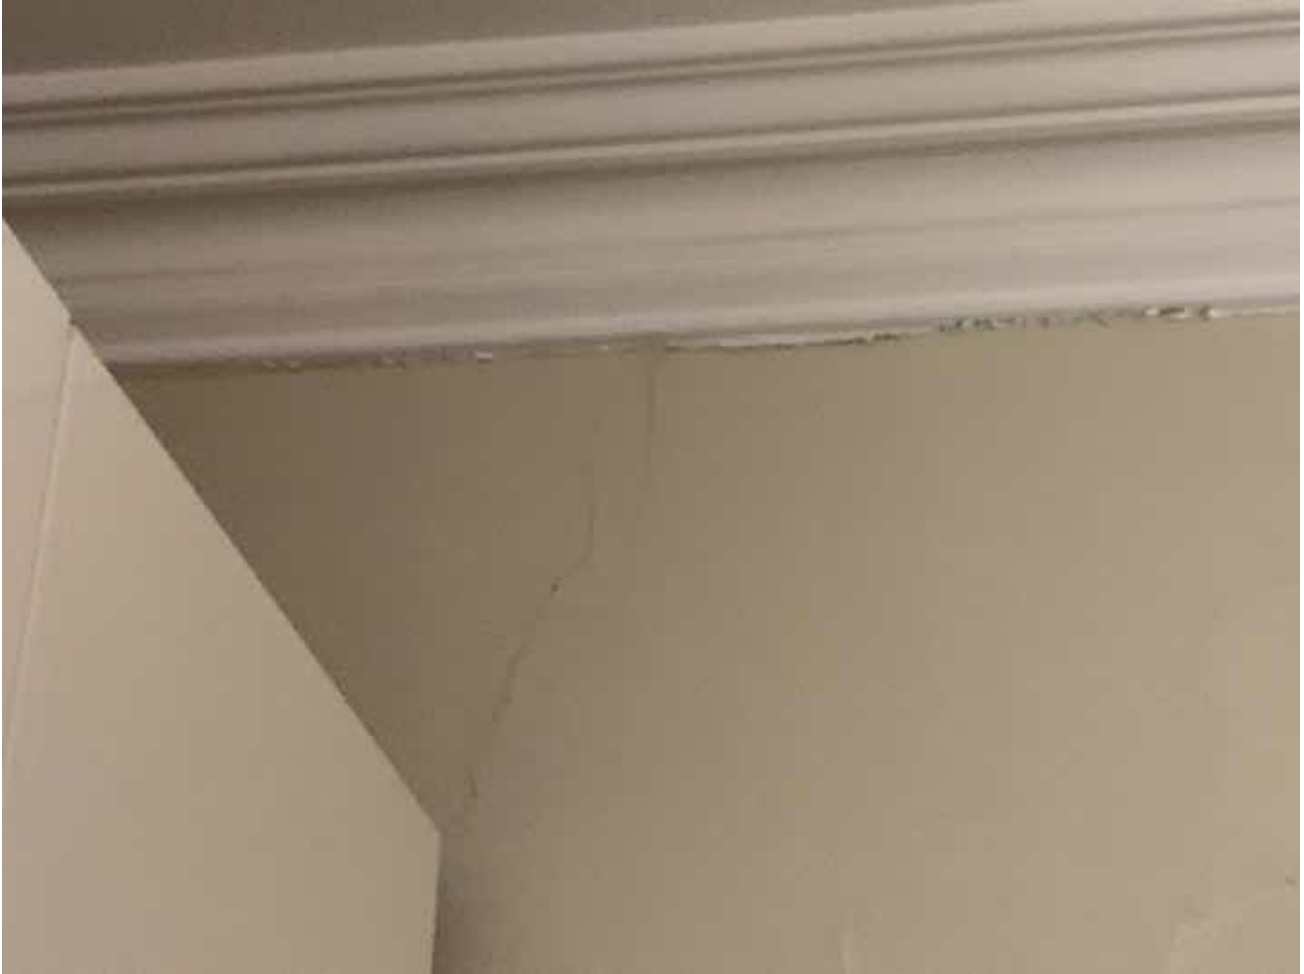
Western wall

Settlement Cracks Present

Pre Existing Damage

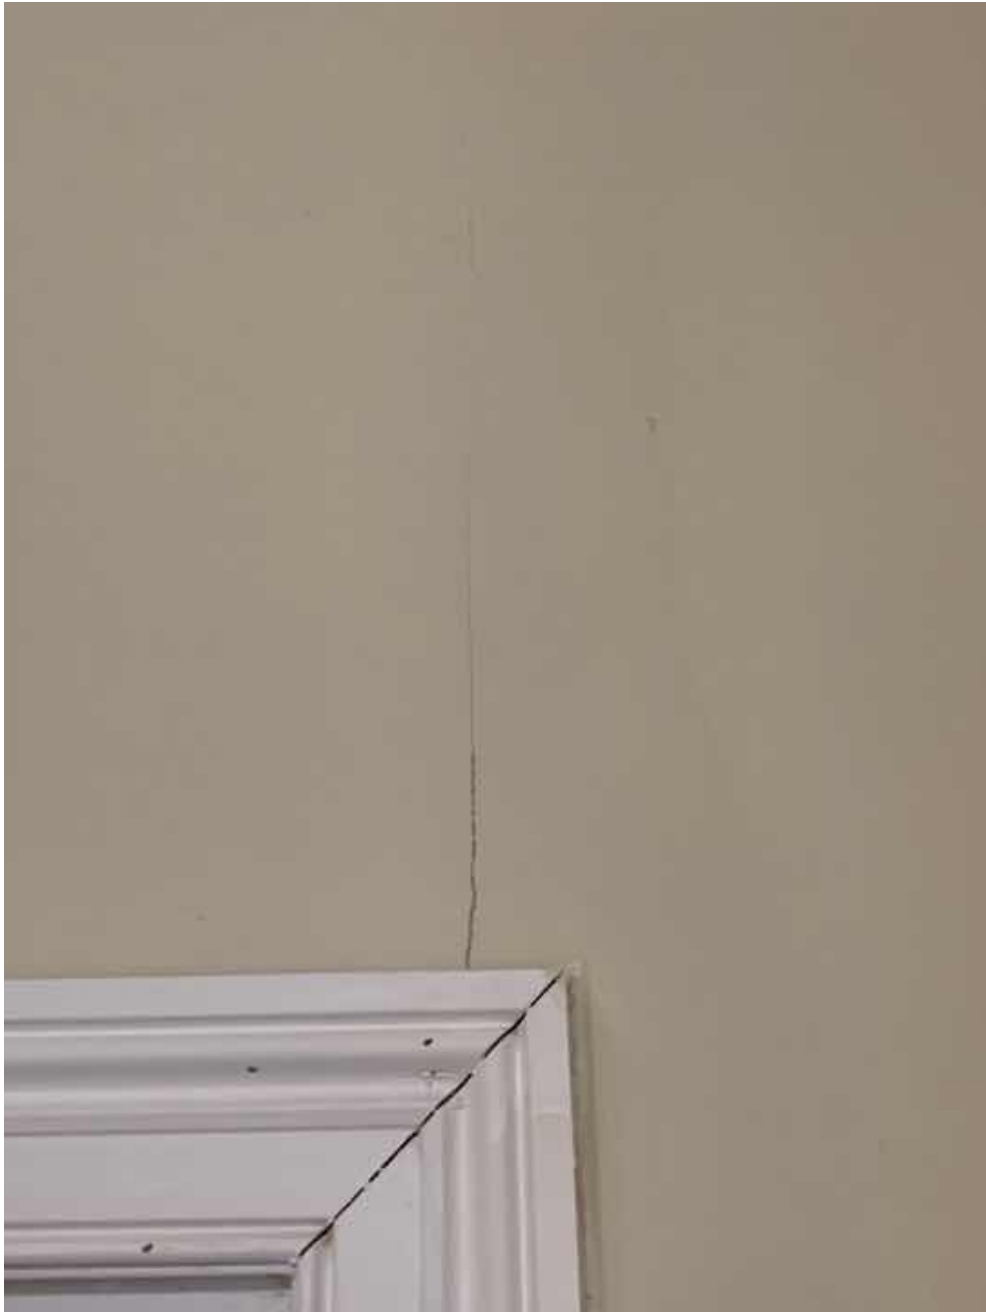
Southern wall

Settlement Cracks Present

Pre Existing Damage

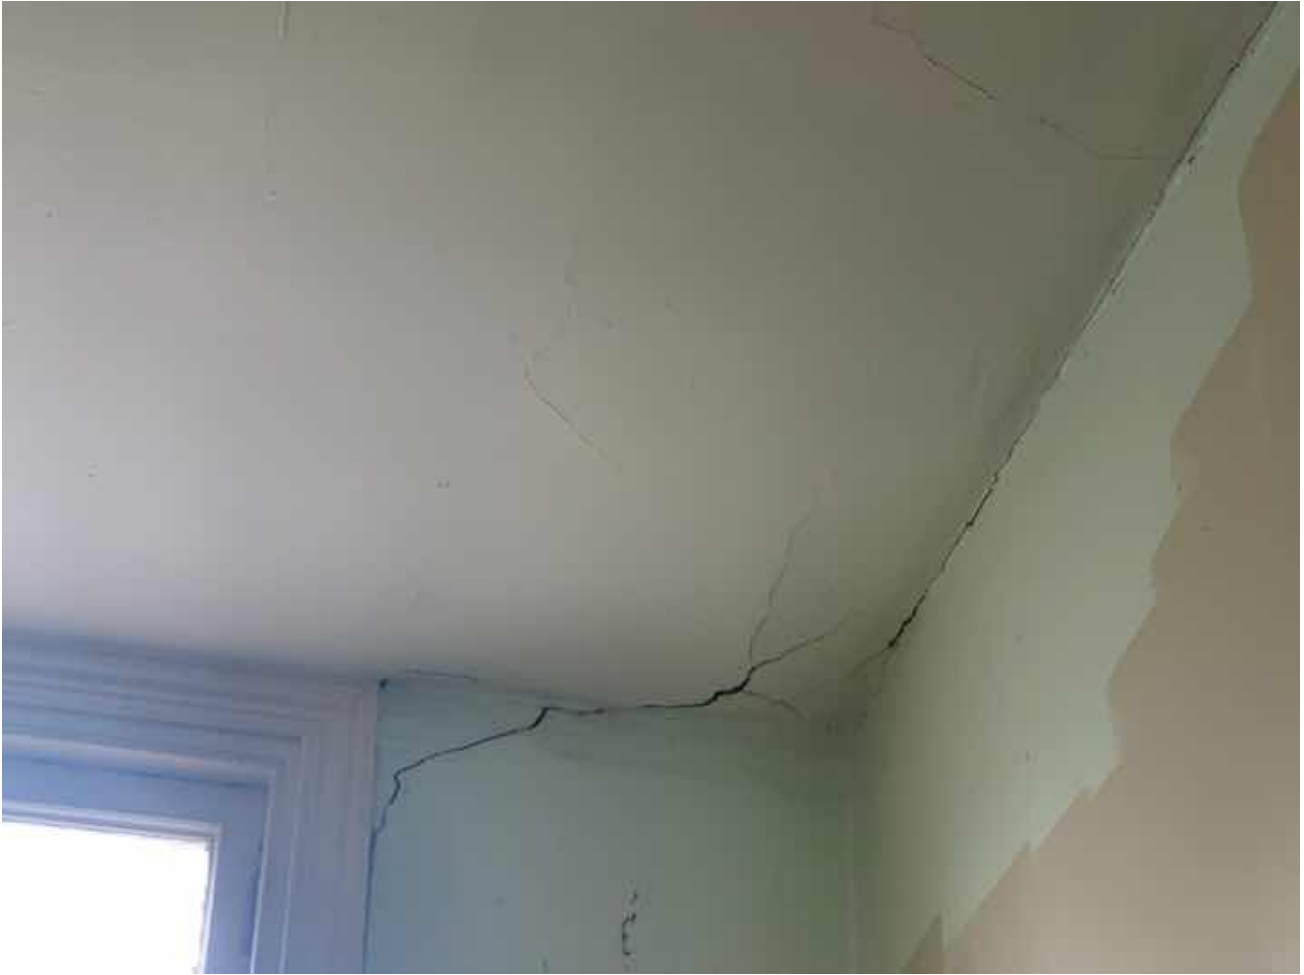
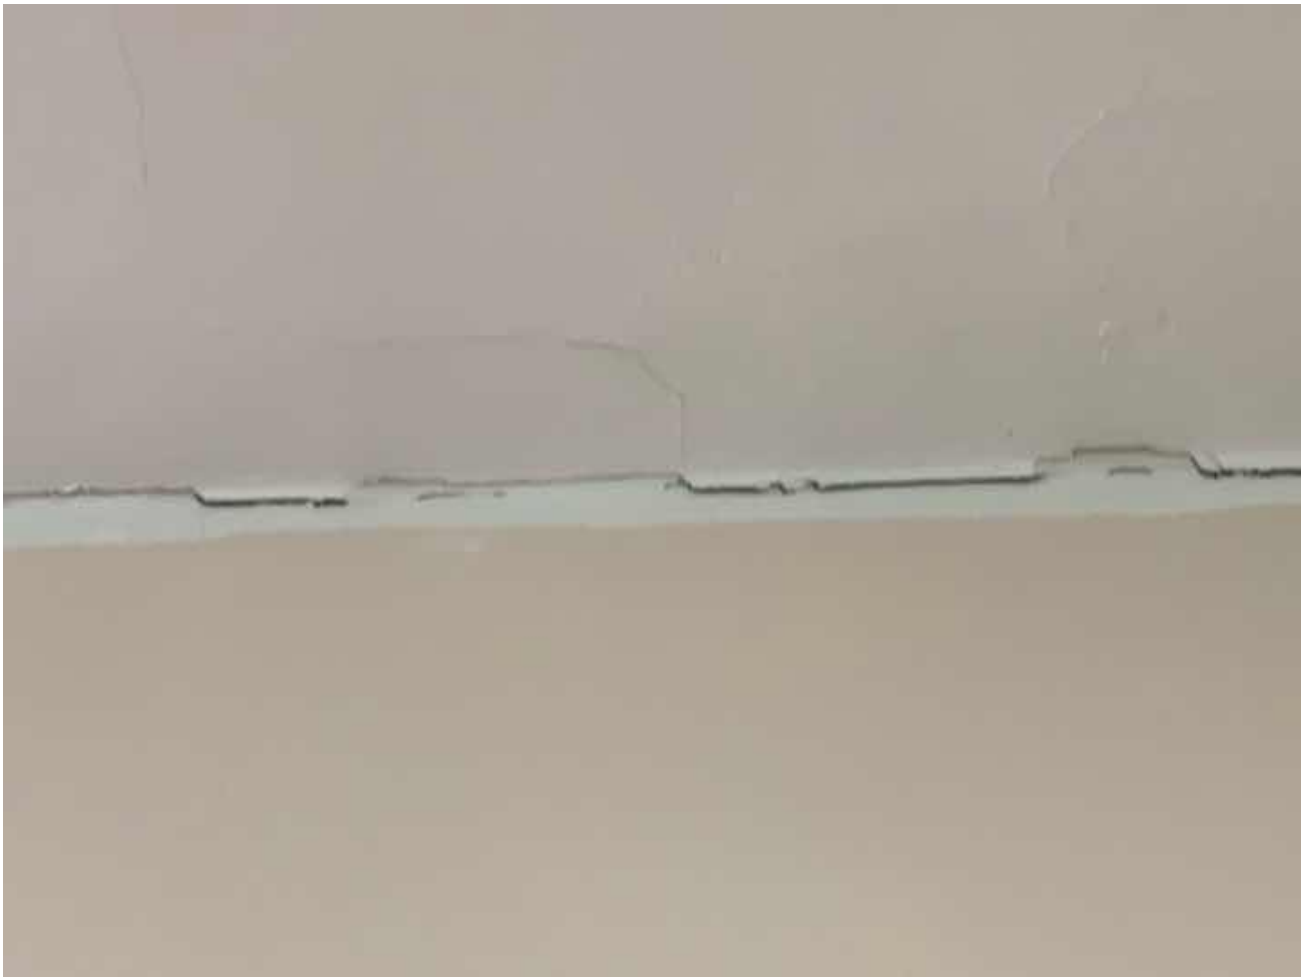
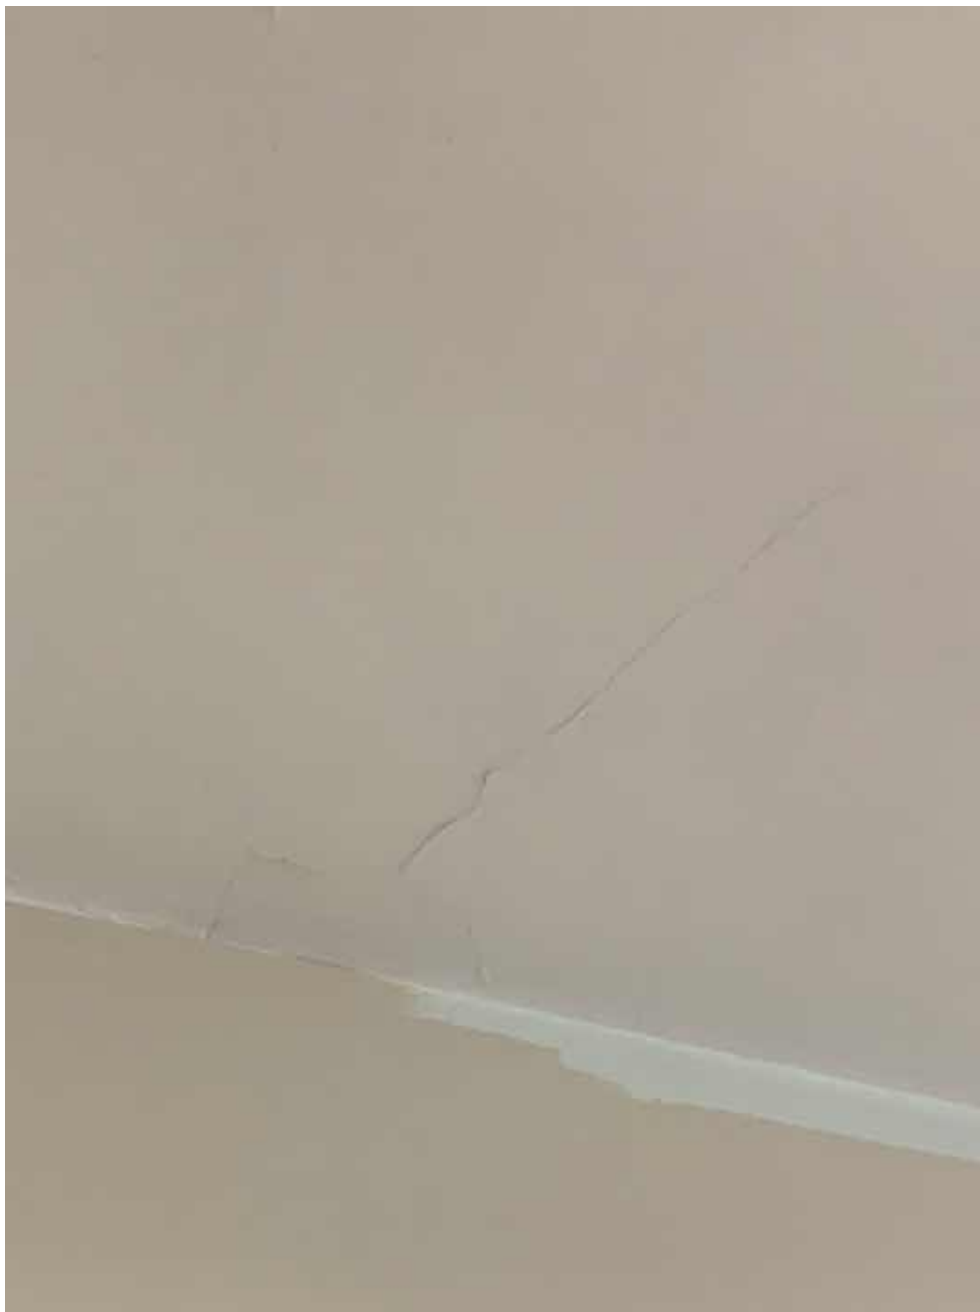
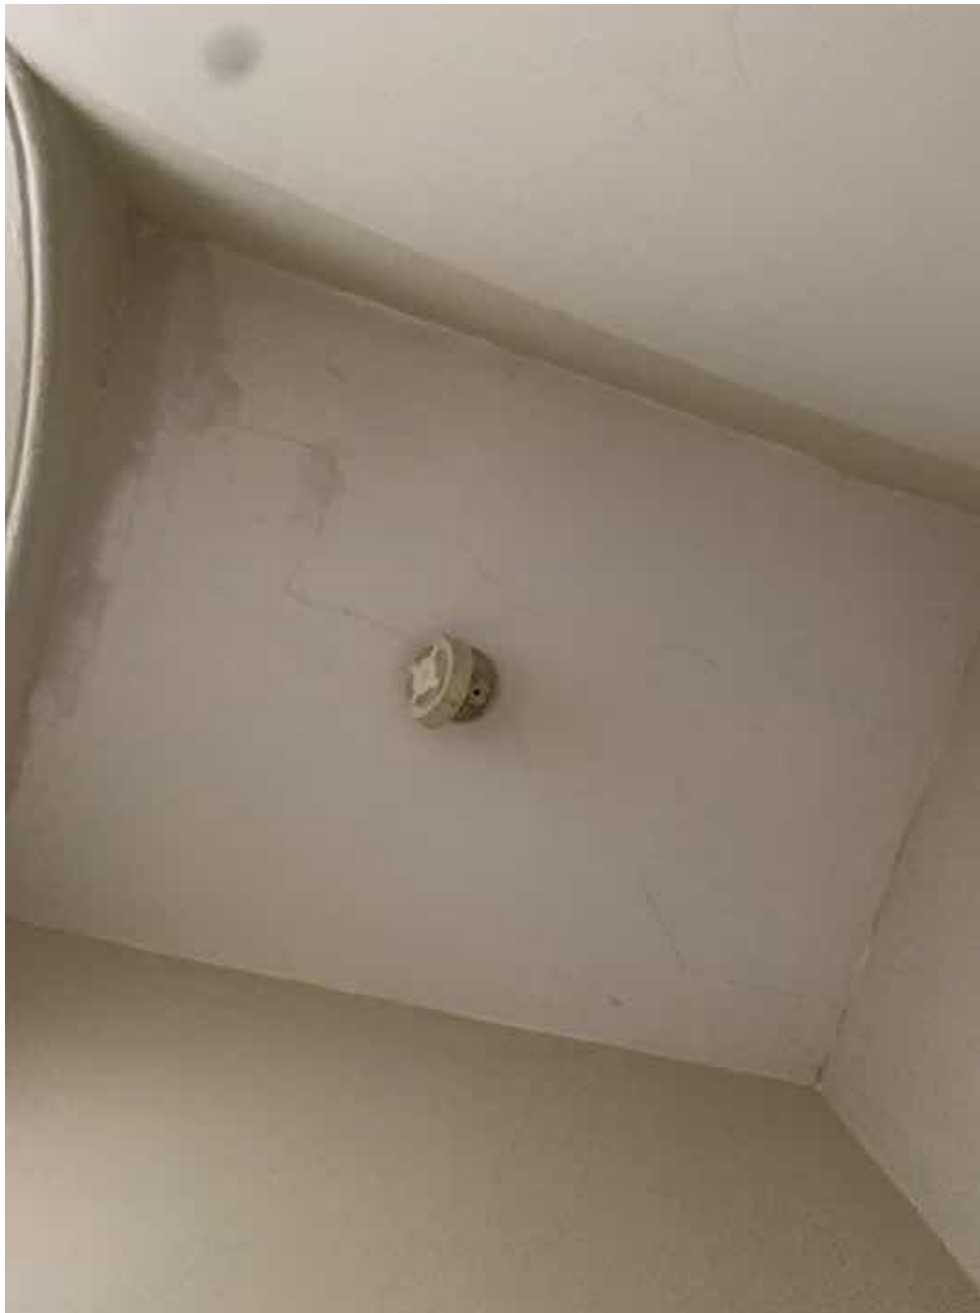
Ceiling

Settlement Cracks Present

Pre Existing Damage

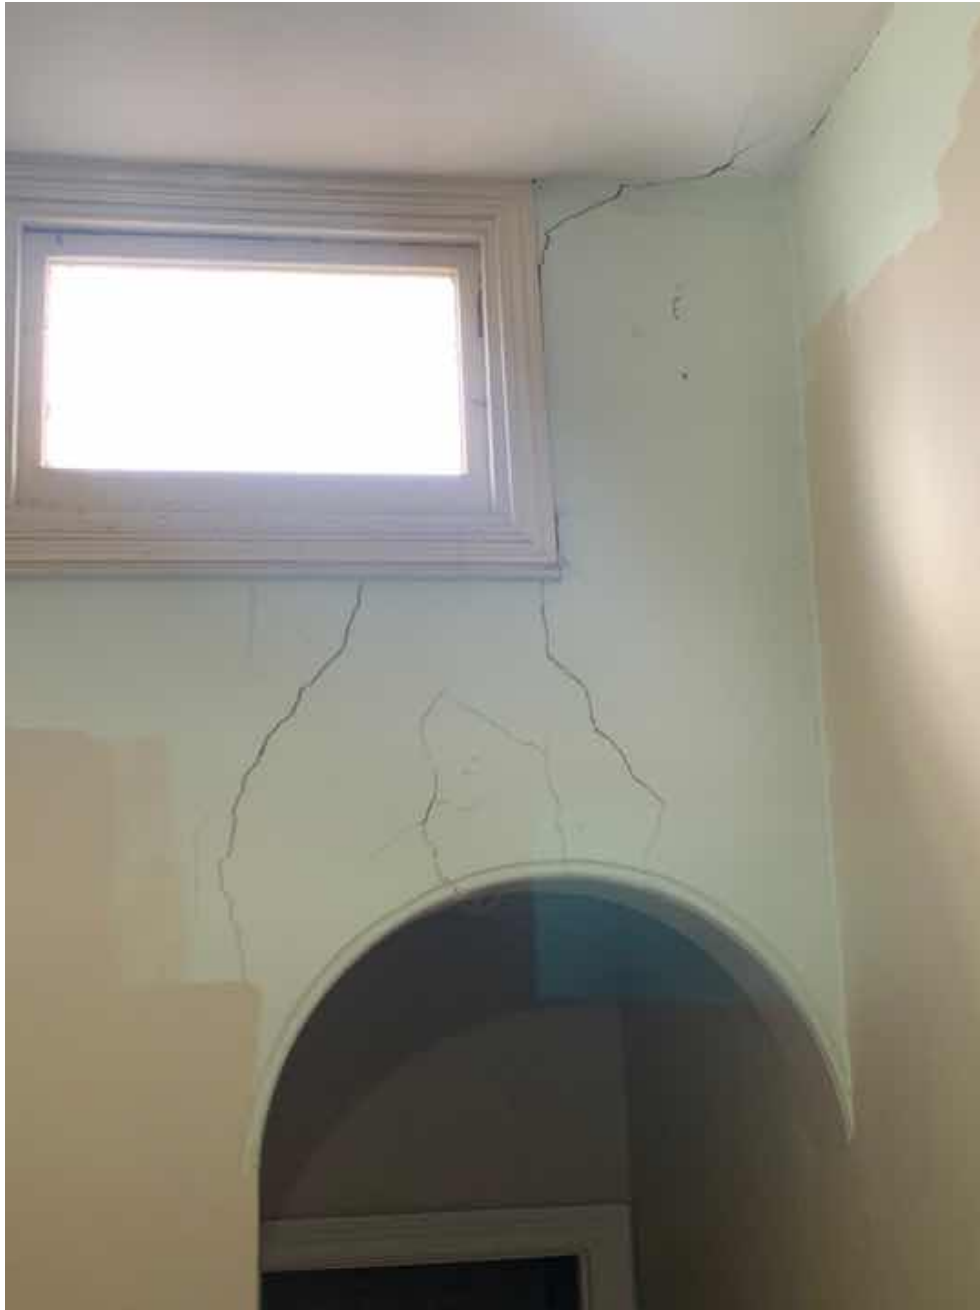
Eastern Wall

Settlement Cracks Present

Pre Existing Damage

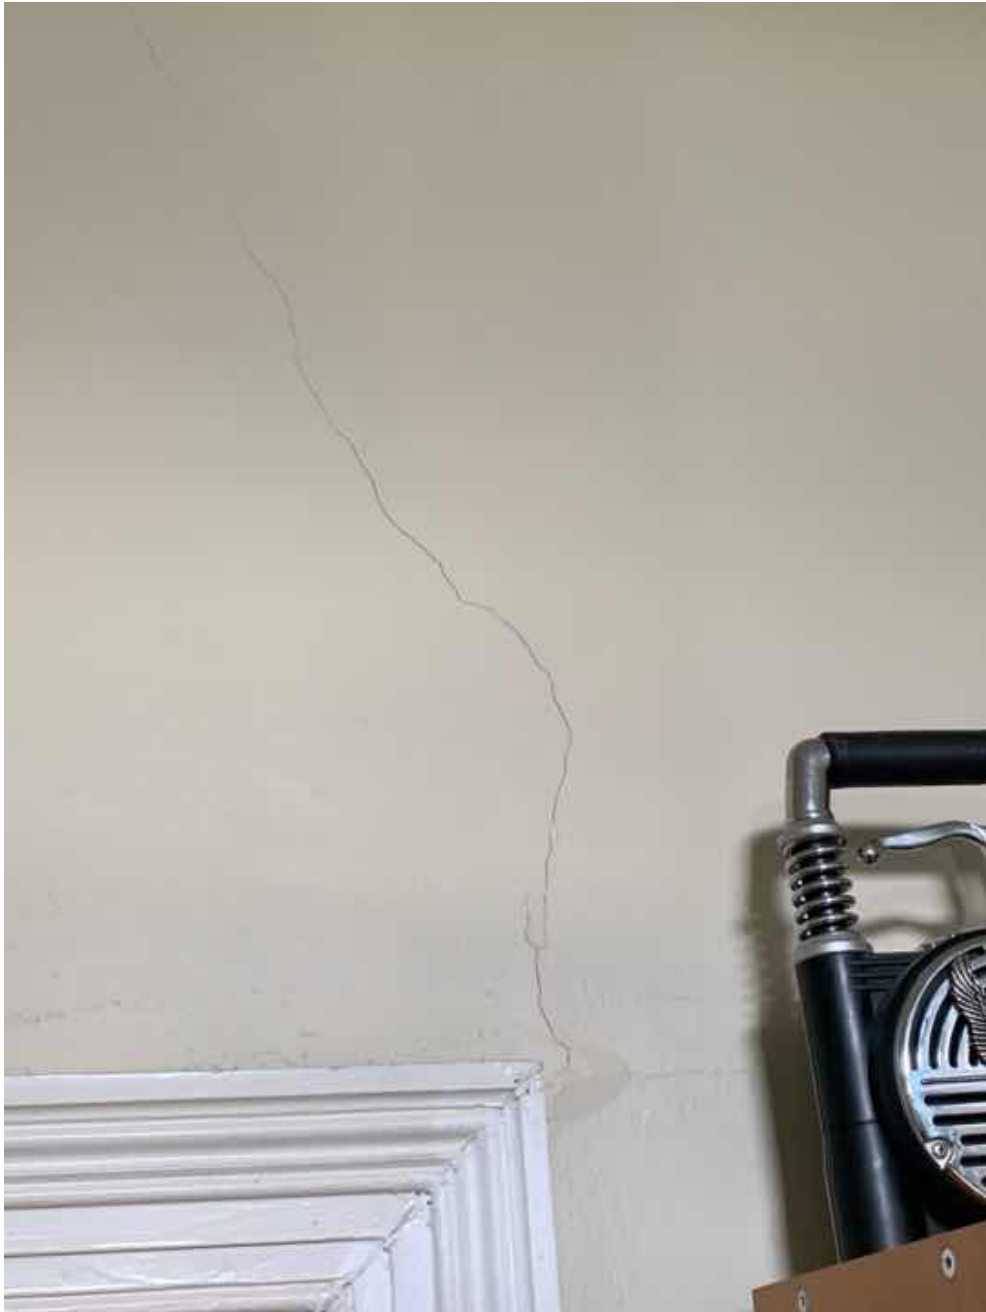
Western wall

Settlement Cracks Present

Pre Existing Damage

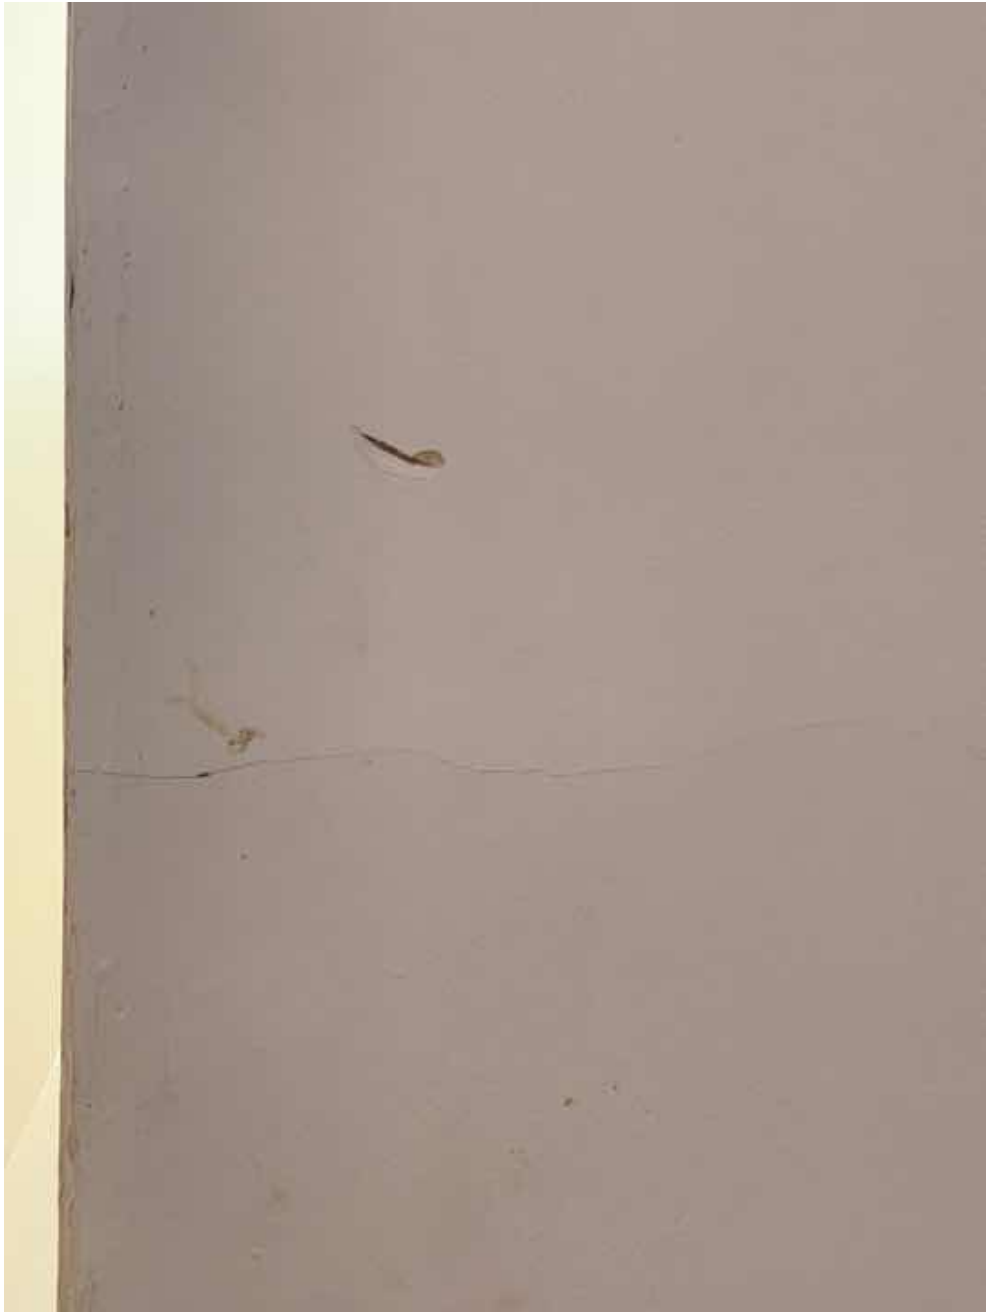
Underside of Stairs

Settlement Cracks Present

Pre Existing Damage

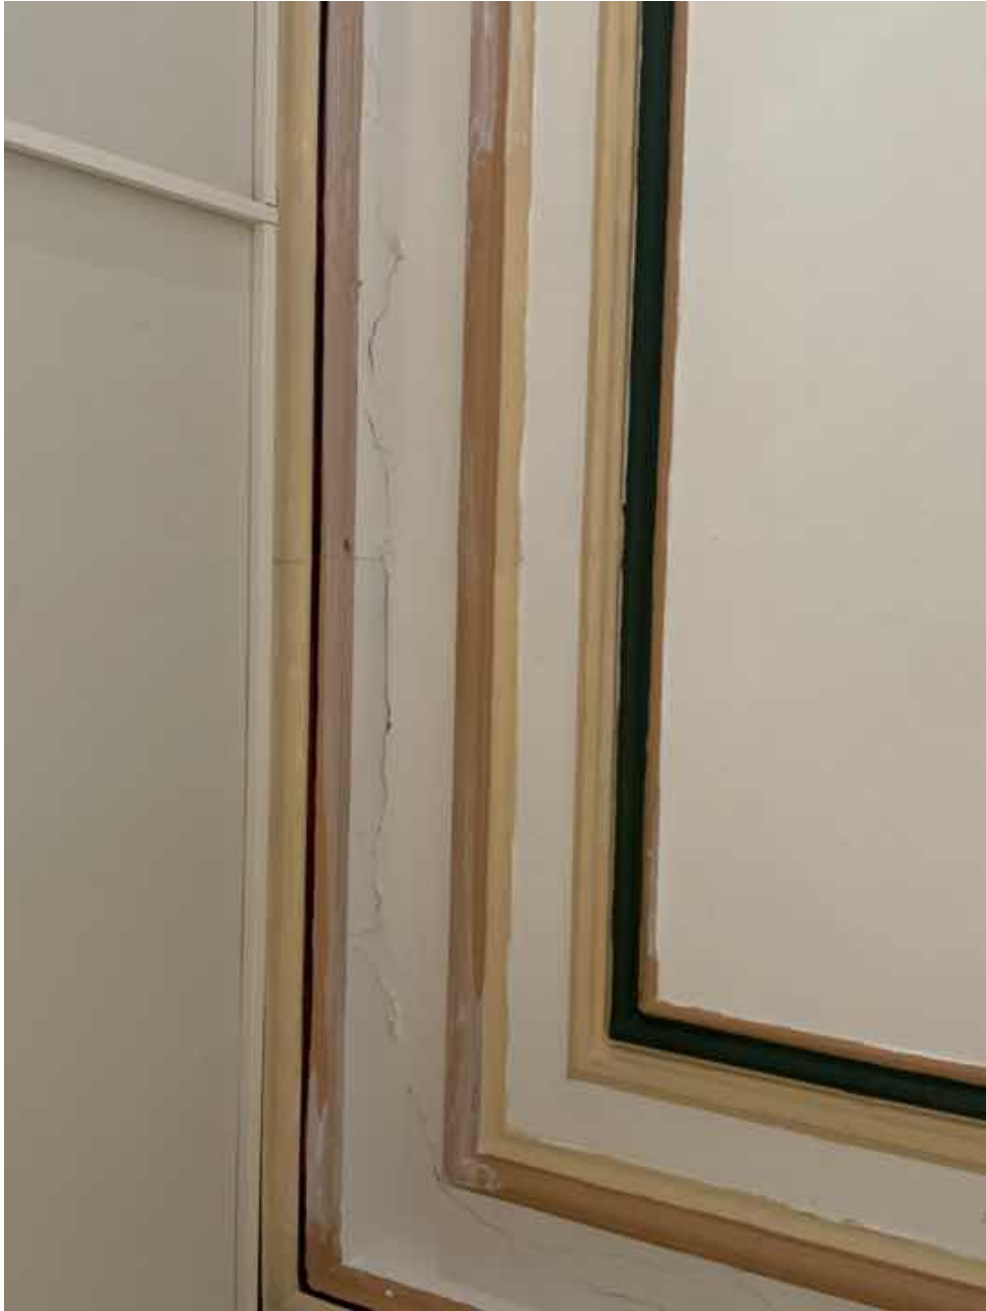
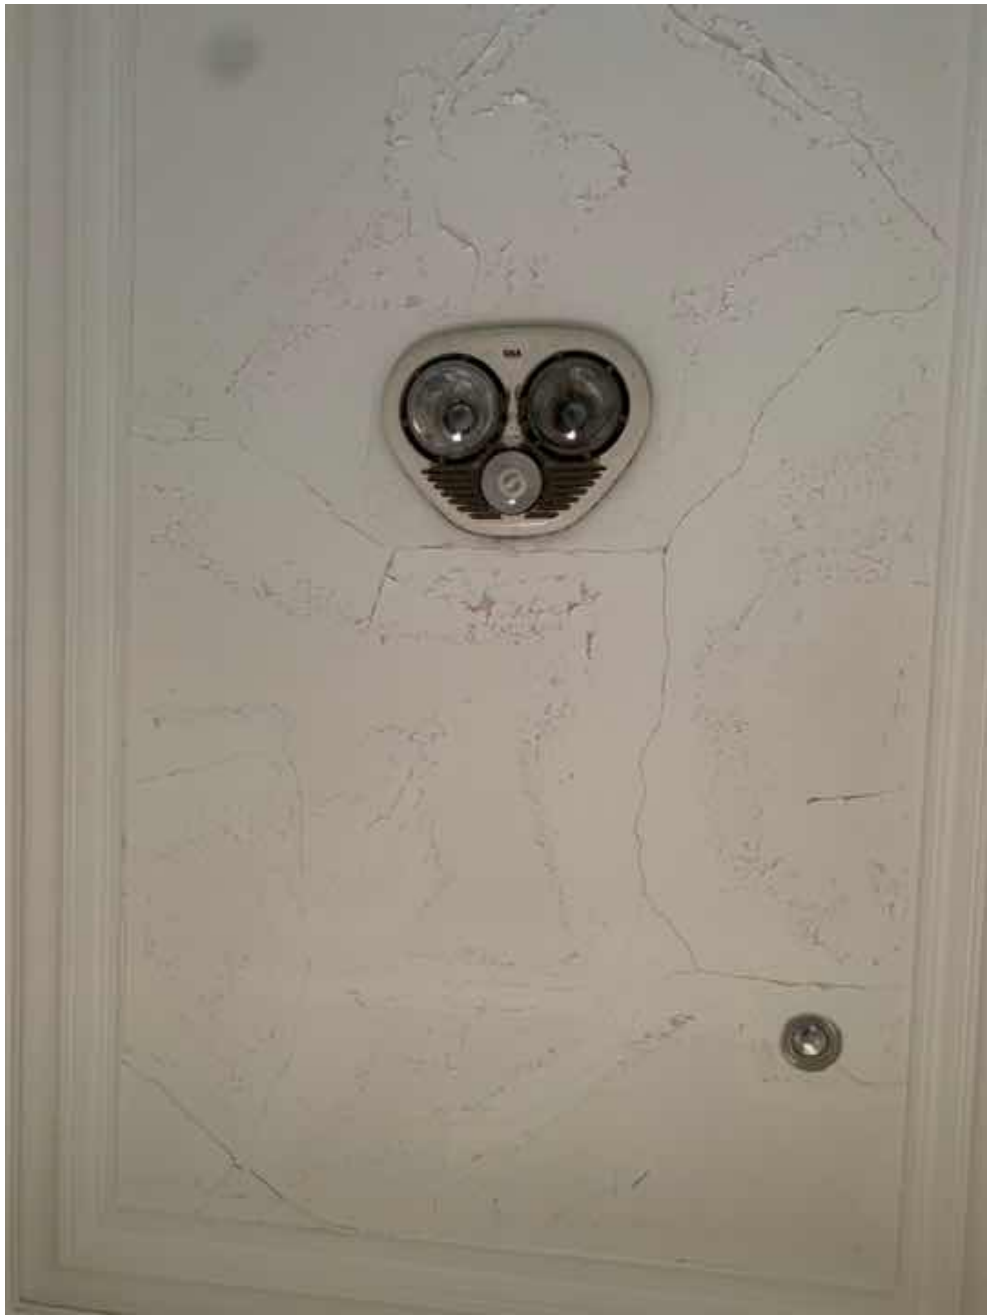
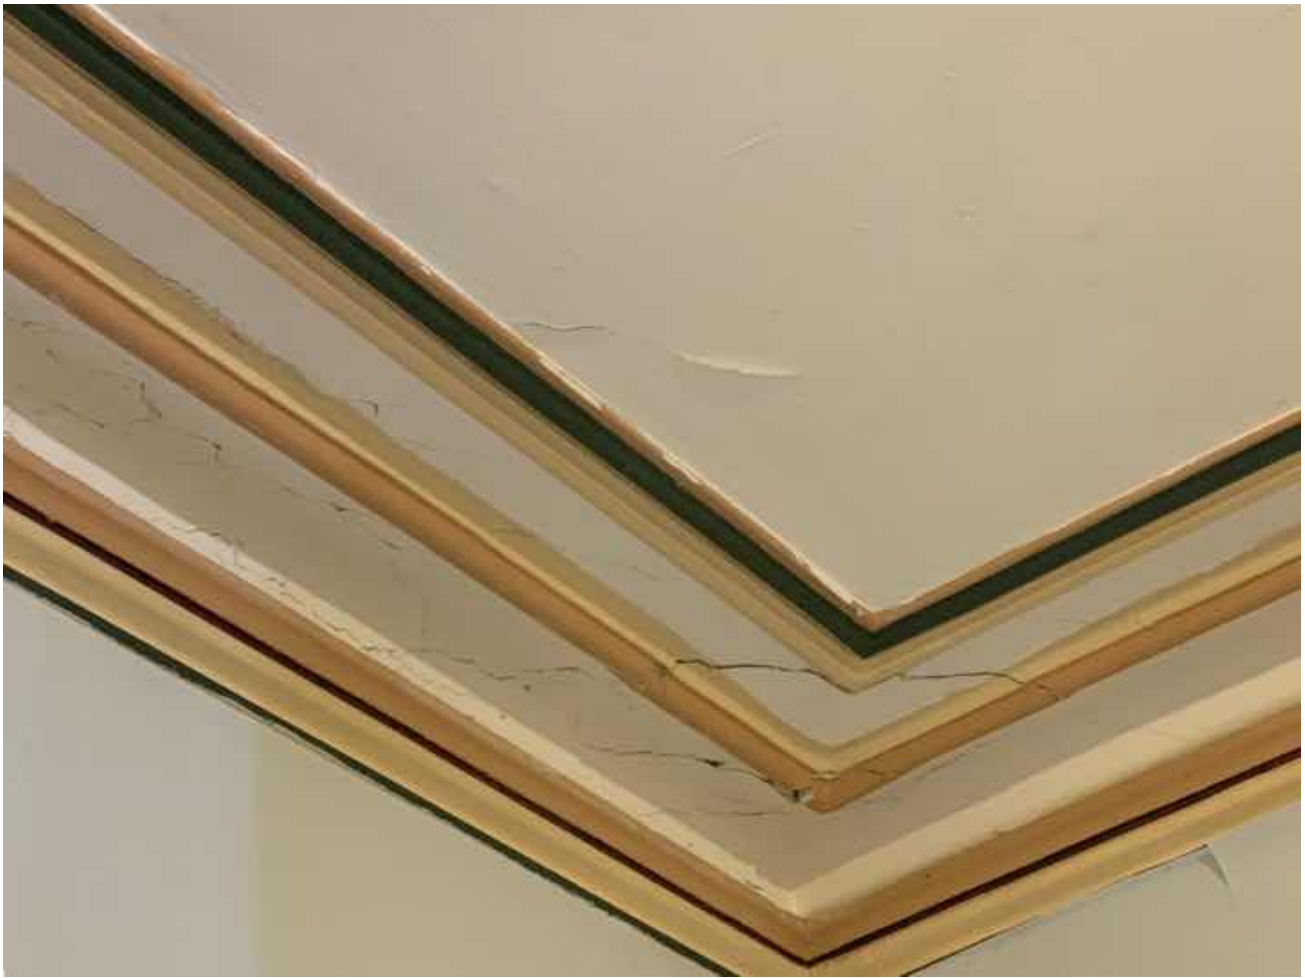
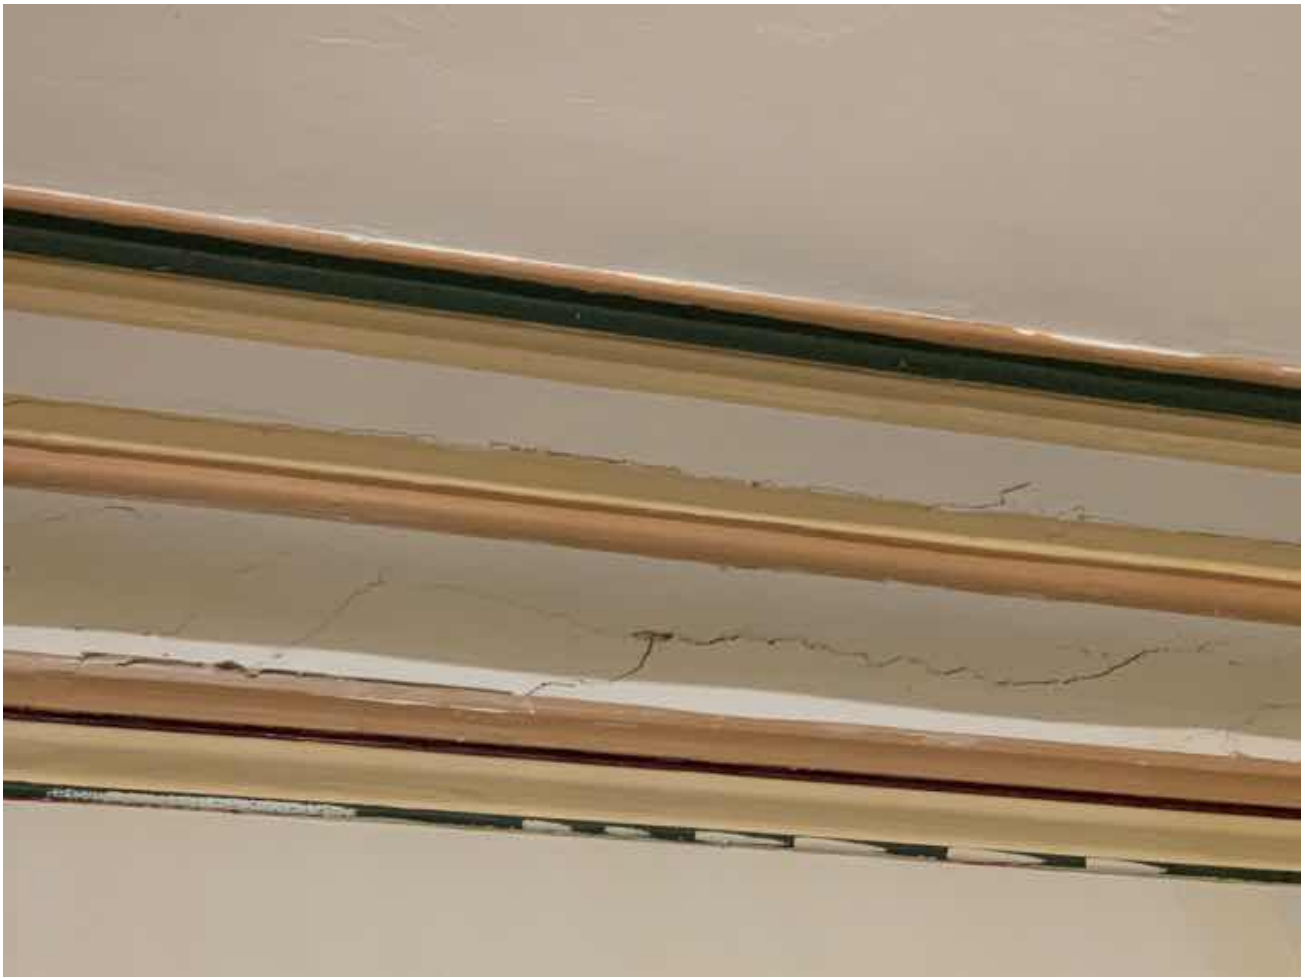
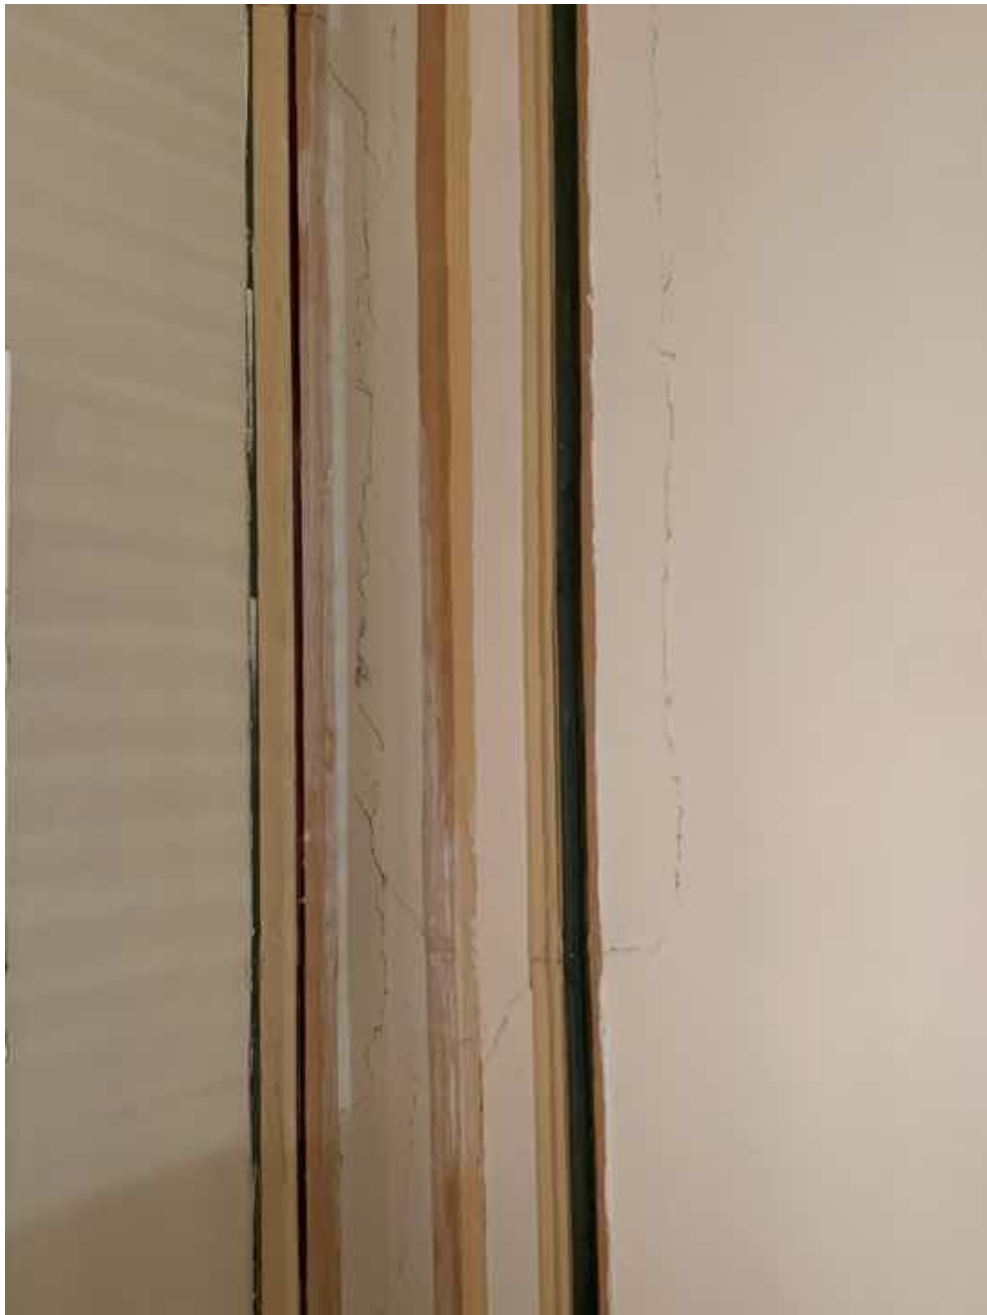
Ceiling

Settlement Cracks Present

Pre Existing Damage

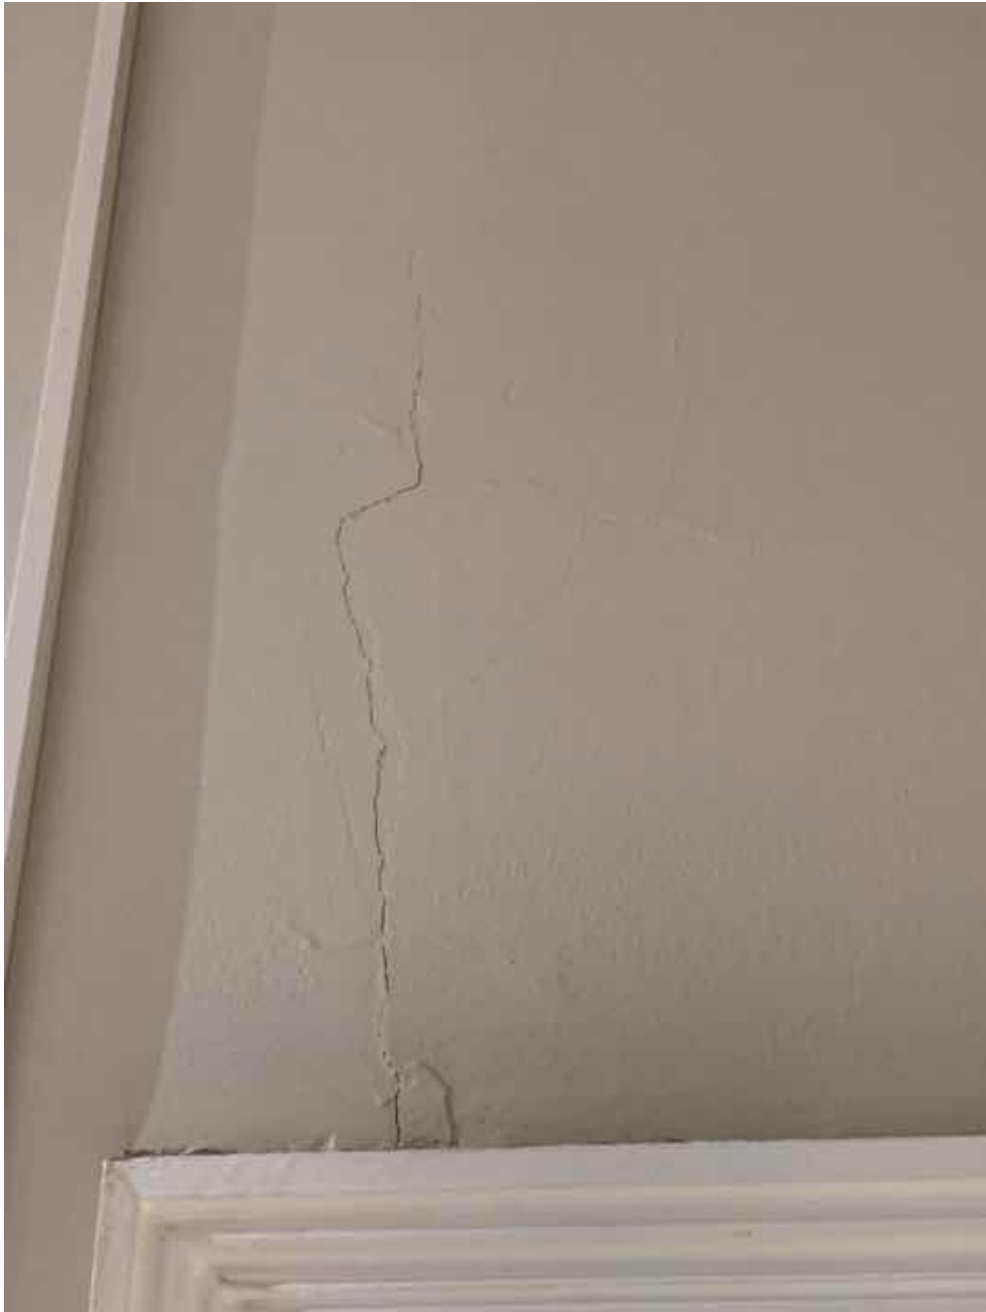
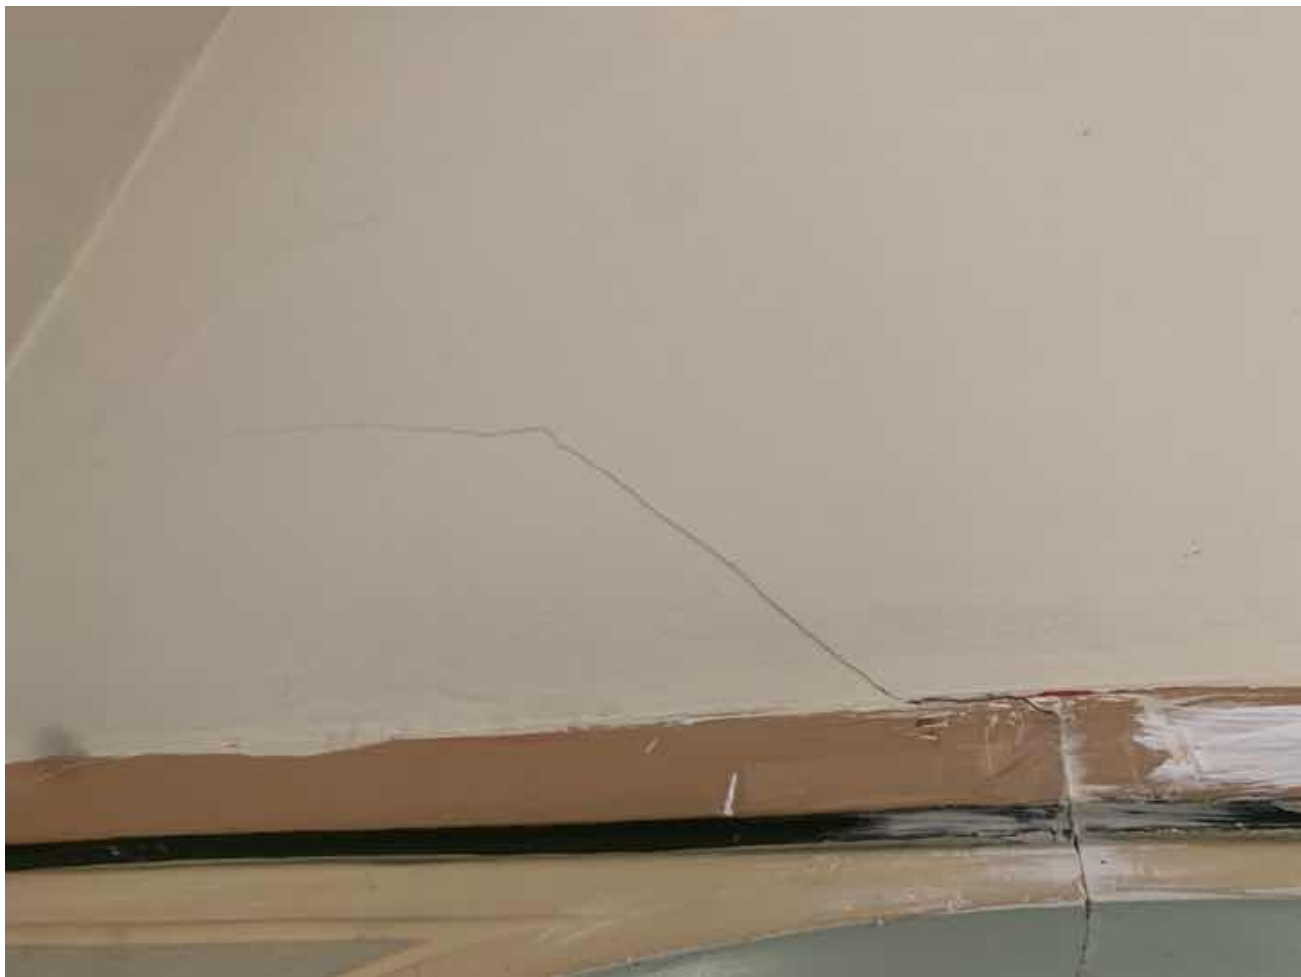
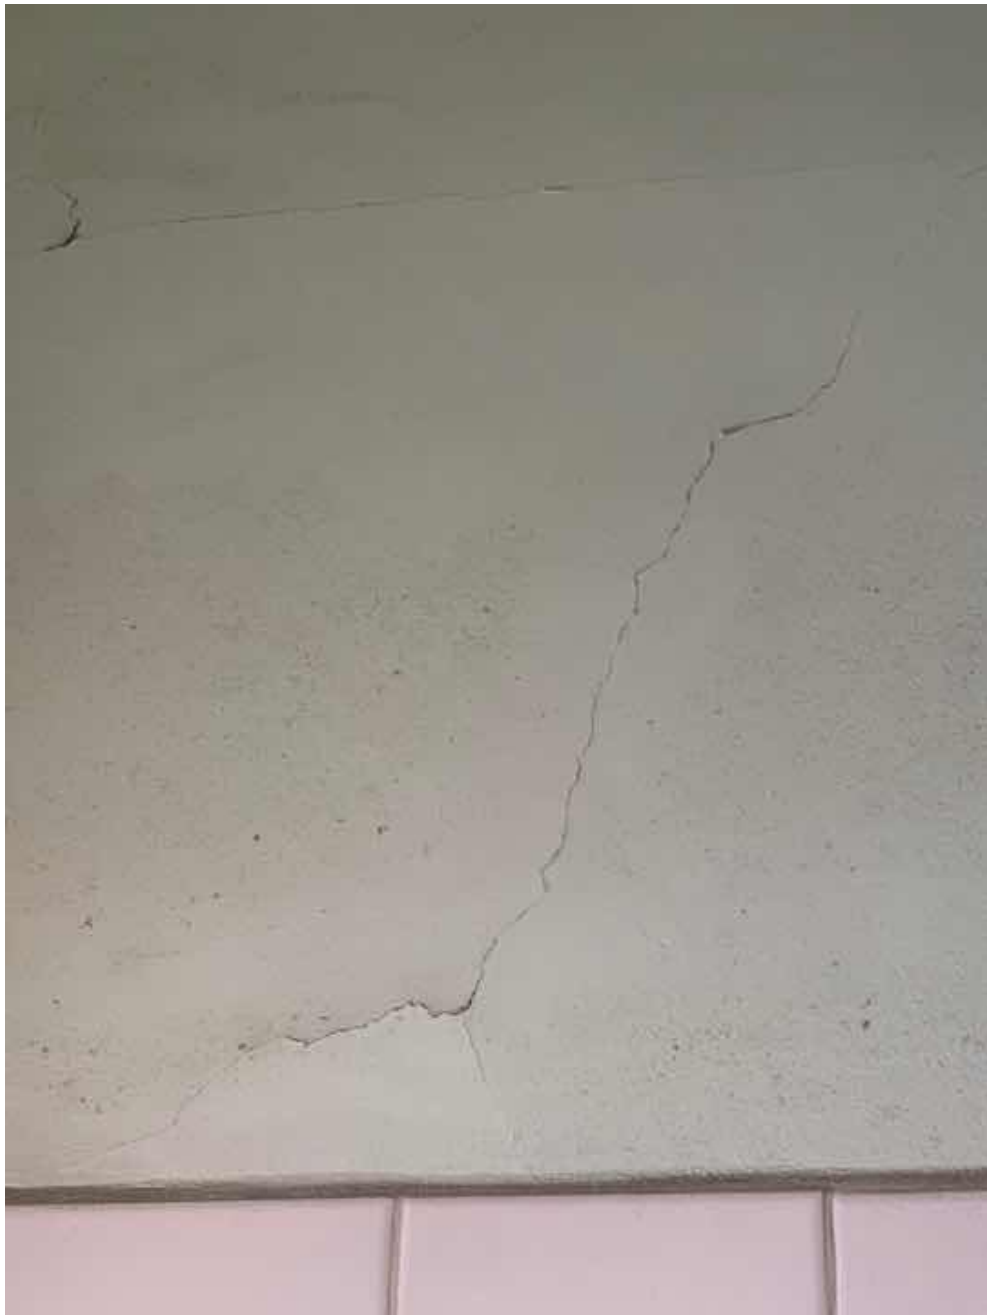
Eastern Wall

Settlement Cracks Present

Pre Existing Damage

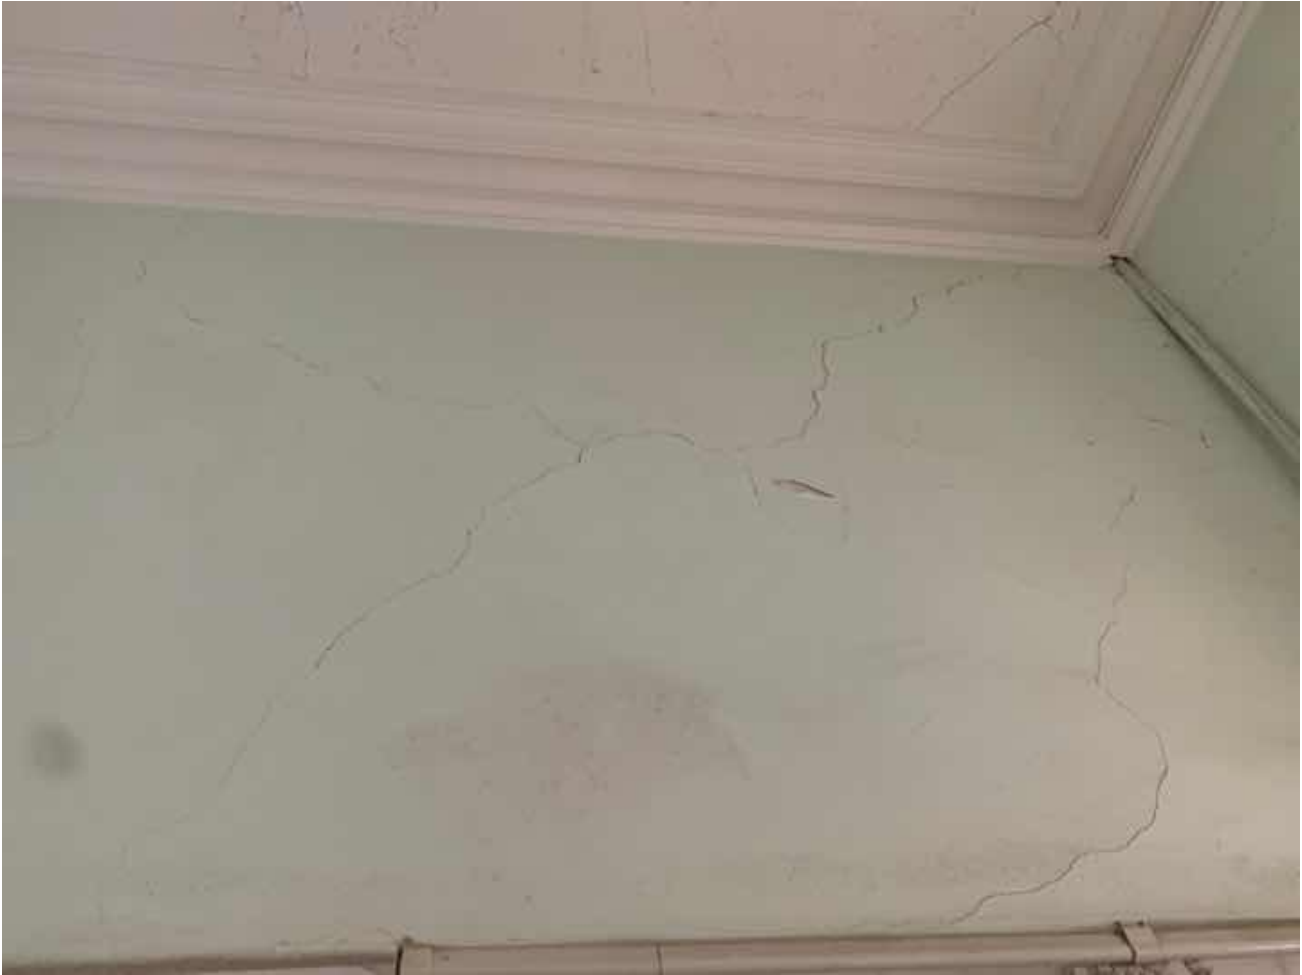
Western wall

Settlement Cracks Present

Pre Existing Damage
