Dilapidation Survey Inspection Report

Report/Agreement # 0202210849412

Inspection Date: 02 Feb 2021

Dilapidation Inspection Report

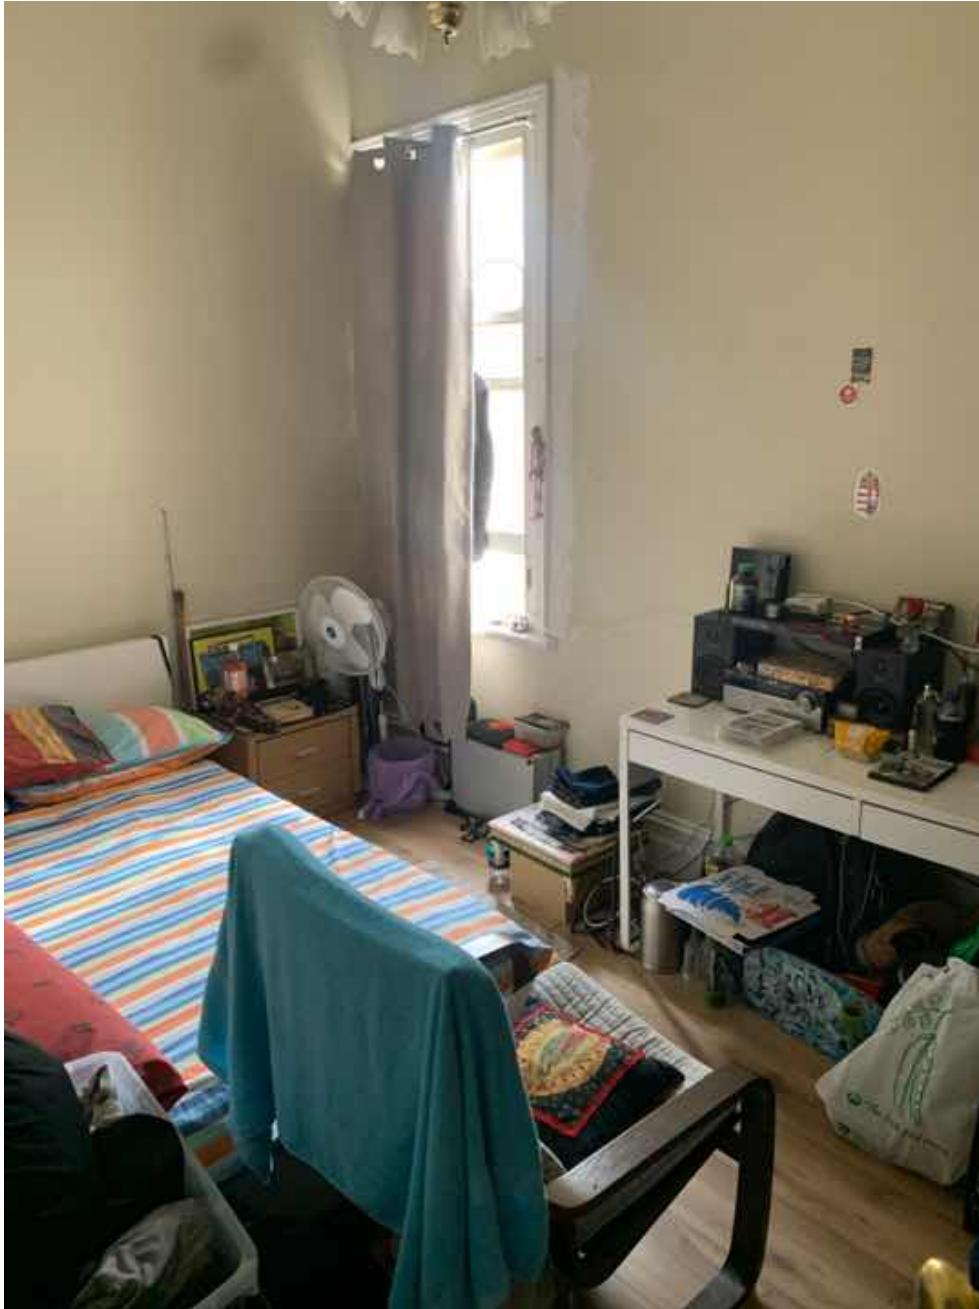
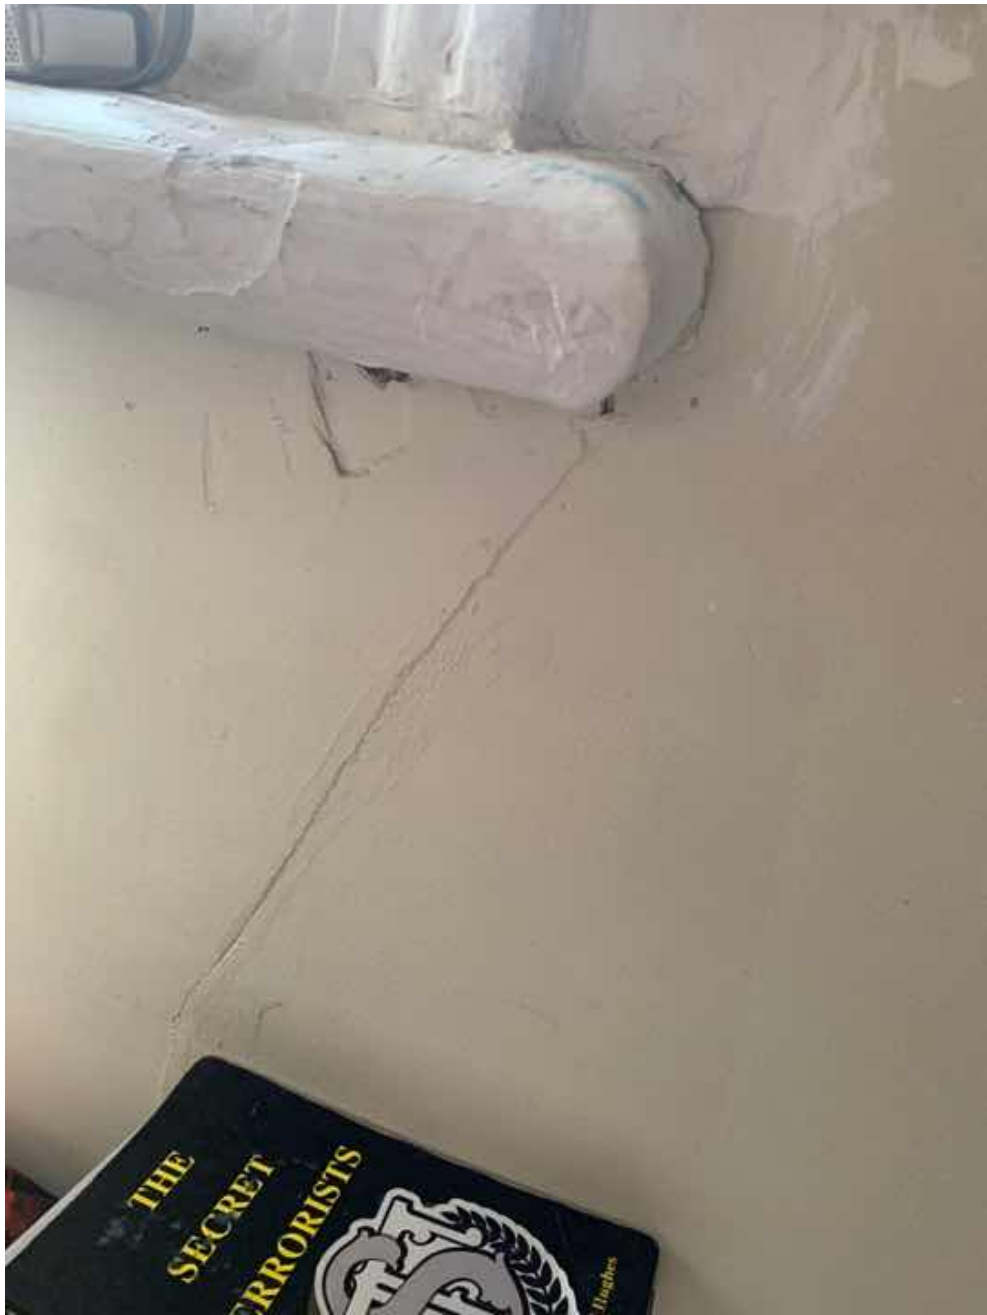
Eastern Wall

Settlement Cracks Present

Pre Existing Damage

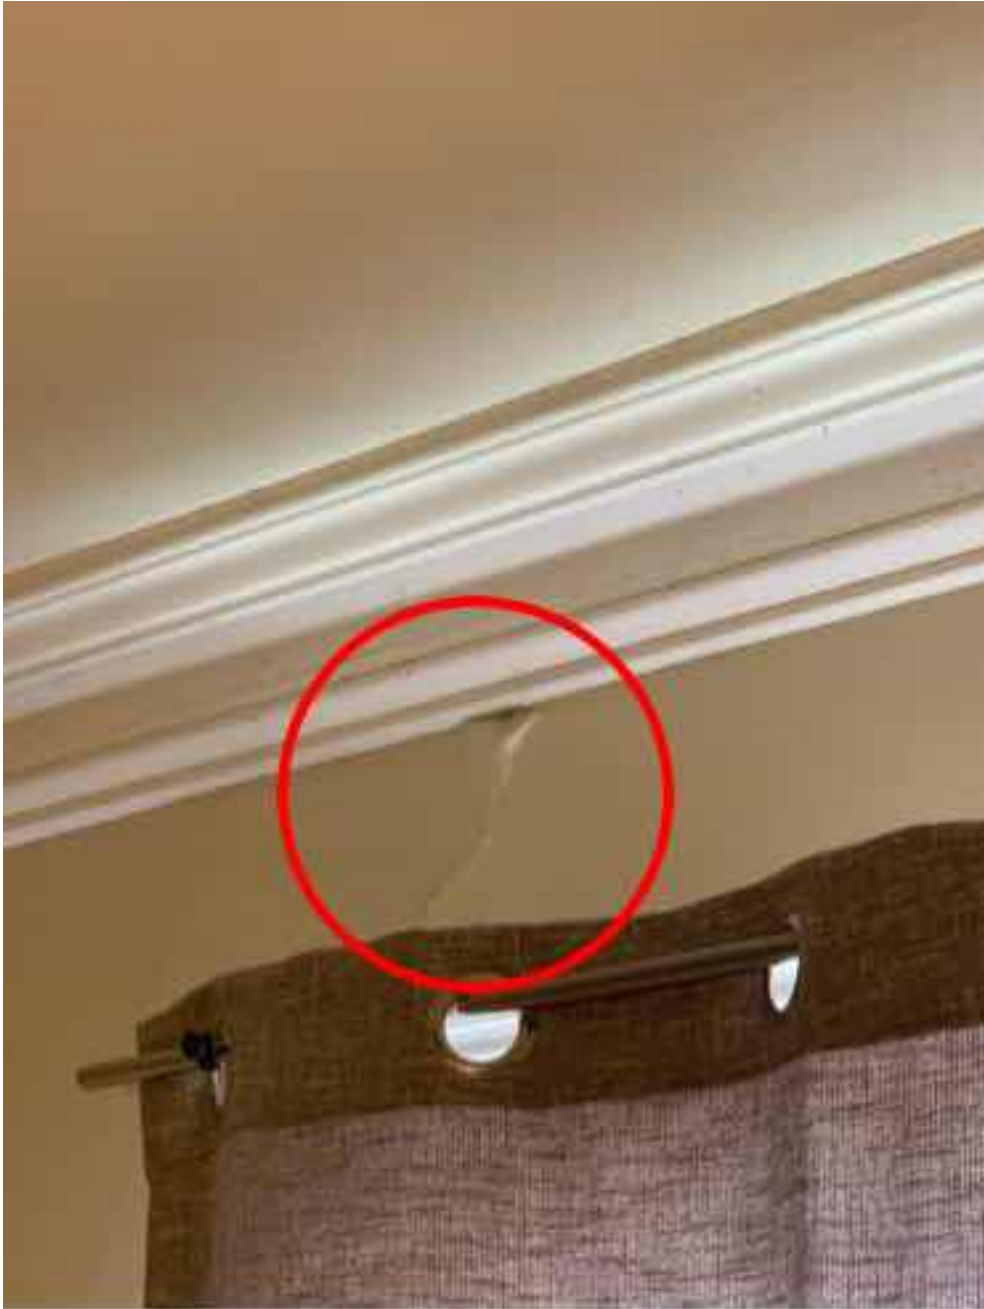
Eastern Wall

Settlement Cracks Present

Pre Existing Damage

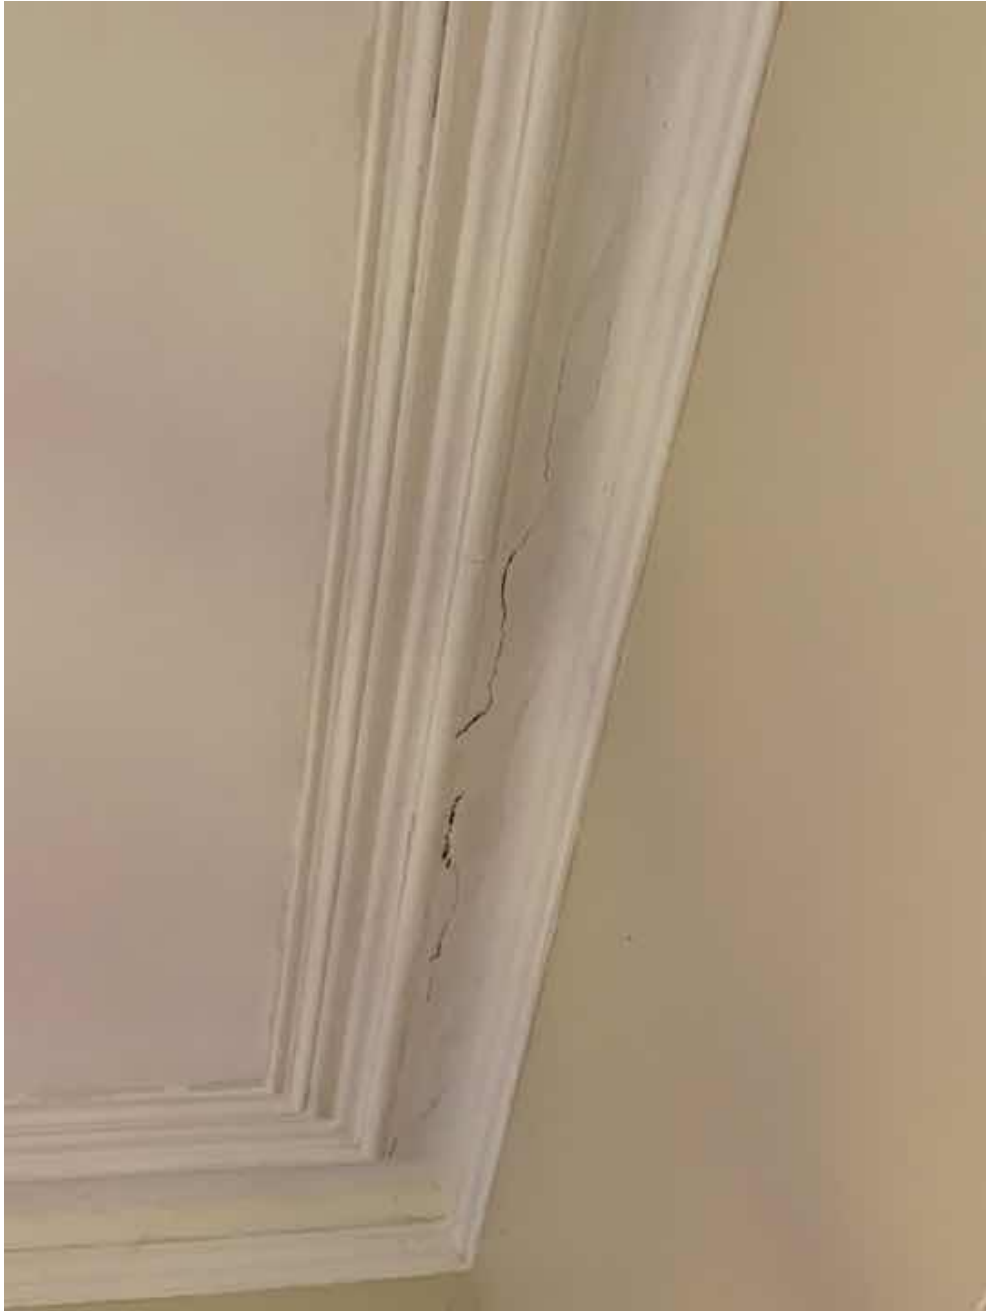
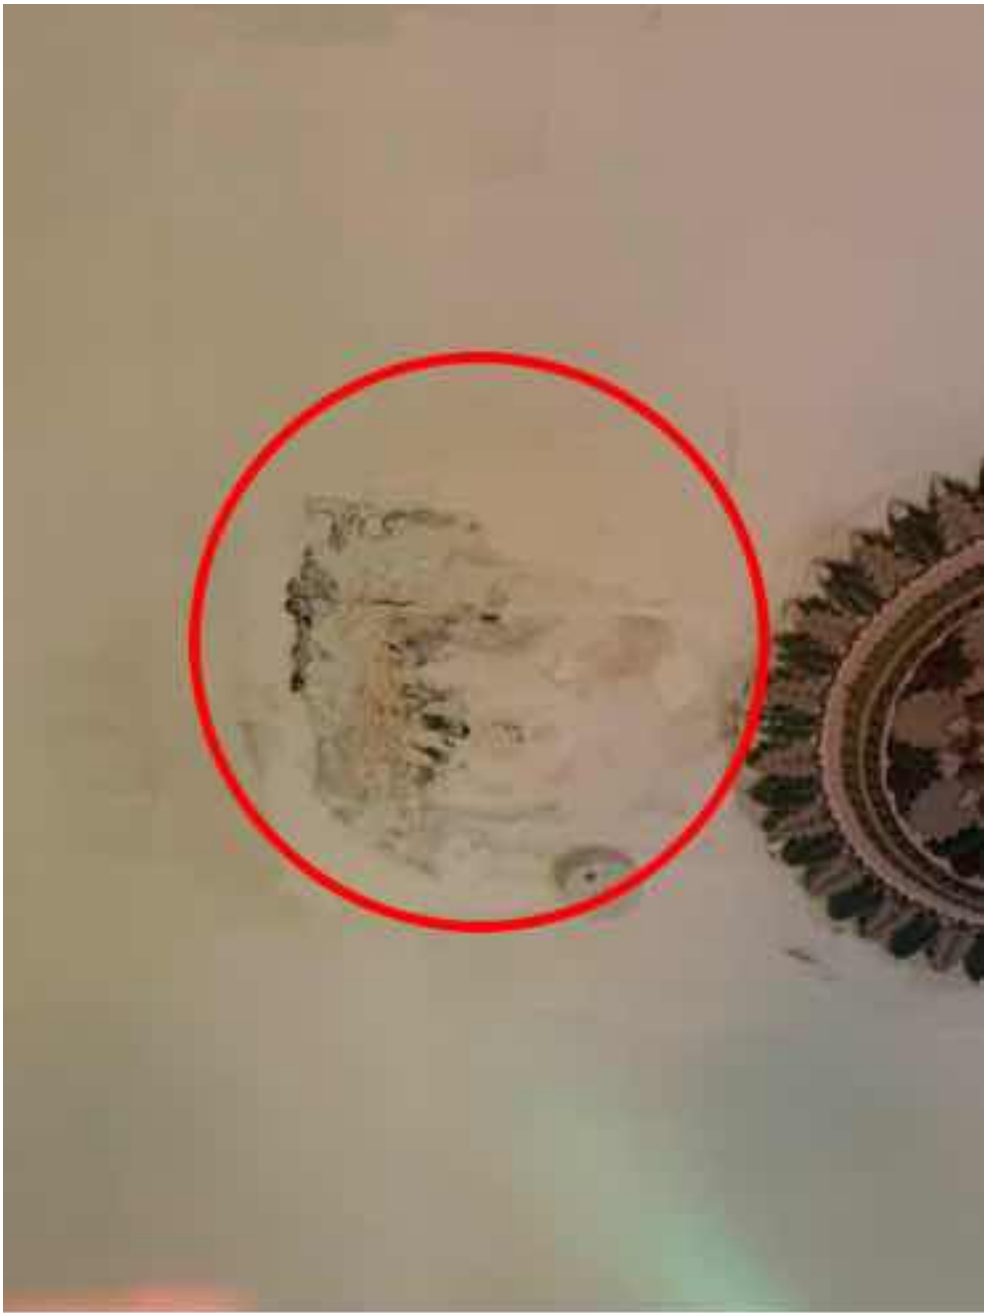
Ceiling

Settlement Cracks Present

Pre Existing Damage
Dry Stain/sag in ceiling

Pre Existing Damage

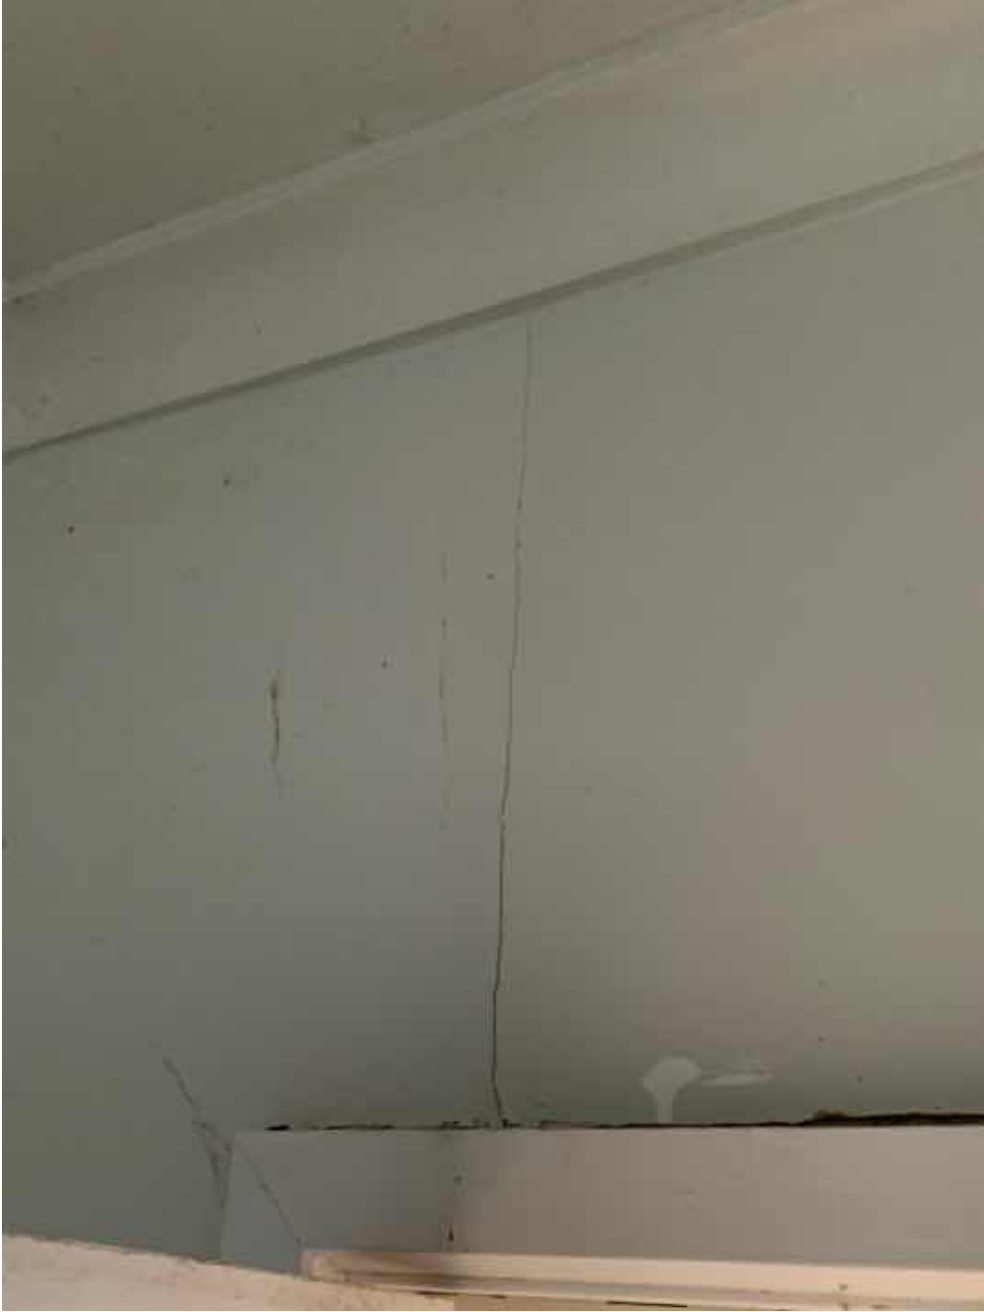
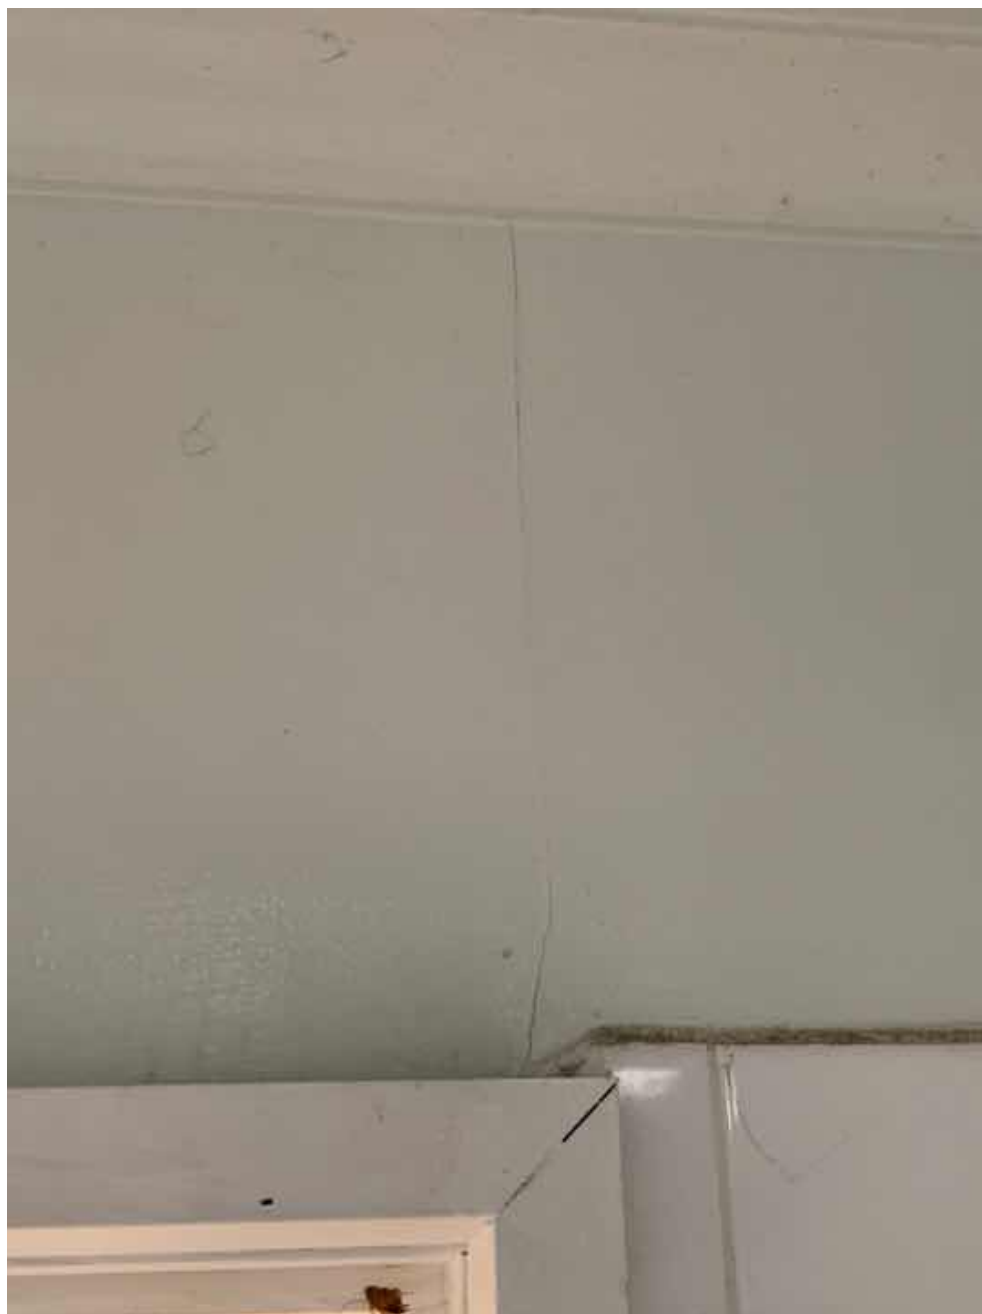
Western wall

Settlement Cracks Present

Pre Existing Damage
