# Building & Timber Pest Inspection Report

**Inspect365**

**VICTORIA, 3087**

Inspection Date:                24 May 2021

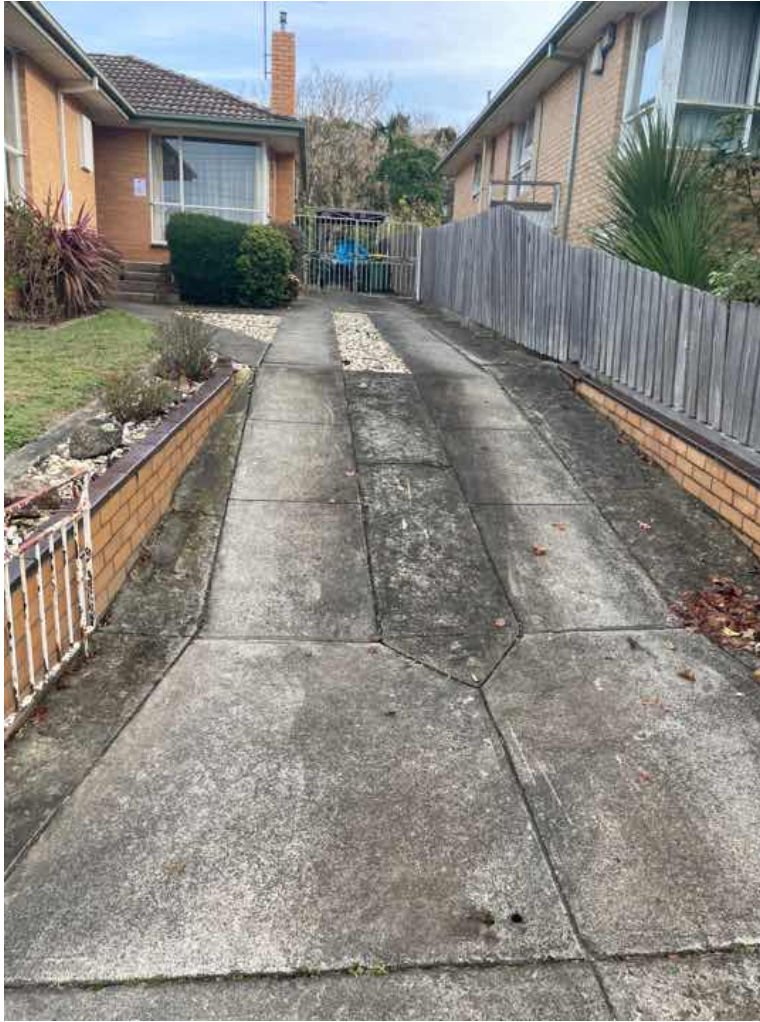
Common cracks were observed on the driveway. Whilst these cracks appeared to be typical at the time of inspection, we strongly recommend you monitor these cracks and if worsening occurs contact a concreter for further advice.

Surface raised and settled in some areas. This can cause water ponding. Relaying recommended.

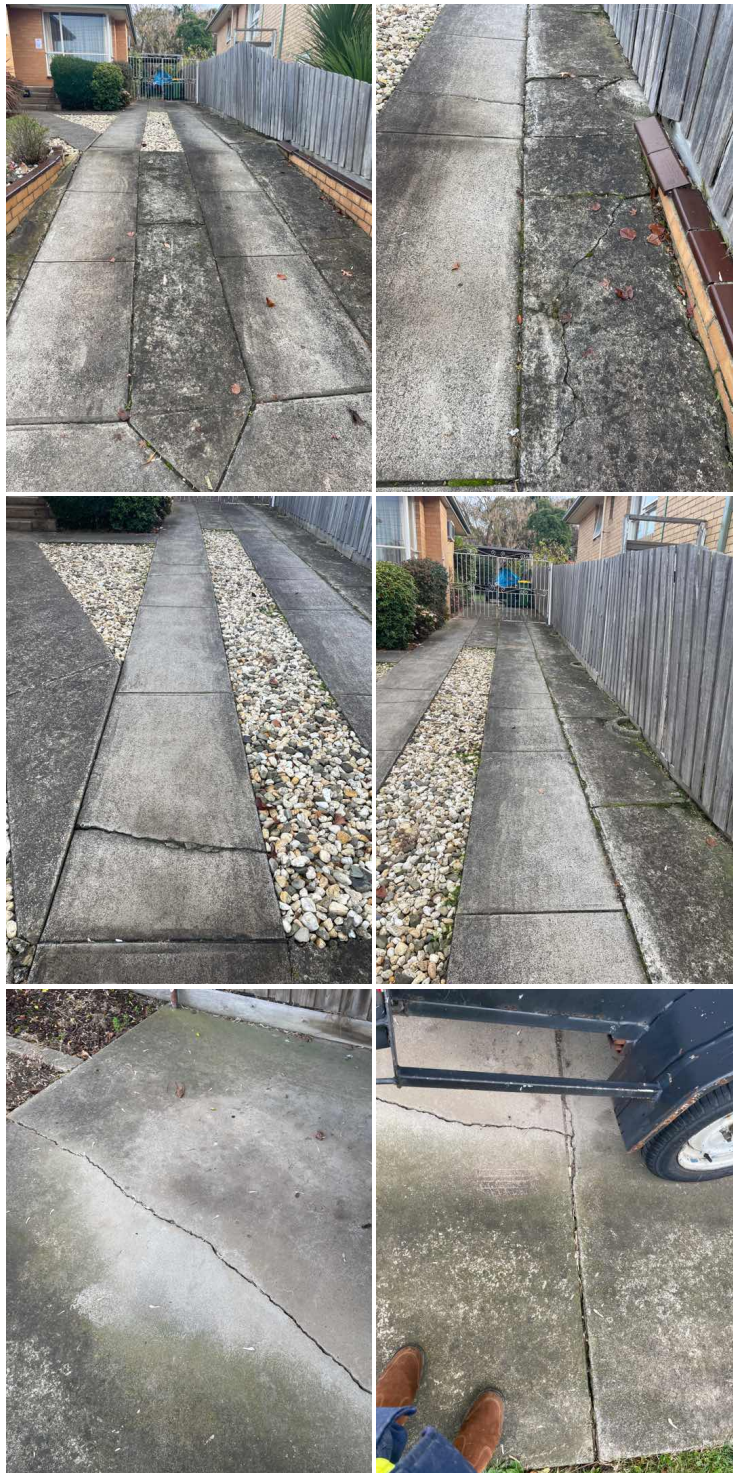
Common cracks and settlement were observed on paths. Whilst these cracks appeared to be typical at the time of inspection, we strongly recommend you monitor these cracks and if worsening occurs contact a concreter for further advice.

Surface raised and settled in some areas. This can cause water ponding. Relaying recommended.

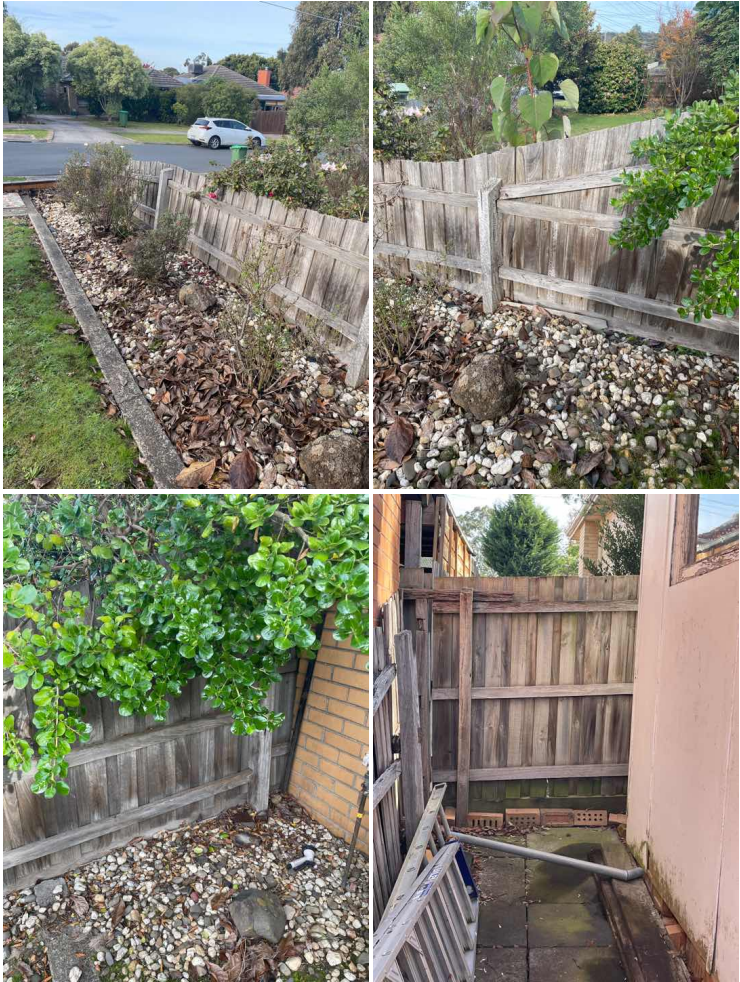
Rust noted to fence. Replacement recommended.

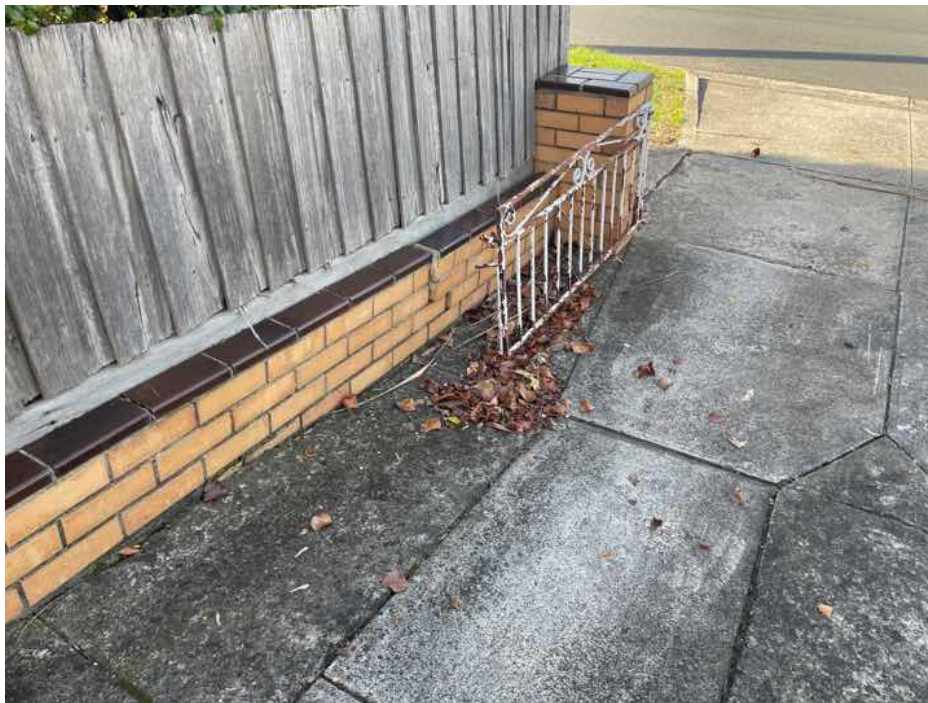
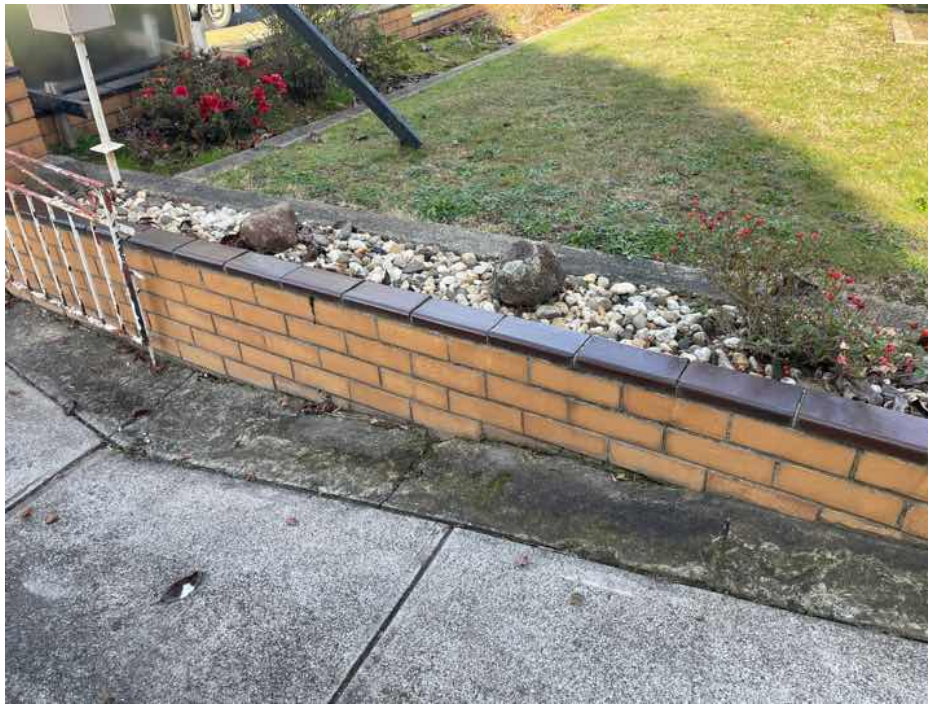
Retaining wall cracking. Normally this occurs if adequate drainage has not been provided (Ag Line) or a poor footing system or a combination of reasons. A qualified brick layer should be engaged for advice and recommendations.

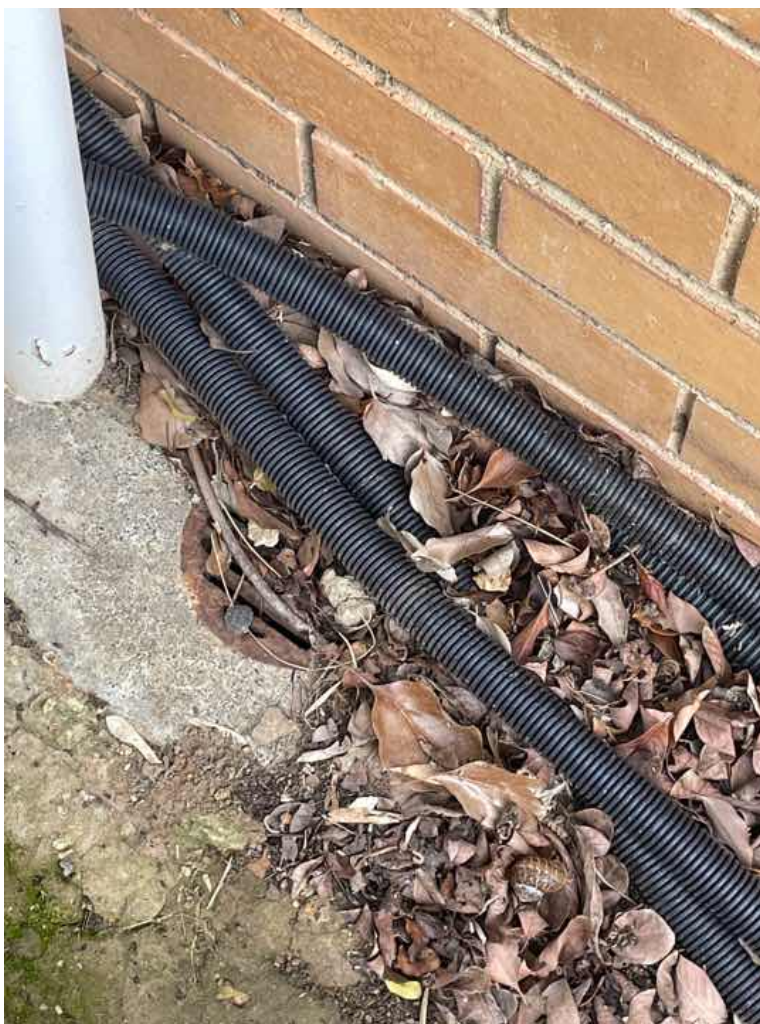
Debris evident in/around drains - Requires cleaning out.

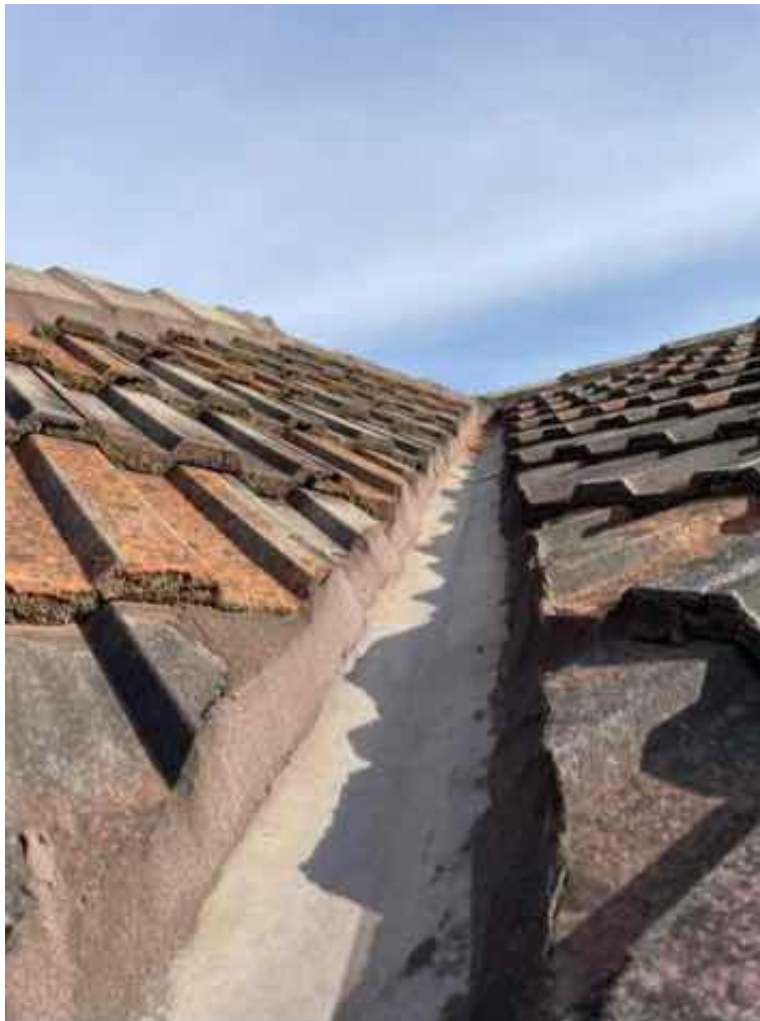
flashing rust sections. A qualified roofer should be engaged for repairs and recommendations.

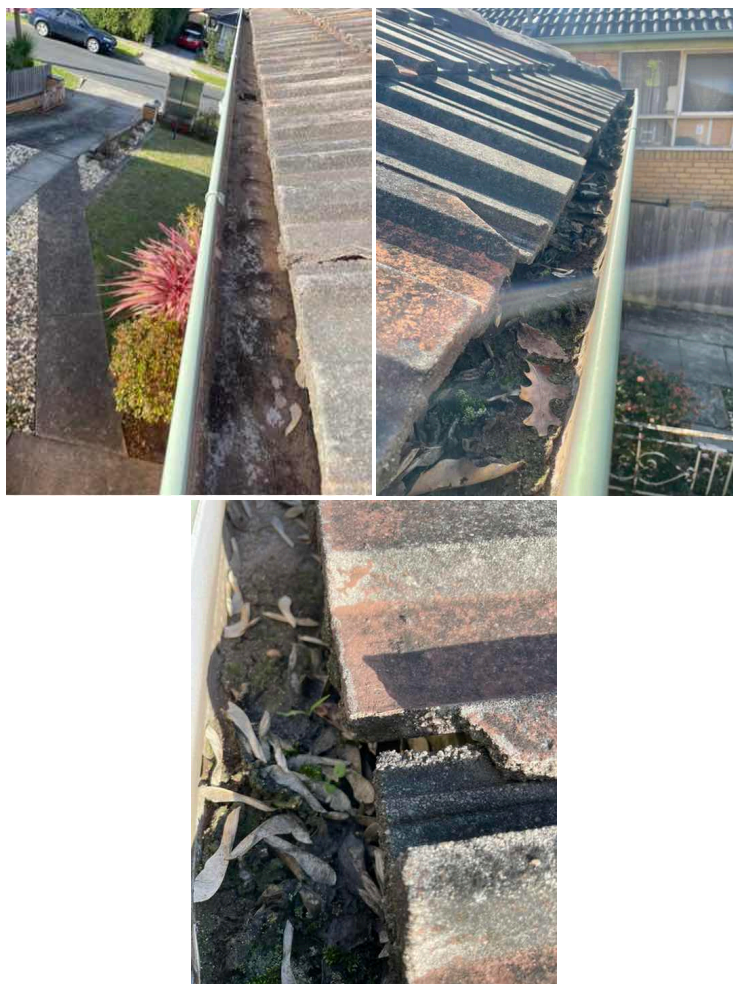
Gutter surface rust in sections- the rust is yet to penetrate and repairs/sealing may be an option. A qualified roof plumber should be engaged for advice and recommendations.

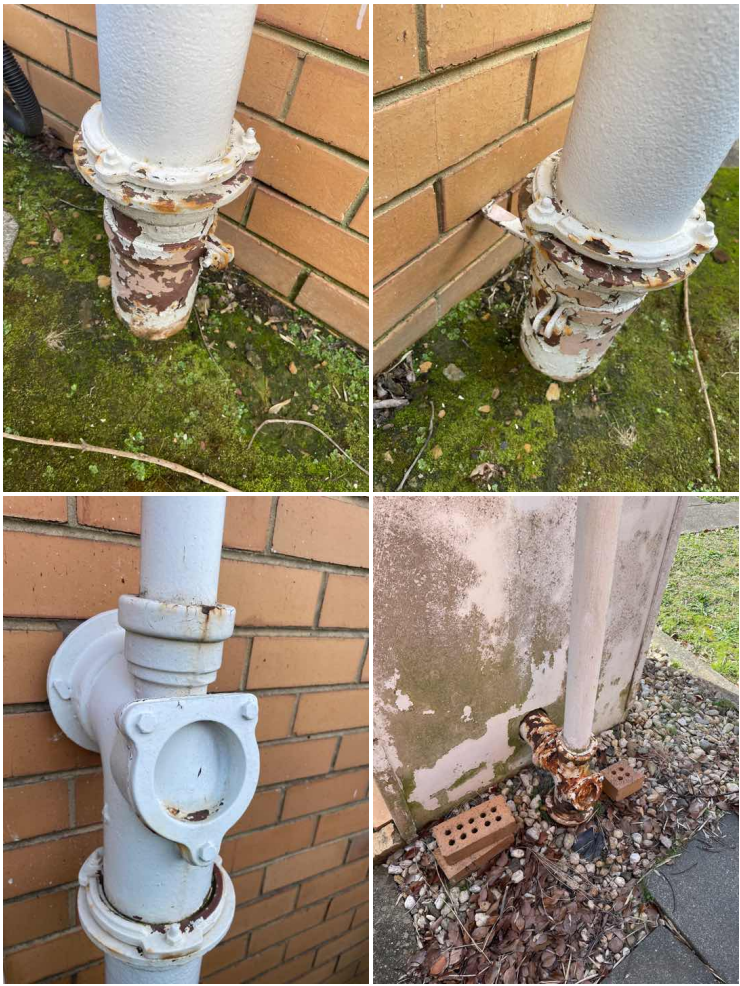
Rusted pipe work. Have a qualified plumber assess and repair as required.

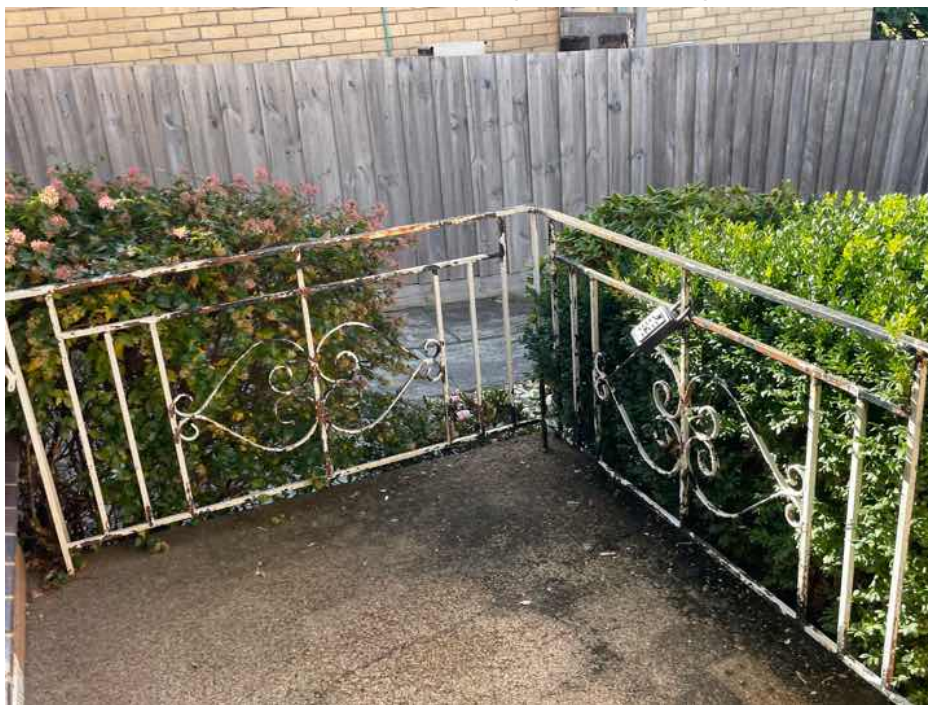
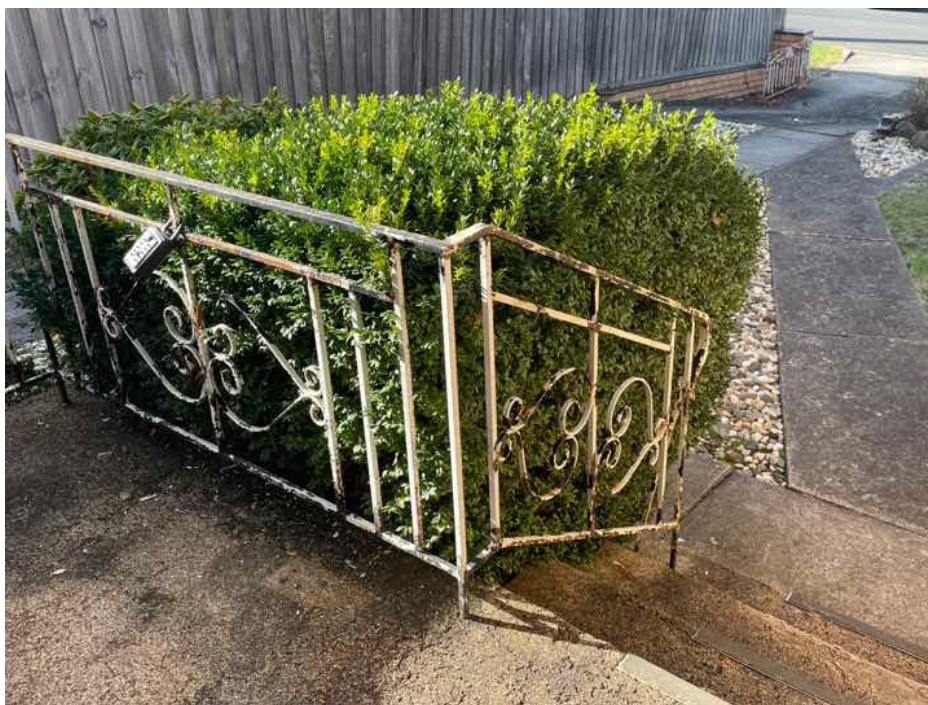
Rust evident on rails / balustrade - Recommendations: A qualified tradesperson should be engaged for repairs

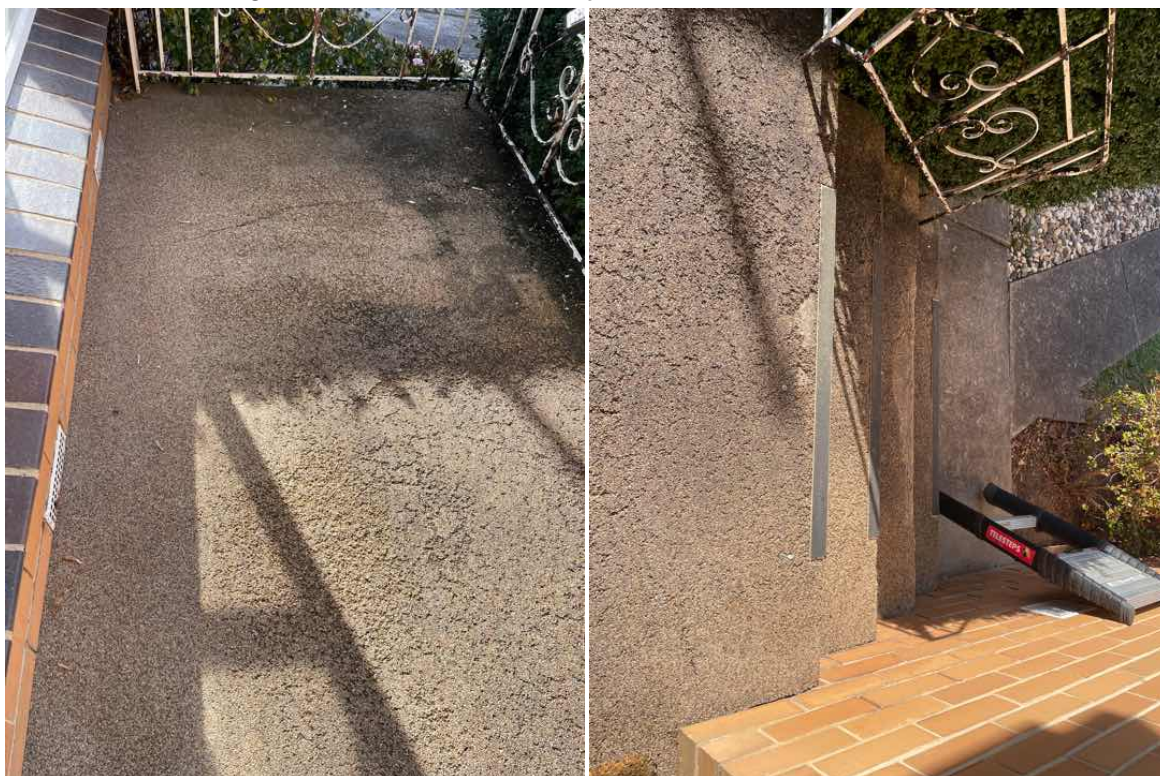
Typical cracks evident - Recommendations: Engage a qualified concreter or tiling contractor to repair. Please note: Whilst these cracks appeared to be minor at the time of inspection, we strongly recommend you monitor these cracks and if worsening occurs contact a brick layer/tiler for advice.

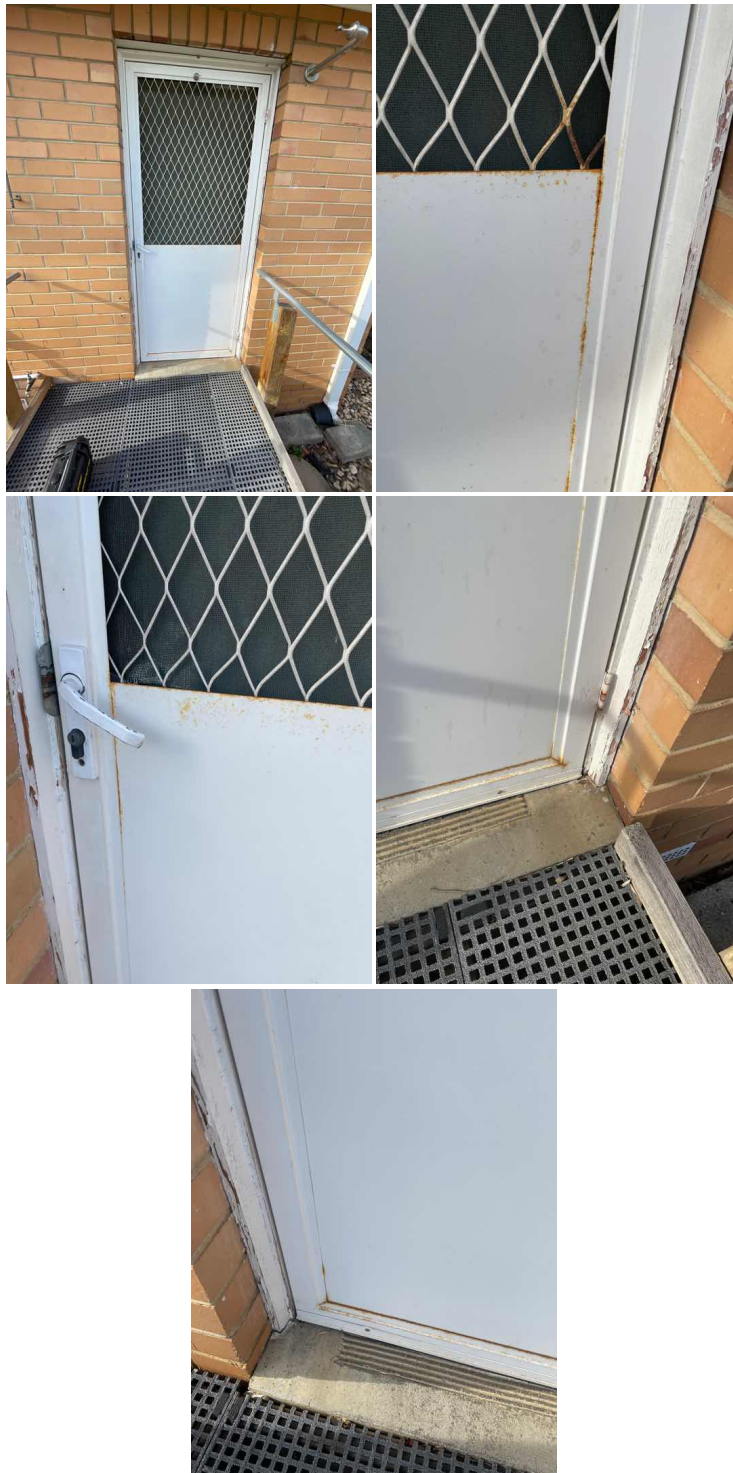
Rust in door/door frame - Recommendations: General repairs required.

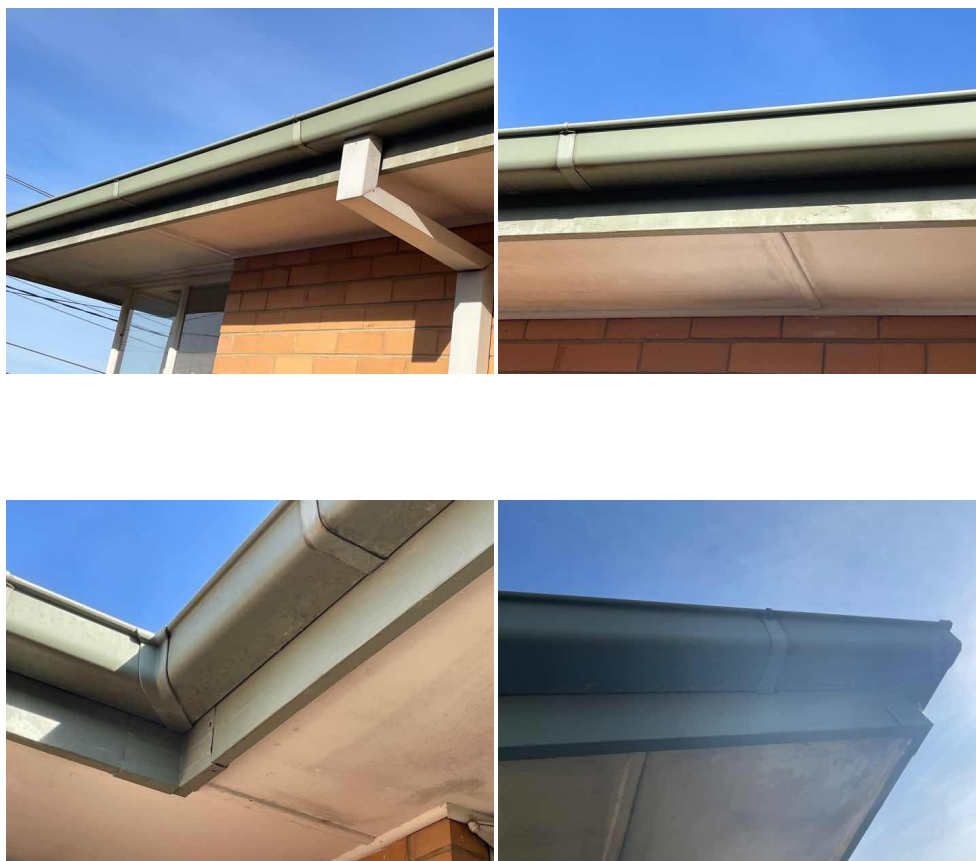
Minor deterioration & ageing evident. Recommendations: Maintenance works, general upkeep should be carried out.

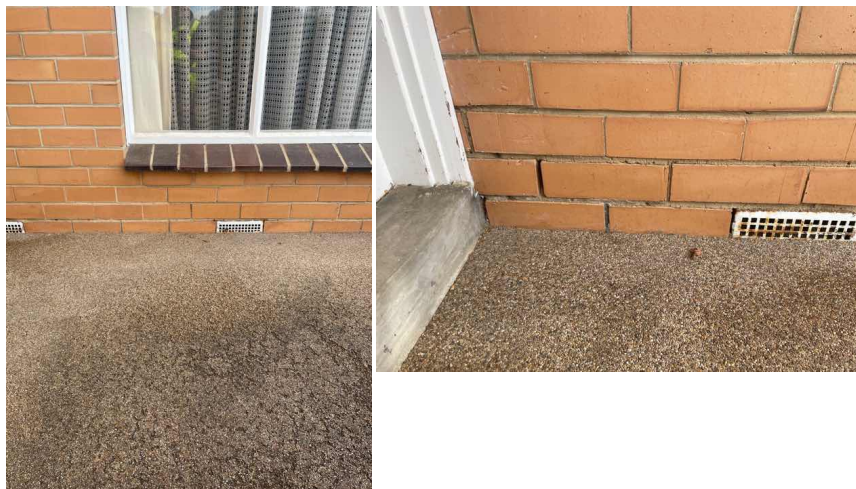
Mortar erosion between the brickwork is eroded. Contact a qualified bricklayer for repairs.

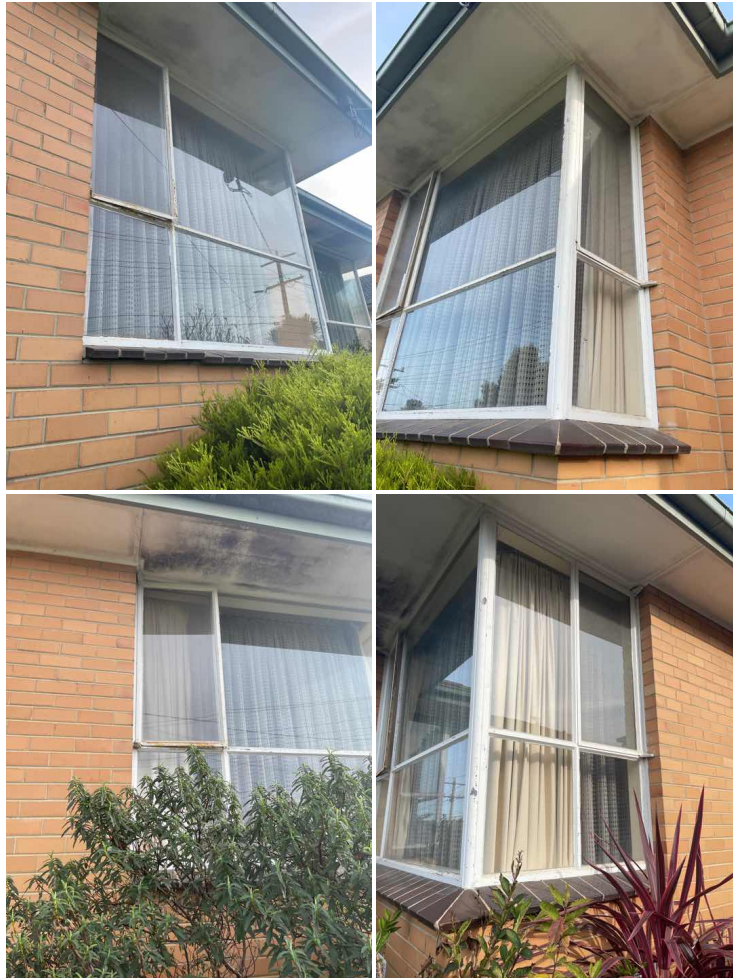
Rust is evident in sections of the homes window framework. Some areas should be repaired. A suitably qualified tradesman should be engaged for advice and recommendations.

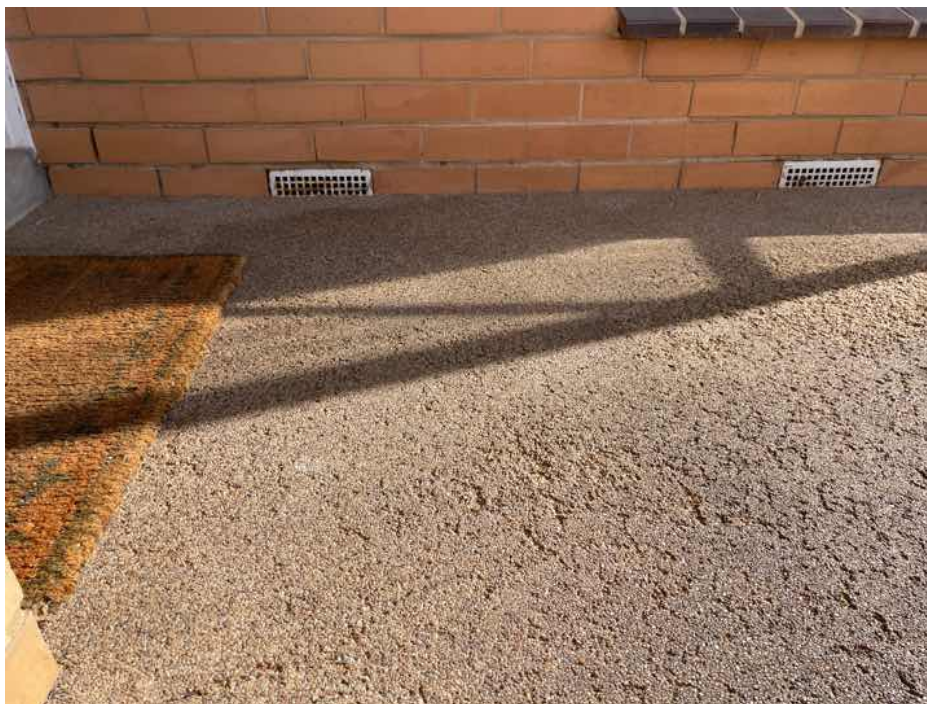
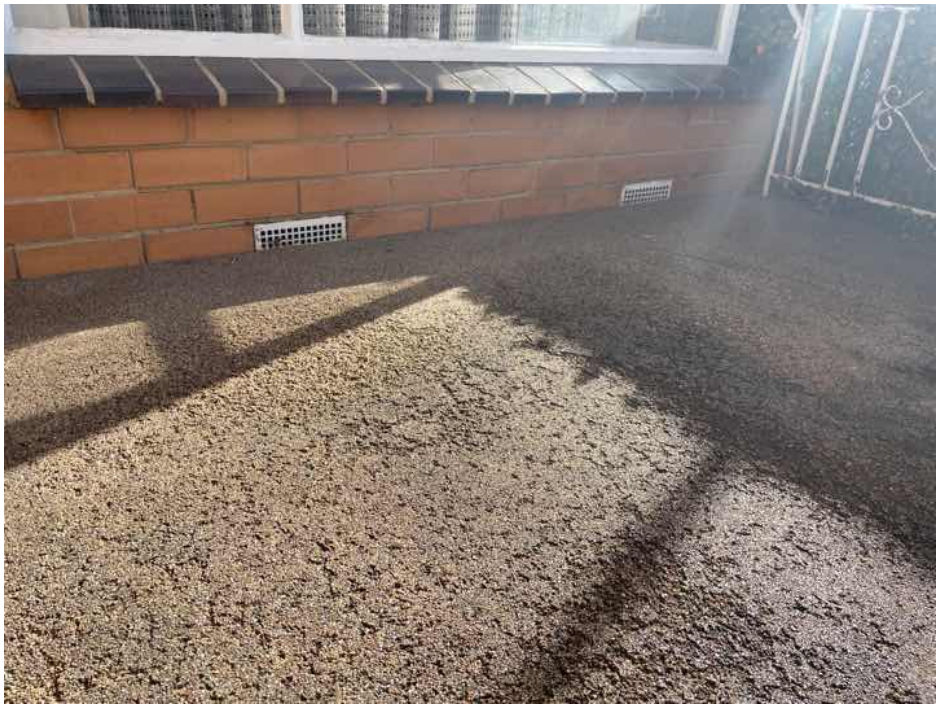
Vents are covered by soil/vegetation/ground level restricting ventilation to the sub floor Recommendations:  
Remove vegetation and or lower soil levels so that sub floor vents are unobstructed and allowing free flowing air.

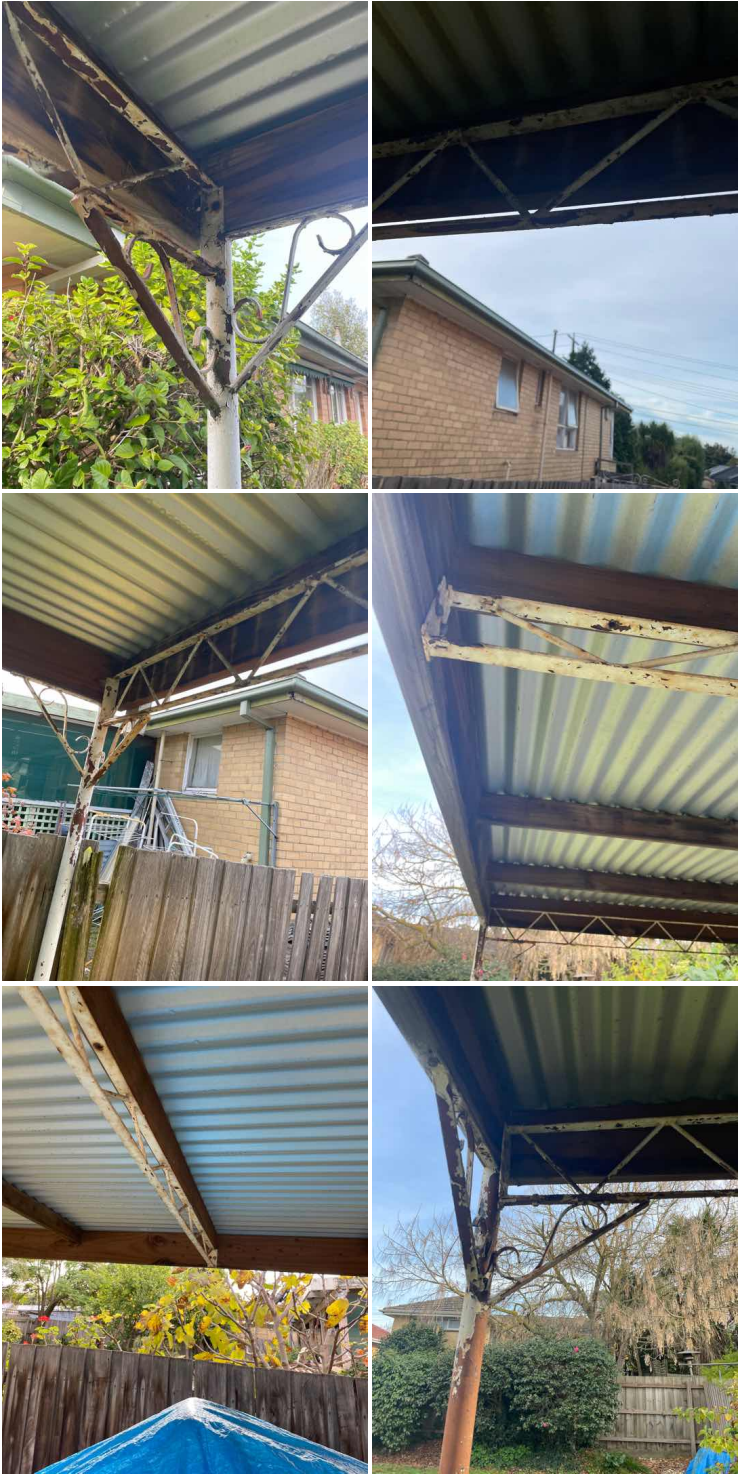
Corrosion noted to the metal frame. Replacement recommended.

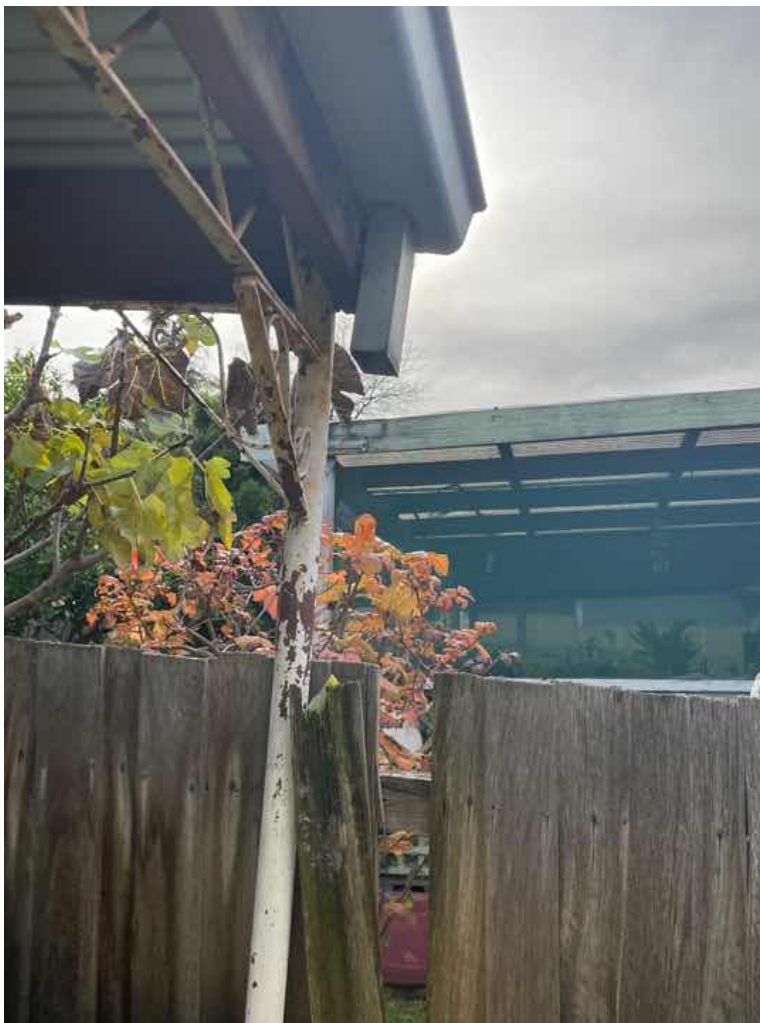
Down pipe is not connected to storm water. Contact a roof plumber for repairs

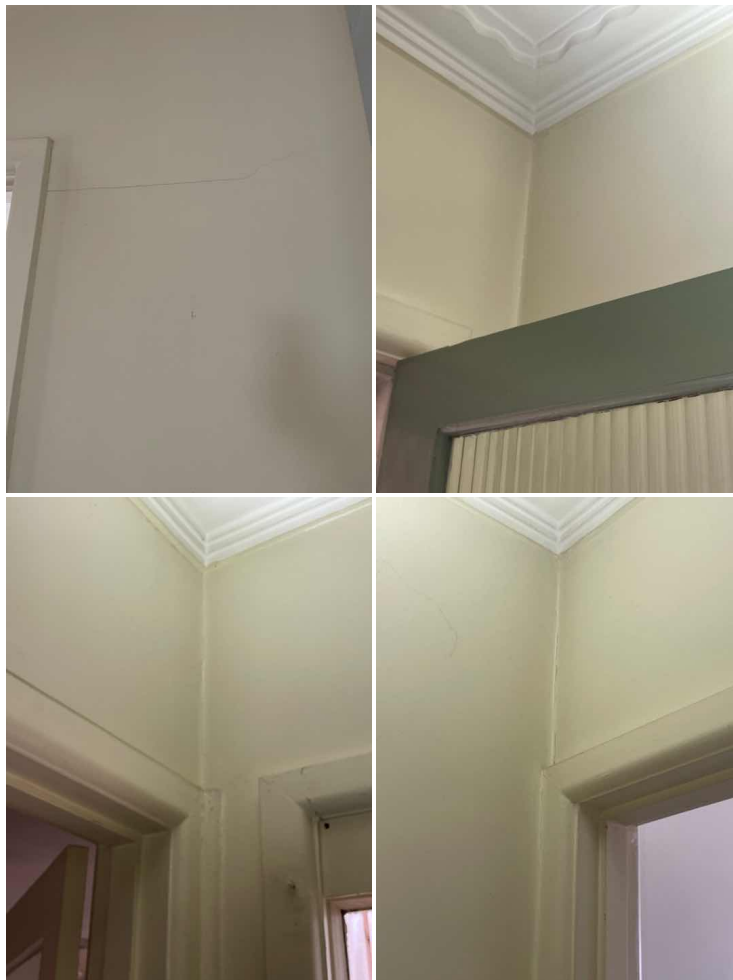
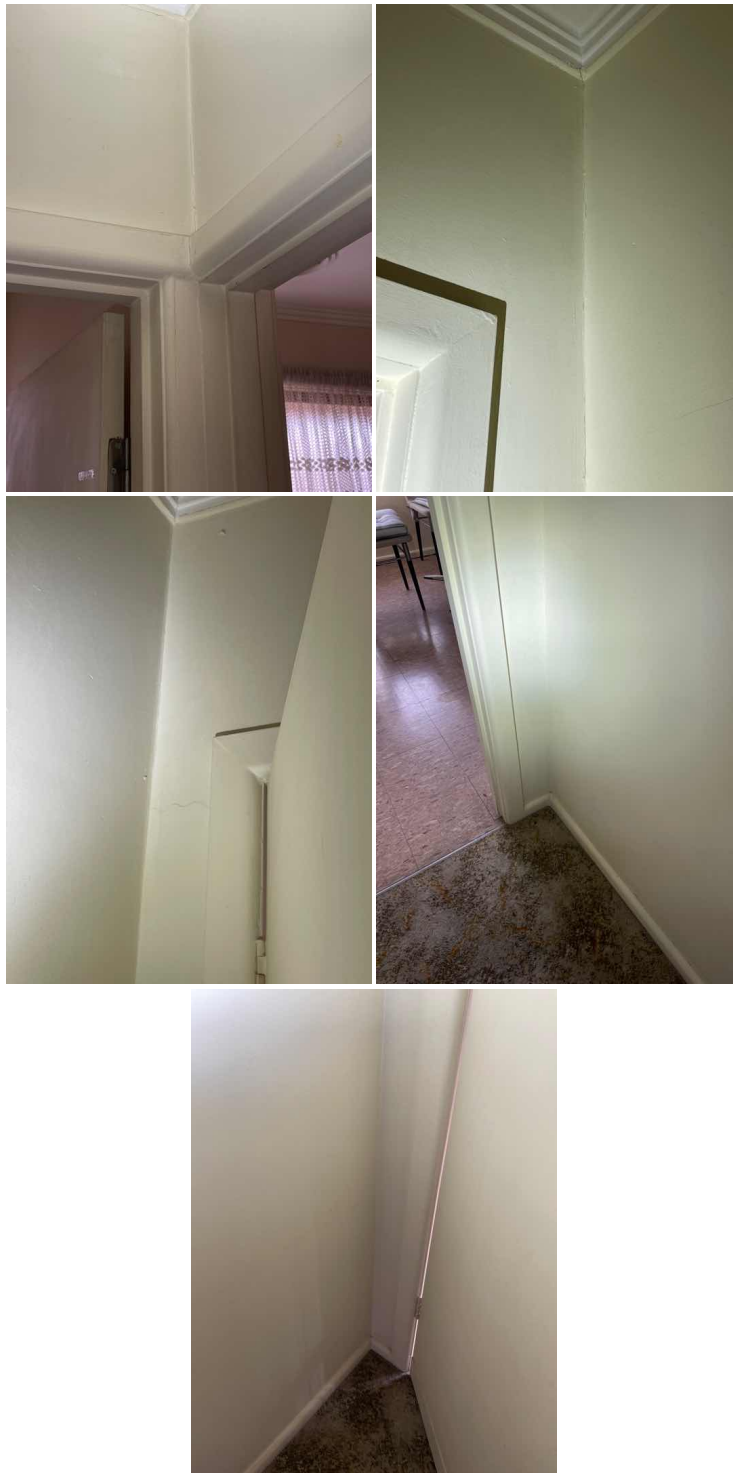
Patched wall cracks visible - Recommendations: Engage a plasterer to assess for further advice and repairs - I am unable to guarantee that these patched areas will not re-open in the future. If further opening occurs the affected areas may require re-assessment by a suitably qualified contractor.

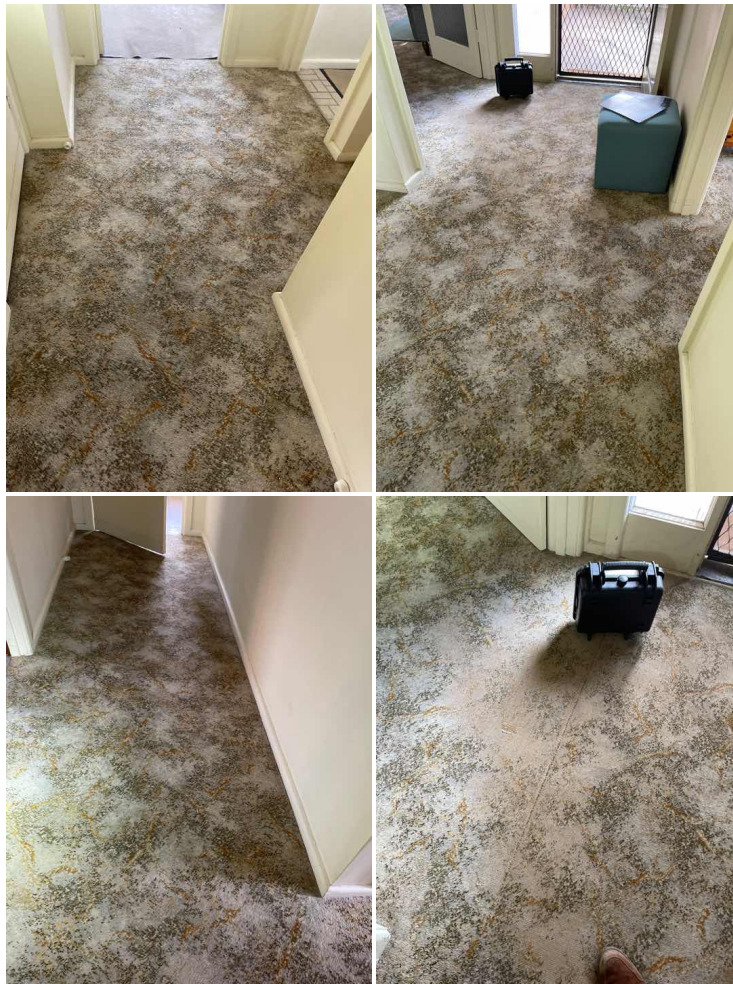
Stains observed - Steam cleaning may rectify stained areas but they appear entrenched.

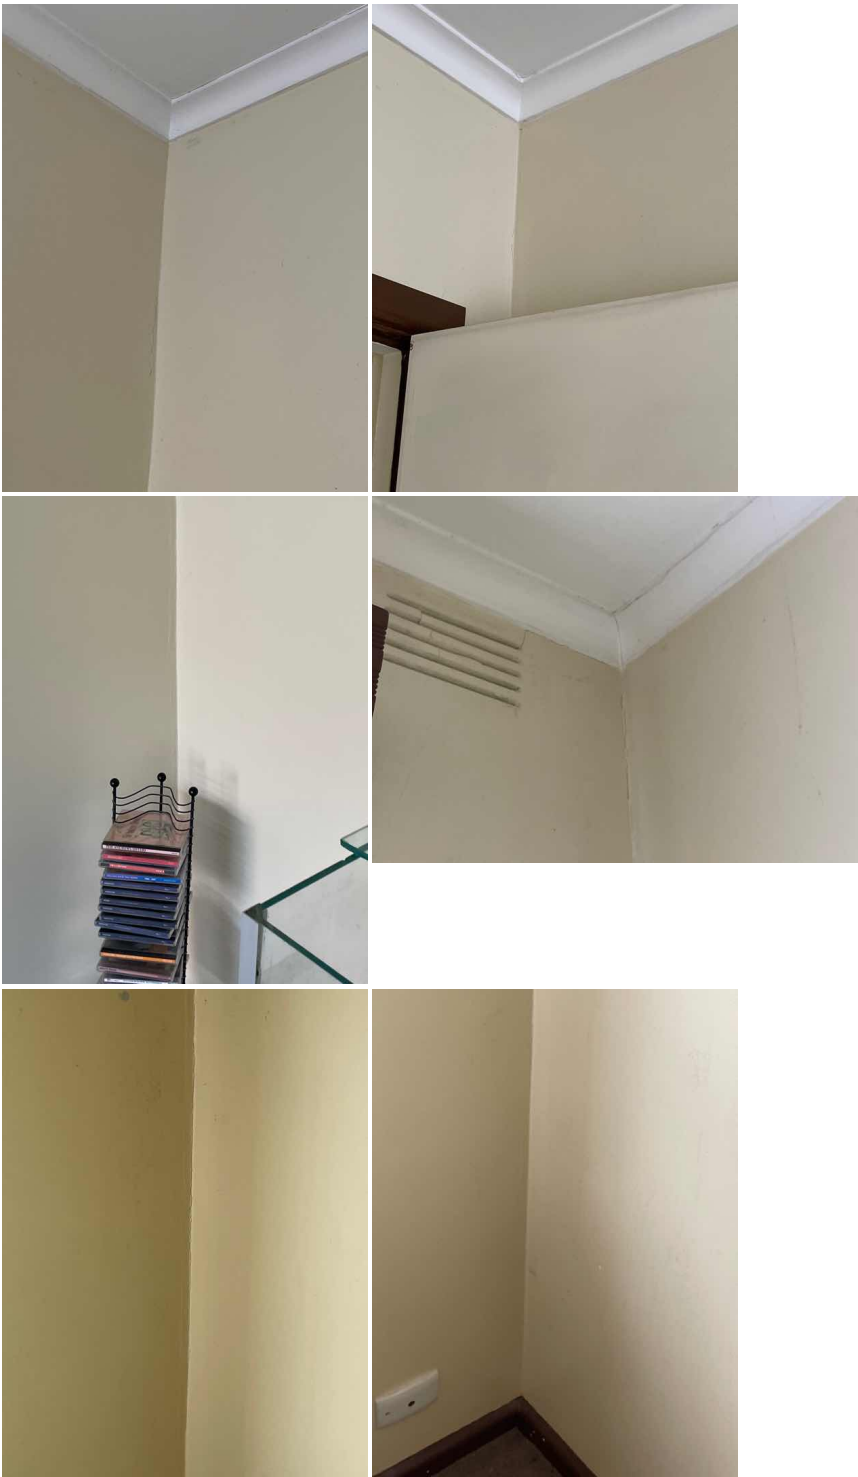
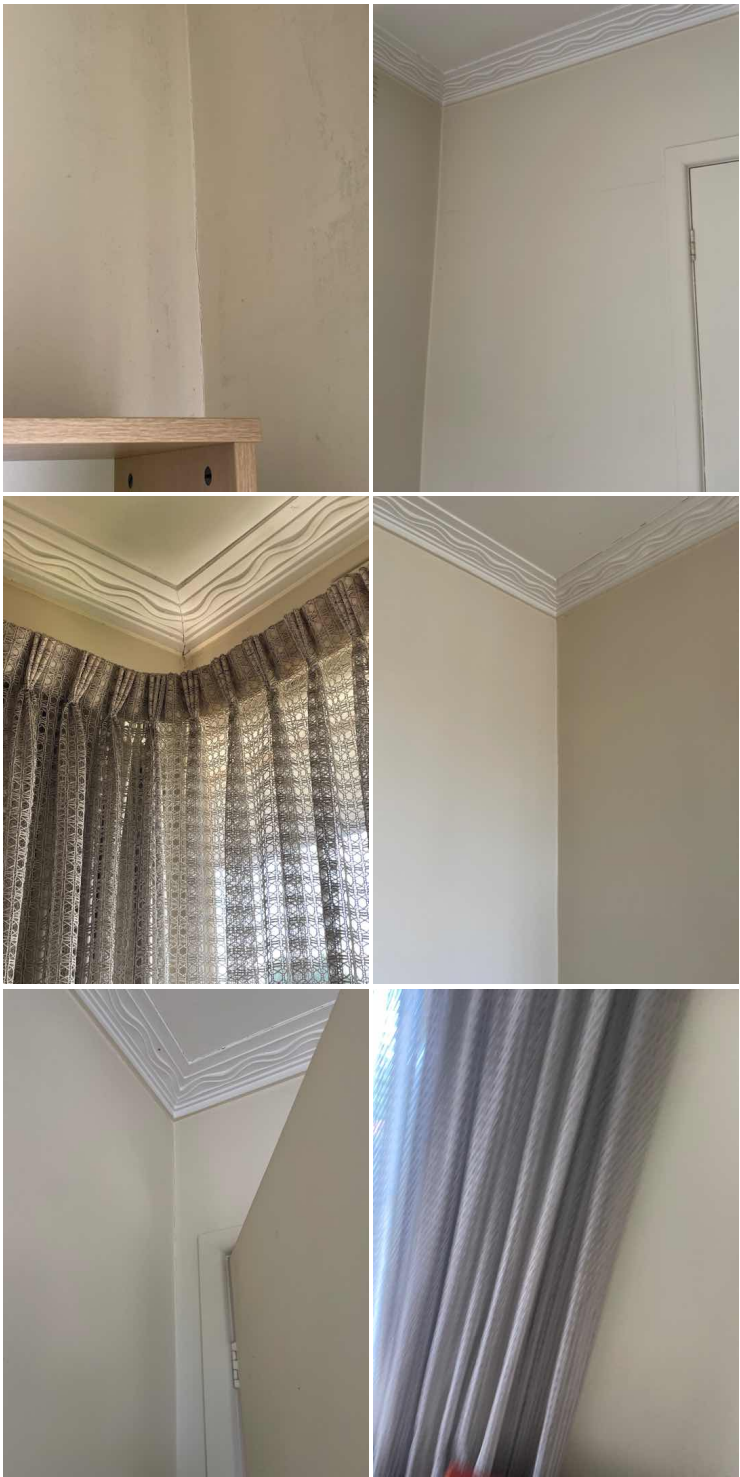
INTERIORS	Bedrooms	Walls	Wall stains observed - High moisture readings obtained. It is in the opinion of the inspector that the backfilling of the eaves and blocked gutters have contributed to the problem. This must be investigated further as there was no access to the roof void at the time of inspection. Recommendations: Contact licensed tradesperson for further assessment advice and repairs
INTERIORS	Bedrooms	Flooring	Unevenness visible in floor. Possibly due to poor workmanship or excessive movement/settlement. A qualified carpenter should be engaged for advice and recommendations re levelling.
CONCLUSION	Condition Of Inspected Structure	The incidence of Major Defects	The incidence of major defects in this residential building as compared with similar buildings is considered TYPICAL

Wall stains observed - High moisture readings obtained. It is in the opinion of the inspector that the backfilling of the eaves and blocked gutters have contributed to the problem. This must be investigated further as there was no access to the roof void at the time of inspection. Recommendations: Contact licensed tradesperson for further assessment advice and repairs

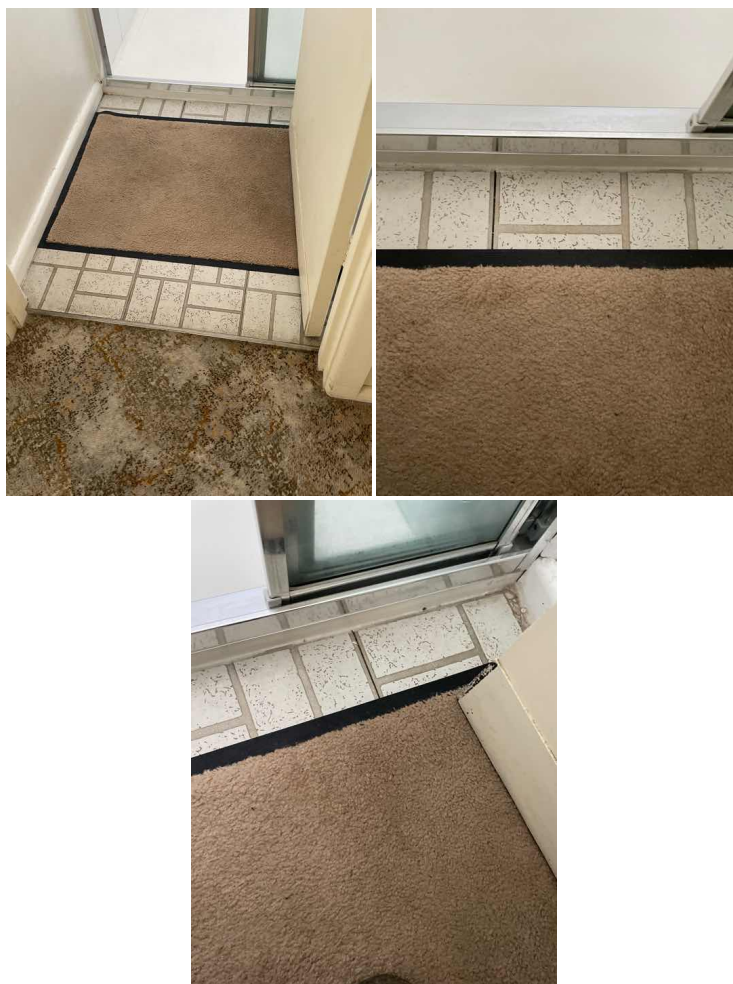
Unevenness visible in floor. Possibly due to poor workmanship or excessive movement/settlement. A qualified carpenter should be engaged for advice and recommendations re levelling.
