# Building & Timber Pest Inspection Report

**Inspect365**

**VICTORIA, 3087**

Inspection Date:                24 May 2021

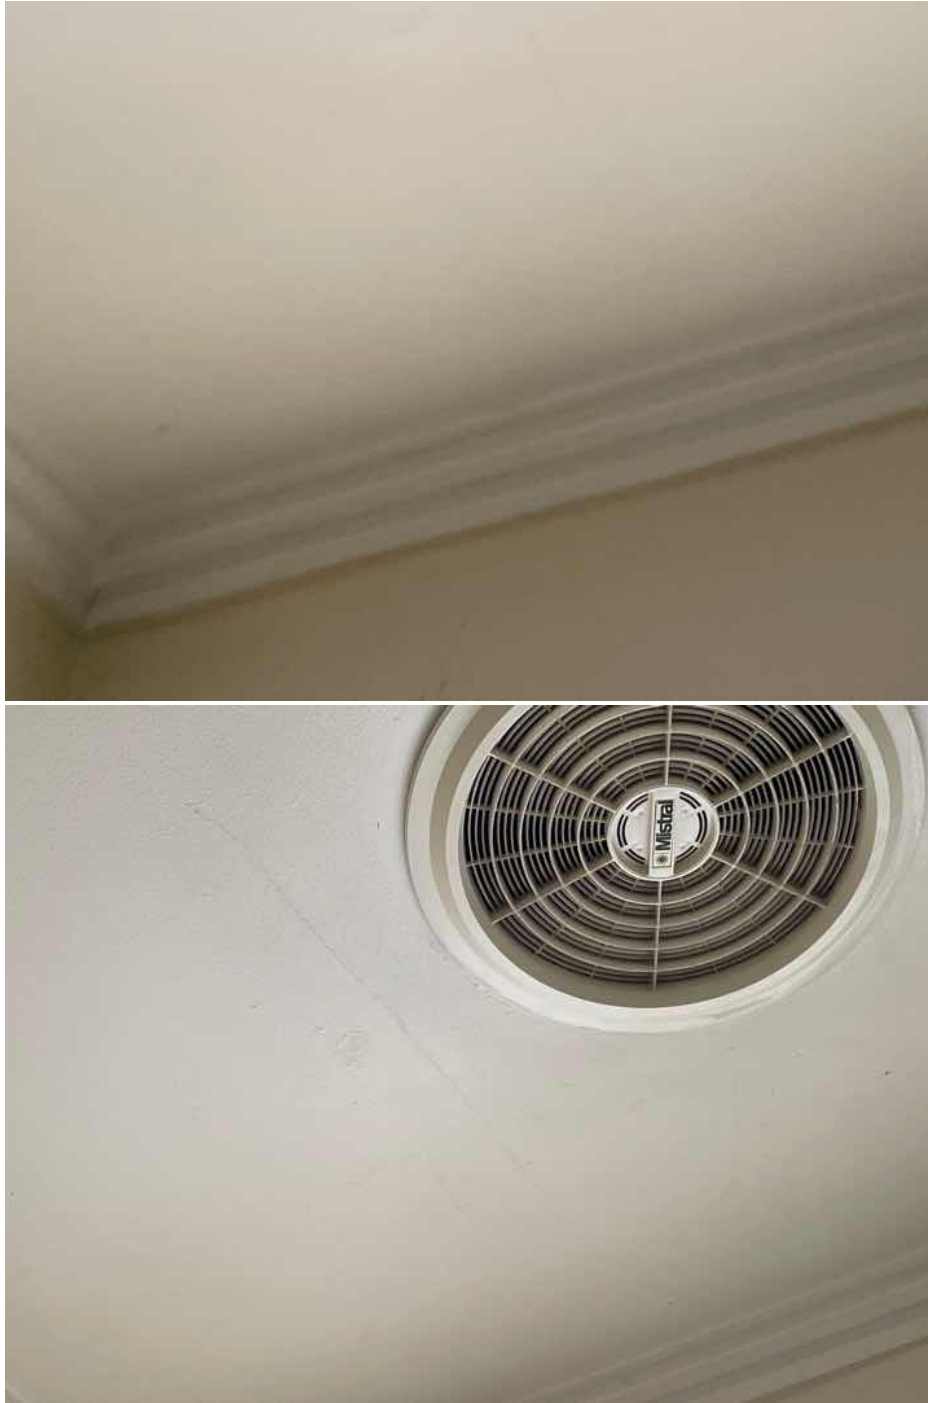
Settlement Cracks Noted. These are typical and generally patch and paint will suffice, however monitoring these cracks advised for 12 months and if become wider or longer, you will need to contact a structural engineers to assess.

Cornice separation. I recommend you contact a licensed plasterer for repairs.

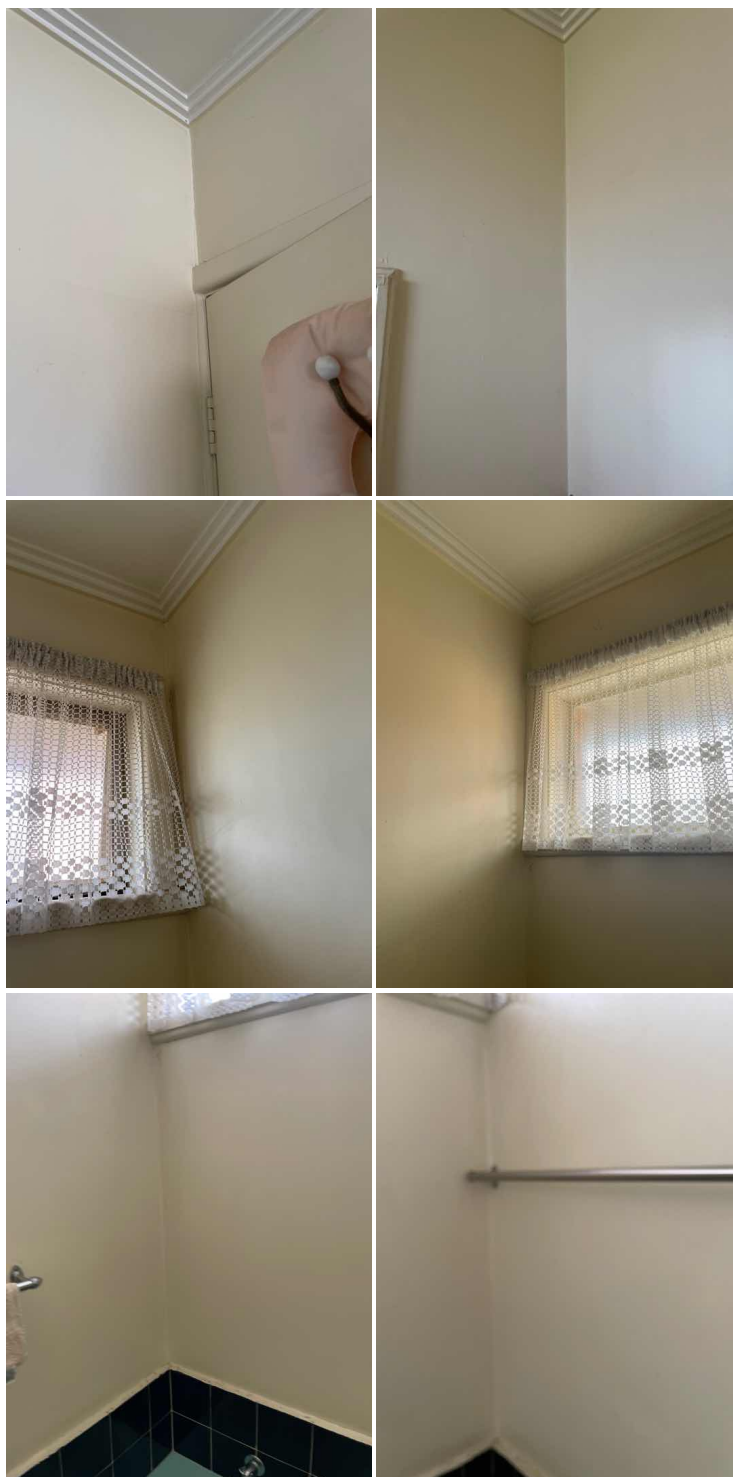
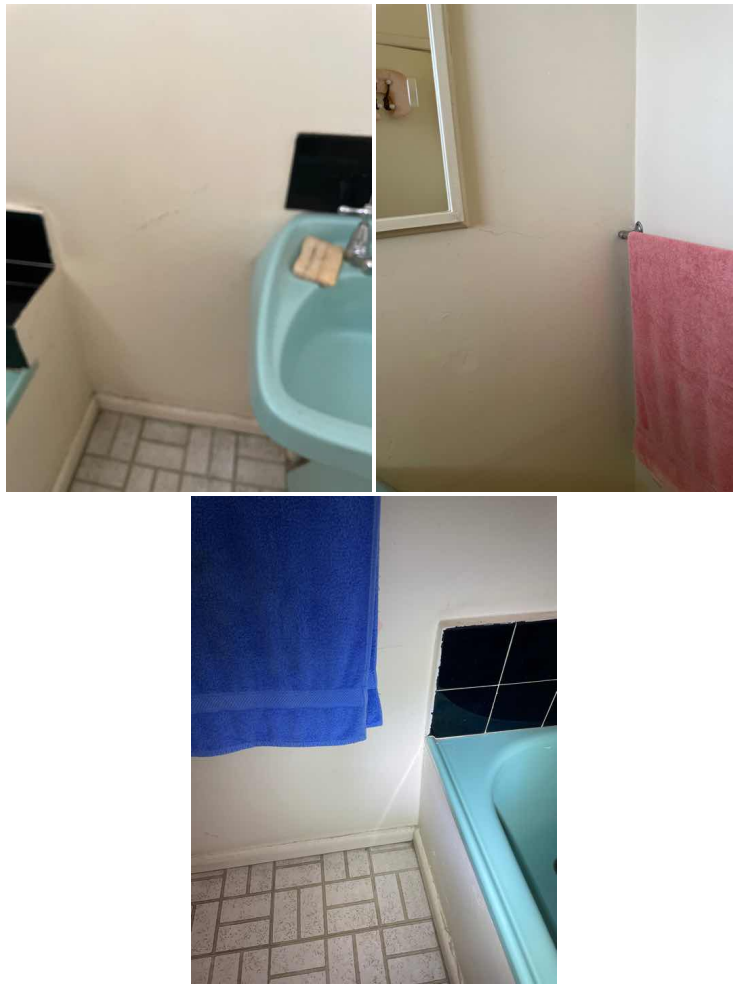
Patched wall cracks visible. Engage a plasterer to assess for further advice and repairs - I am unable to guarantee that these patched areas will not re-open in the future. If further opening occurs the affected areas may require re-assessment by a suitably qualified contractor.

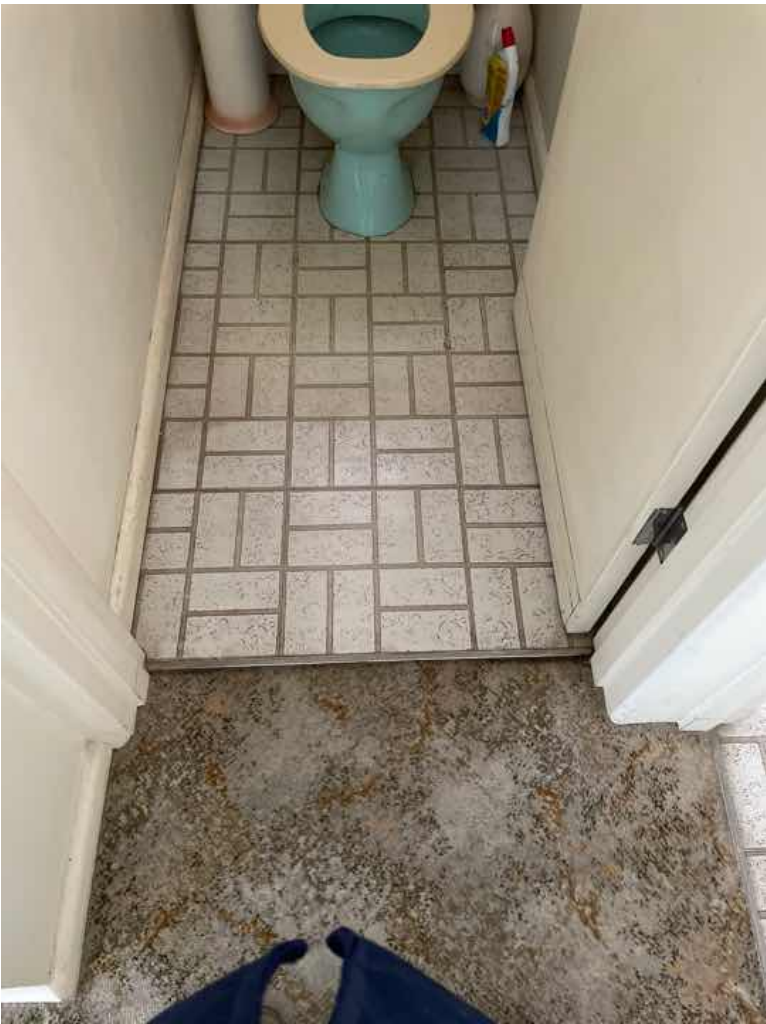
Unevenness visible in floor. Possibly due to poor workmanship or excessive movement/settlement. A qualified carpenter should be engaged for advice and recommendations re levelling.

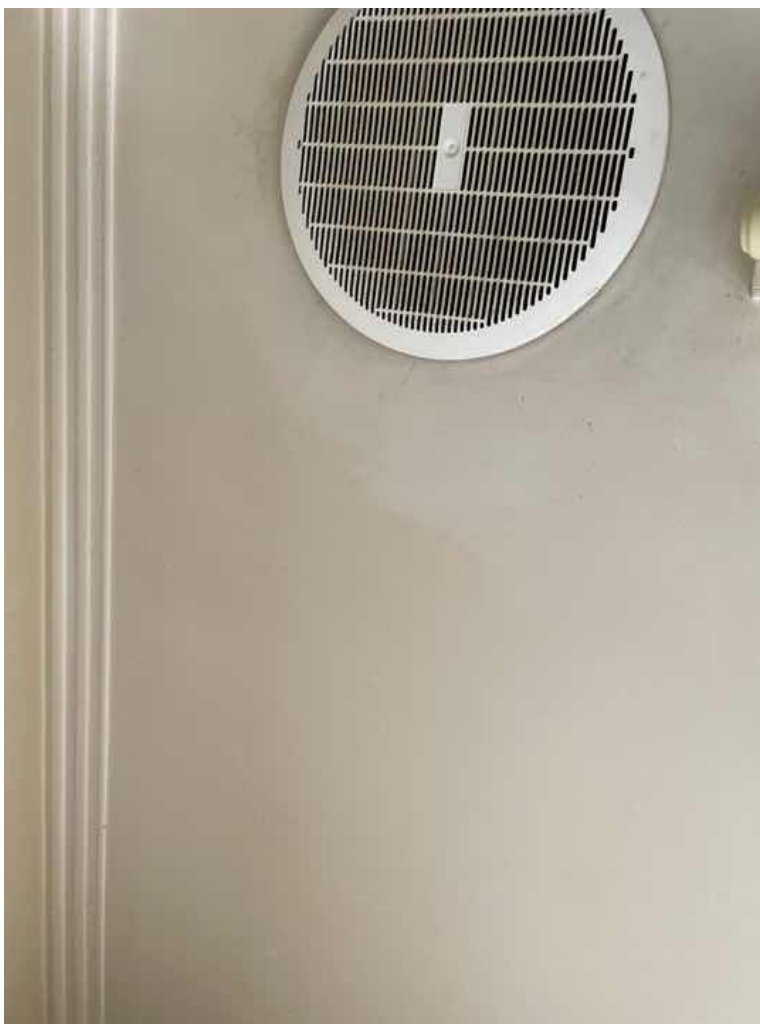
General ageing and/or denting and/or wear and/or previous wall patching and the like is evident on ceiling linings - Recommendations: A qualified painter should be engaged to assess and repair as required.

Settlement Cracks Noted. These are typical and generally patch and paint will suffice, however monitoring these cracks advised for 12 months and if they become wider or longer, you will need to contact a structural engineer to assess.

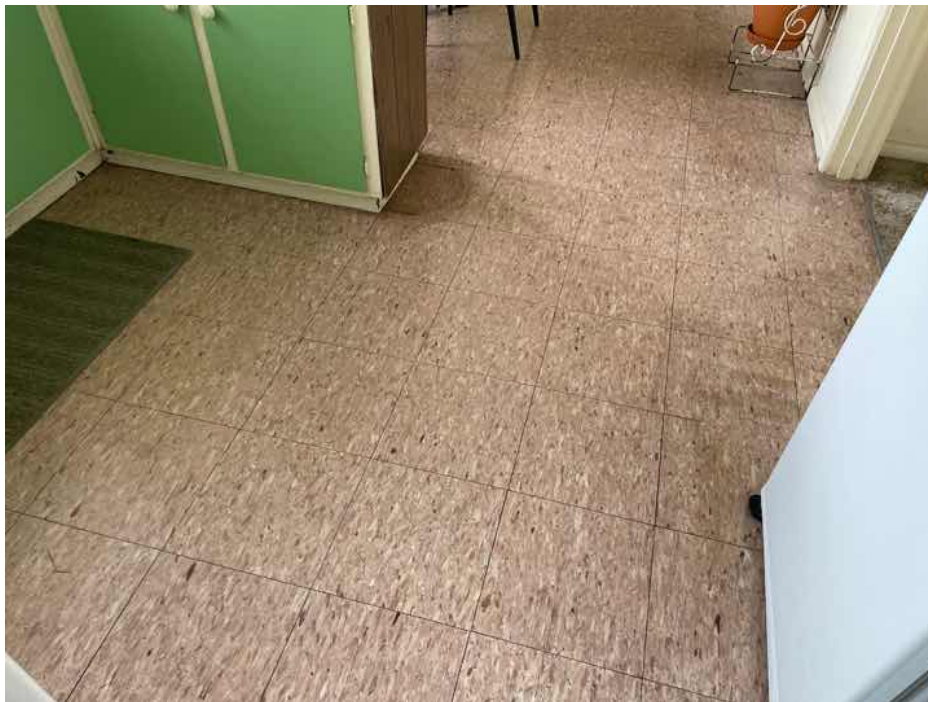
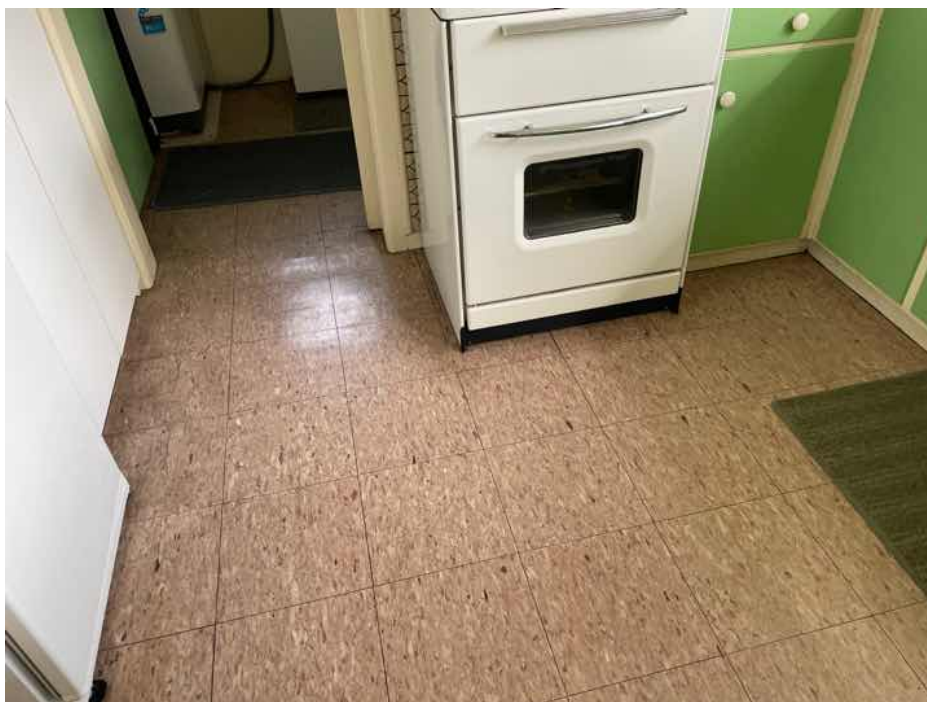
Unevenness visible in floor - Floor linings may require removal to ascertain cause. Recommendations: A qualified carpenter should be engaged for advice and recommendations re levelling.

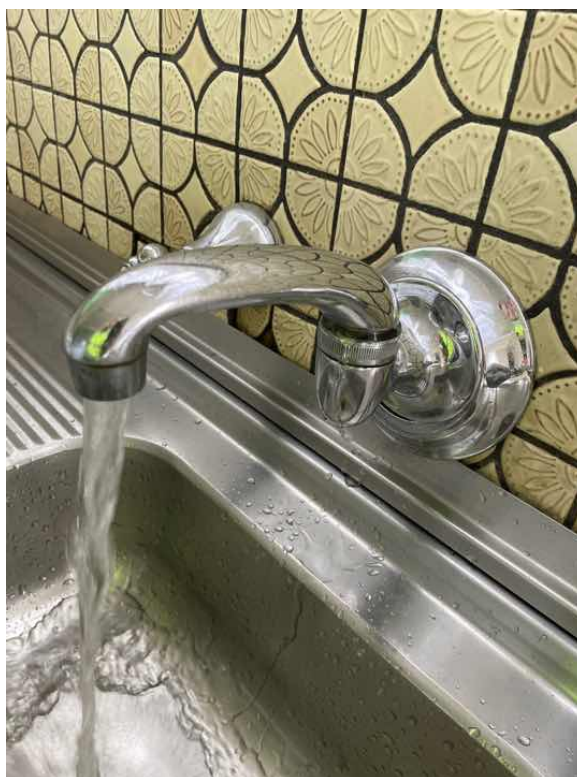
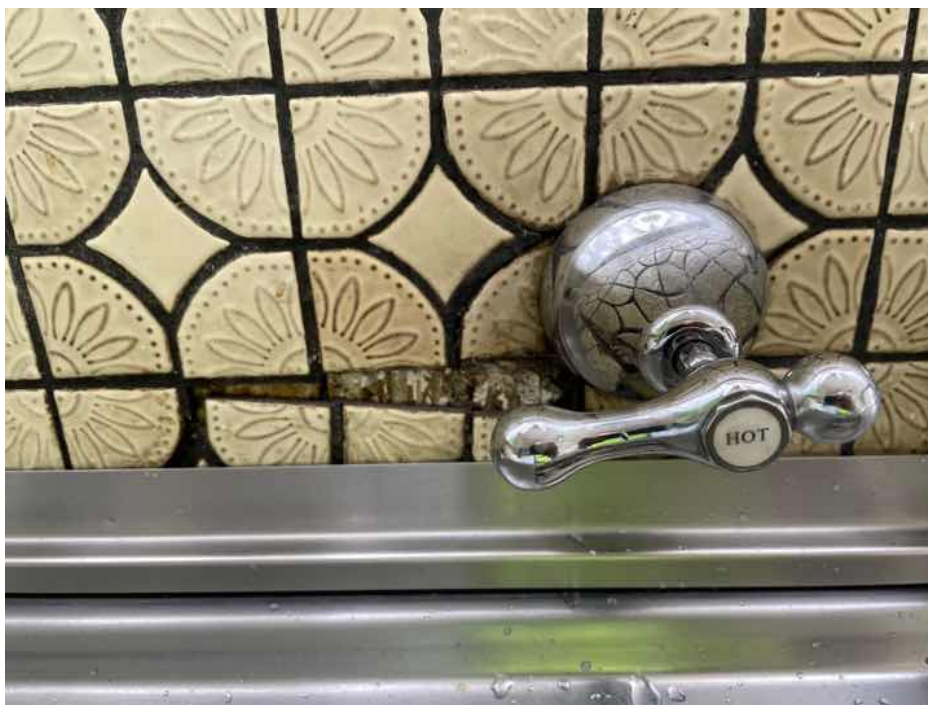
Splash back grout deteriorated. Repairs by qualified tiler is recommended.

The tap / tap head is loose. Might be as simple as tightening or a replacement maybe required. A qualified plumber should be engaged for assessment and recommendations.

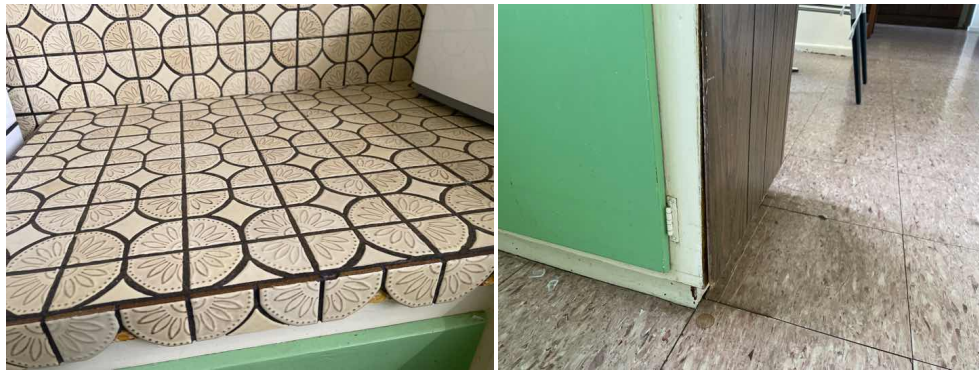
Damage was noted to the bench top tiles, contact a joinery company for repairs

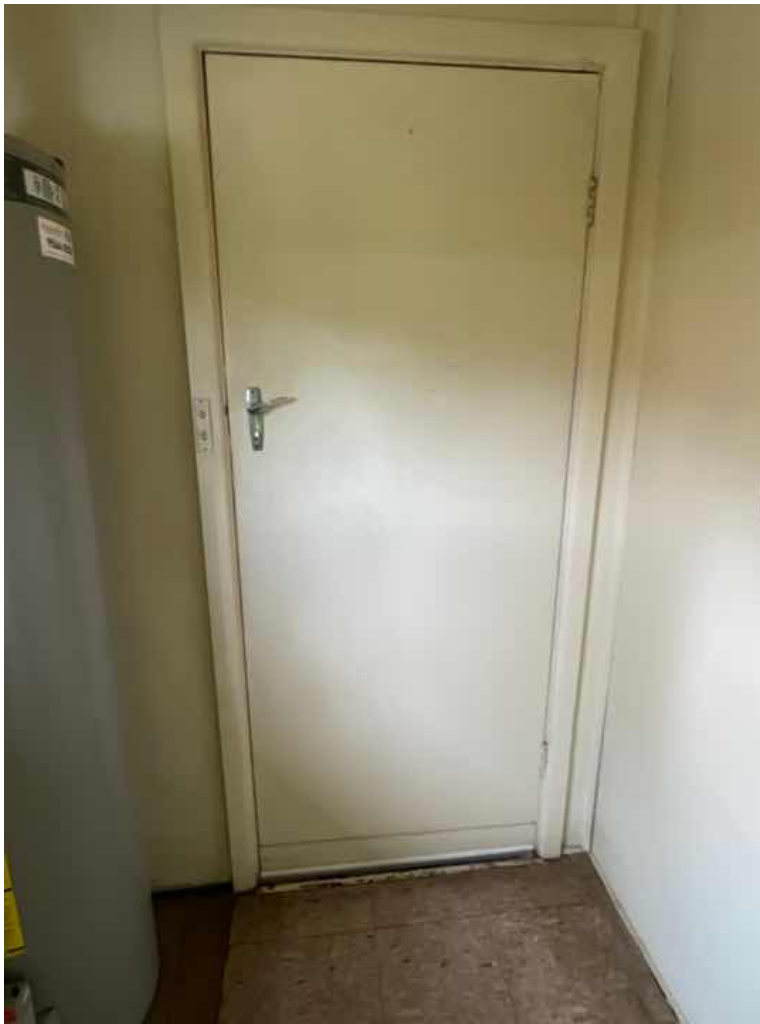
Door locked - Not opened or tested for binding. Recommendations: Obtain keys to open and assess.

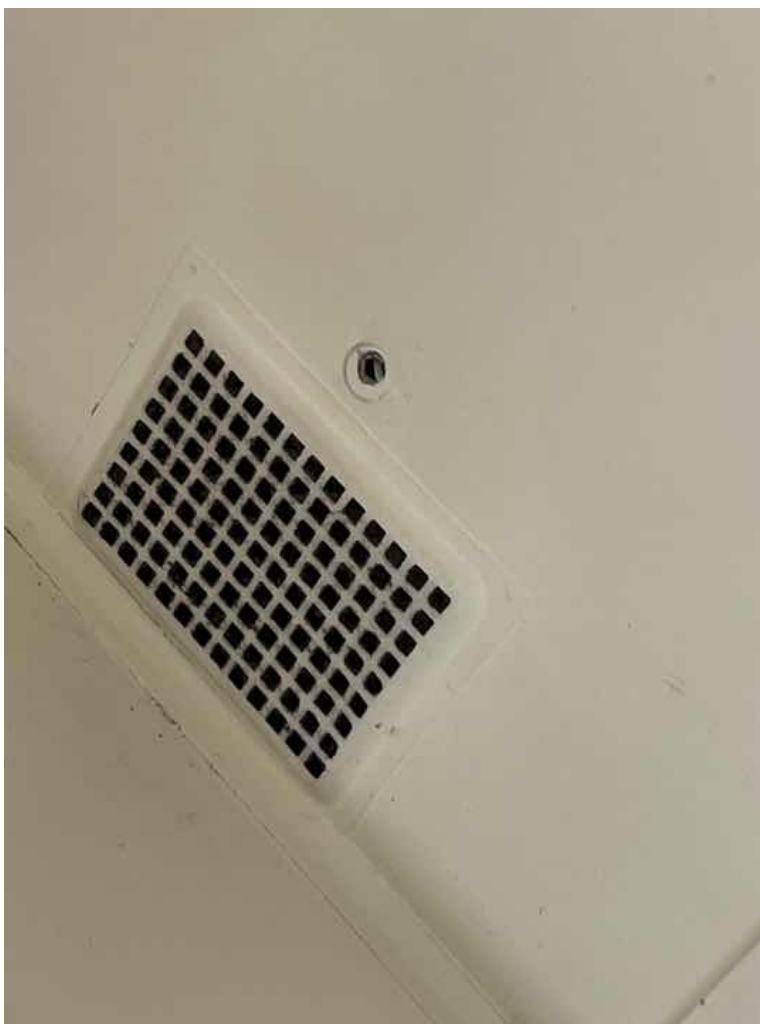
Incomplete Patch/Paint repairs noted. Call a qualified painter for repairs.

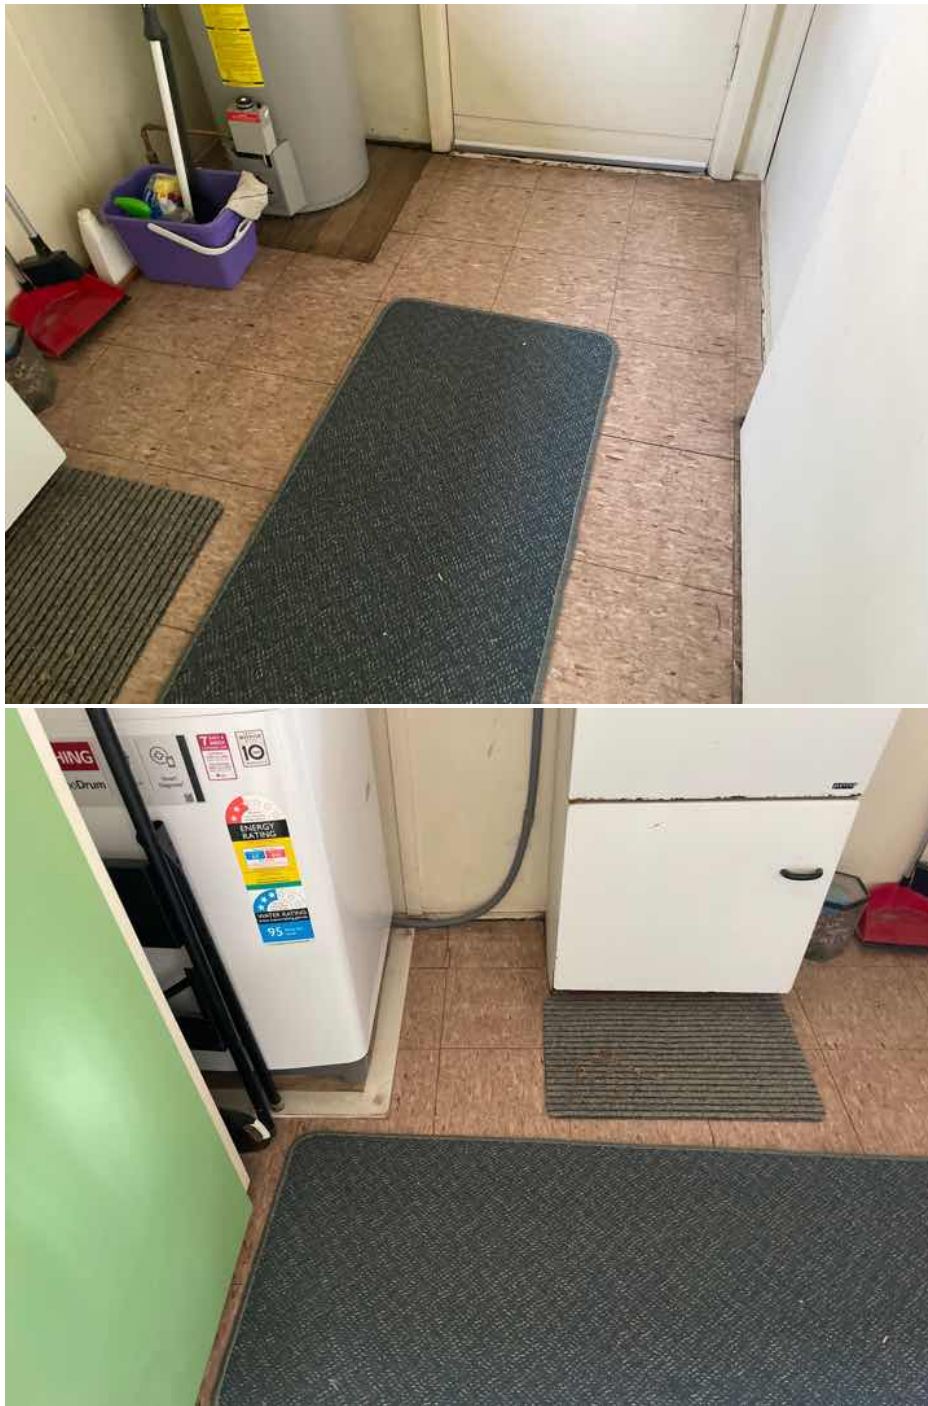
General age, wear and tear - Recommendations: General repair and maintenance advised.  
Unevenness visible in floor - Floor linings may require removal to ascertain cause. Recommendations: A qualified carpenter should be engaged for advice and recommendations re levelling.

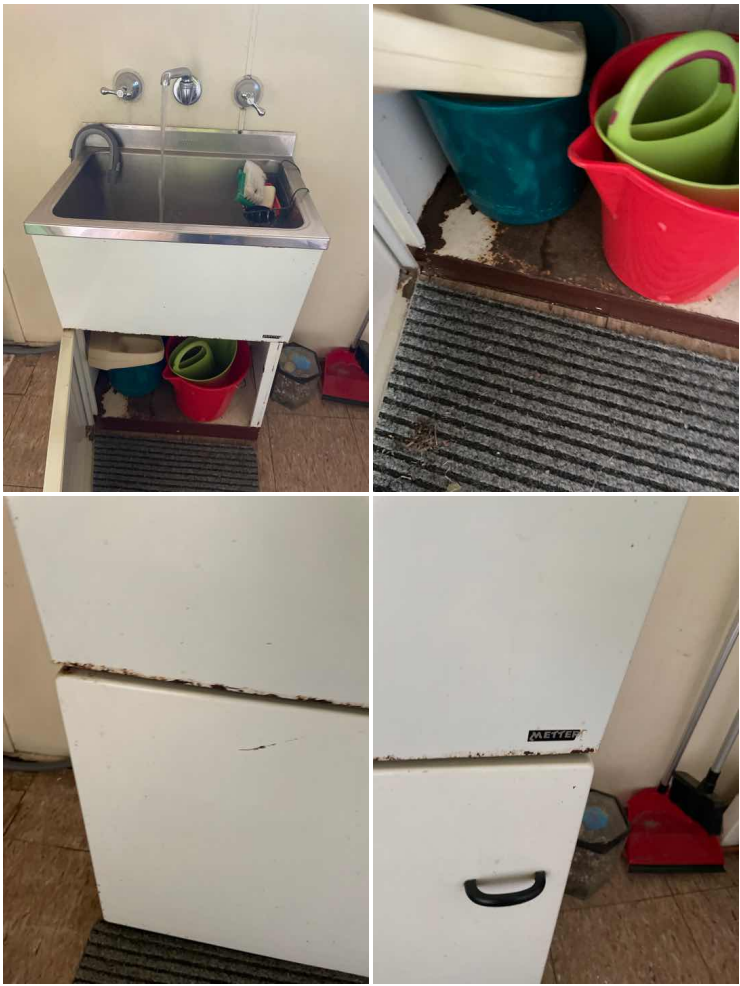
Tub is corroded. Replacement recommended.

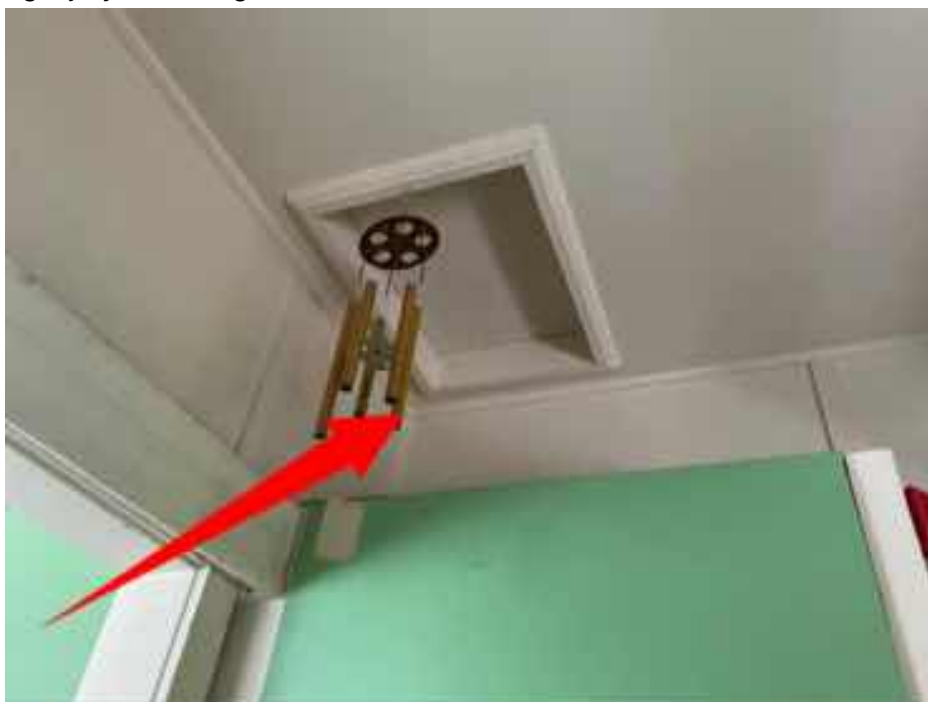
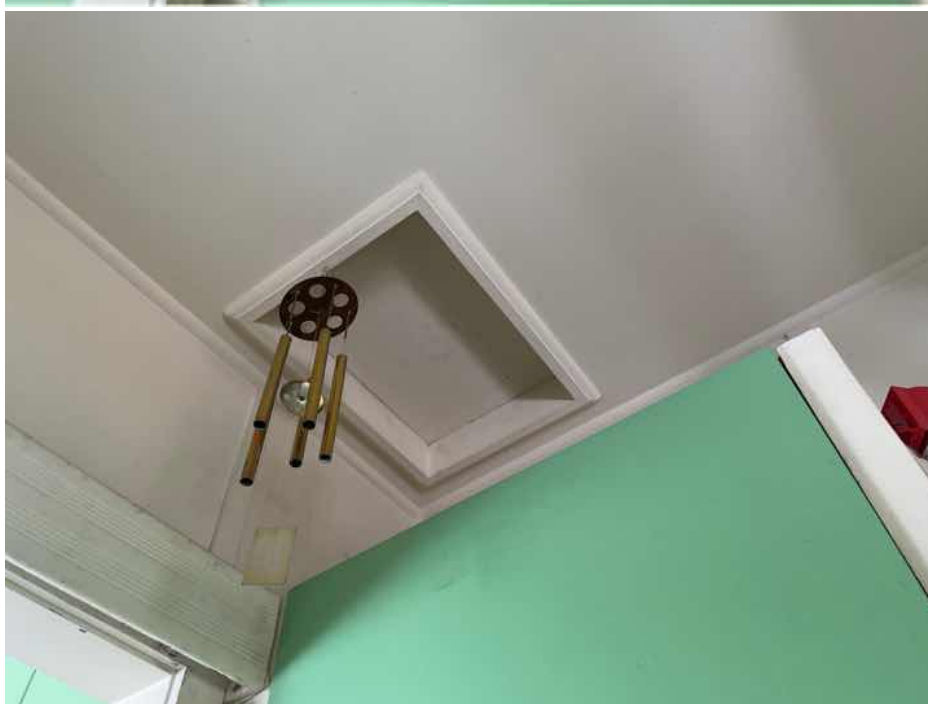
Inability to safely enter through the man hole without causing damage or injury to the inspector due to the access door being mostly above the cabinets thus preventing safe placement of the ladder to gain entry into the roof void. I would recommend relocating the access door to an area with adequate clearance to be able to safely enter without causing injury or damage.

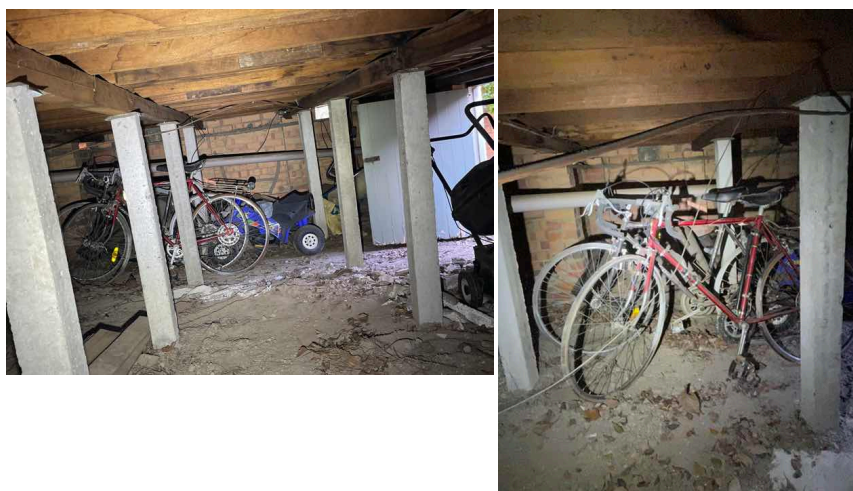
Stored items restricted visual inspection.

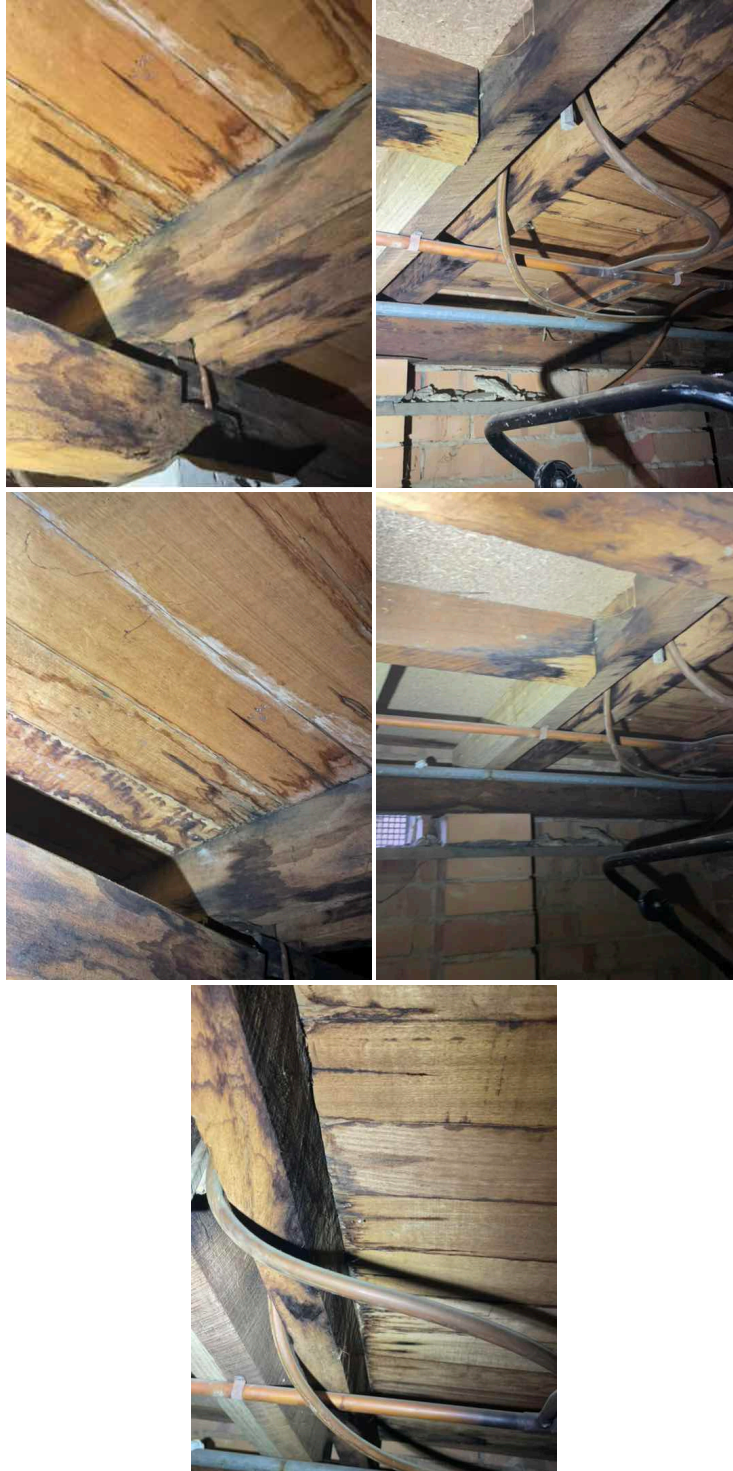
Water damage noted floor boards water leaks have been fixed.

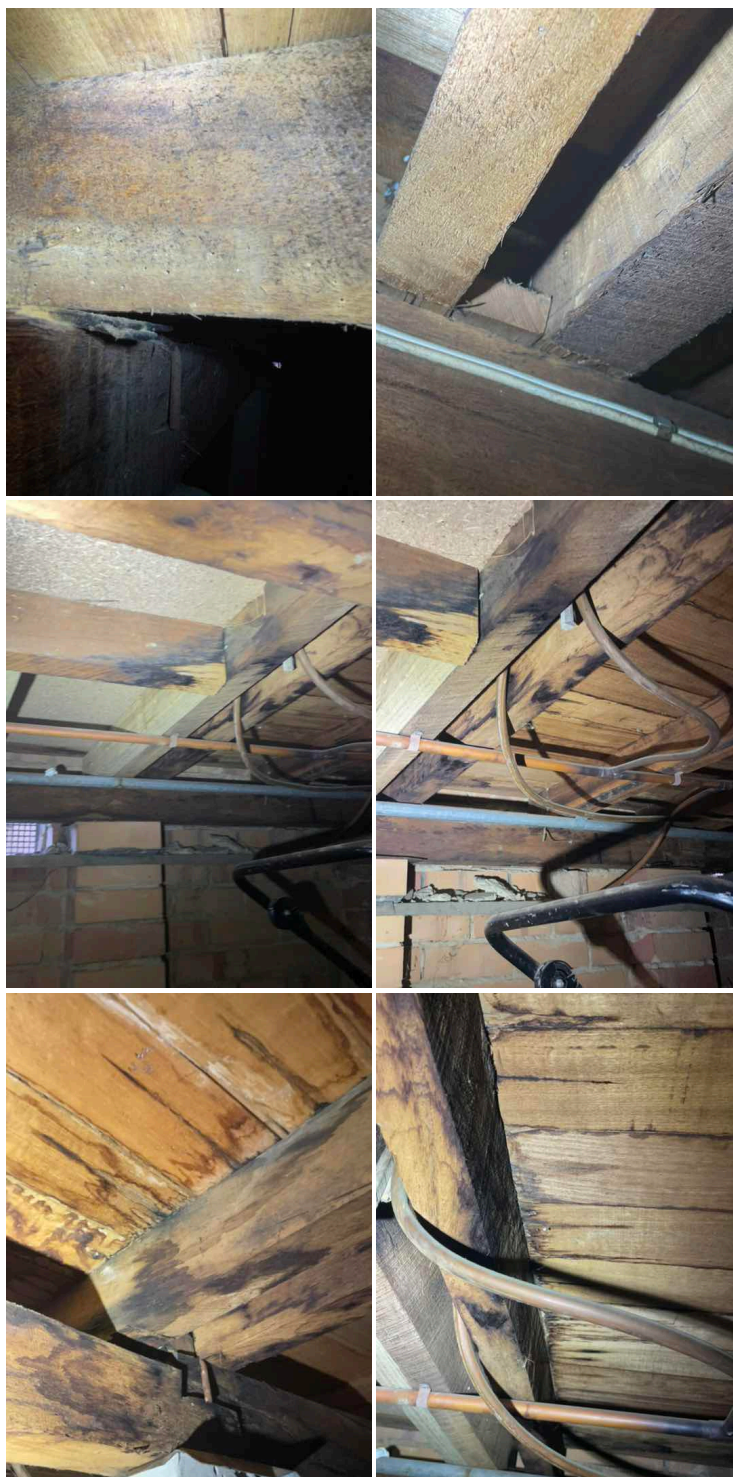
Some of the joists appear to have been recently replaced. I recommend enquiring as to whether the replacement was as a result of timber pest attack, rot or some other reason.
