Building Defect Inspection

Sample , Epping, VIC

Report/Agreement # 100124023859311
 Inspection Date: 10 Jan 2024
 Inspection Time: 02:38 pm

Pest And Building Inspection

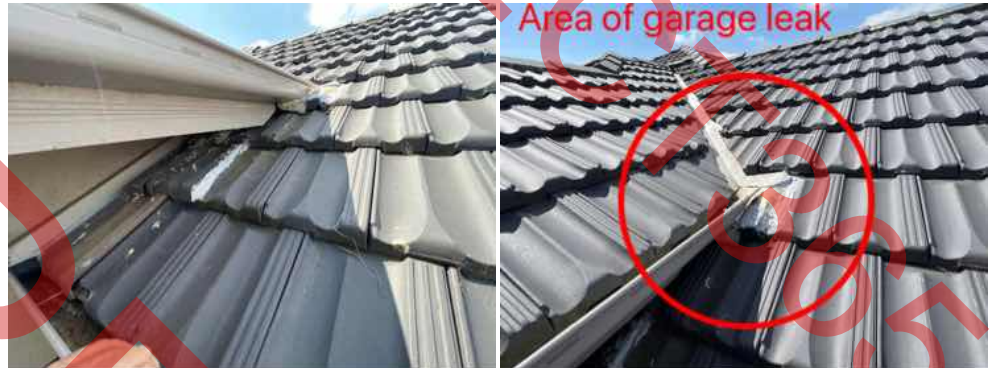
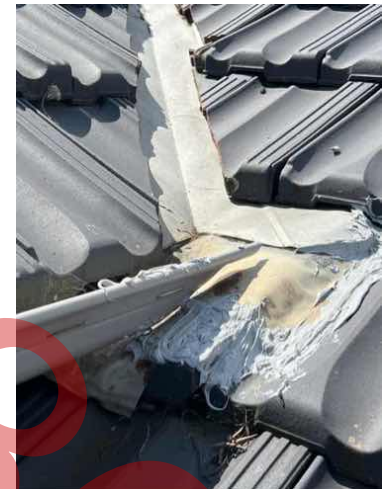
Flashing Conditions

Debris was noted in the valley flashing. This accumulated matter can cause water to overflow the flashing during heavy rain periods. Recommend licensed roof plumber to clean and assess flashing above garage leak to confirm the cause of water ingress

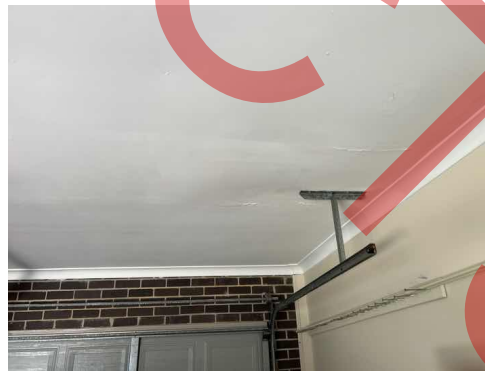
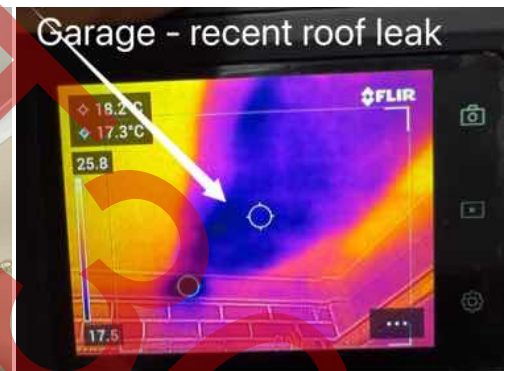
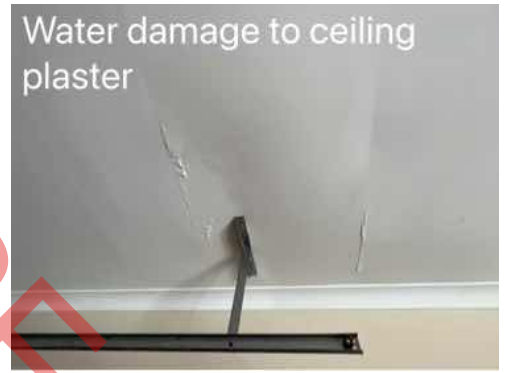
Ceiling stains - Moisture readings obtained - Possibly still active leaking. Recommendations: A qualified plumber should be engaged for advice and recommendations. We strongly recommend that all water damaged plaster replaced by a qualified plasterer due to potential detachment or collapse. Considered a Major Defect and a Safety Hazard

Water damage to ceiling plaster

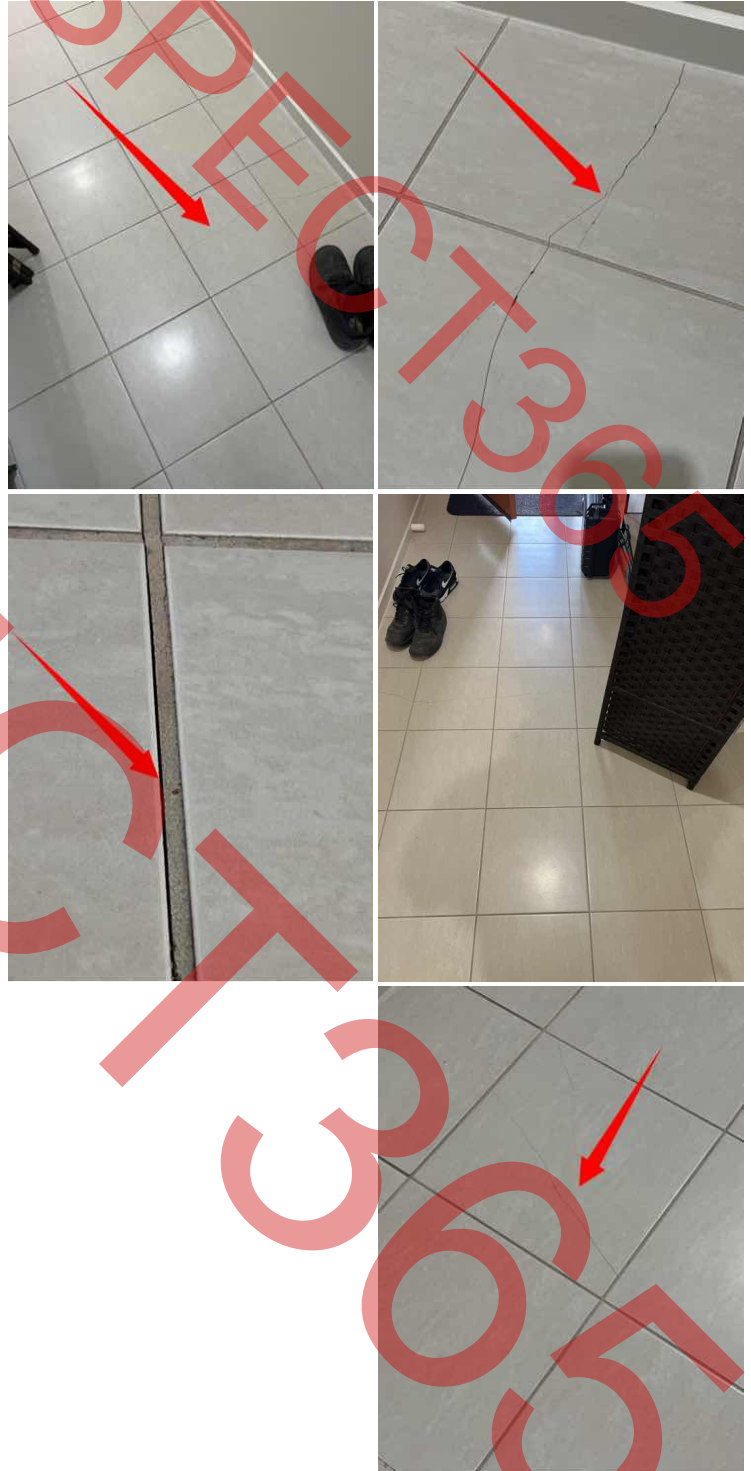
Cracked floor tiles noted - The cracking is typical of movement cracking. Recommendations: A qualified tiler should be engaged for repairs and the installation of control joint /expansion measures - in accordance with the relevant Australian standards.

We recommend a structural engineering investigation and assess should the cause of cracking be required or the cracking continues.

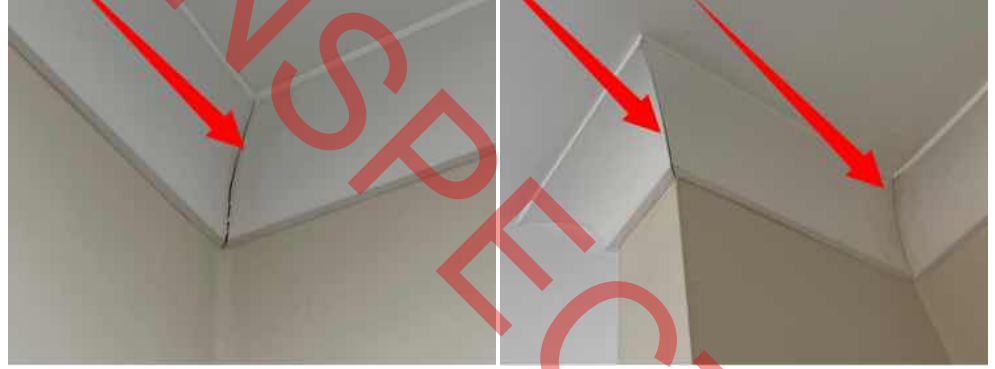
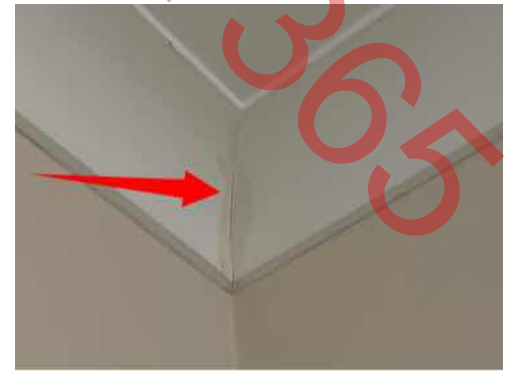
Lounge Room

Cornice separation - I recommend you contact a licensed plasterer for repairs.

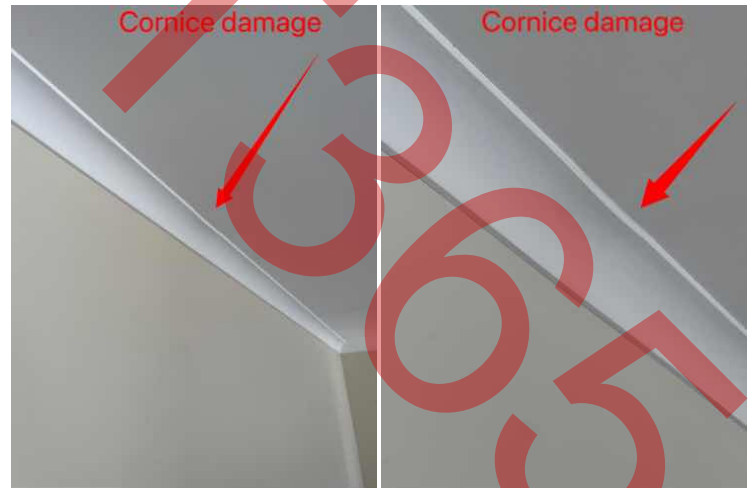
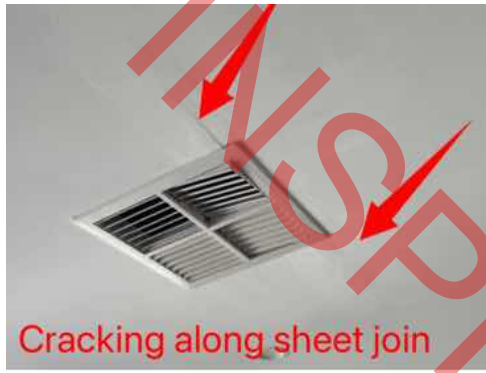
Family Room

Damage was observed to the cove cornice. This damage is consistent with compression from the deflection of the girder truss directly above. Although trusses are designed to deflect under load, we recommend a structural engineering investigation and assess should the damage worsen.

Cracking along sheet joint

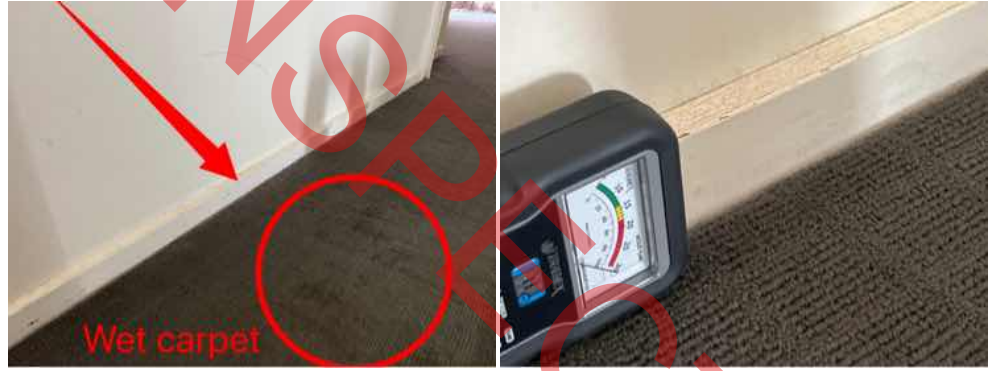
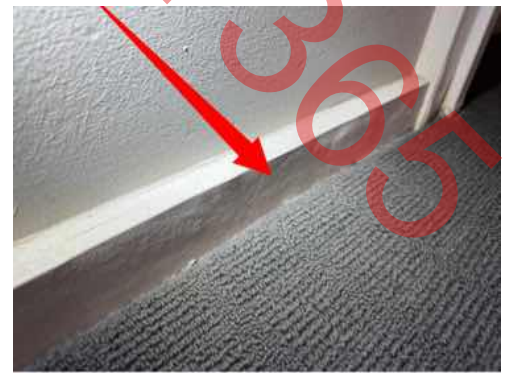
Hallway/passage

Skirting board damage. Possibly bath/shower recess leak related.
 Recommendations: Have bathroom/shower assessed by a leak detection plumber for leaks and maintenance. Replace skirting boards as required by qualified trades

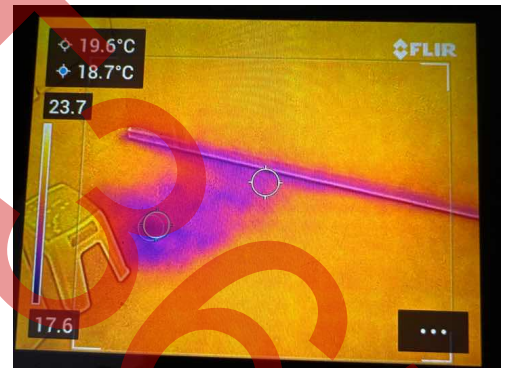
Flooring

Elevated moisture was detected to the carpet adjoining the shower wall. Suspected shower leak. Recommend leak detection to confirm cause of leak.

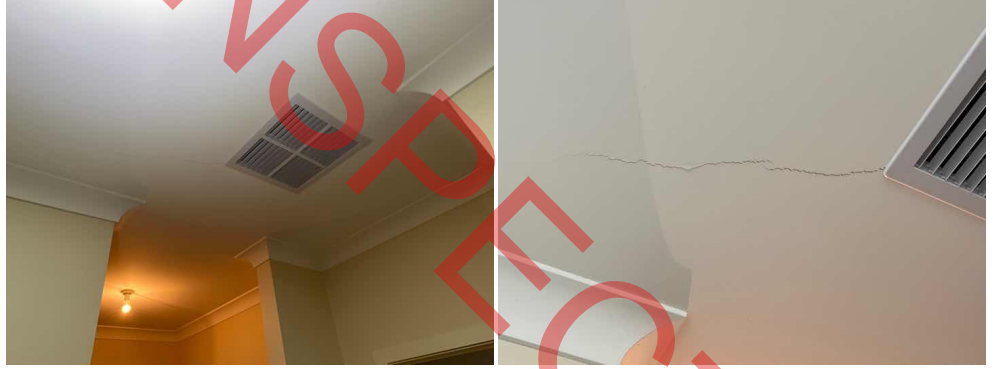
Bedroom 1

Settlement Cracks Noted . These are typical and generally patch and paint will suffice, however Monitoring these cracks advised for 12 months and if become wider or longer, you will need to contact a structural engineers to assess.

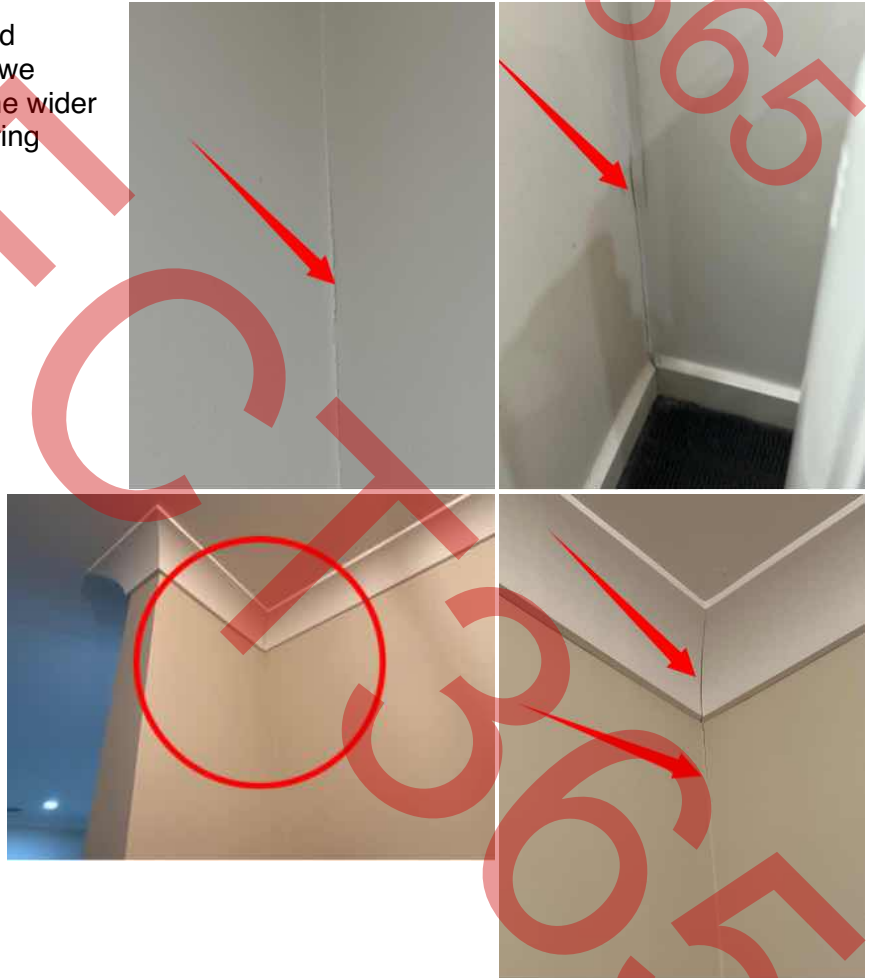
Settlement Cracks Noted. These are typical and generally patch and paint will suffice, however we recommend monitor these cracks and if become wider or longer, we recommend a structural engineering investigation and assessment.

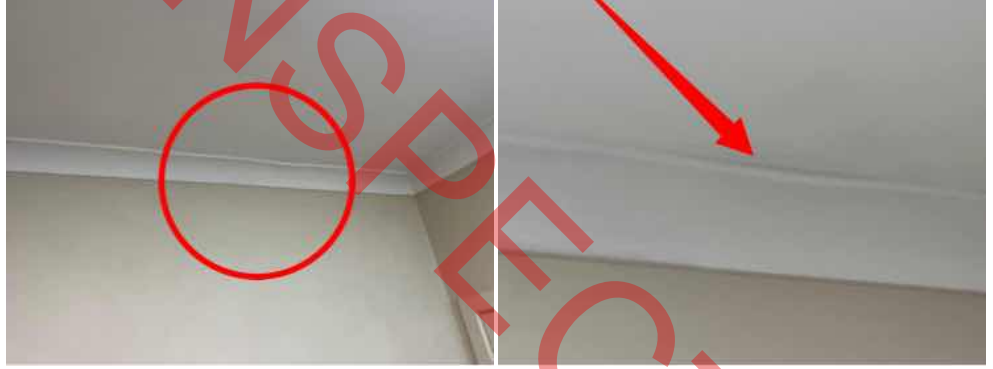
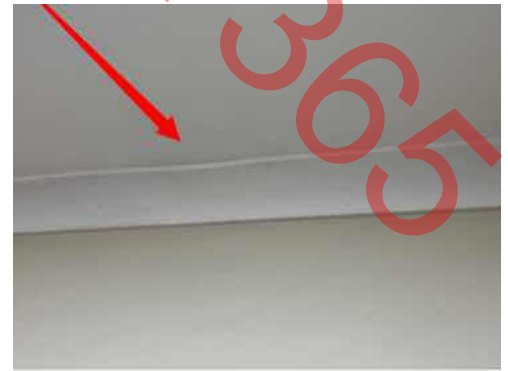
Bedroom 2

Damage was observed to the cove cornice. This damage is consistent with compression from the deflection of the girder truss directly above. Although trusses are designed to deflect under load, we recommend a structural engineering investigation and assess should the damage worsen.

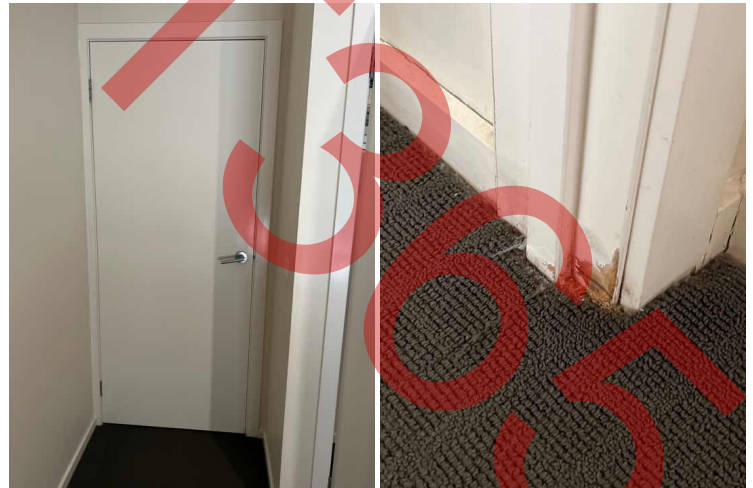
Bedroom 3

The door frame was water damaged. Suspected leak from shower due to the close proximity. Recommend leak detection to confirm cause of leak. Carpenter/ painter required for repairs.

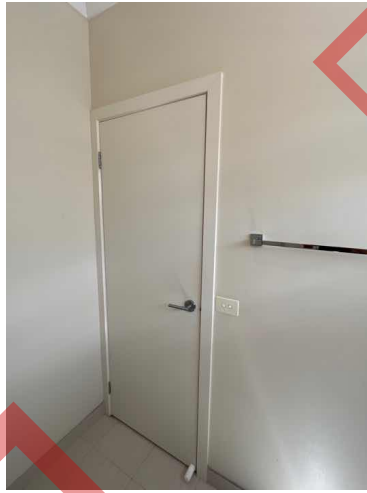
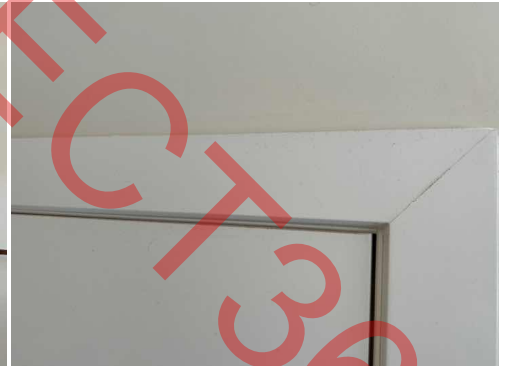
Uneven / out of square door frame - This can relate to some differential settlement in the footings, frame movement, age, expansion, shrinkage and the like. Recommendations: A qualified carpenter should be engaged for advice and recommendations.

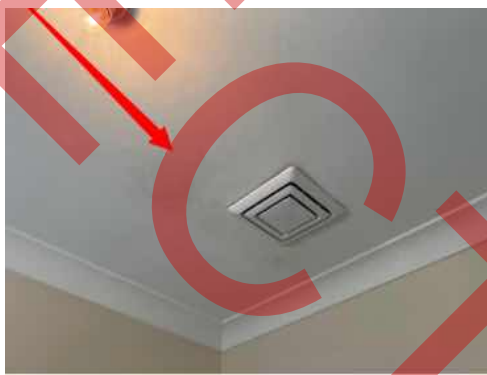
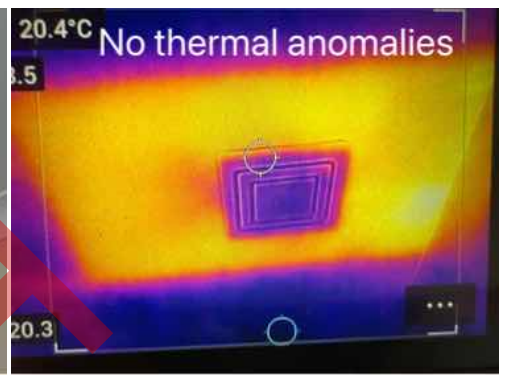
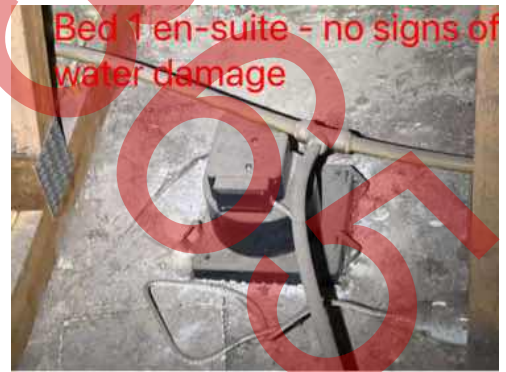
Mould spores noted to ceiling. This is a health hazard. See ventilation section

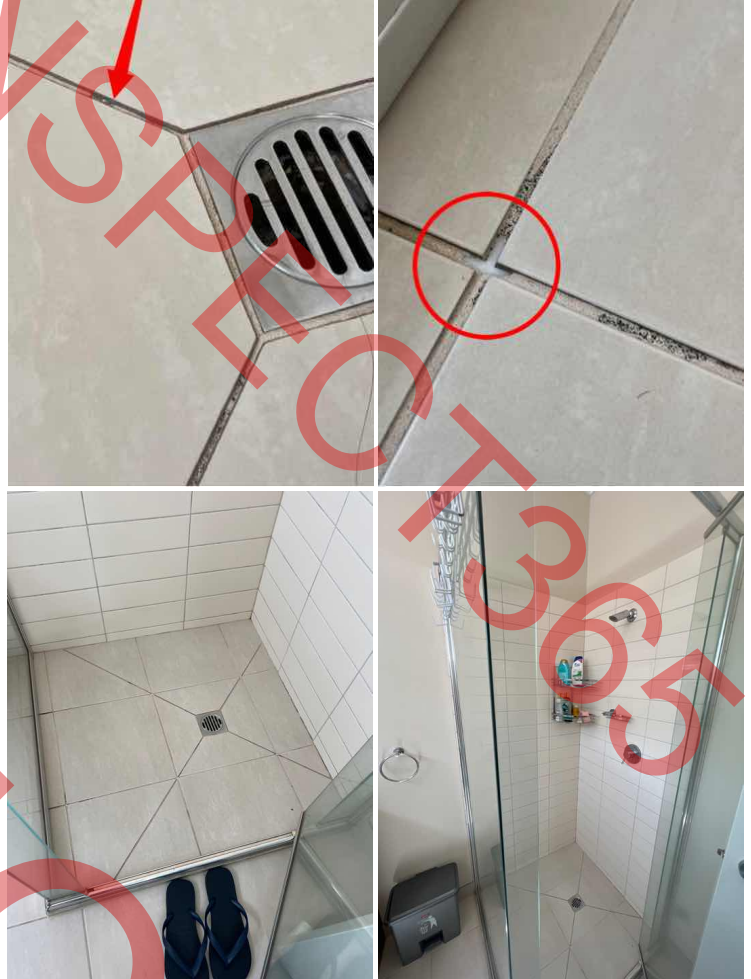
Tile grout deterioration. Re-grout / seal the shower tiles and screen junctions. A qualified tiler or leak seal specialist should be engaged for advice and recommendations.

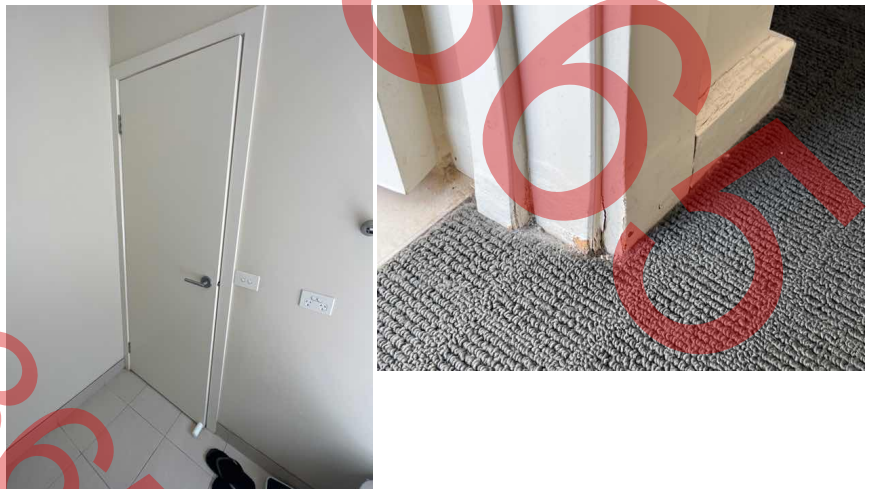
Binding entry door - Doors that bind on the frame can relate to some differential settlement, frame movement, age, expansion, shrinkage or poor hanging. A qualified carpenter should be engaged for repairs.

The door frame was water damaged. Suspected leak from shower due to the proximity. Recommend leak detection to confirm cause of leak. Carpenter/painter required for repairs upon rectification of the leak.

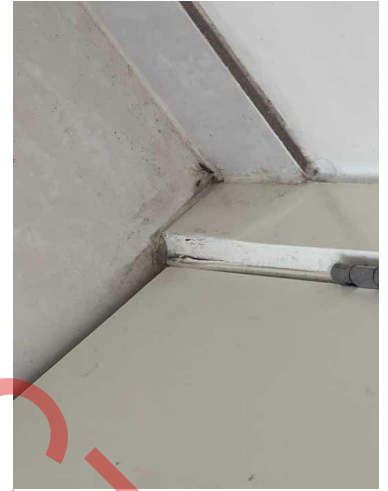
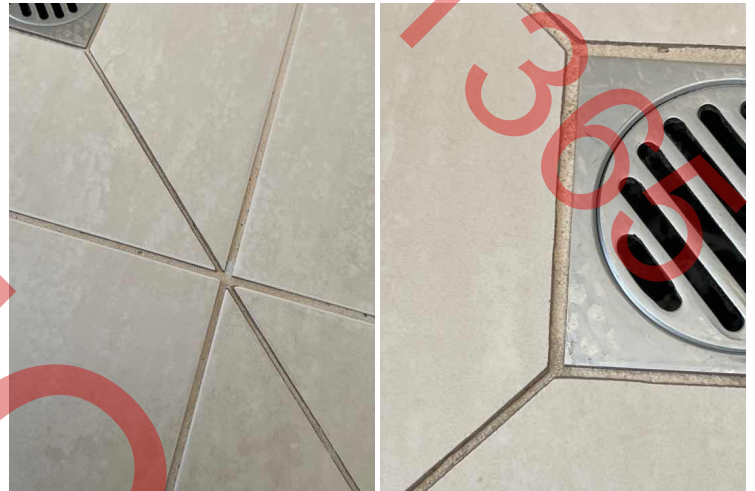
Tile grout deterioration. Re-grout / seal the shower tiles and screen junctions. A qualified plumber should be engaged for advice and recommendations.

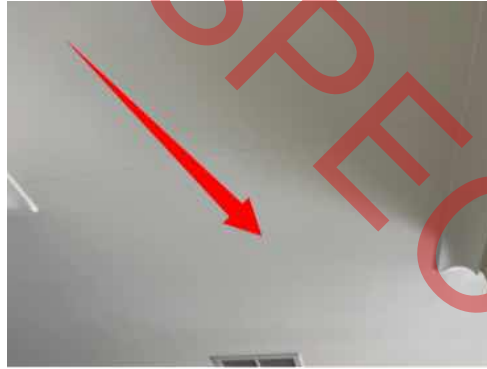
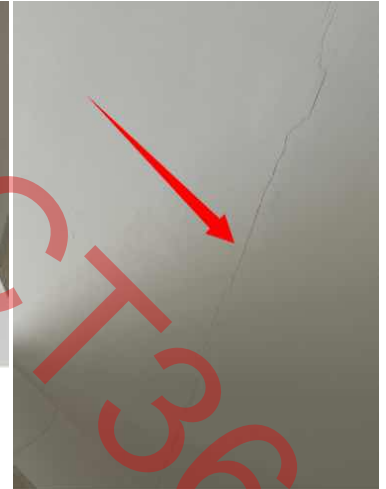
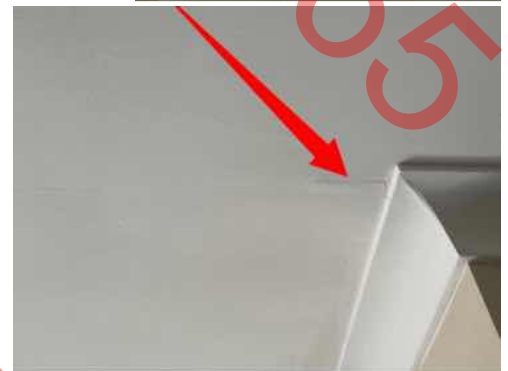
Settlement Cracks Noted . These are typical and generally patch and paint will suffice, however Monitoring these cracks advised for 12 months and if become wider or longer, you will need to contact a structural engineers to assess.

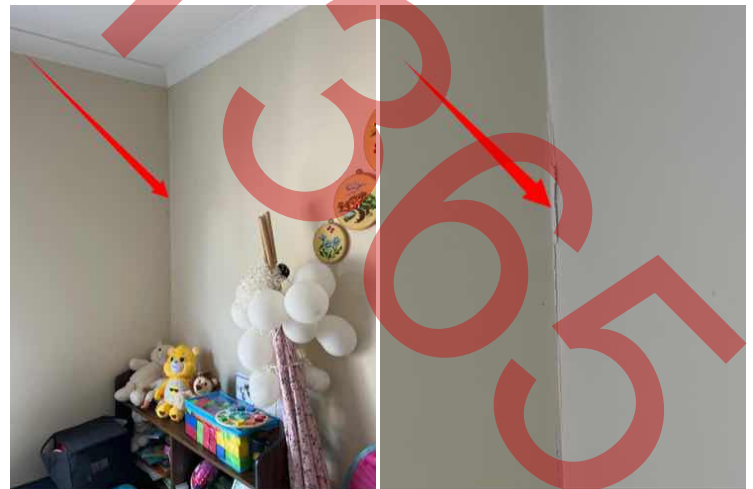
Settlement Cracks Noted . These are typical and generally patch and paint will suffice, however Monitoring these cracks advised for 12 months and if become wider or longer, you will need to contact a structural engineers to assess.
