Building & Timber Pest Inspection Report

Inspect365

Sample St, Melbourne , VIC, 3000

Report/Agreement # 220124021820381
Inspection Date: 22 Jan 2024
Inspection Time: 02:18 pm

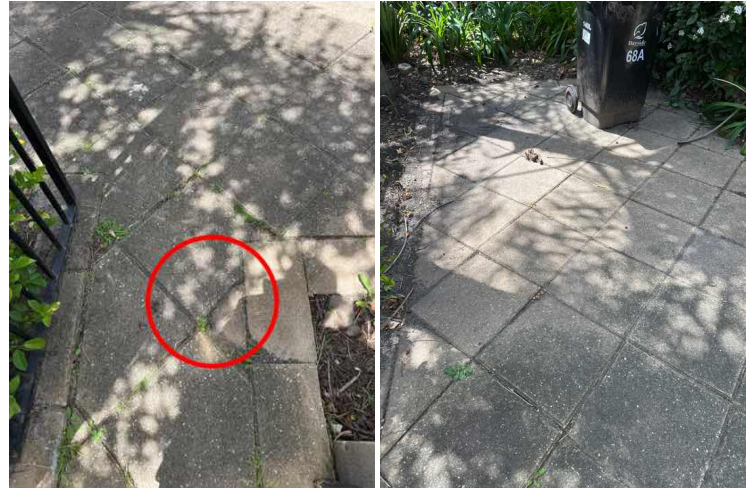
Pathways Condition

Surface raised and settled in some areas. This can cause water ponding. Relaying recommended.

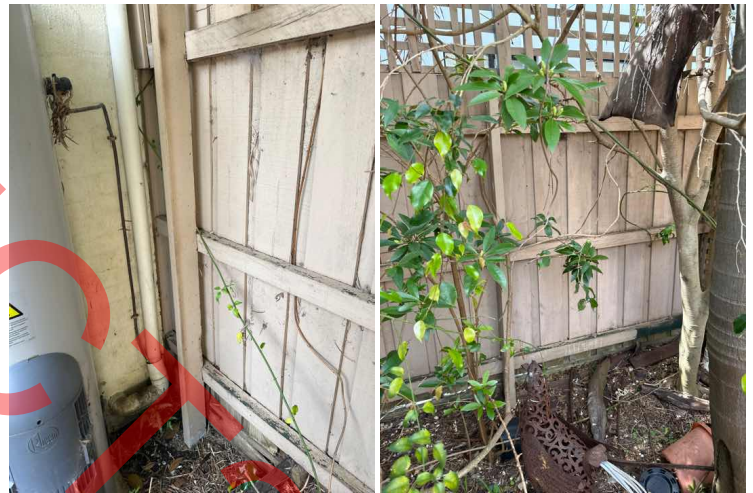
Fences & Gates

Fence rot/leaning - Recommendations: Repairs are required by fencing contractor to avoid unsafe conditions. Considered a Safety hazard

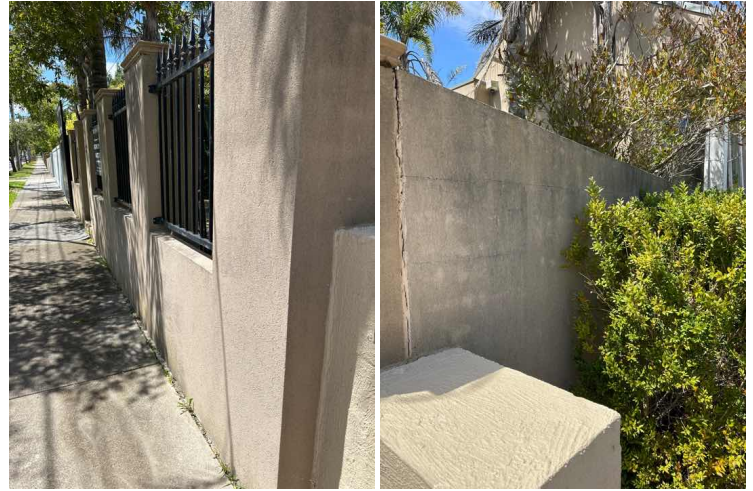
Retaining wall cracking - Recommendations:
A qualified brick layer should be engaged for
advice and recommendations.

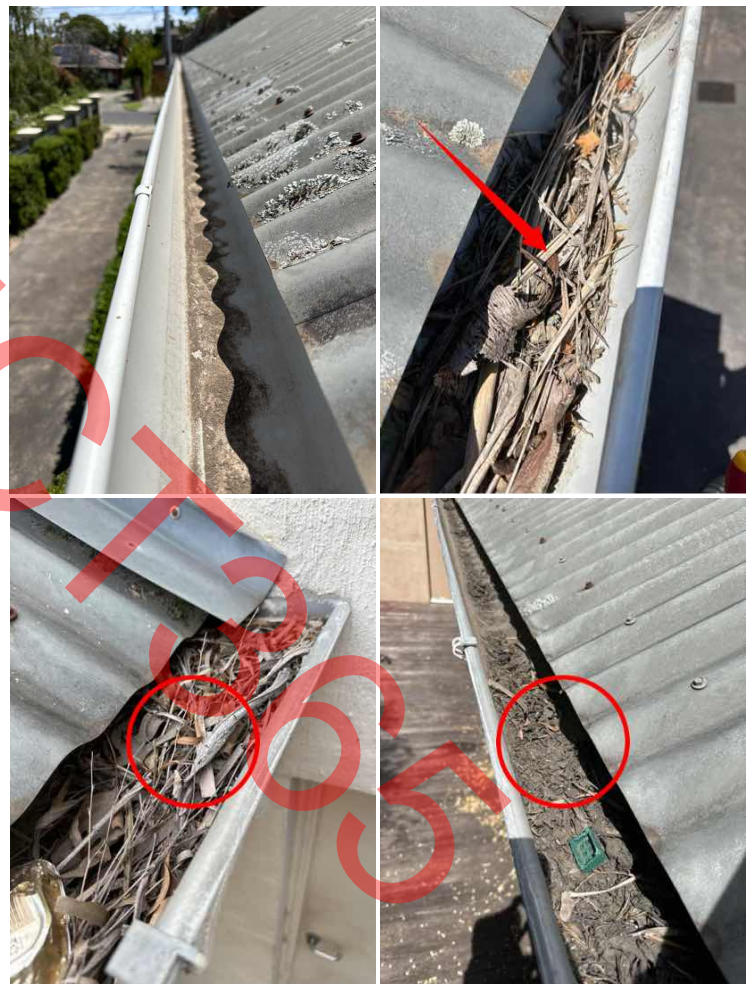
Debris in guttering areas- this requires cleaning out to prevent blocking of down pipes and leaking into eaves and fascia. Recommendations: Have gutters cleaned and assessed by a plumber for adequate fall. Also regularly clean to prevent ponding. Ponding water will contribute to rust.

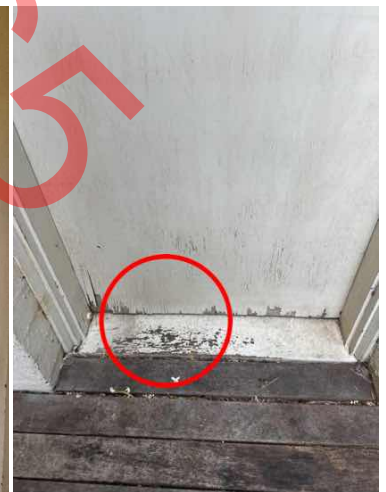
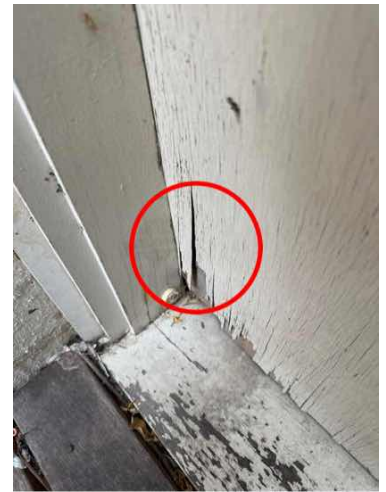
The laundry door is weathered and deteriorated. Repair or replacement recommended

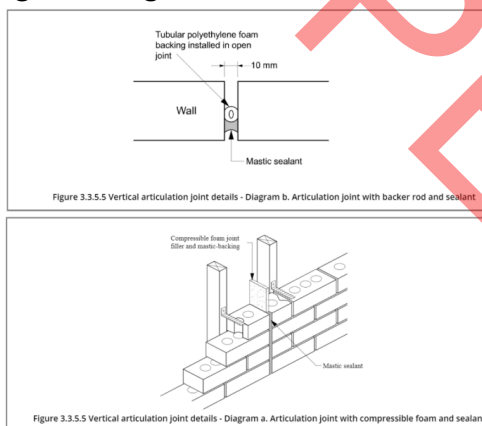
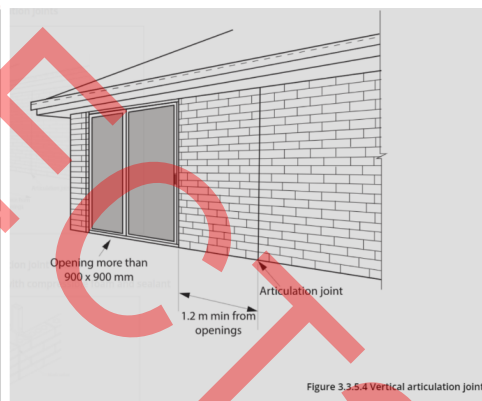
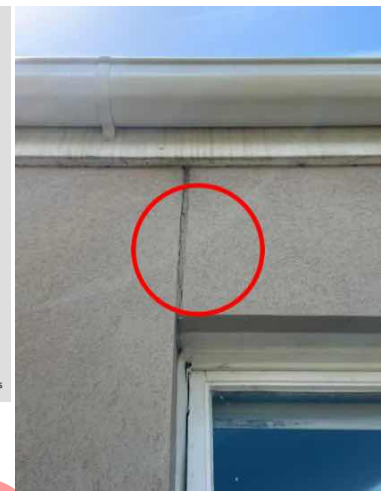
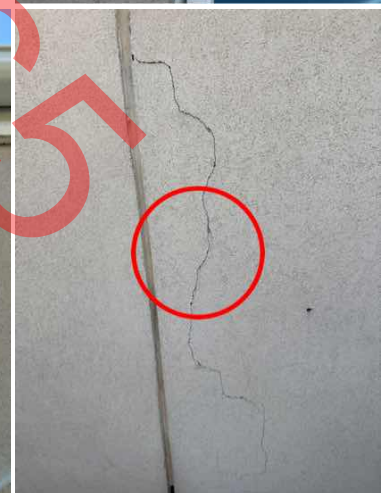
There appears to have been some settlement in the building which has caused some cracking to the walls. These cracks are categorized as 0 to 2. This can also cause some doors to bind or be out of square. In the inspectors opinion these cracks are due to settlement, usually due to ground movement and subsequent movement to building materials can be expected. Any cracks should be monitored and if cracks increase in size.

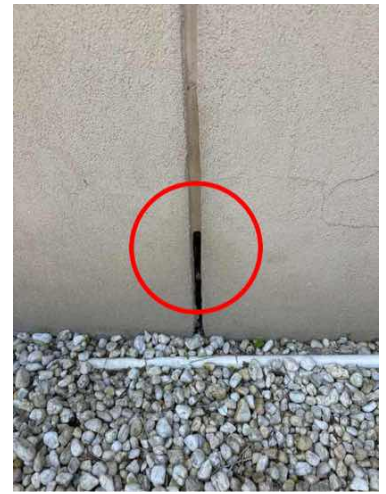
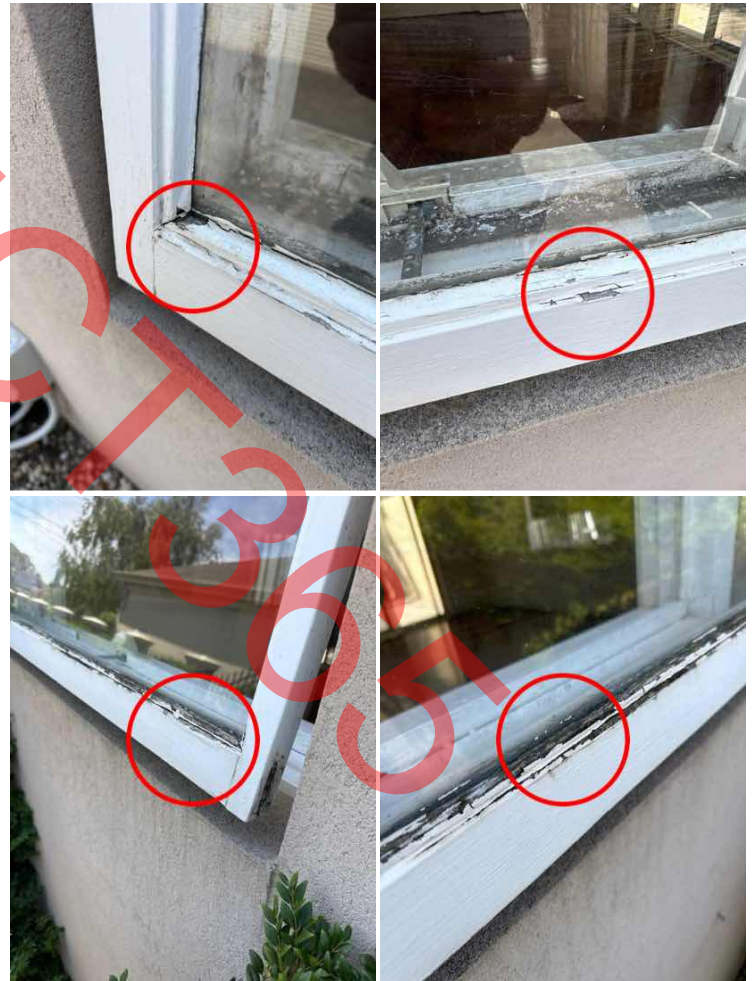
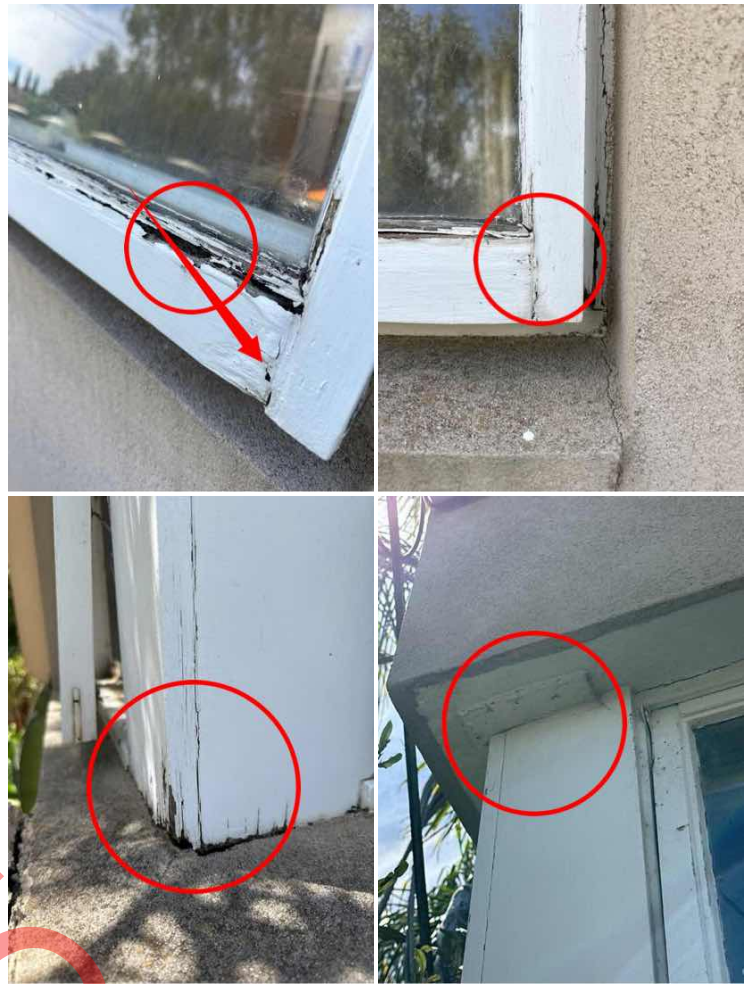
Exterior Windows

Timber fungal decay is evident in sections of the window framework - All affected areas should be replaced. Recommendations: A qualified carpenter should be engaged for advice and recommendations.

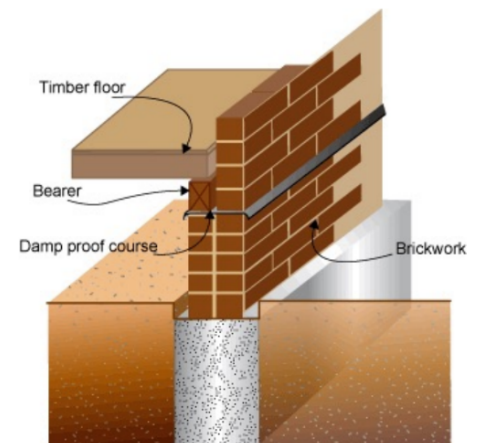
Damp Proof Course

A damp proof course is not visible or could not be visually identified. This may cause rising damp issues. Contact a damp proof course specialist to further investigate and make recommendation.

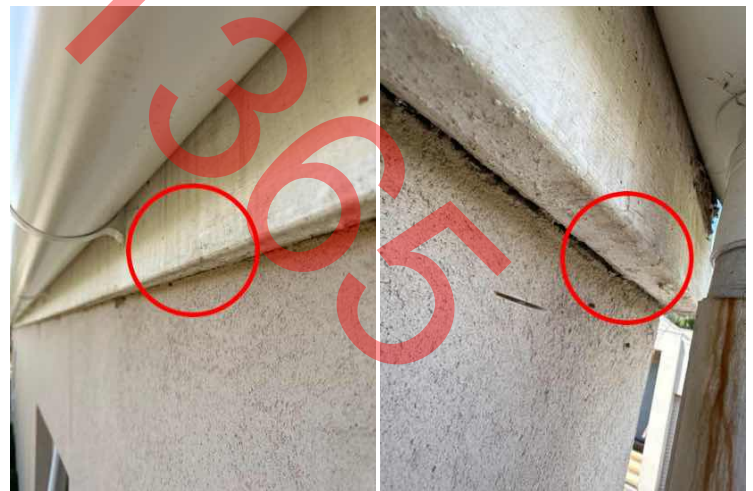
Fascia and Barge Boards

Paint / finish was deteriorated in areas and is in need of maintenance - Sanding back affected areas and painting required.

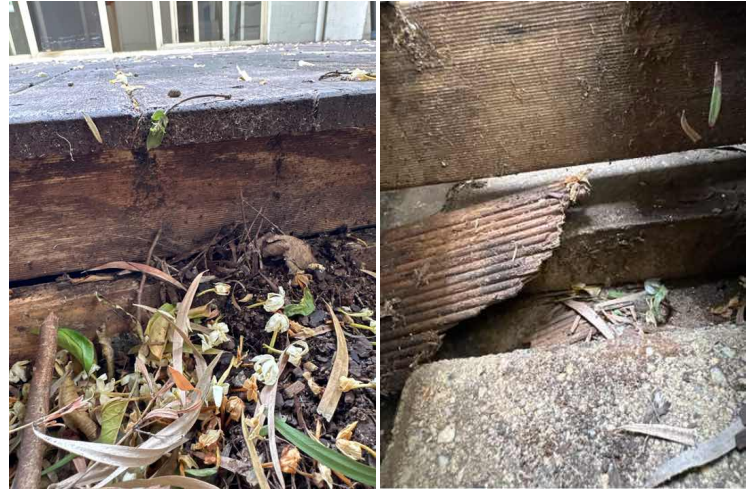
Post base timber fungal decay - The pergola posts had timber fungal decay (rot) on the base and were unstable. Recommendations: This is a safety concern and repairs required by a carpenter. It is preferable to keep posts out of contact with ground soil due to decay and also being conducive to timber pest infestation.

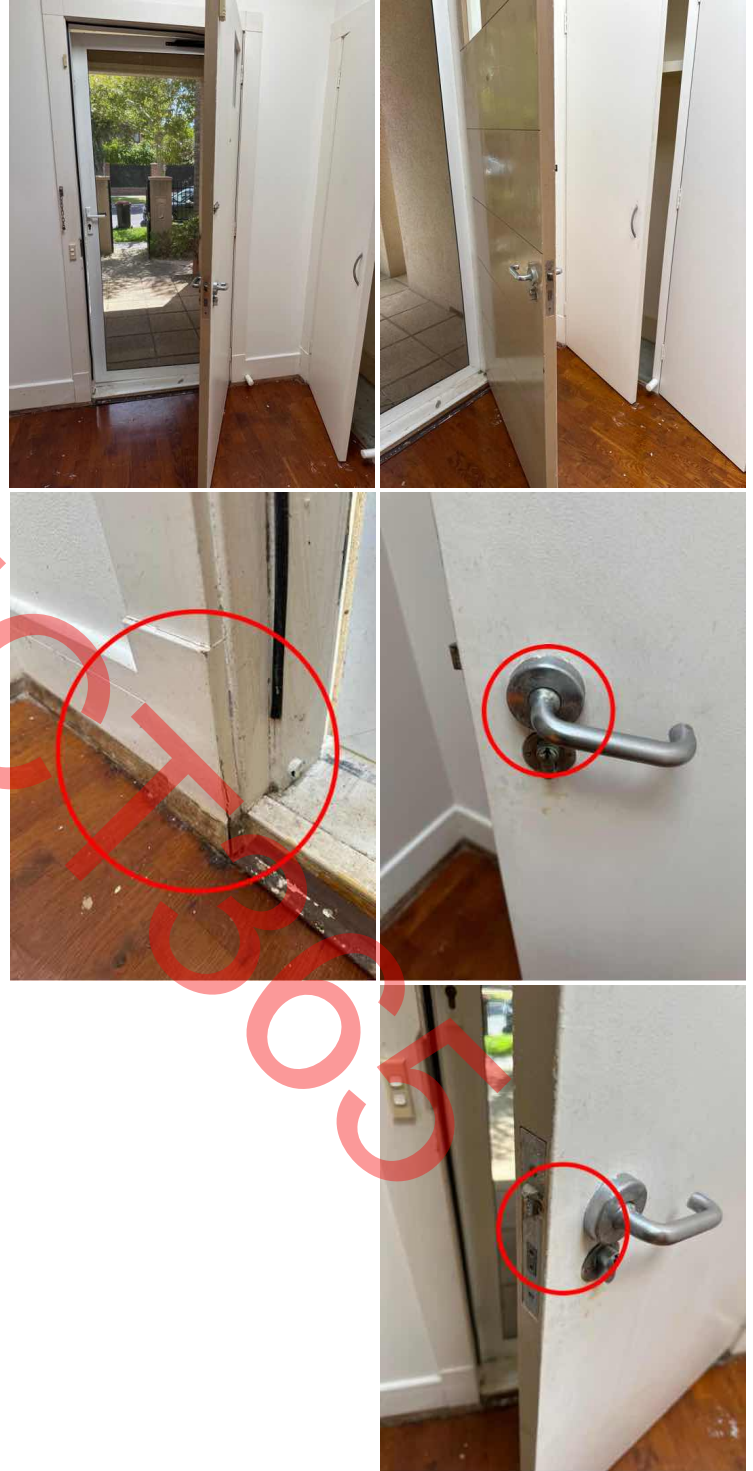
The entry door lock was damaged/deteriorated - Recommendations: A locksmith should be engaged for advice and recommendations.

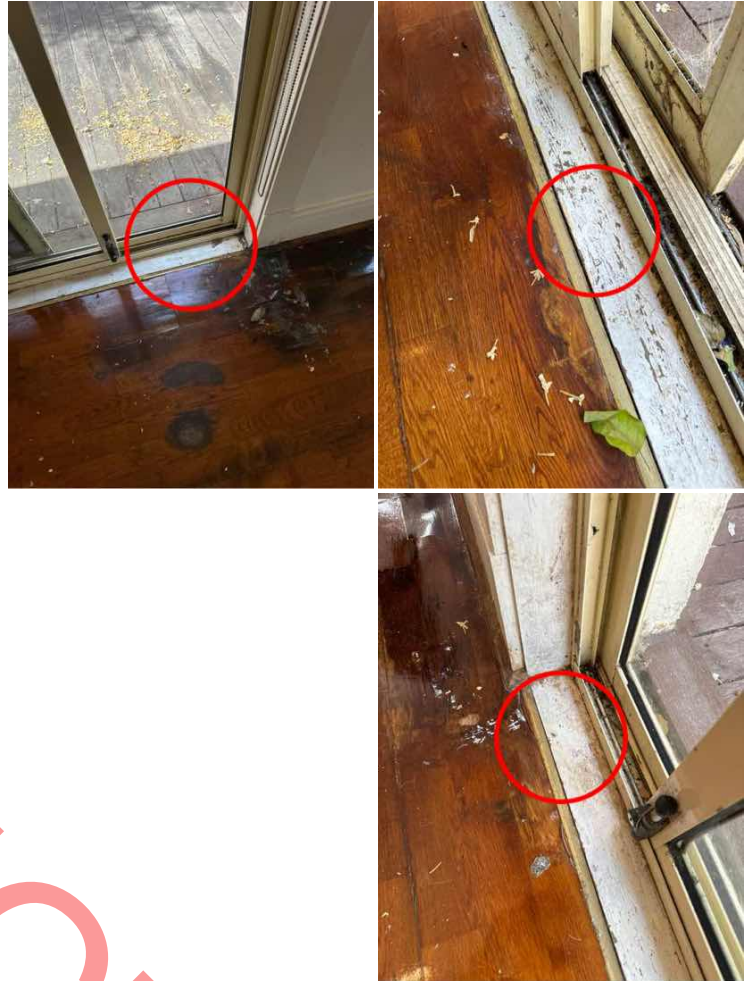
Other Doors

Rear door / frame deterioration - General age/damage has occurred to door frame, face or components.
Recommendations: A qualified carpenter should be engaged for advice and recommendations.

Damp damage to door/frame. Replacement recommended.

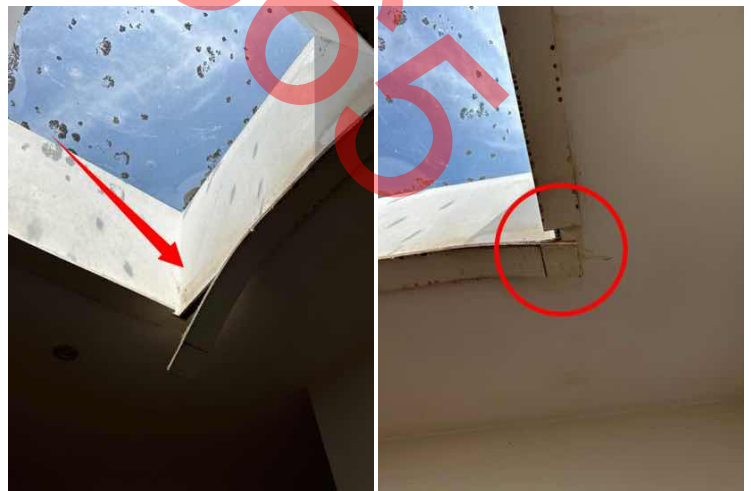
Ceiling stains - Moisture readings obtained. In the absence of rain It's difficult to ascertain with certainty the location of the leak. Recommendations: A qualified roofer should be engaged for advice and recommendations. All water damaged plaster should be replaced by a qualified plasterer.

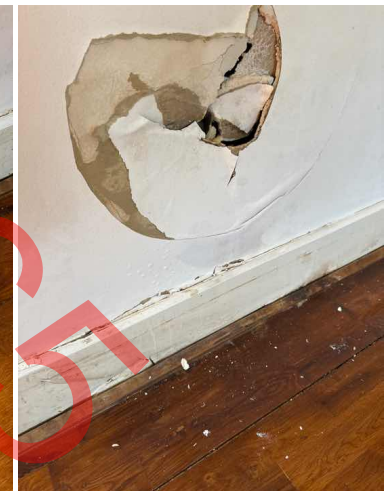
Skirting board damage. Possibly bath/shower recess leak related. Recommendations: Have bathroom/shower assessed by a plumber for leaks and maintenance / replace skirting boards as required.

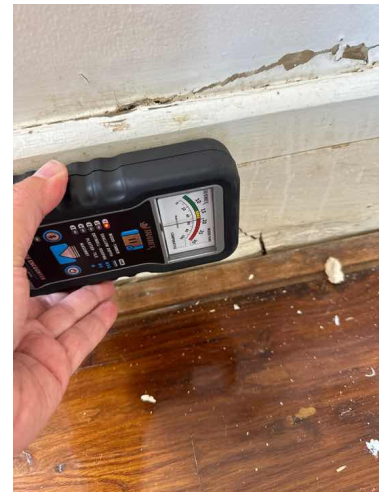
Flooring

Stained timber flooring - This is normally due some water penetration. This will not be able to be removed and options include replacement, staining all the boards dark or lining same to cover. Recommendations: A qualified carpenter should be engaged for advice and recommendations.

Skirt Moisture Damage/Swelling observed.
Replacement recommended.

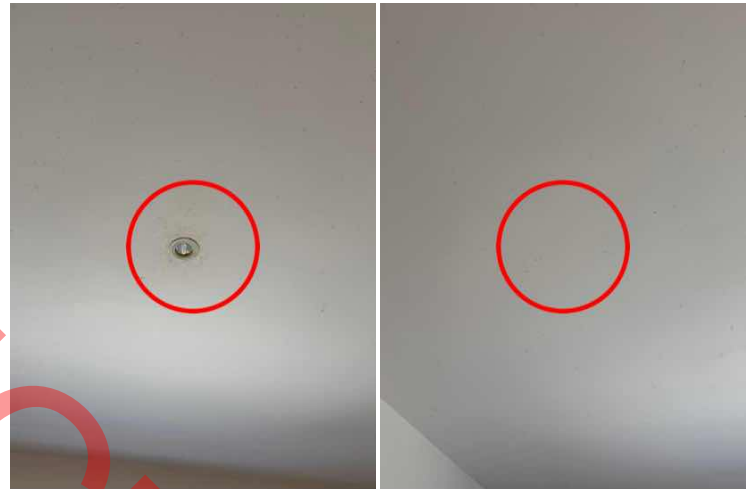
Mould growth noted . Due to health risks we strongly recommend that a expert in the field of mould treatment be engaged for further advise and recommendations

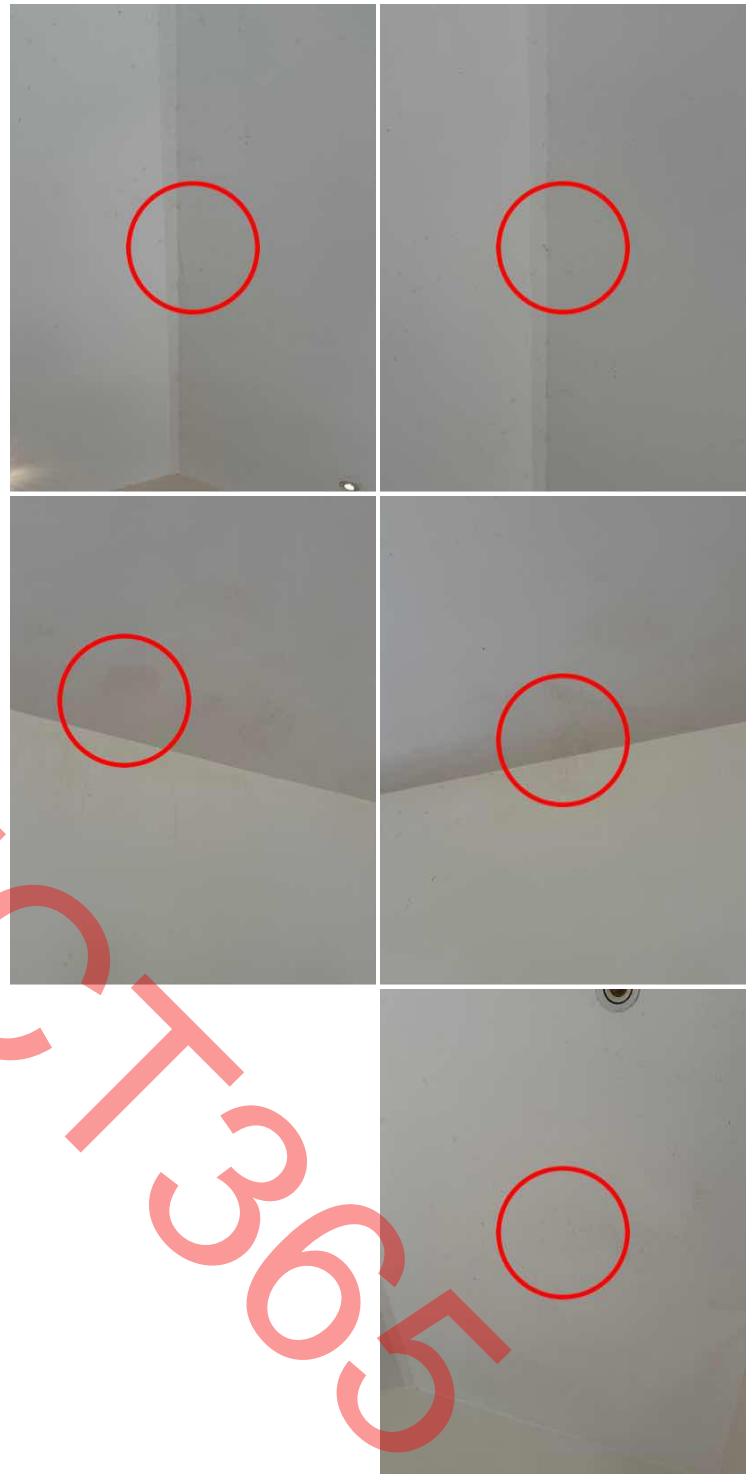
Mould growth noted . Due to health risks we strongly recommend that a expert in the field of mould treatment be engaged for further advise and recommendations

Ceiling paint flake/deterioration is evident.
Recommendations: General maintenance / painting as required.

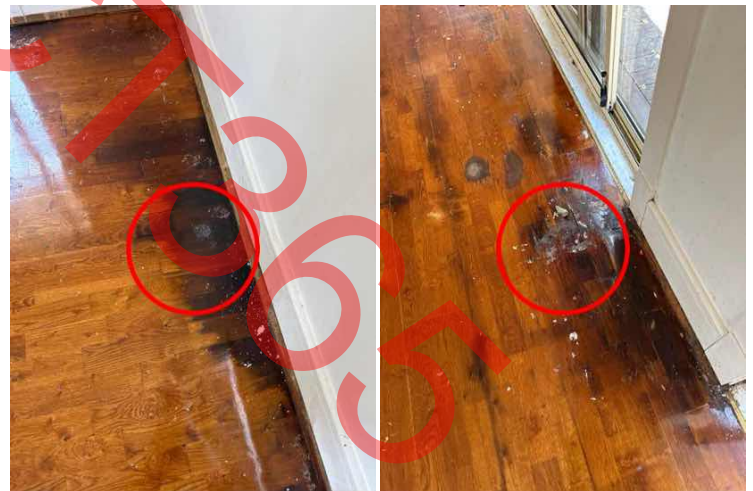
Flooring

Stained timber flooring - This is normally due some water penetration. This will not be able to be removed and options include replacement, staining all the boards dark or lining same to cover. Recommendations: A qualified carpenter should be engaged for advice and recommendations.

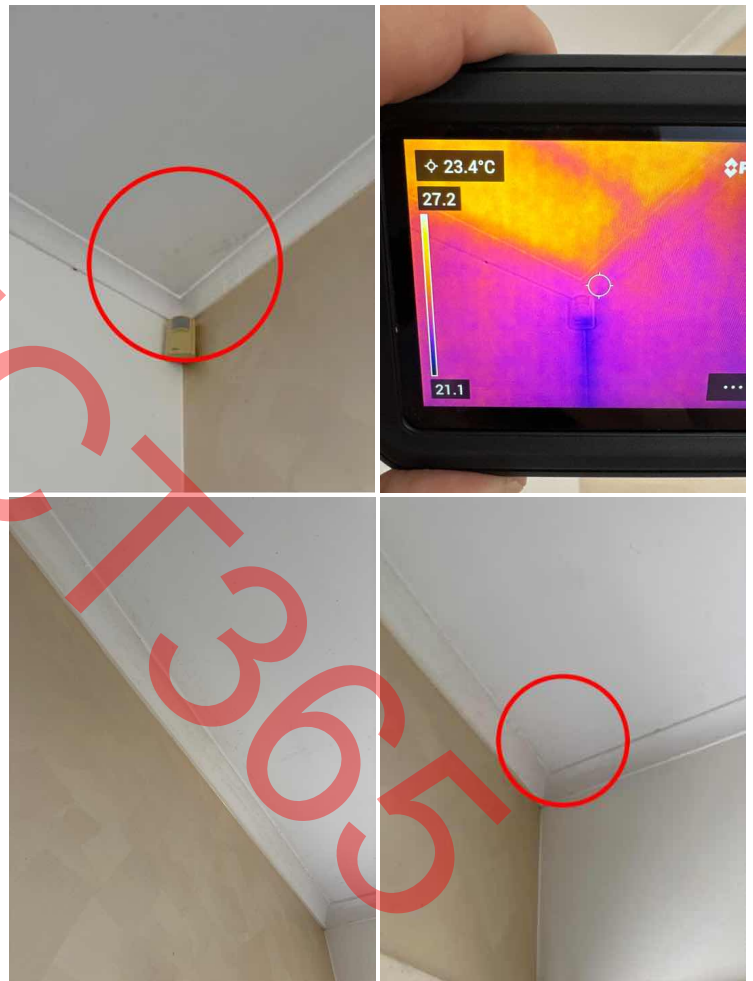
Ceiling stains - Moisture readings obtained. In the absence of rain It's difficult to ascertain with certainty the location of the leak. Recommendations: A qualified roofer should be engaged for advice and recommendations. All water damaged plaster should be replaced by a qualified plasterer.

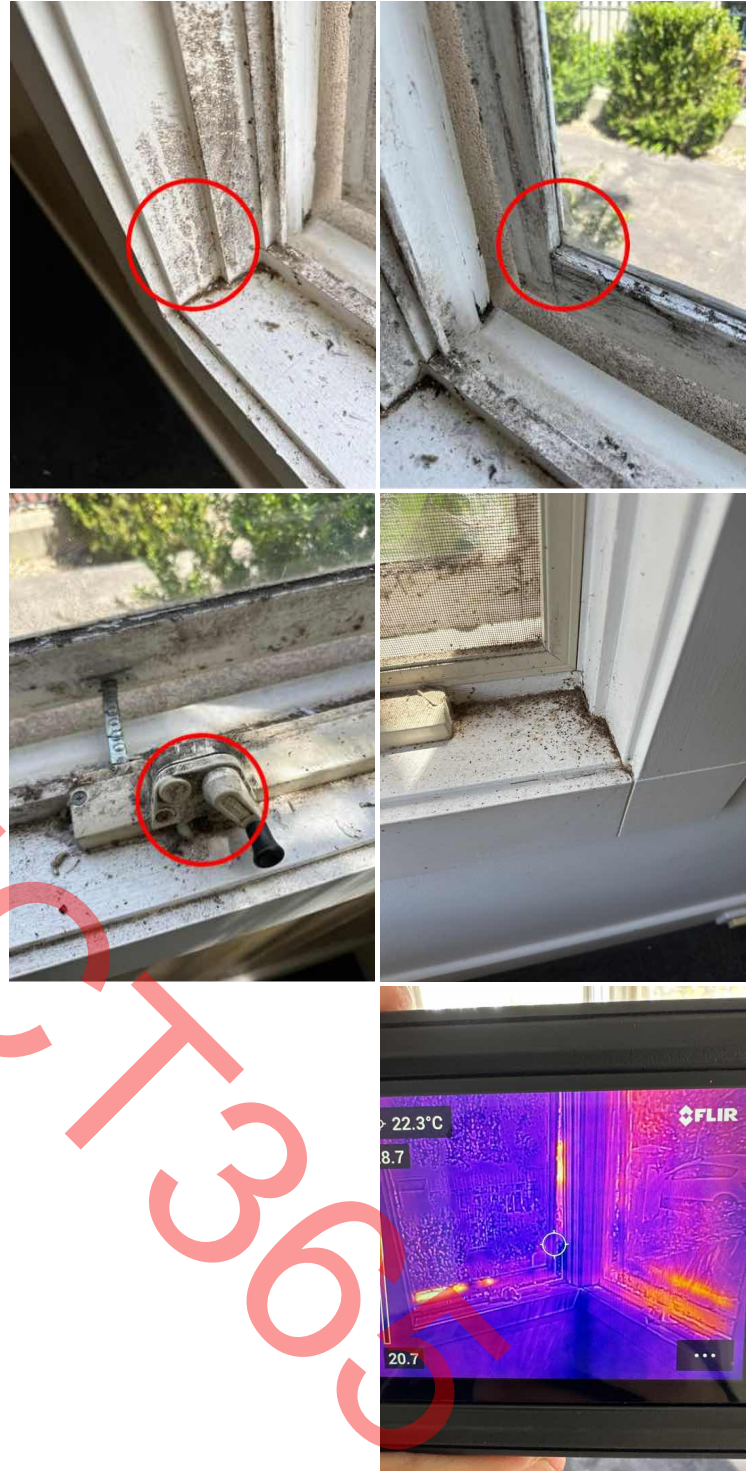
Timber fungal decay on window frames.
Recommendations: A qualified carpenter should be engaged for advice and recommendations.

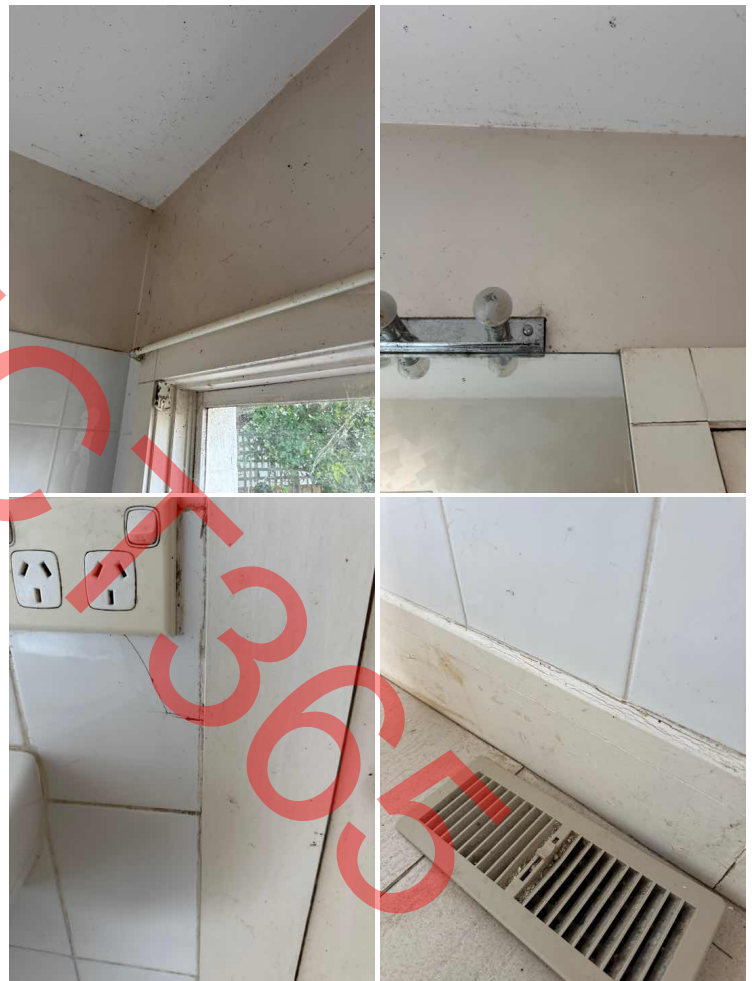
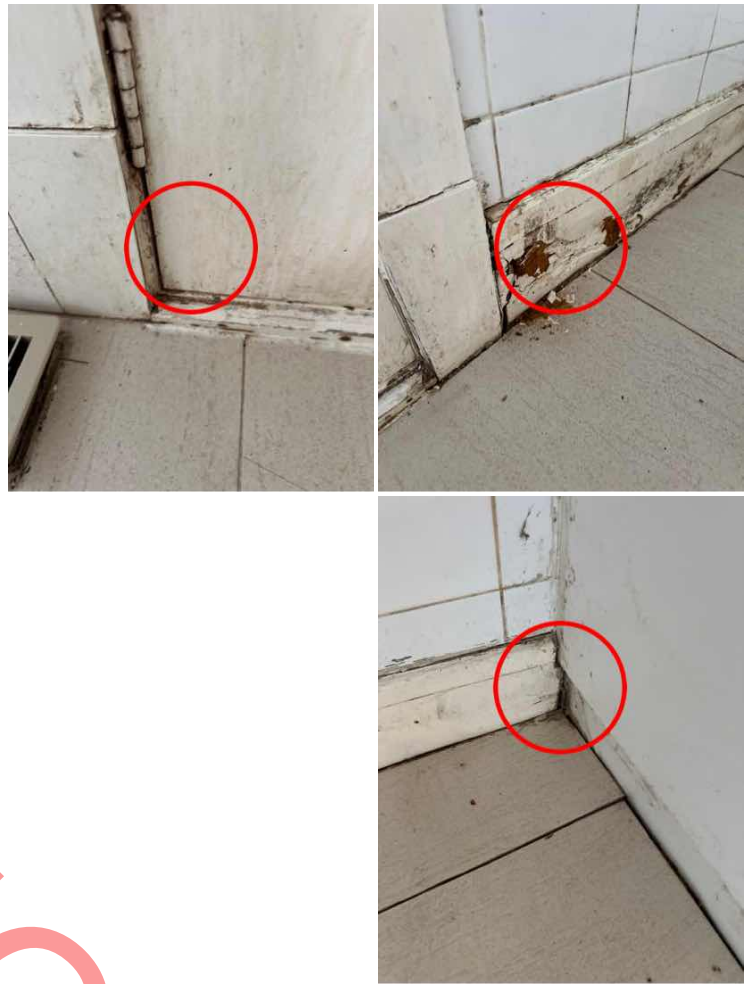
Suspect waterproofing membrane failure. Contact a licensed water proffer for repairs and advice. Note generally re-instating a water proof membrane to a wet area requires the tiles to be removed. This may prove to be costly.

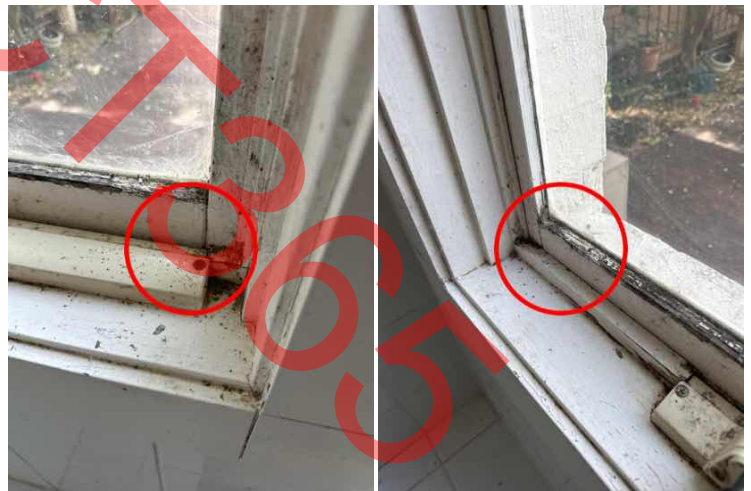
Window

Timber fungal decay on window frames.
Recommendations: A qualified carpenter should be engaged for advice and recommendations.

Mould spores noted to this area. This is a health hazard. See ventilation section

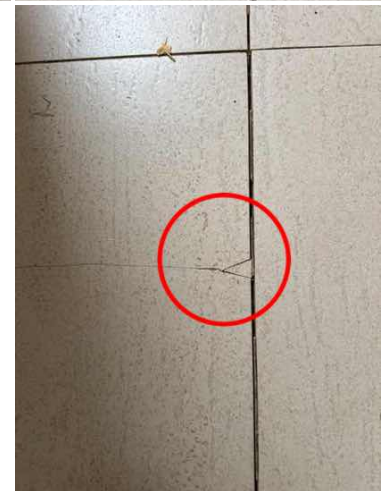
There are loose/delaminating tiles. As this is a wet area these should be repaired as soon as possible by a licensed tiler and waterproofing specialist.

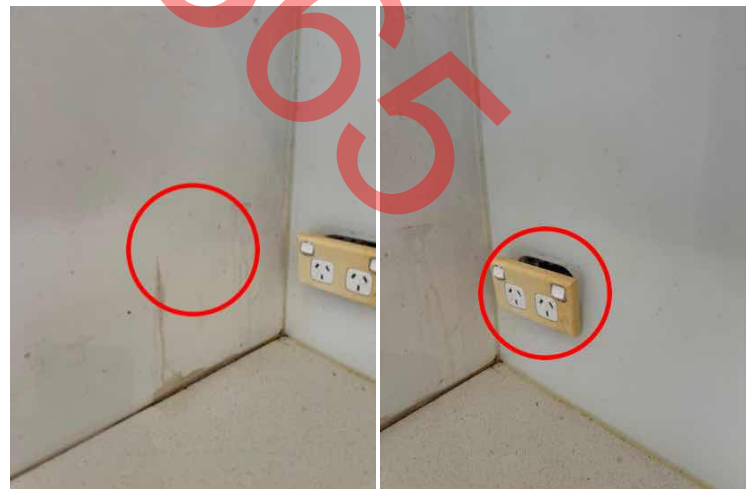
Settlement Cracks Noted . These are typical and generally patch and paint will suffice, however Monitoring these cracks advised for 12 months and if become wider or longer, you will need to contact a structural engineers to assess.
