# Frame Stage Inspection Report

**Sample, Truganina, VIC, 3029**

071223023312242

07 Dec 2023

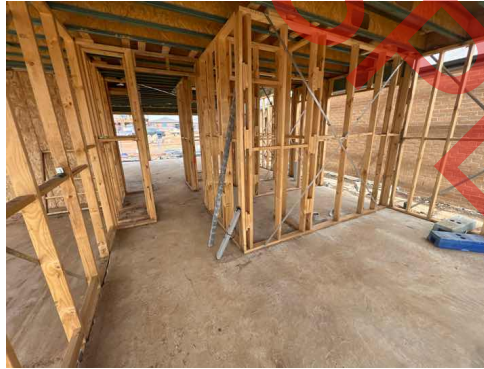
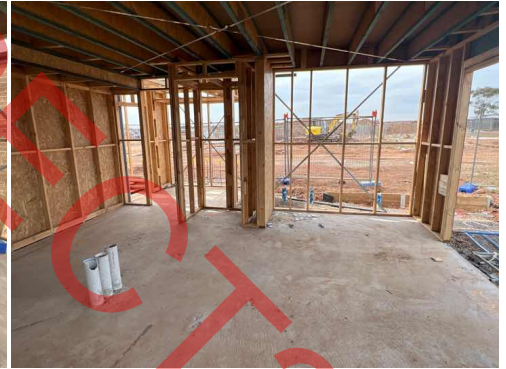
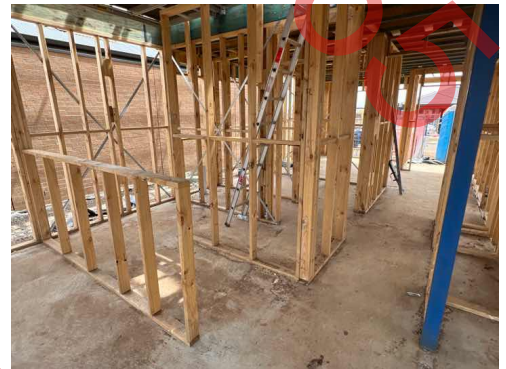
#### Layout/Setout

The layout conforms with the plans provided.

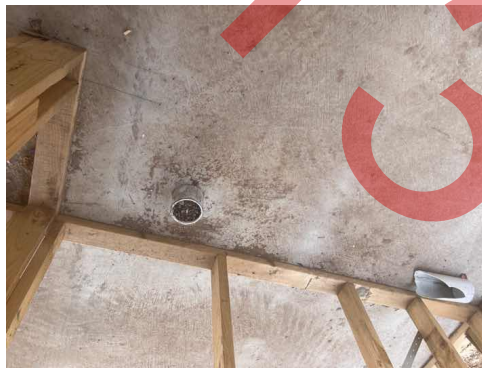
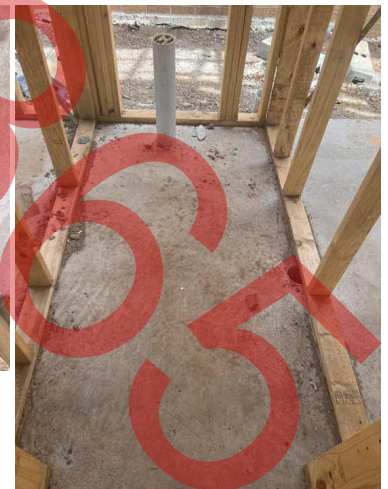
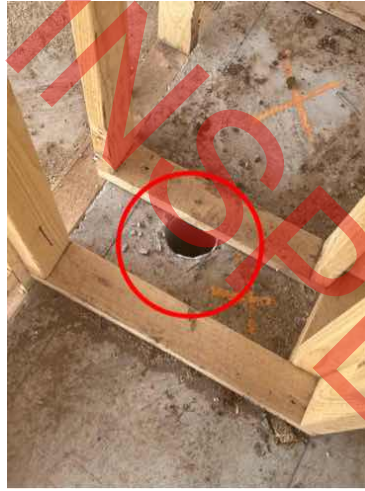
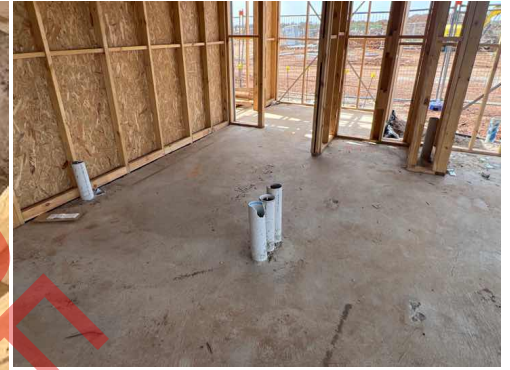
#### Service Pipes

The service pipes to the first floor are not yet installed, however this is carried out at plumbing rough-in.

The installation will be checked at the pre-plaster stage.

Generally conforms with supplied plans at the time of inspection.

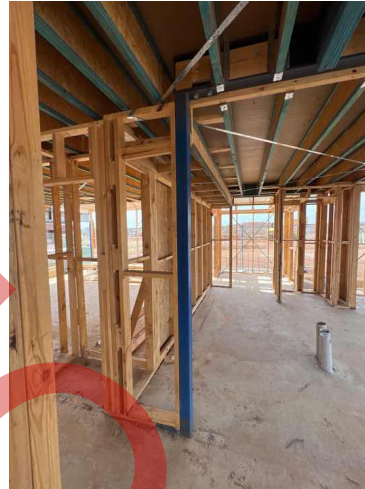
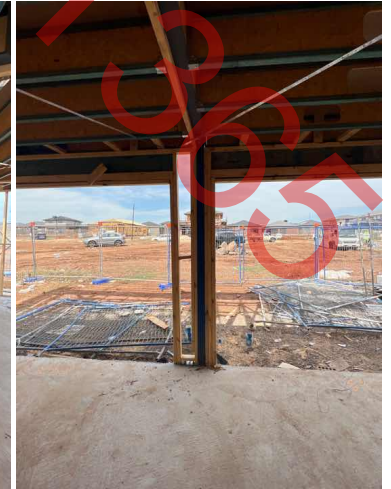
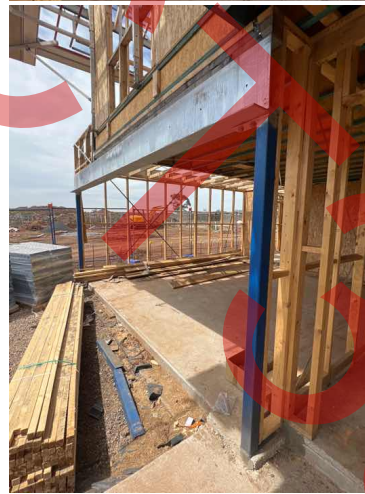
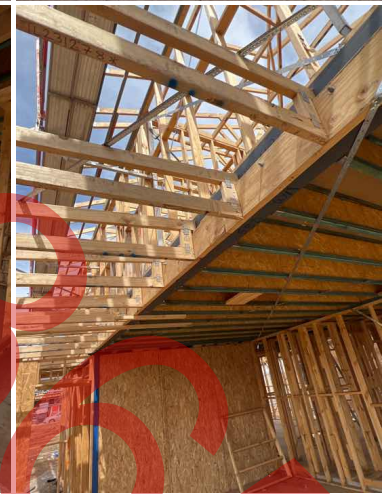
## Structural Steel

Generally conforms with supplied plans at the time of inspection.

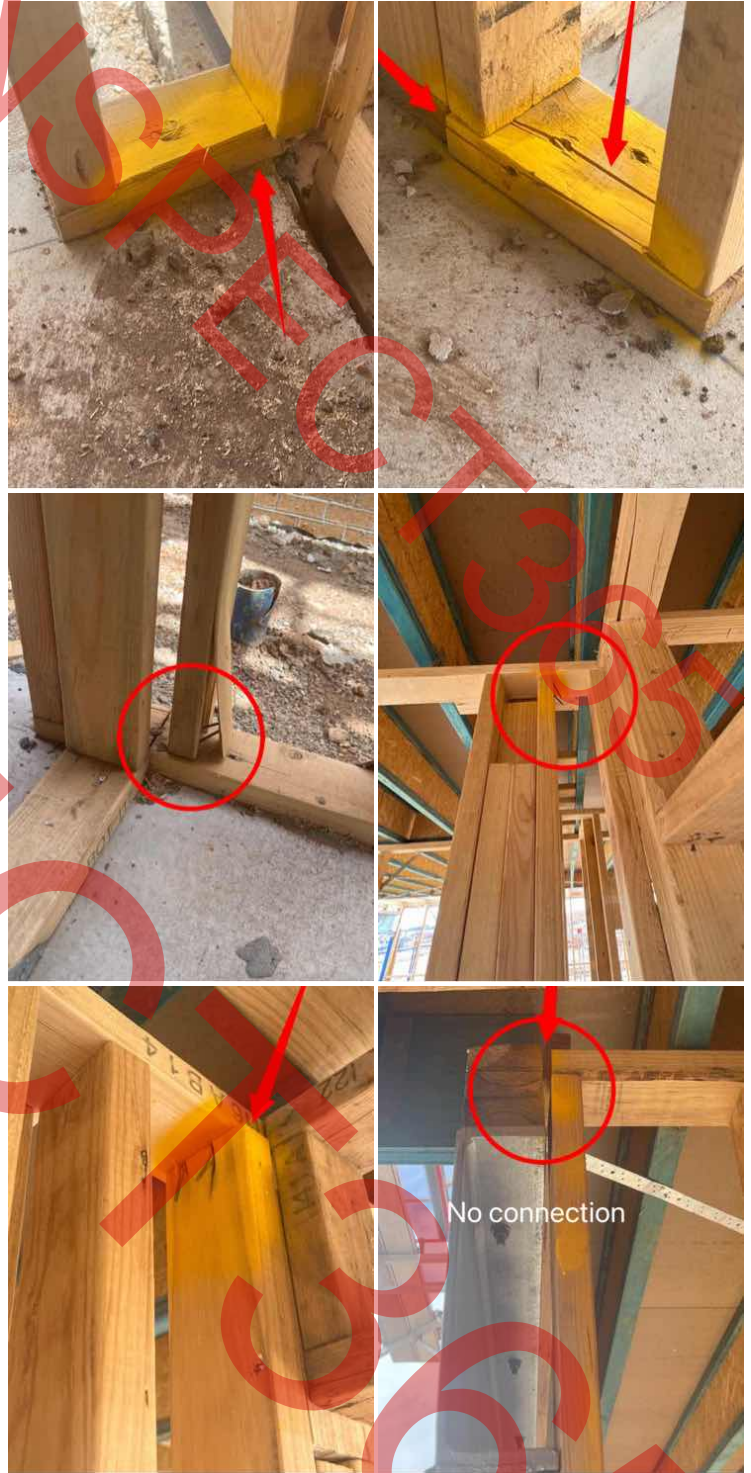
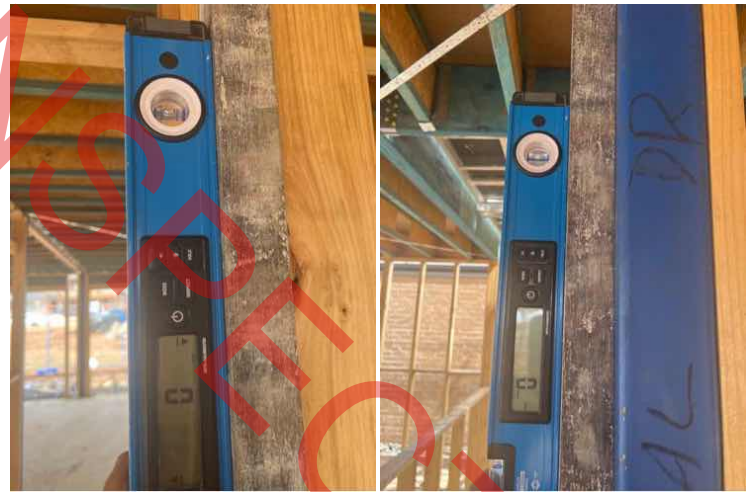
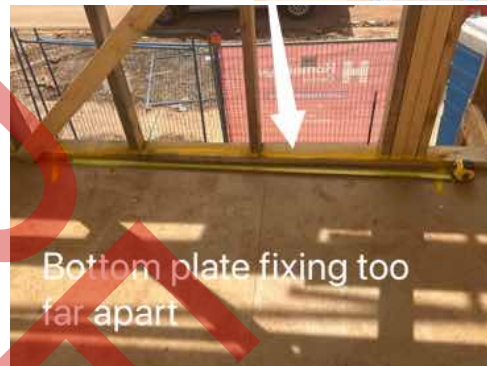
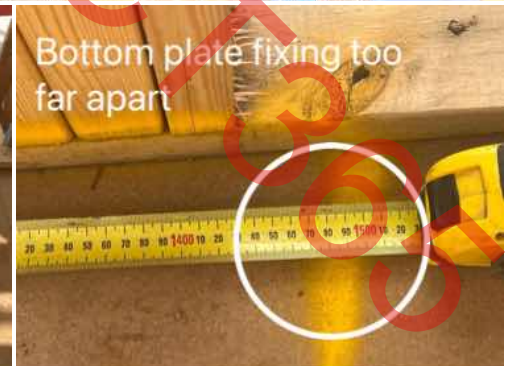
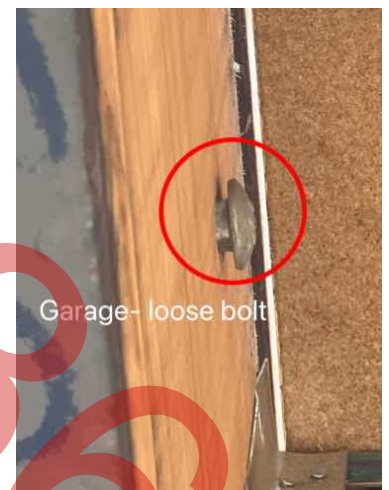
## Wall Frame Construction & Fixings

The bottom plates has insufficient fixings.

A number of misfired nails were identified.

Misfired nails are a workmanship issue only, and do not affect the structural integrity of the home where the timber is connected appropriately.

The bottom pipe was observed to be loose/damaged.

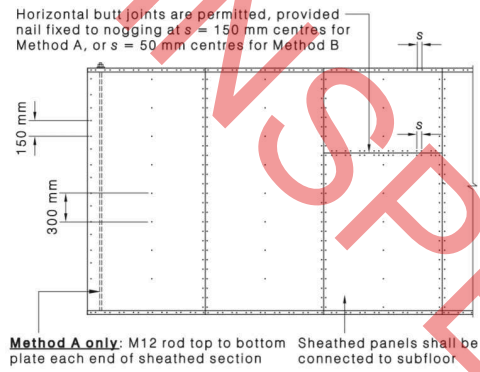
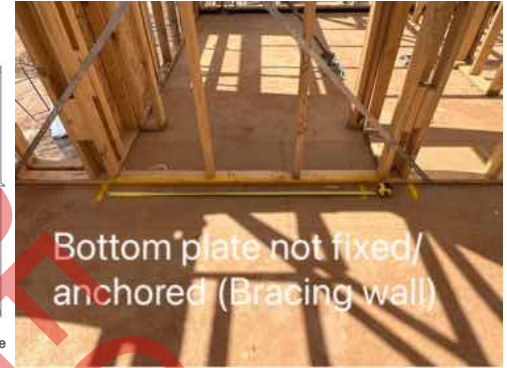
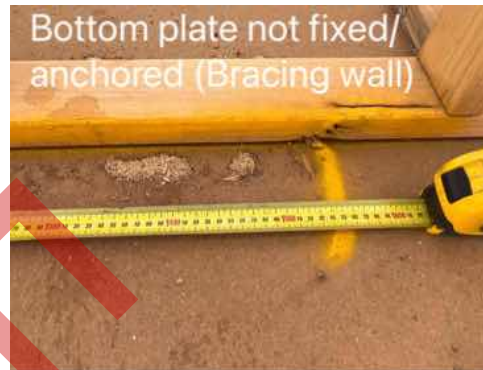
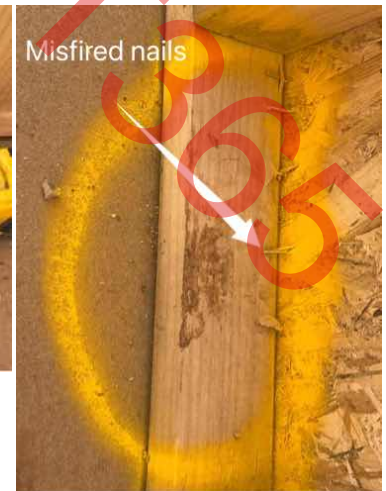
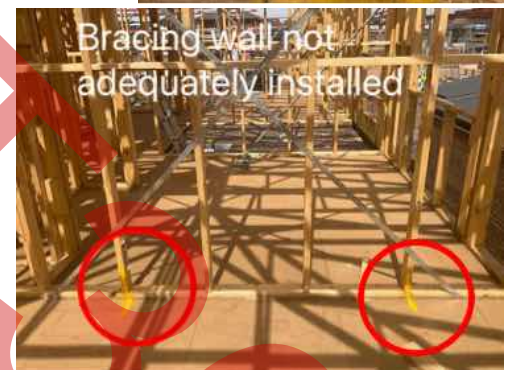
## Wall Bracing

The installation to the ply/speed bracing does not conform to the supplied engineers drawings.

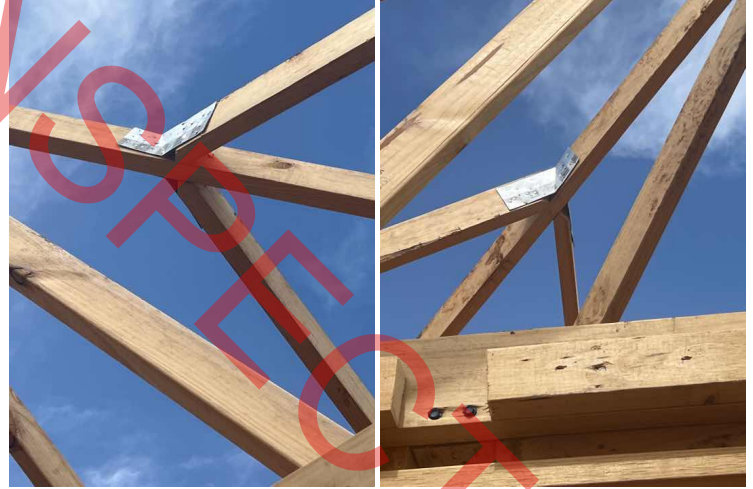
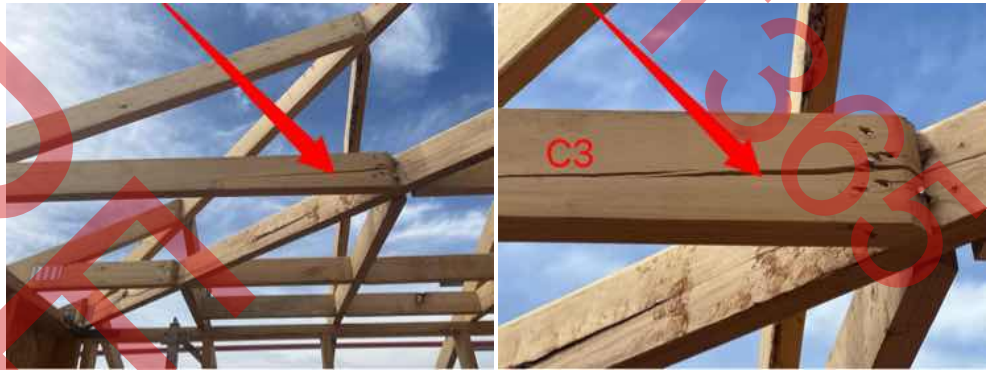
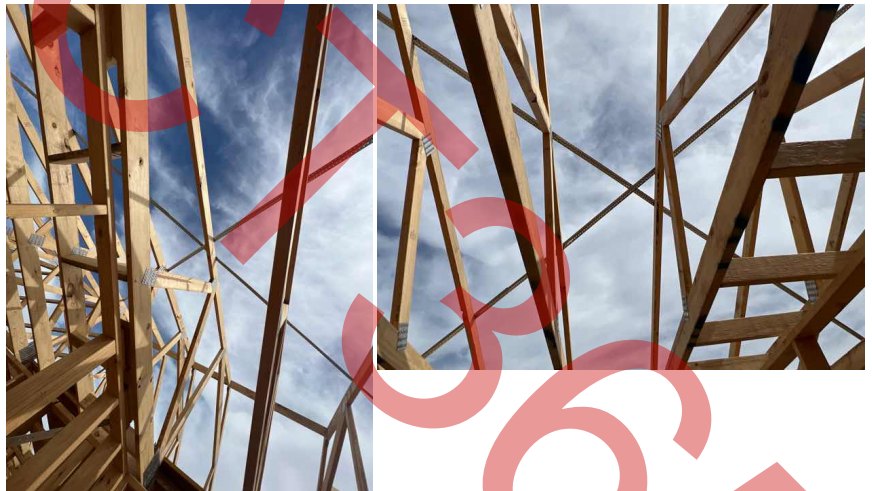
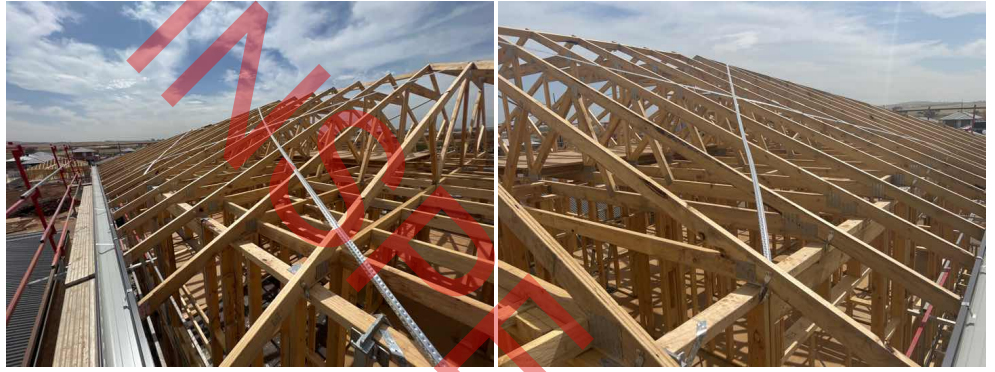
## Roof Frame Construction And Fixing

Generally conforms with supplied plans at the time of inspection.

Split roofing timber observed. Rectifications required.

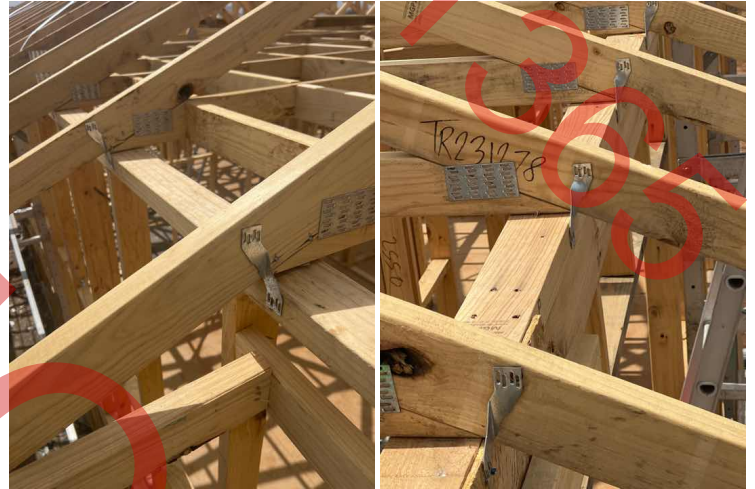
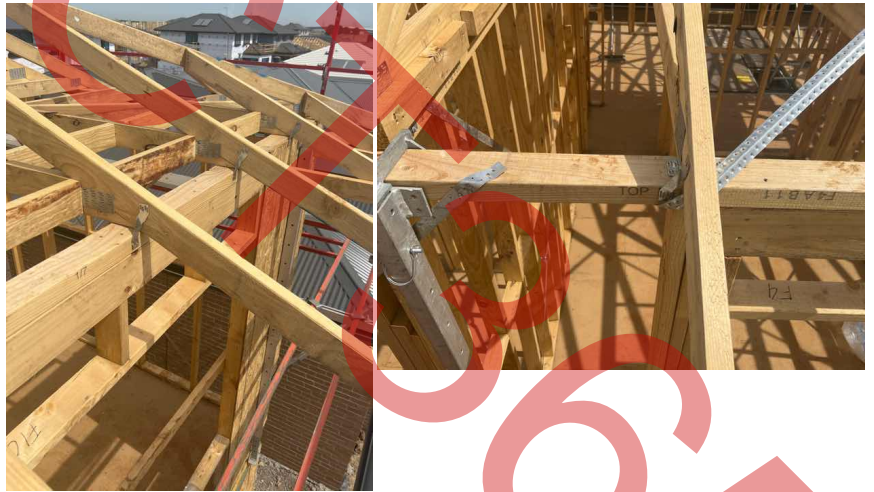
## Roof Tie Down

Conforms to supplied truss layout

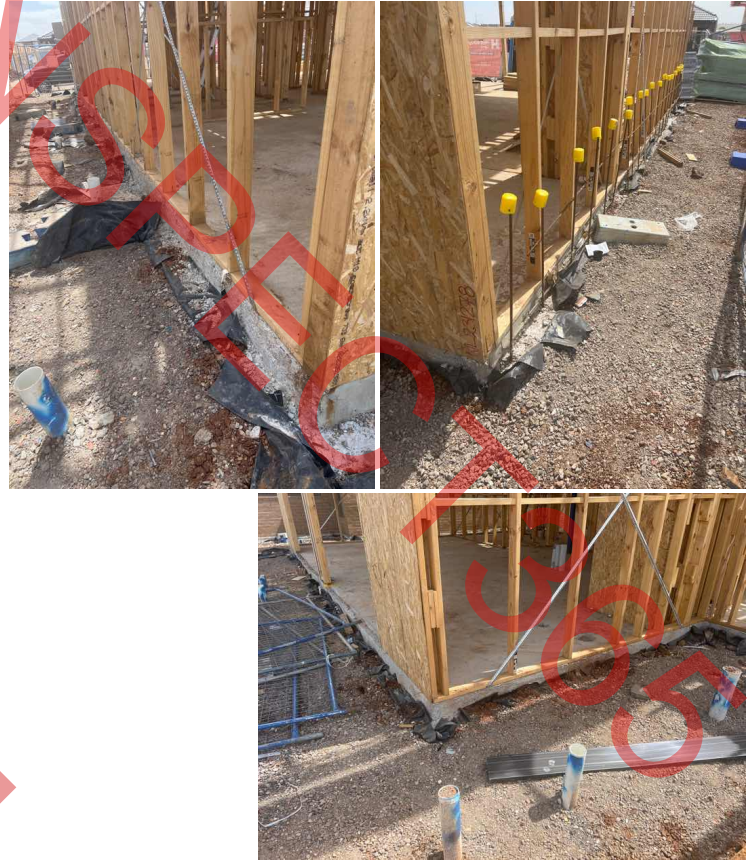
## Termite Treatment

No external termite management system has been installed. This may be due to an external reticulation system being installed.

Please check your specifications or contact your site supervisor to confirm the type of termite management system that is to be installed.

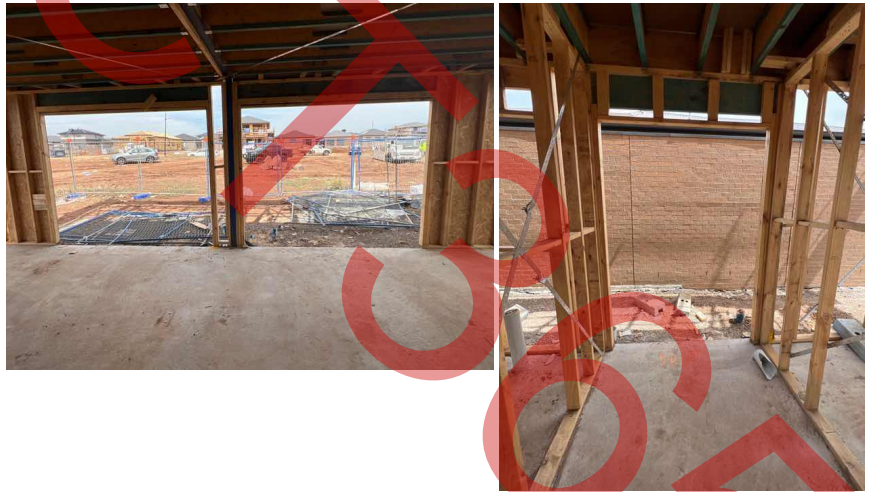
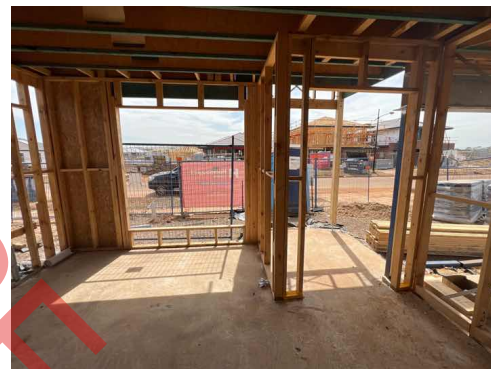
## Glazing

Windows not yet installed
