Stage Inspection Report - Pre Slab Steel

Lot Sample, Sample, VICTORIA, 3030

Inspection Date: 21 Mar 2022

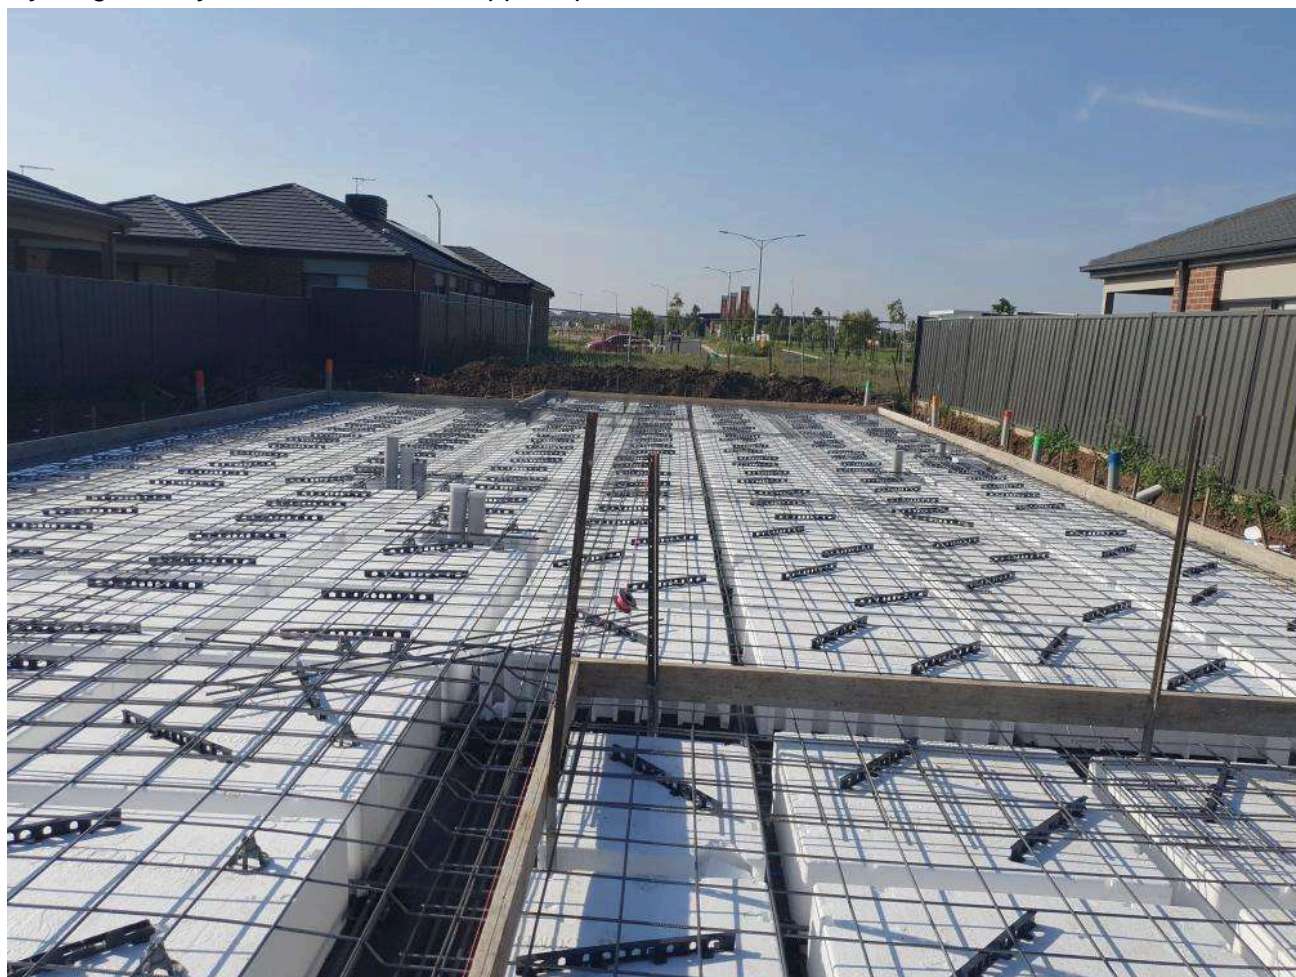
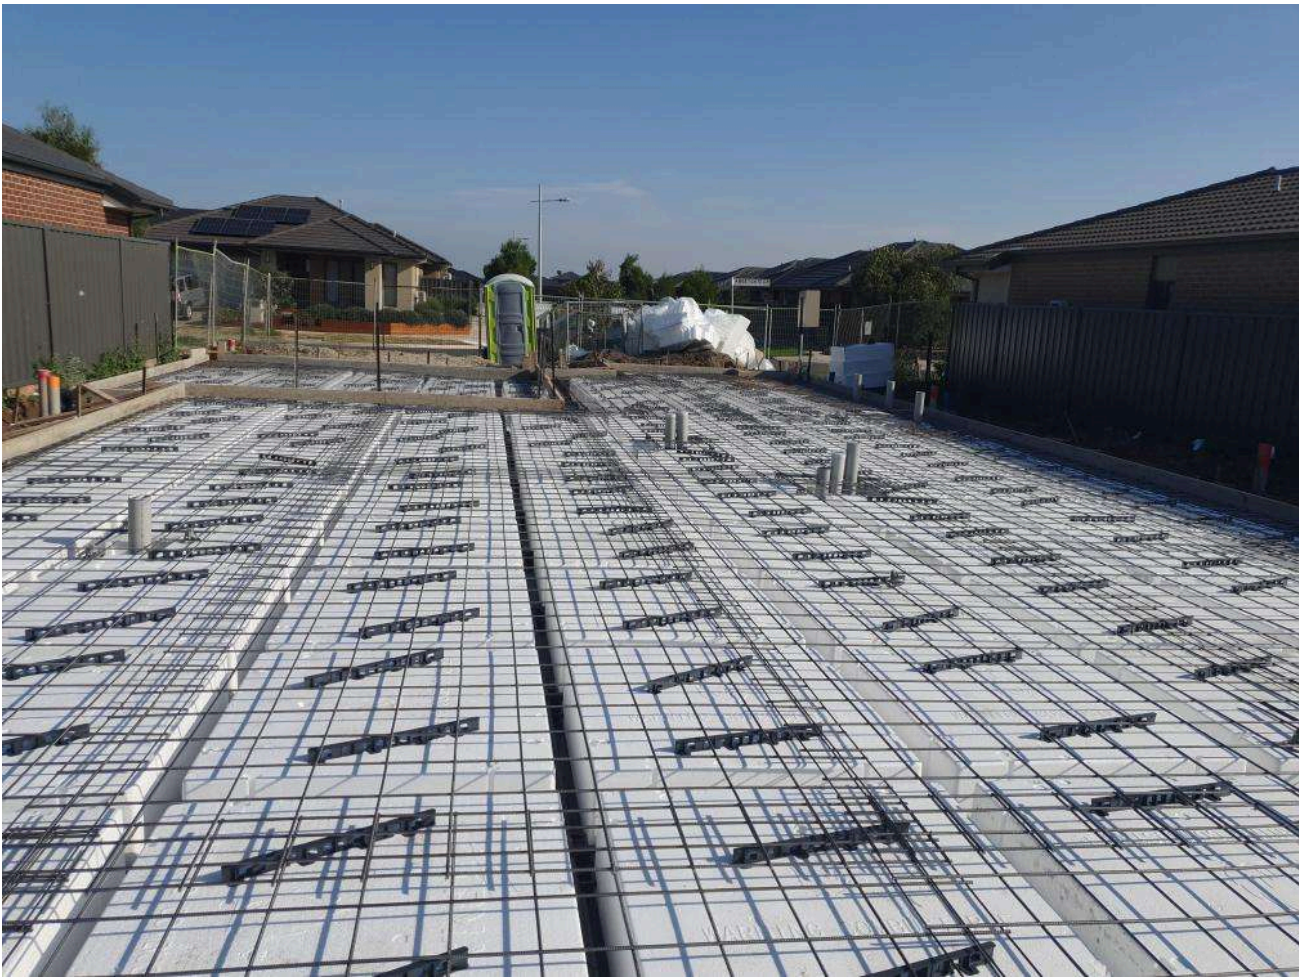
The layout generally conforms with the supplied plans.

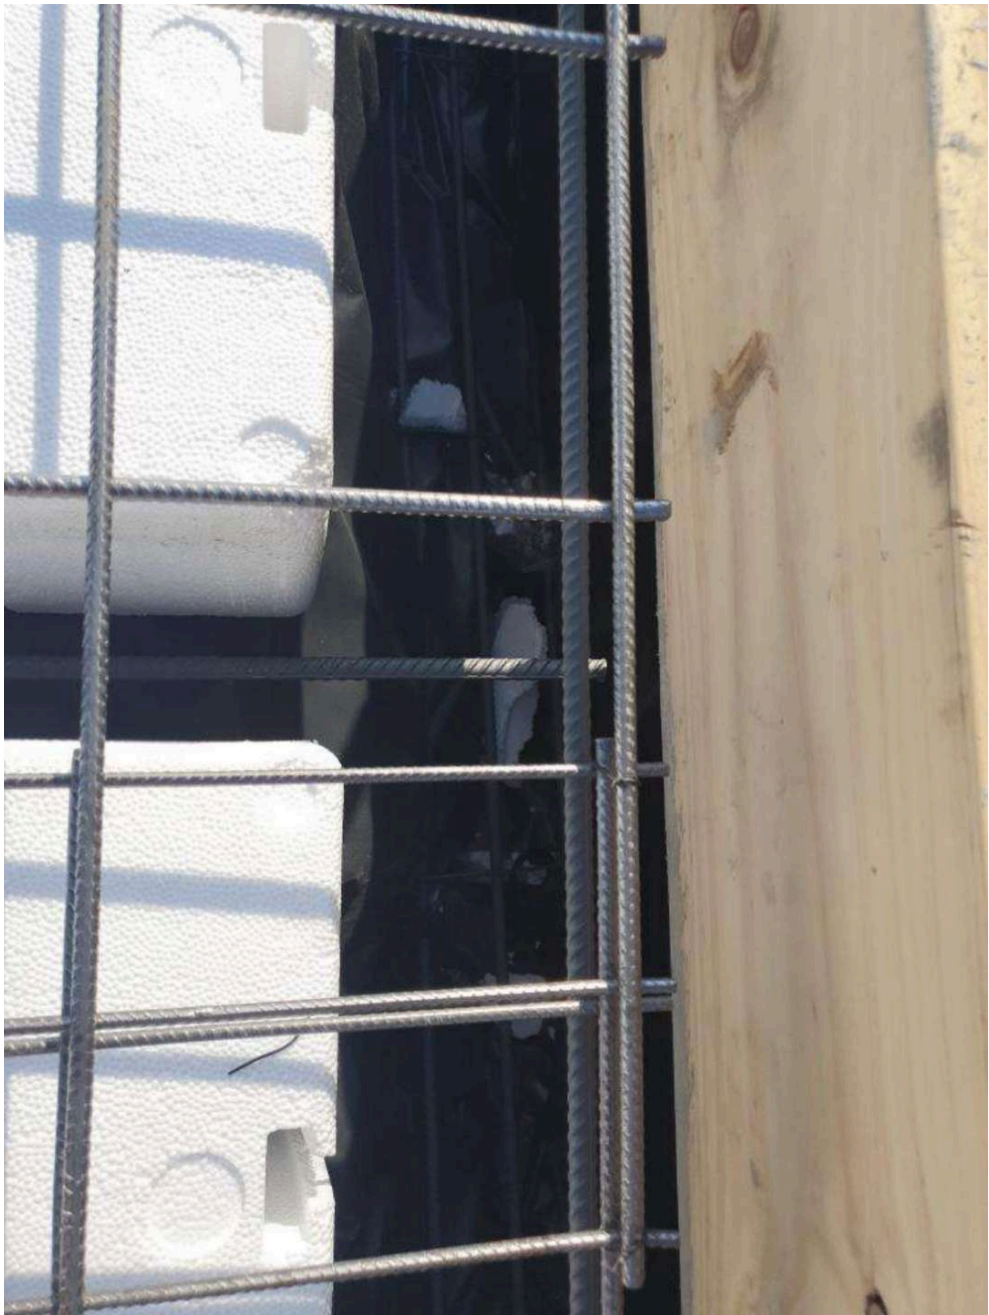
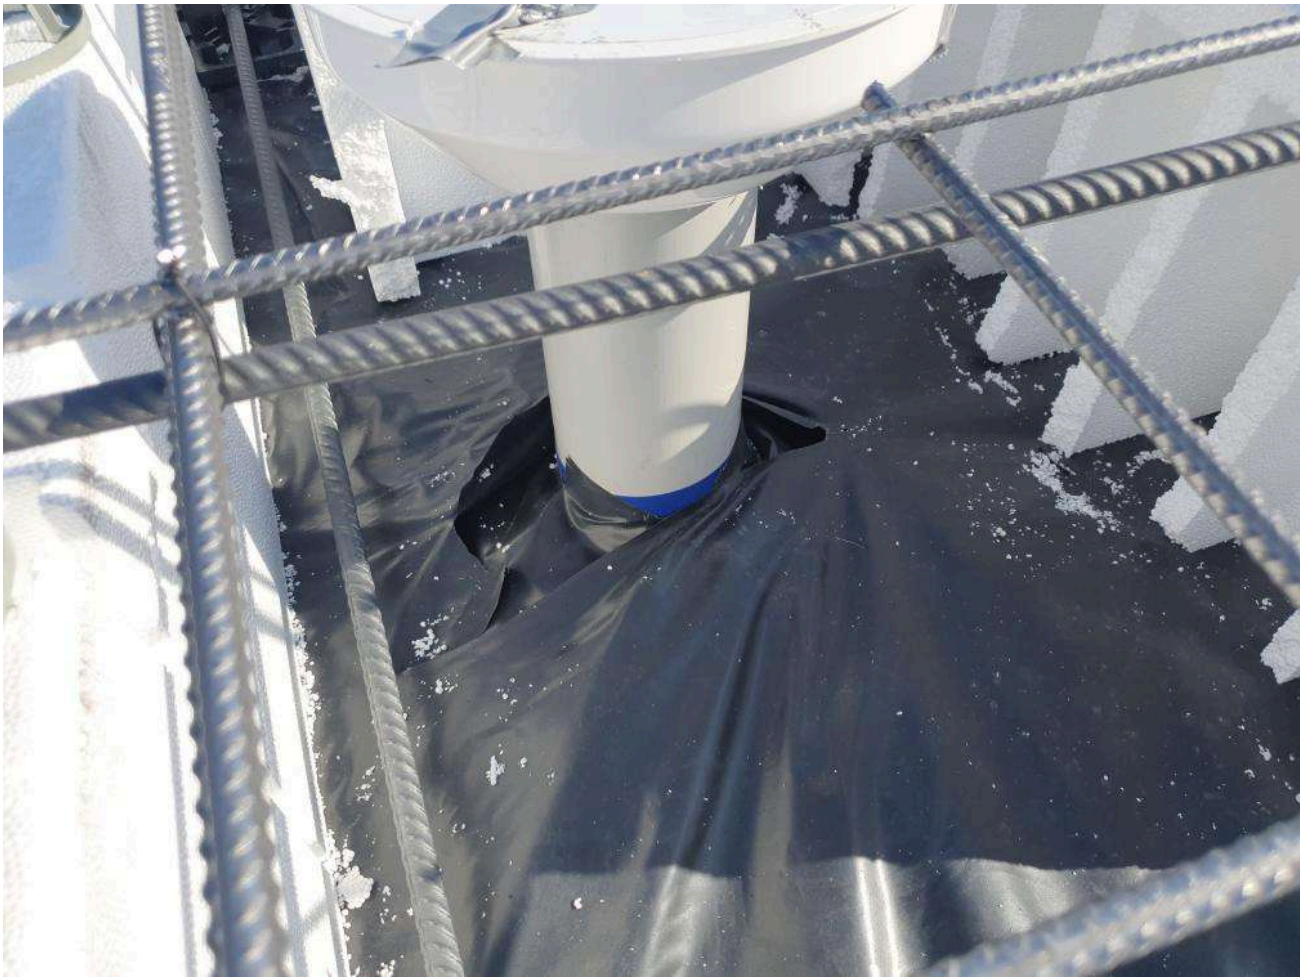
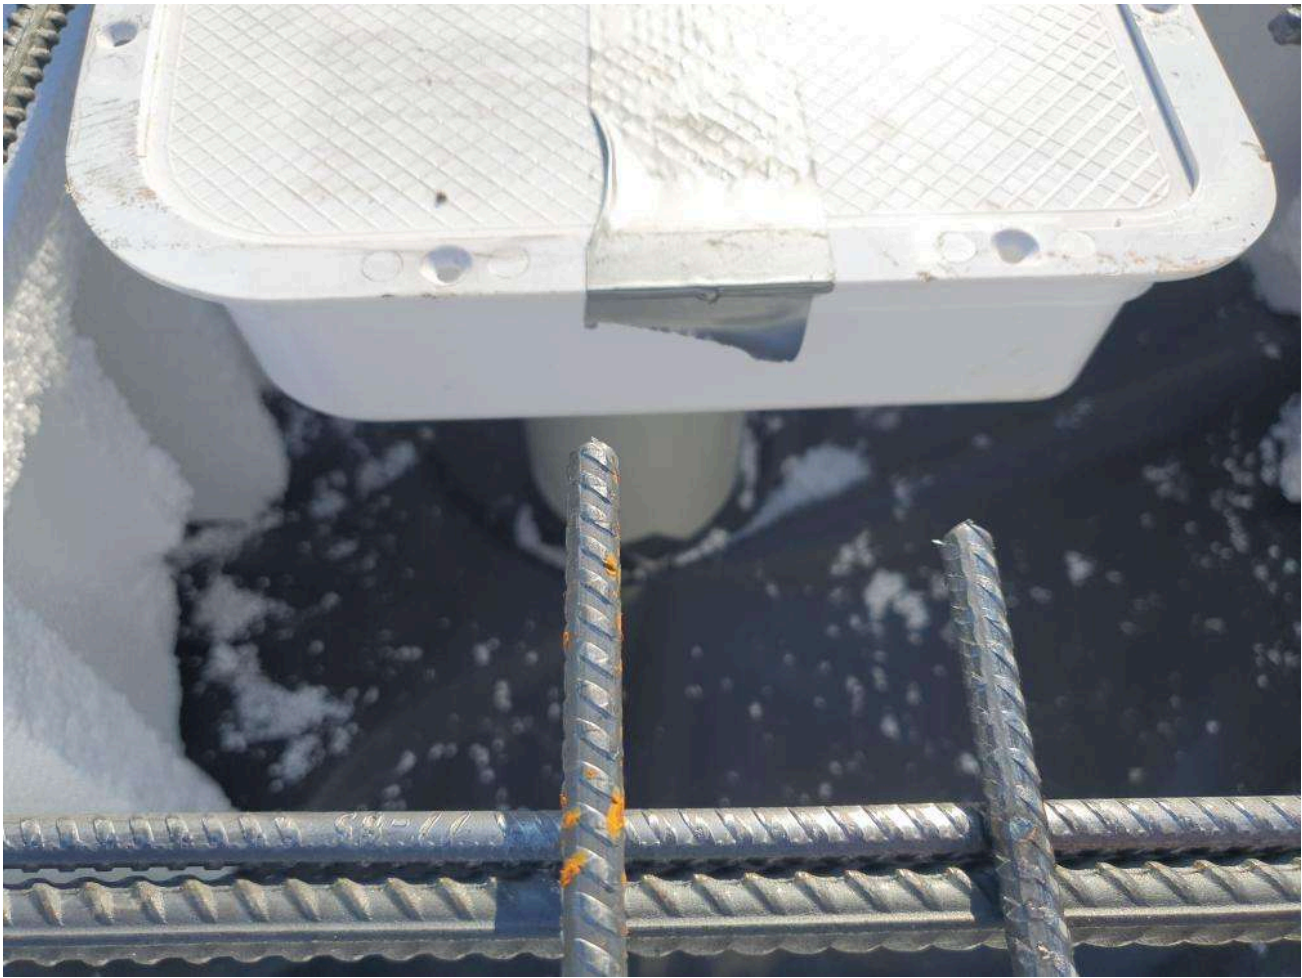
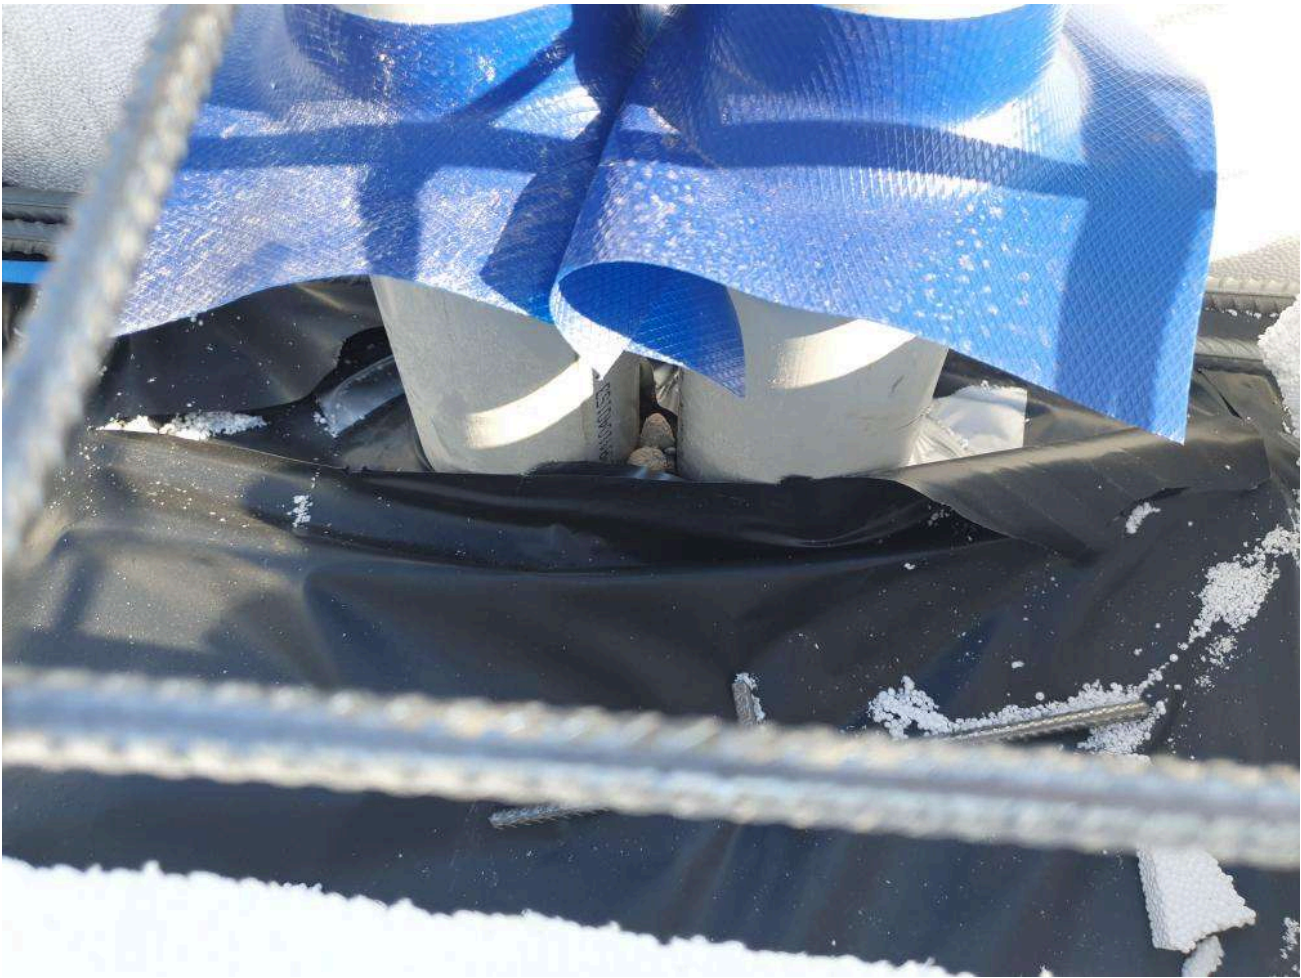
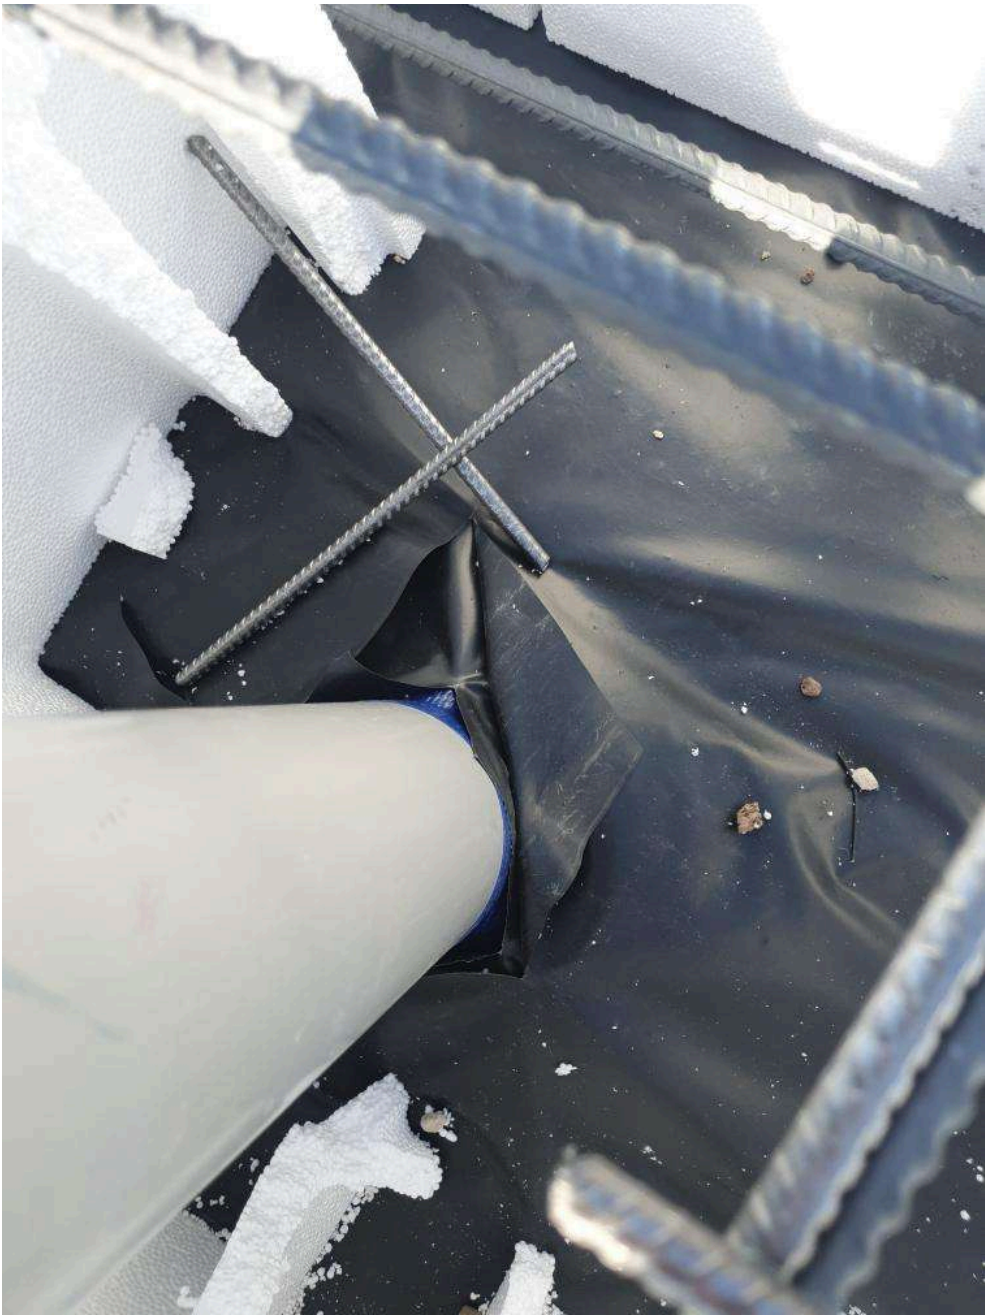
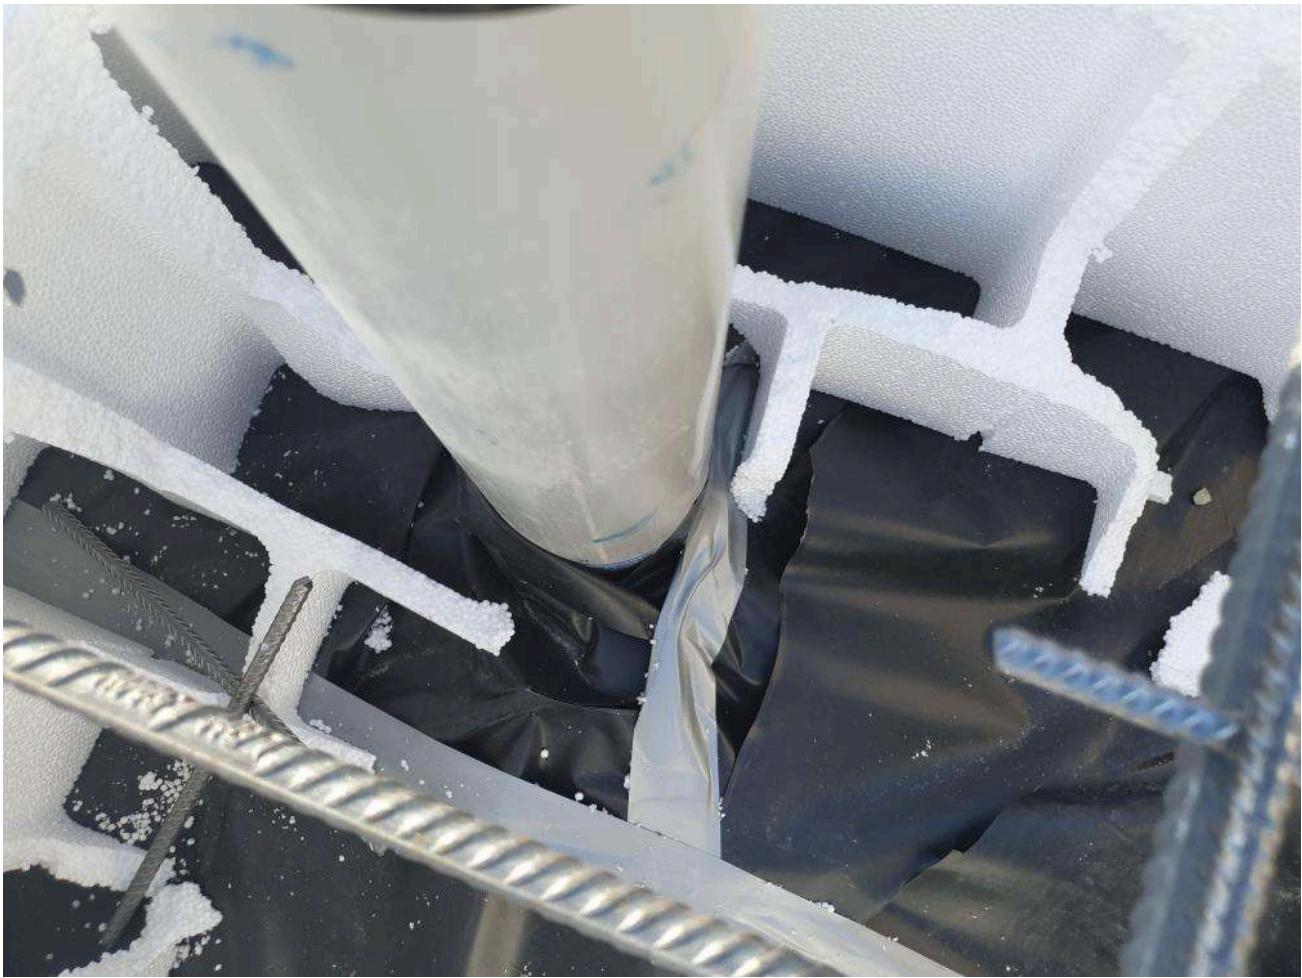
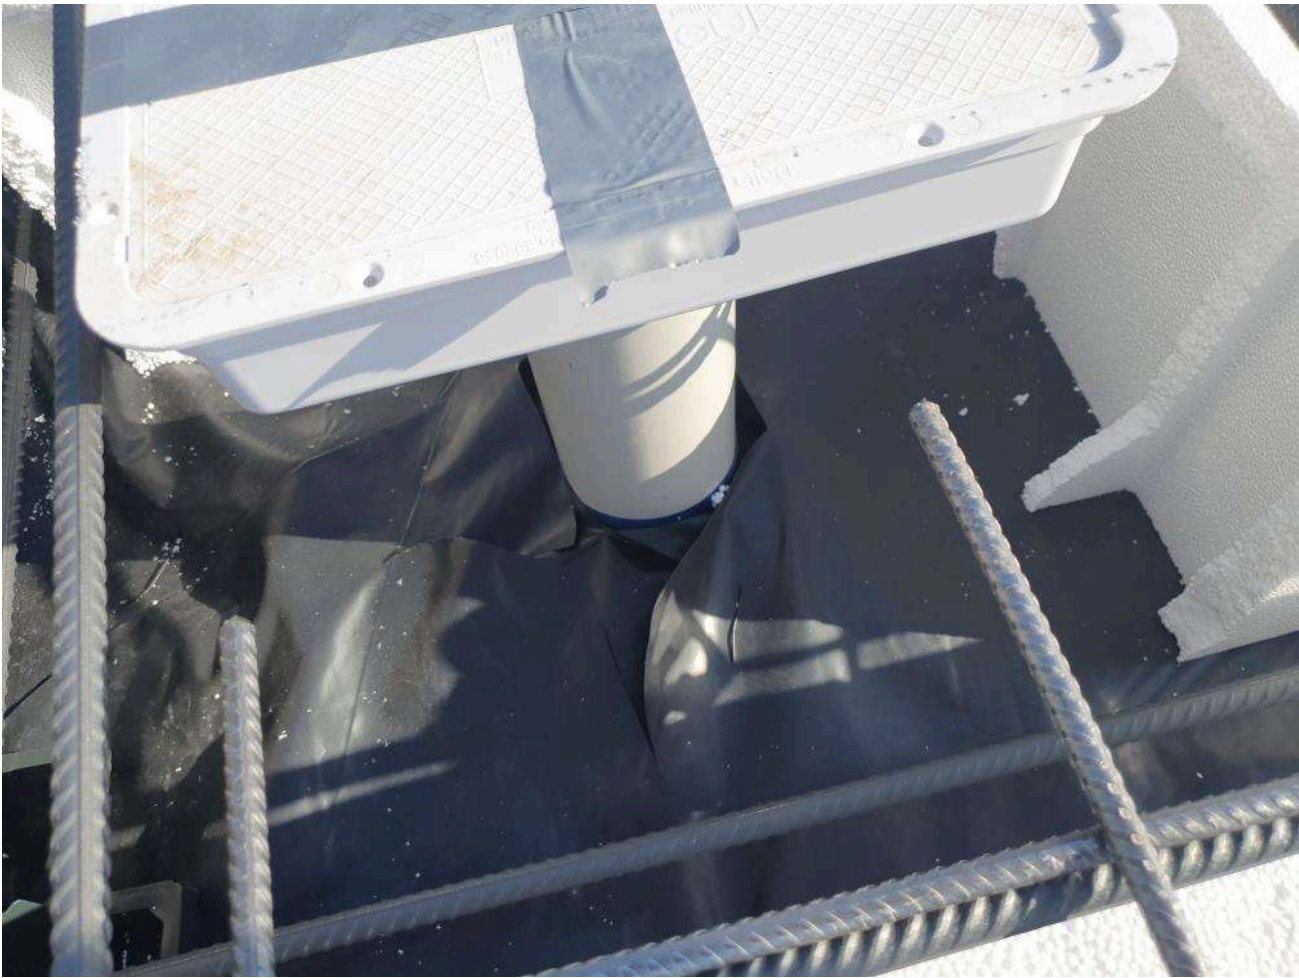
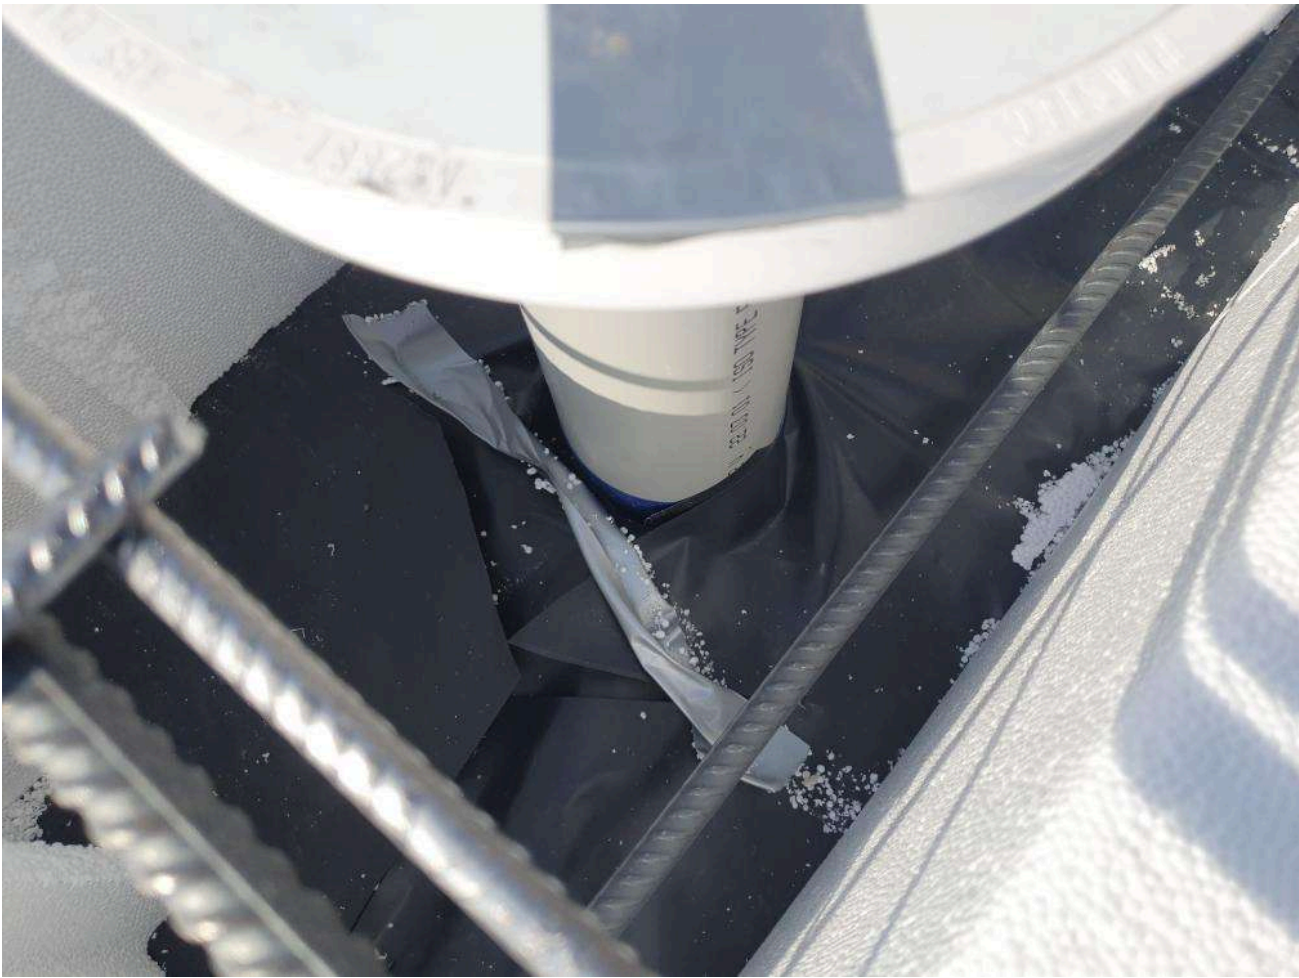
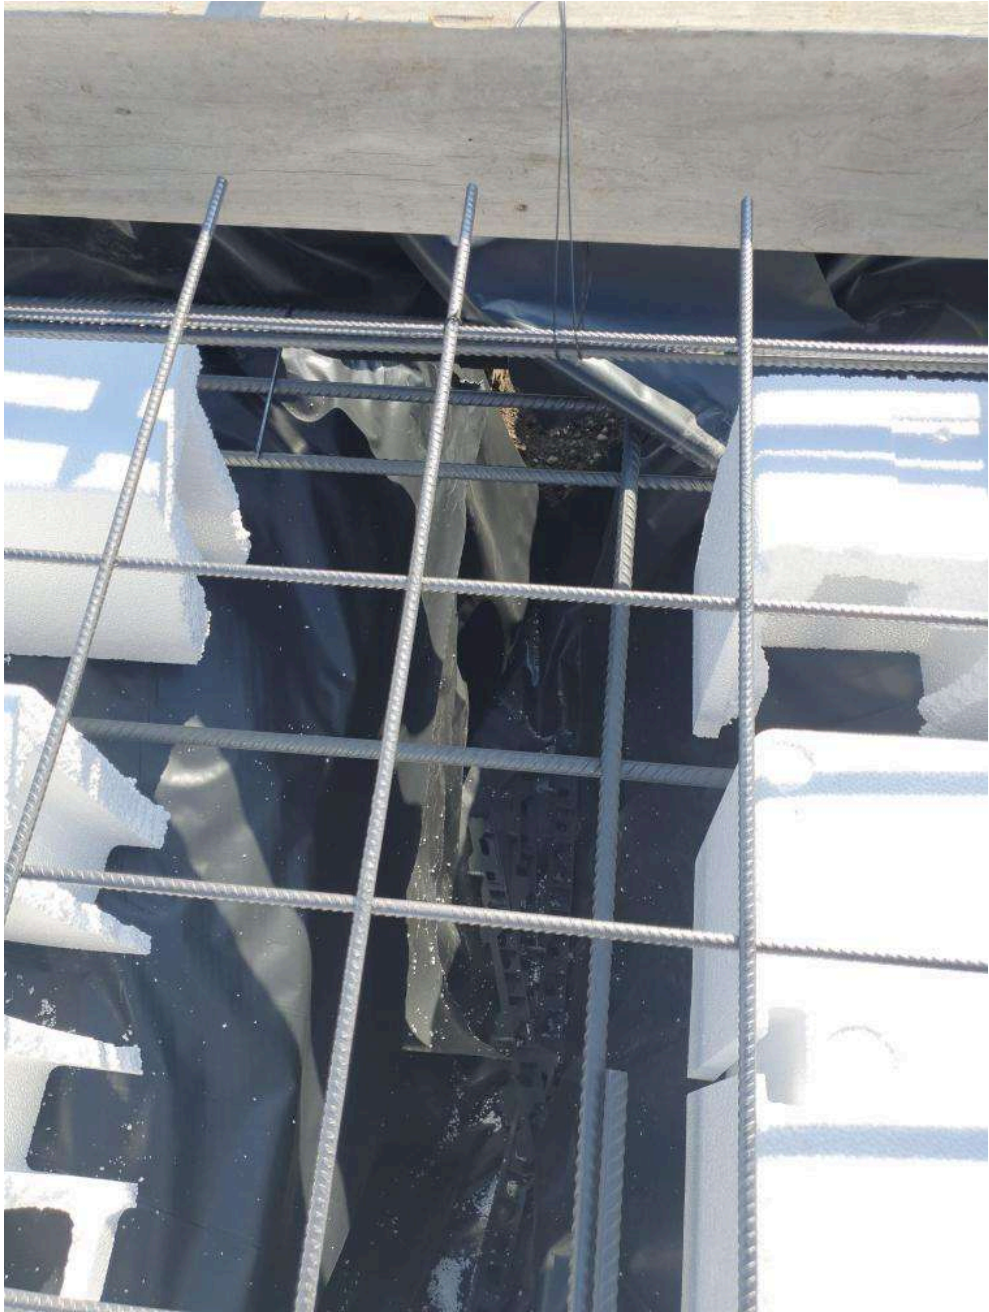
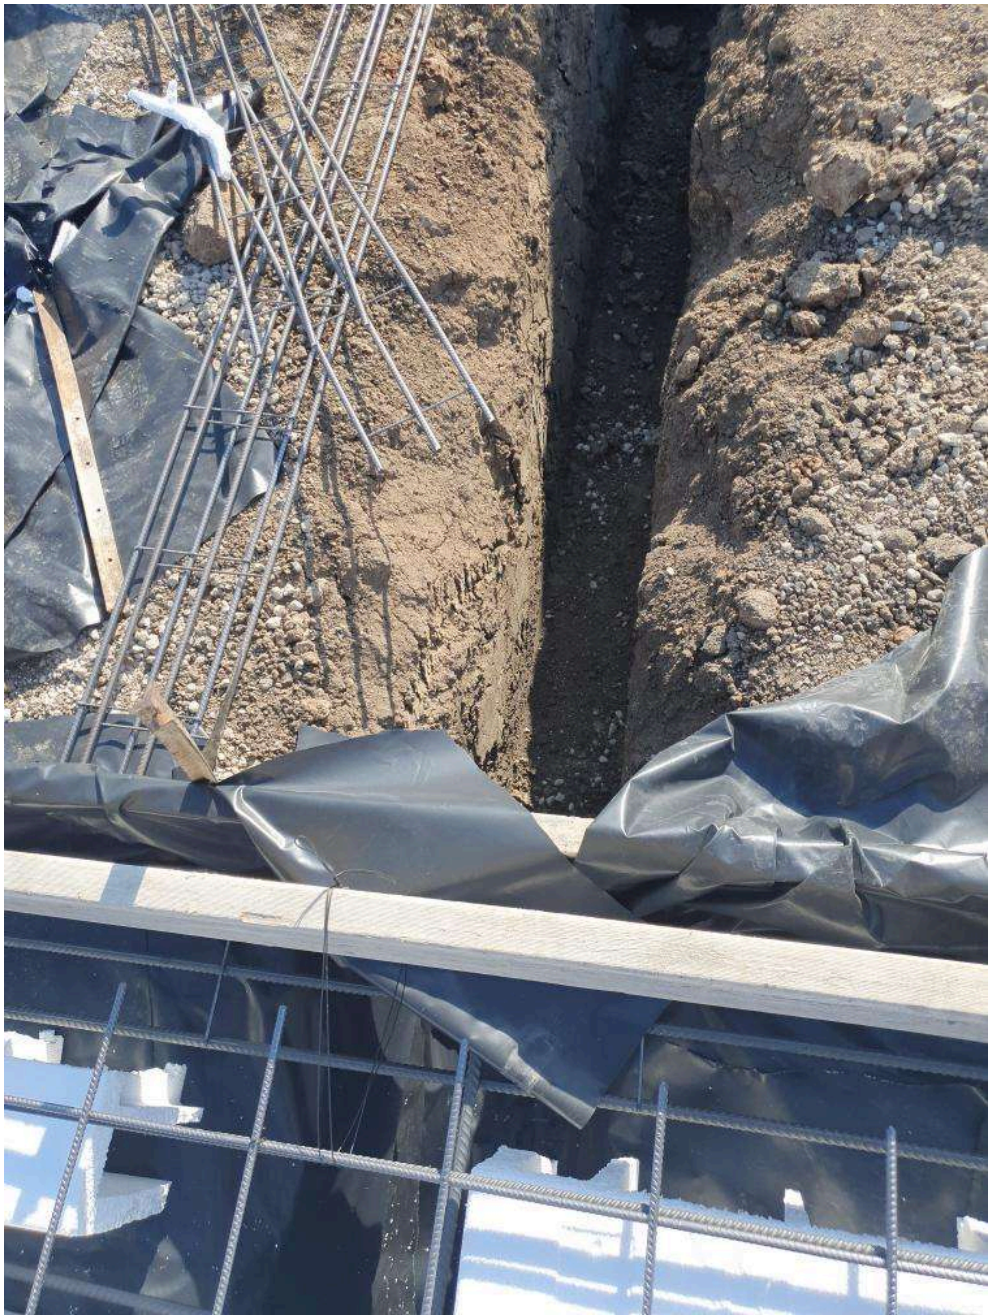
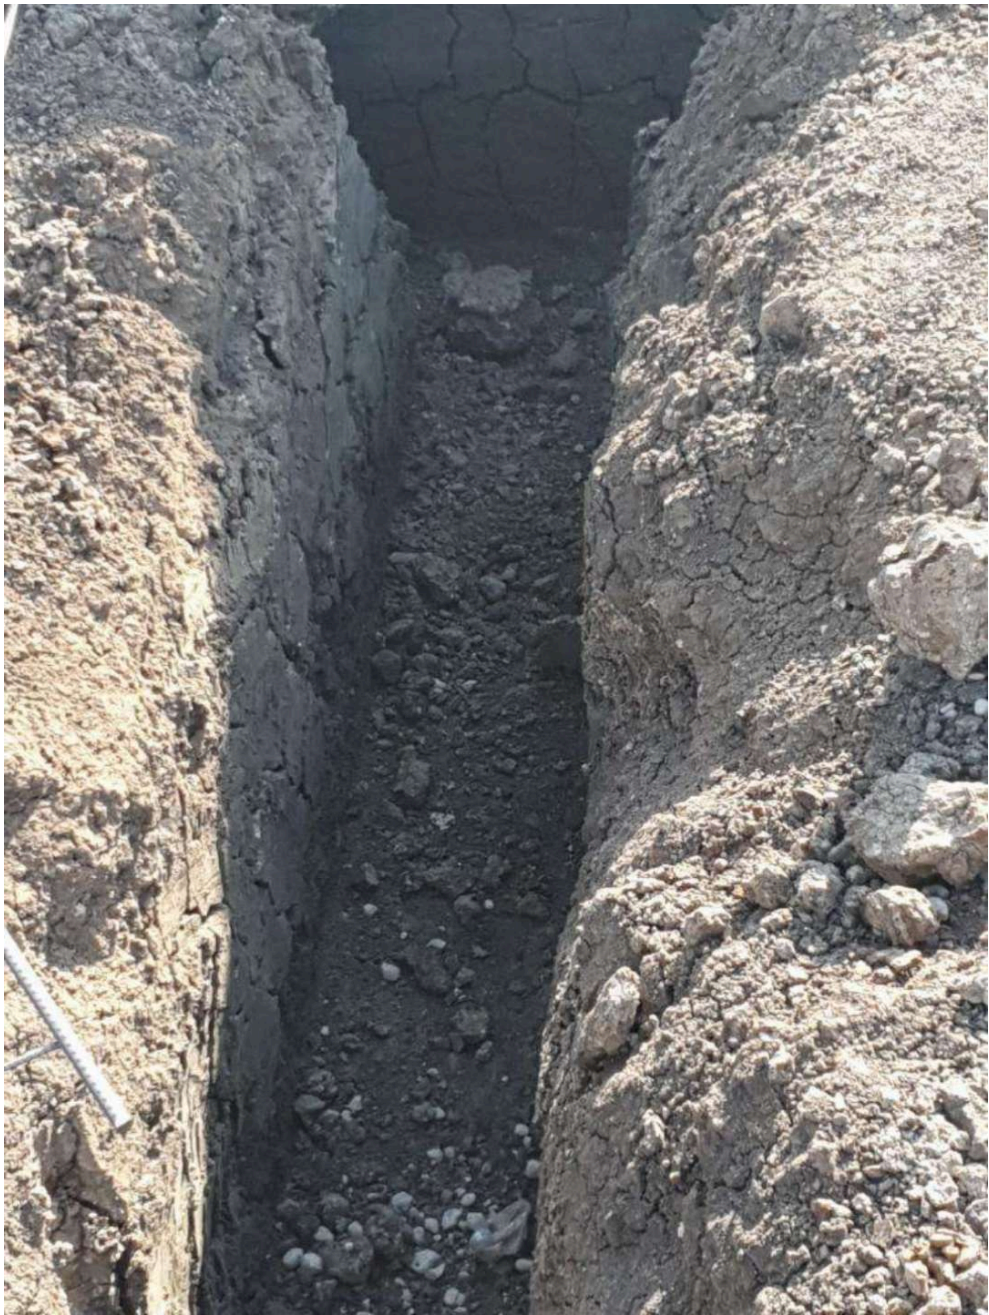
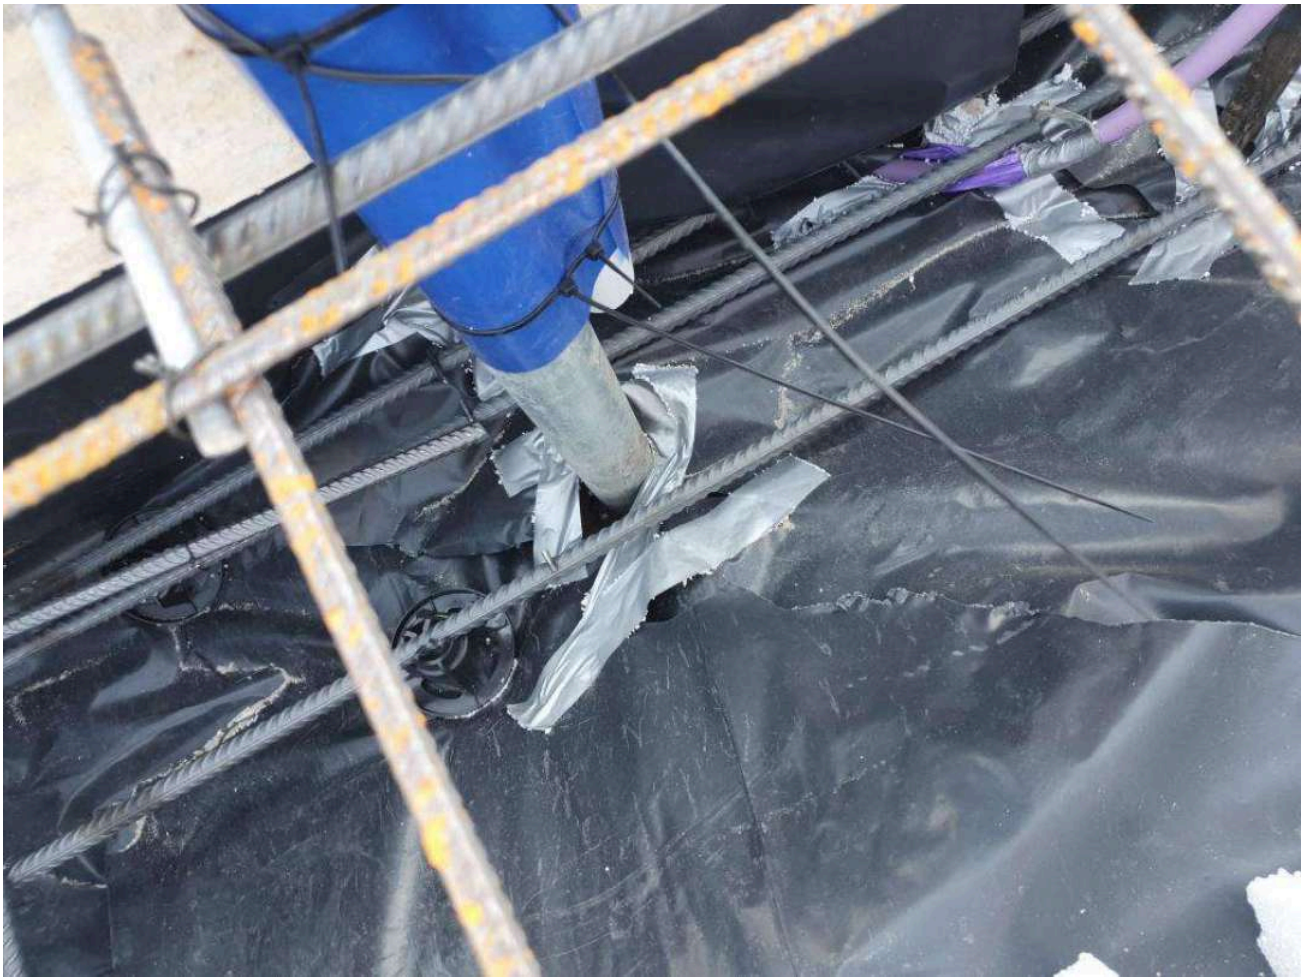
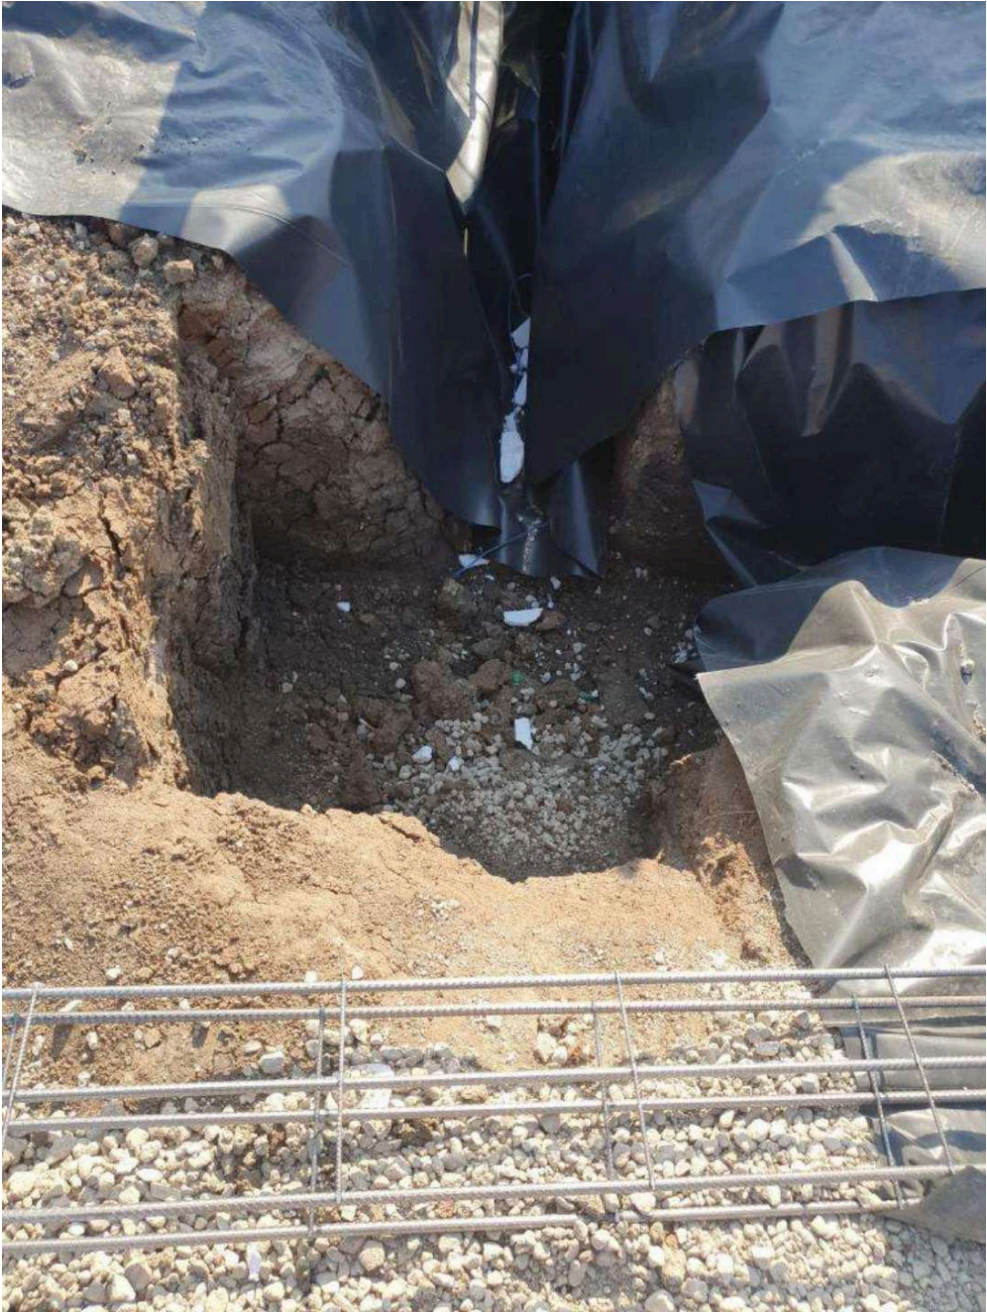
Broken sections of waffle pods were identified to various sections of the trenches.

At the time of inspections, the vapour barrier does not comply in that various penetrations have not had the black builders plastic adequately taped.

The **BCA 3.2.2.6** states "A vapour barrier must be installed under slab-on-ground construction for all Class 1 buildings and for Class 10 buildings

Section(s) of form work timber is missing

Sections of the trenches have rubble and spoil. Clean out prior to pour.

We recommend that all trenches are to be cleaned out prior to concrete pour.

around all service penetrations; and the vapour barrier membrane in this area will need to be properly extended, lapped and sealed

Some areas of boxing still need to be

completed, prior to any concrete pour, to avoid any blow-out and widening.
