Stage Inspection Report - Pre Slab Steel

Lot Sample, Sample, VICTORIA, 3030

Inspection Date: 21 Mar 2022

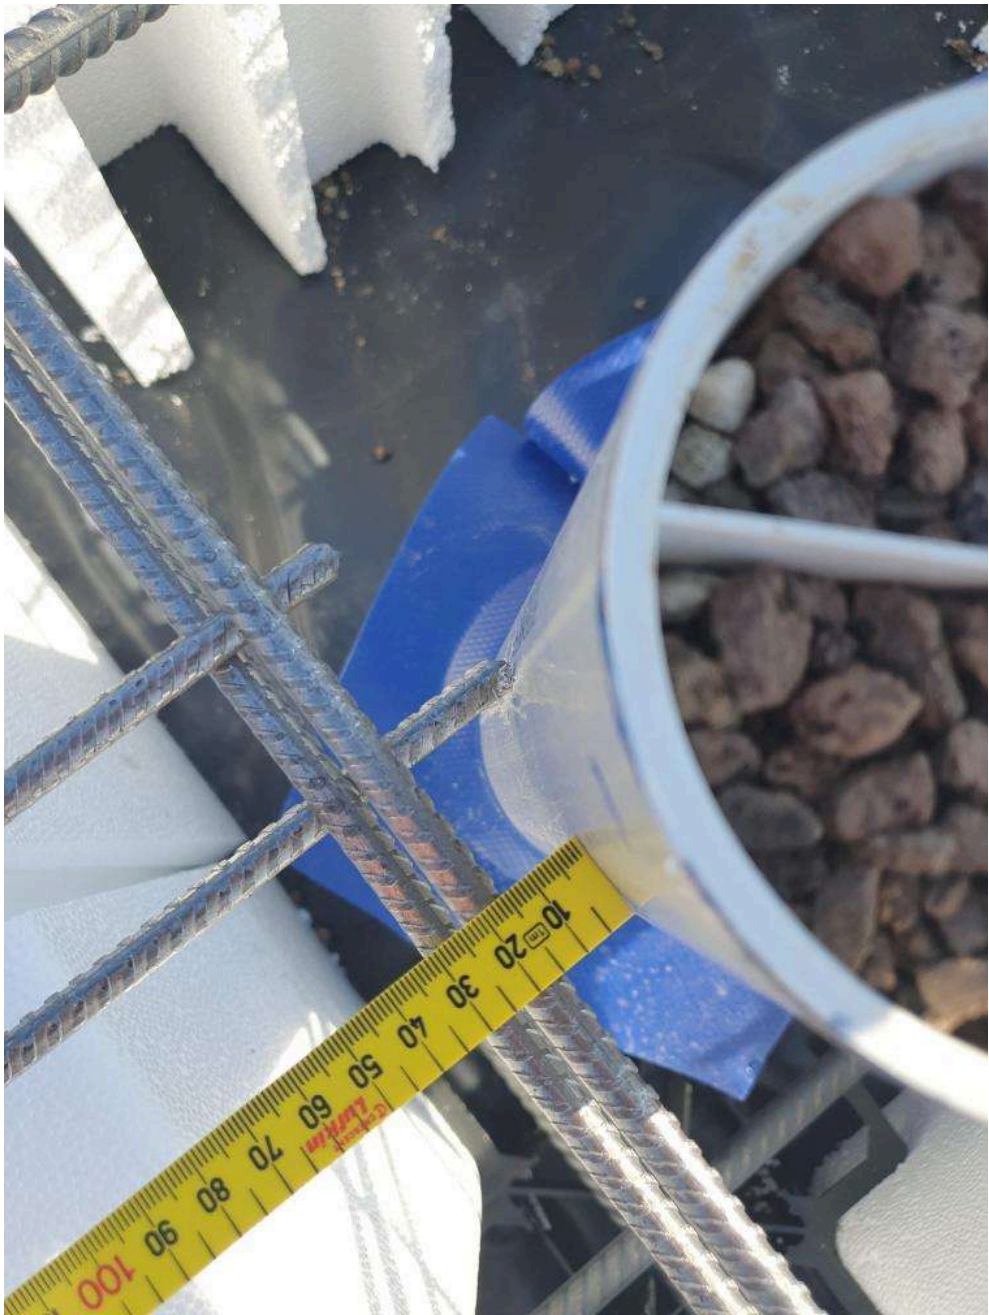
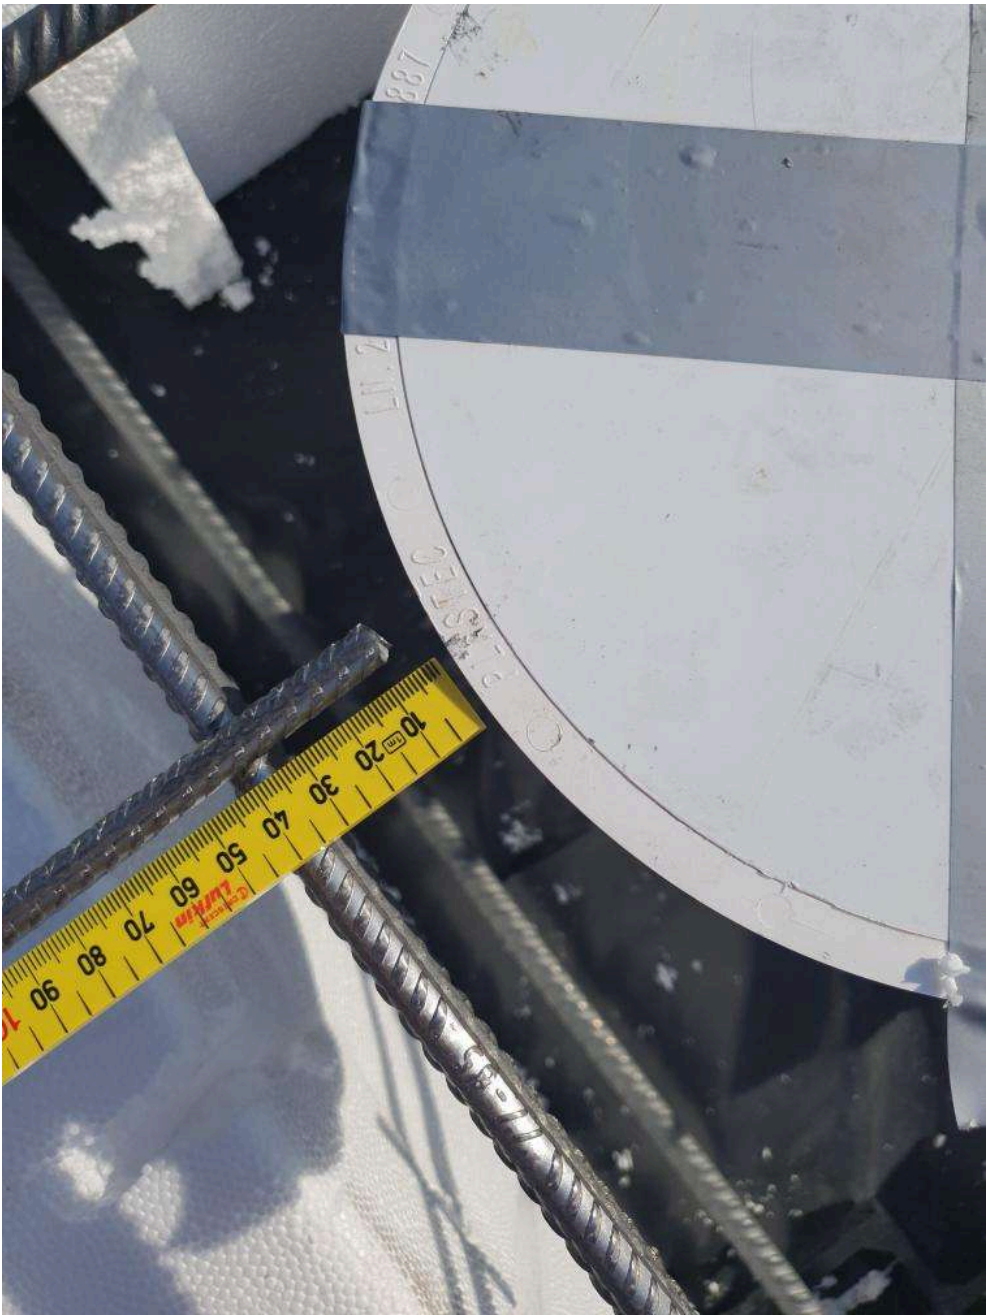
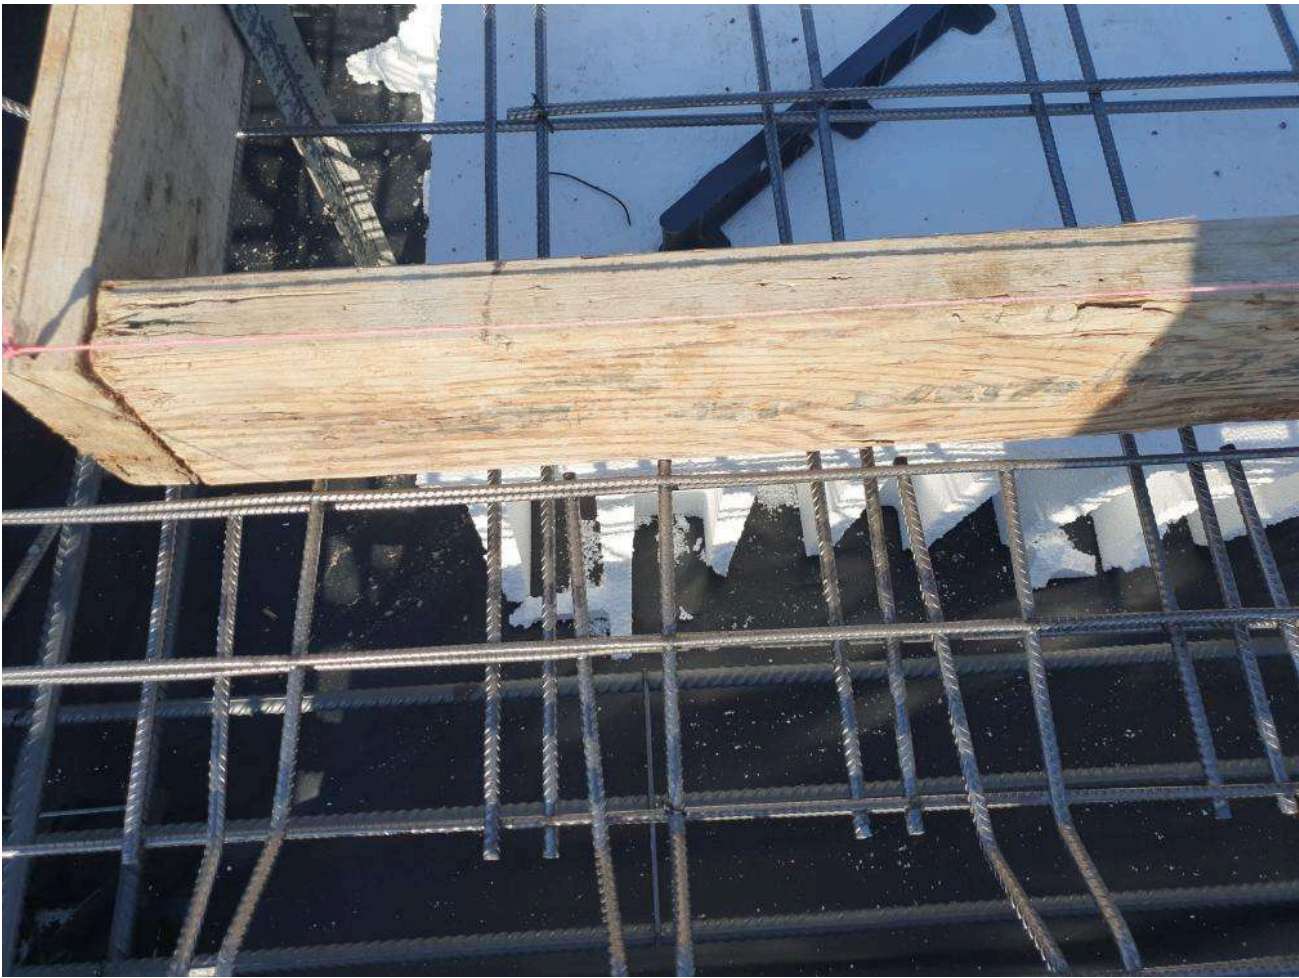
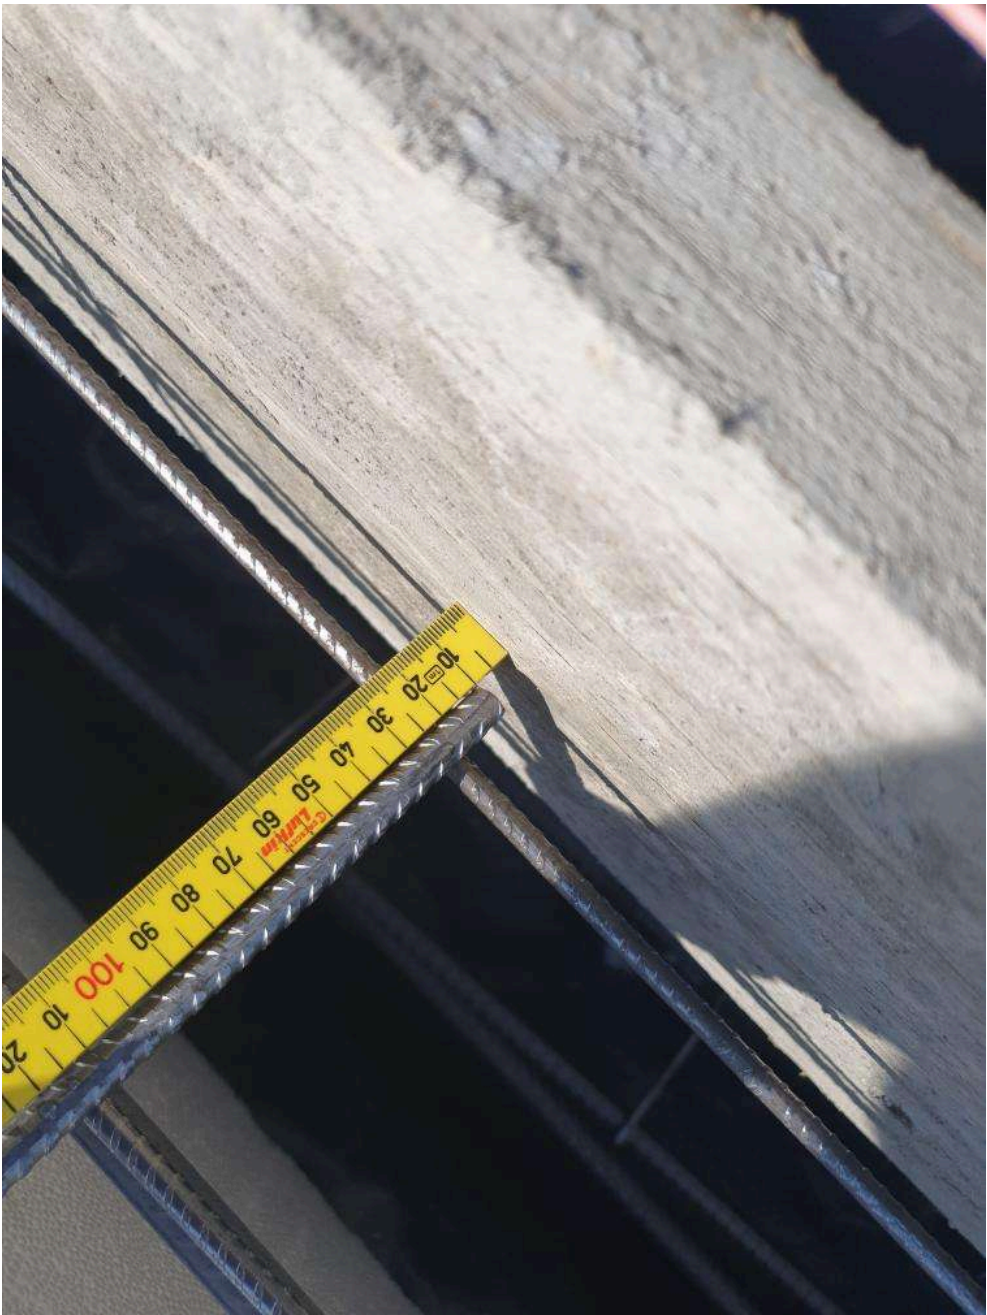
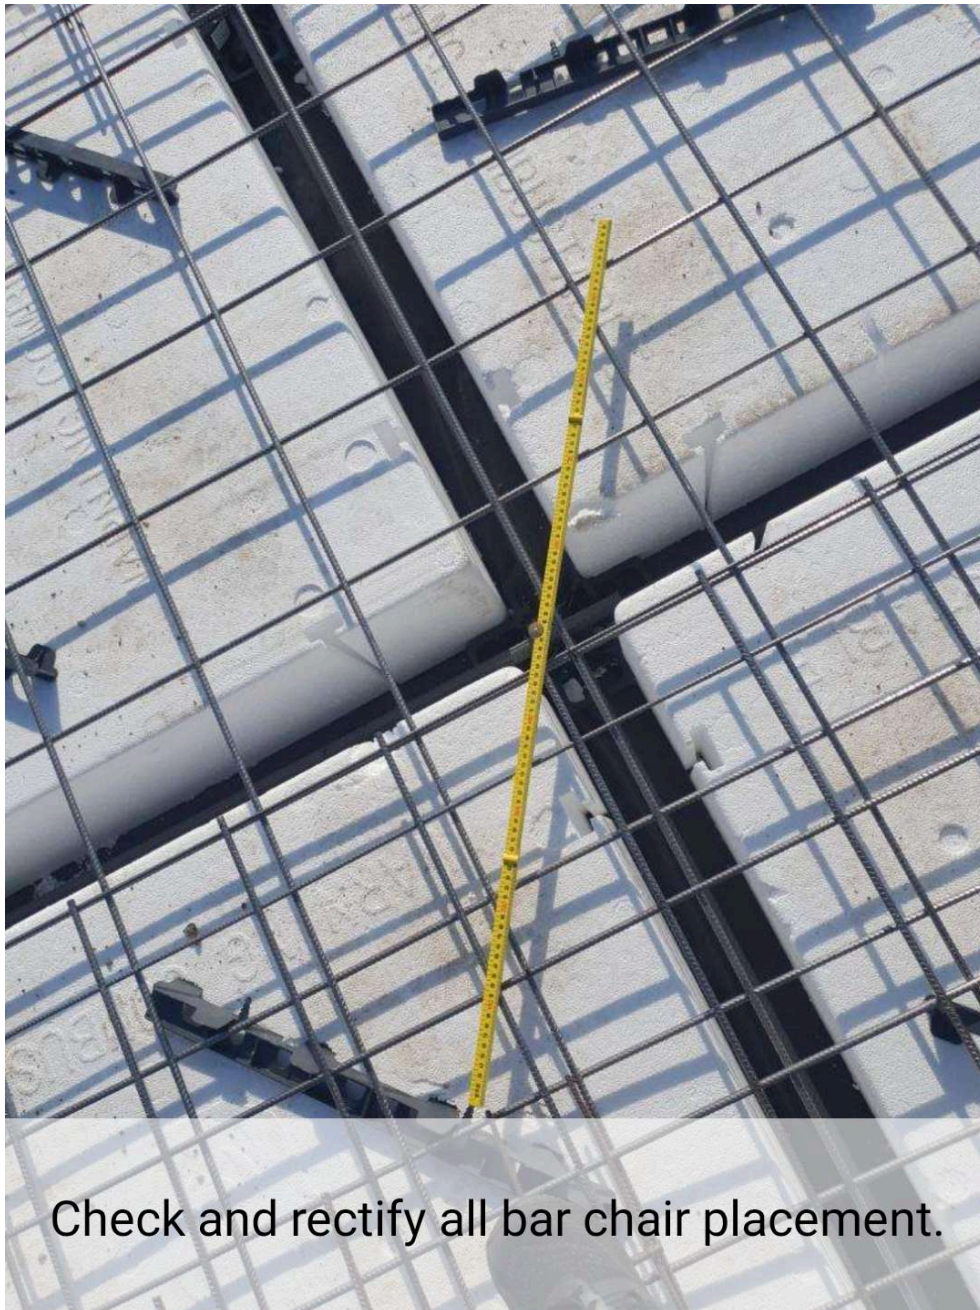
The steel reinforcement does not conform in that sections of the Steel mesh do not overlap in accordance with the Australian Standards in areas

AS 2870, Section 3.2.3.2 (c) Steel Reinforcement require that the 2 outermost wires overlap in accordance with Figure 3.2.3.1 as below.

Support of the steel mesh does not conform in that sections of the bar chair spacing exceed the maximum spacing required.

AS2870 3.2.3.2 (v) Steel Reinforcement states that bar chairs must be spaced at not more than 800 mm centres for steel fabric.

We recommend that the mesh be installed correctly prior to concrete pour or an engineers justification provided by the builders engineer.

Check and rectify all bar chair placement.

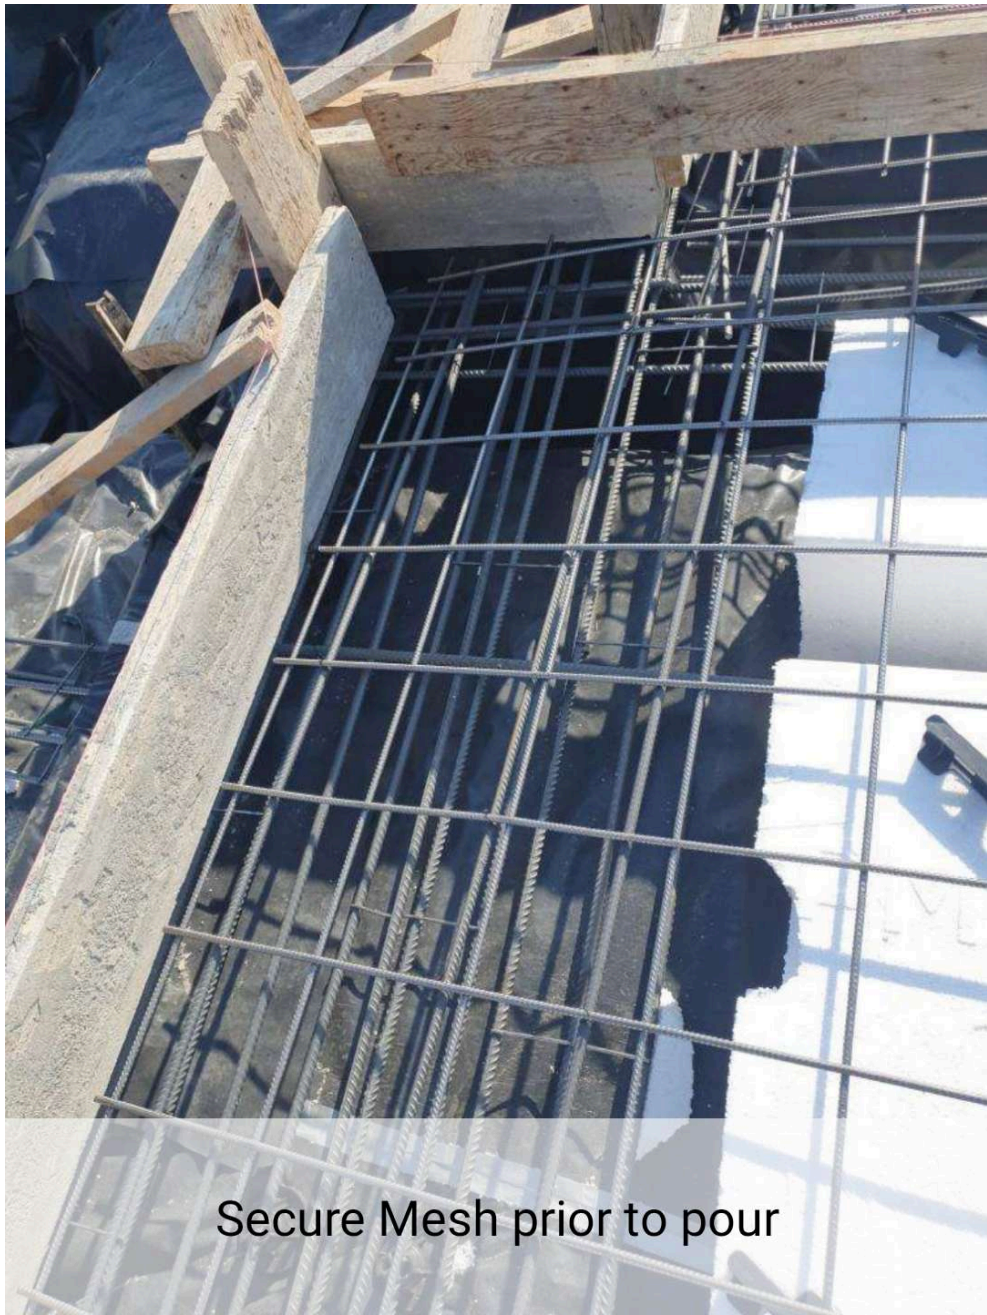
The mesh to the garage/porch area has been installed too low and requires securing in position prior to pour.

Secure Mesh prior to pour

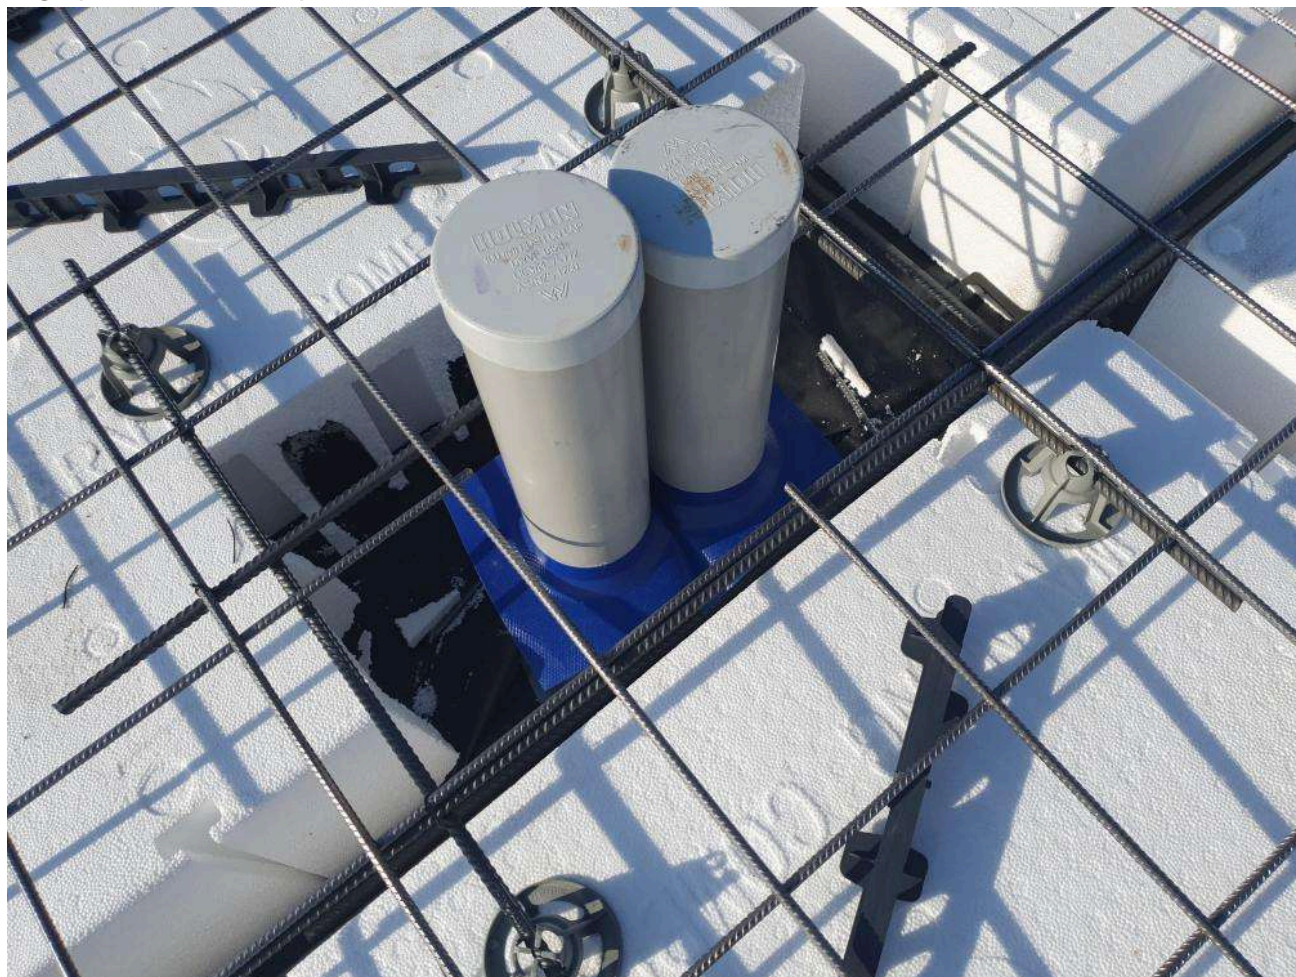
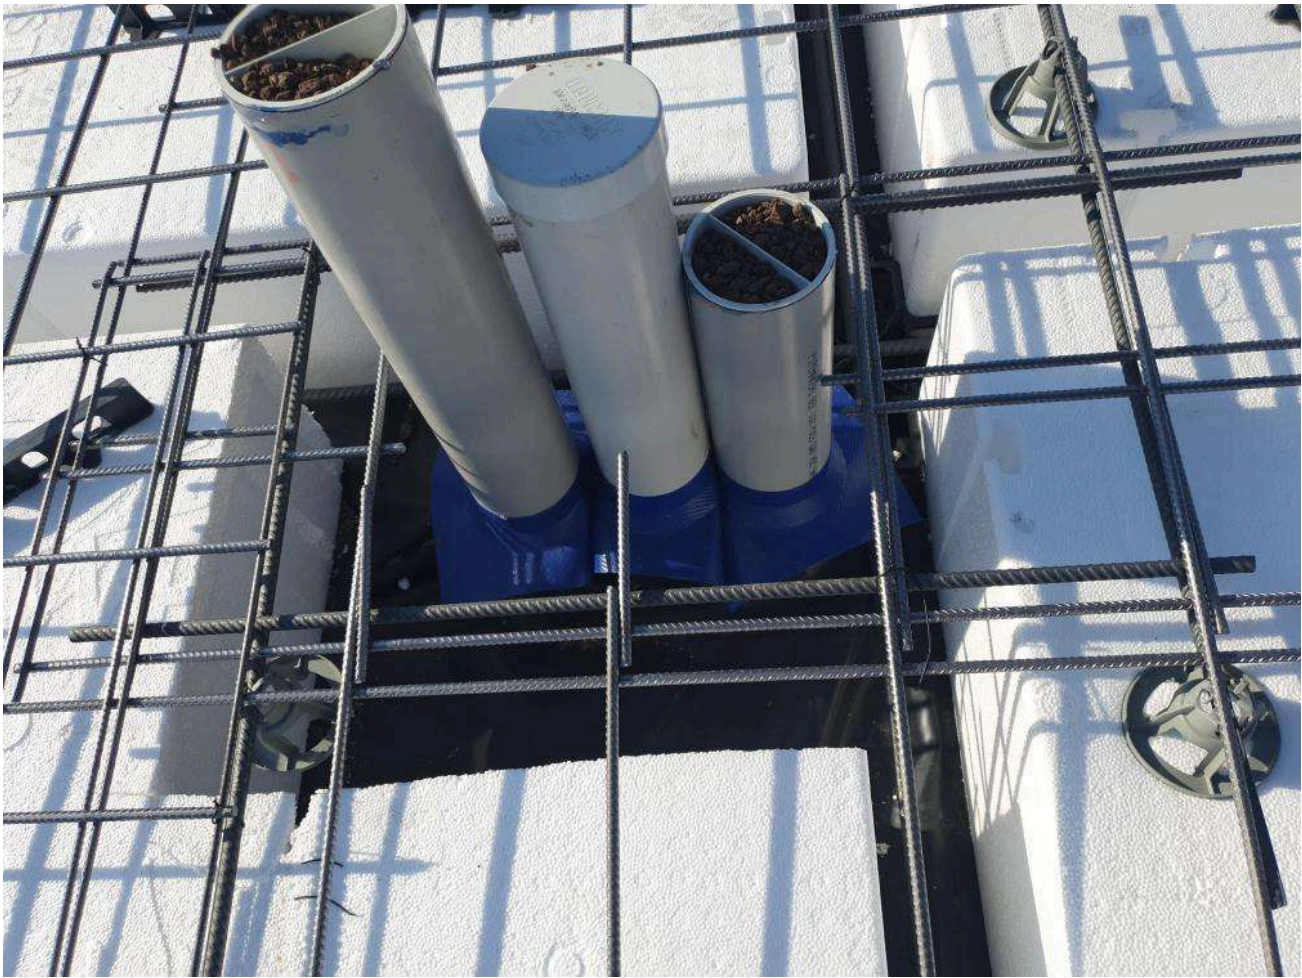
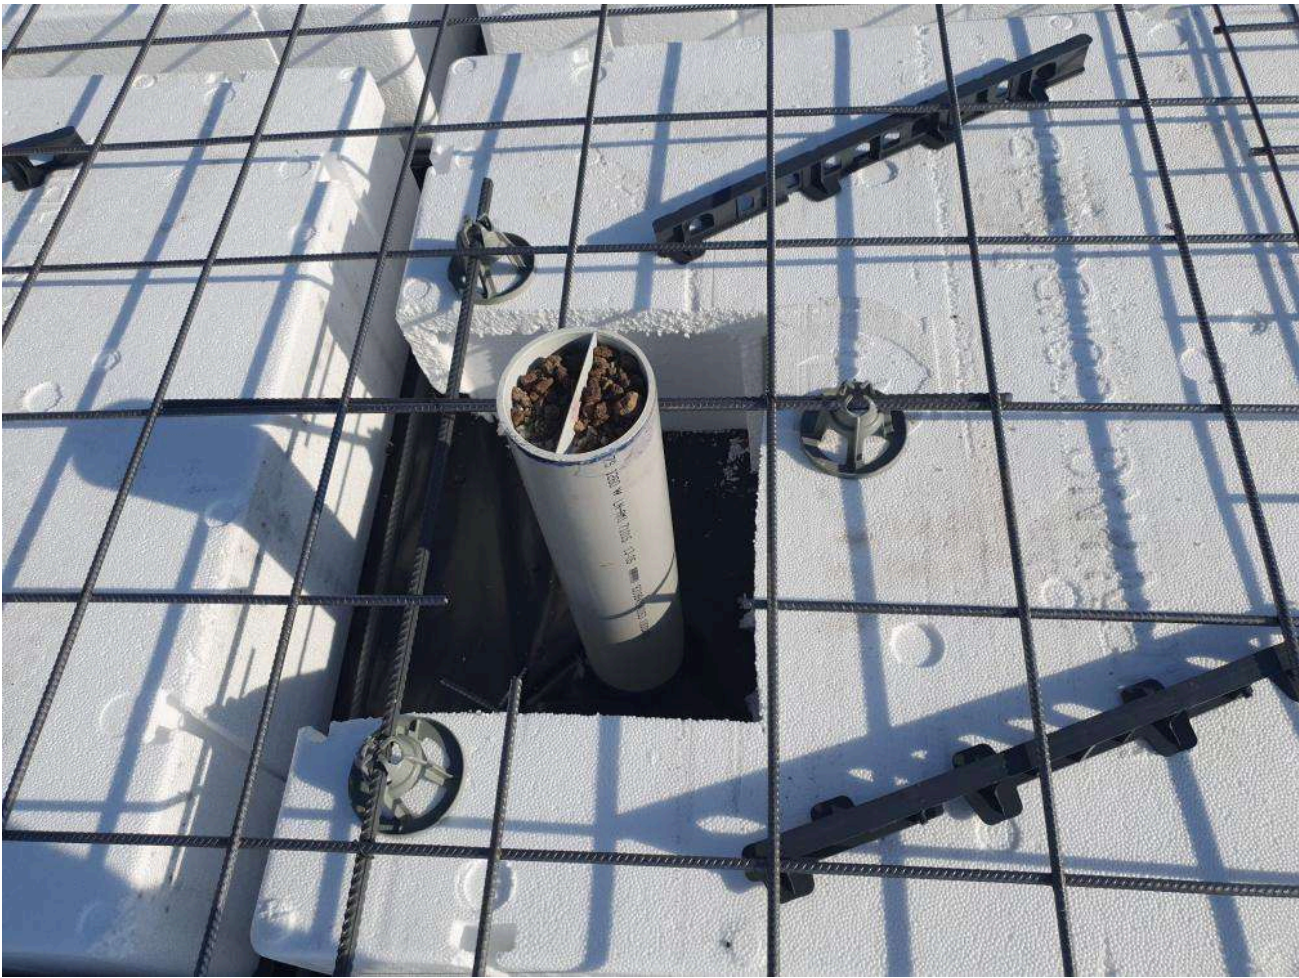
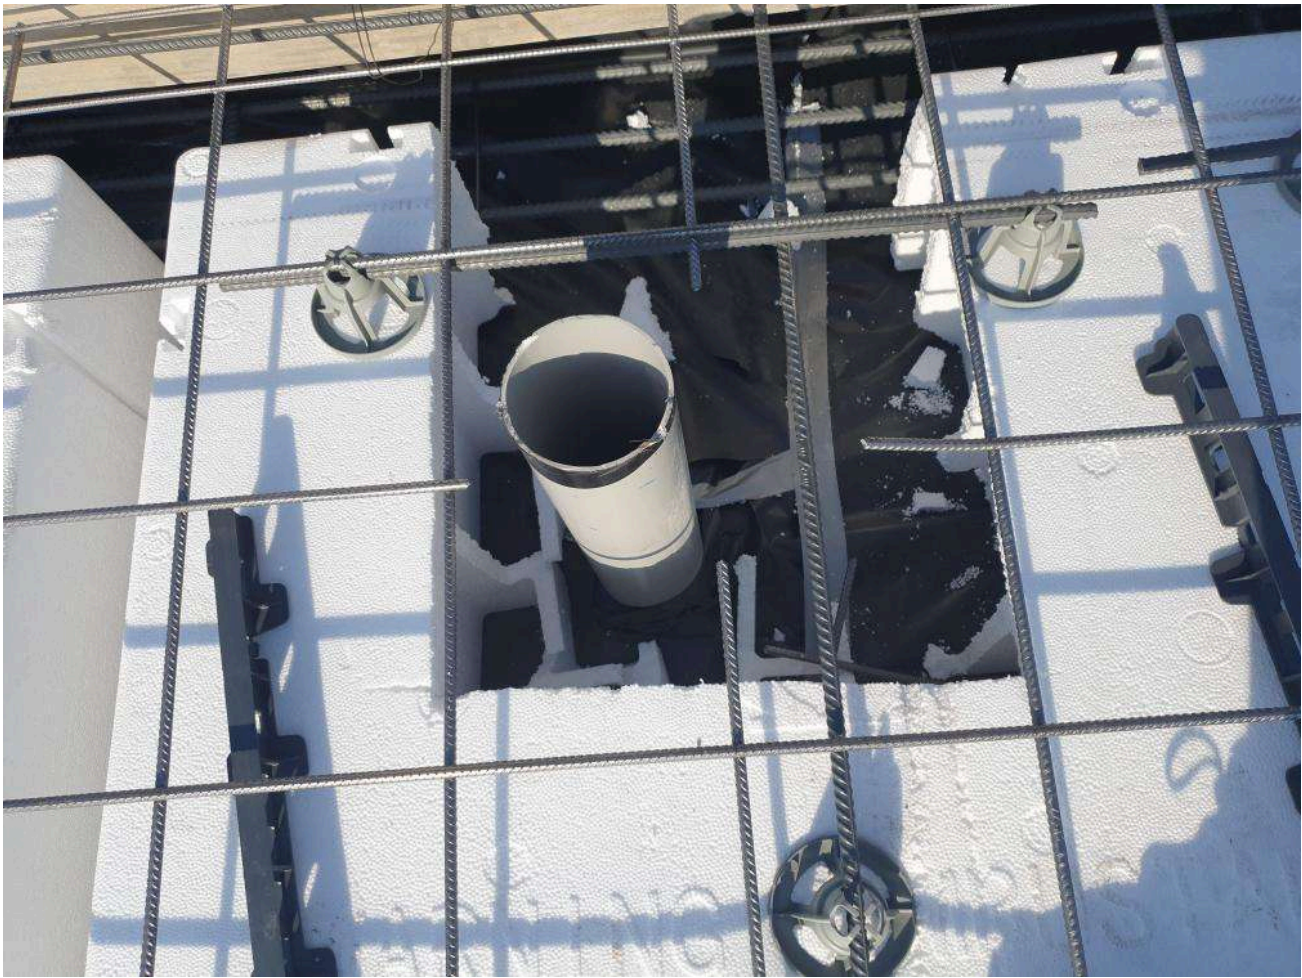
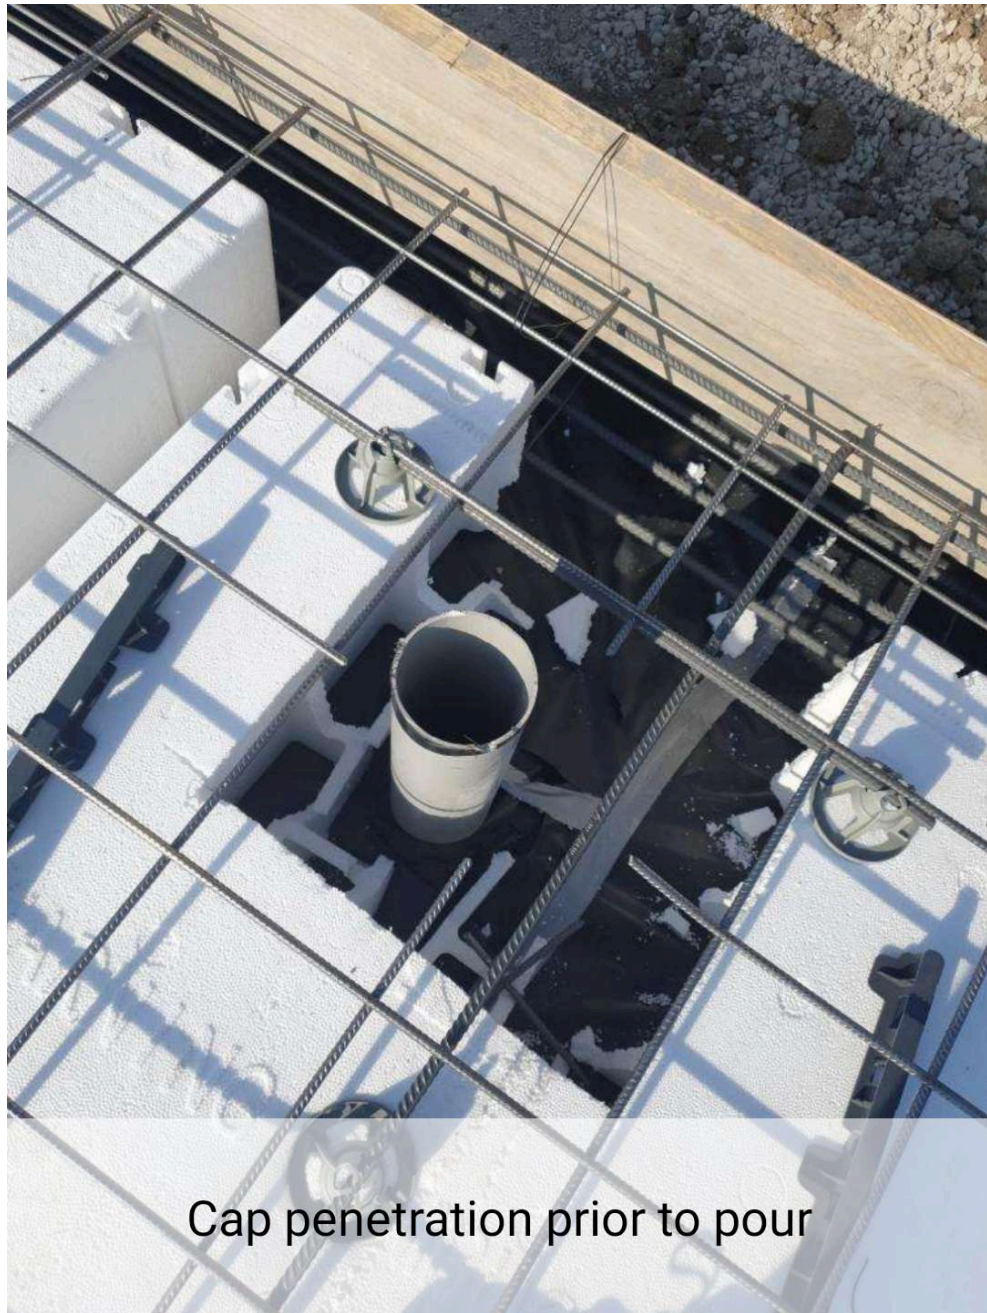
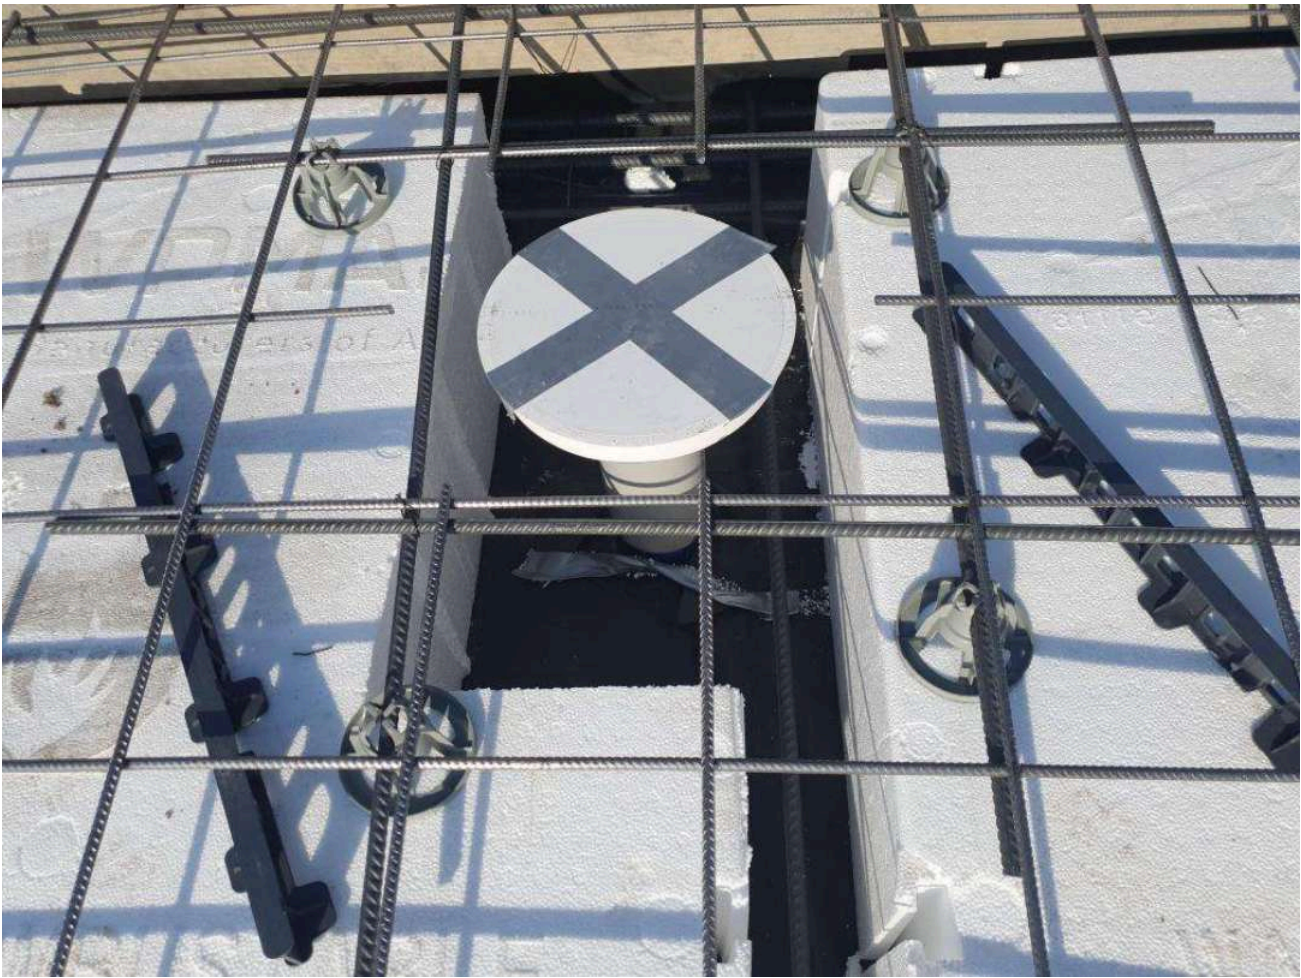
Lagging to the pipes penetrations has not been installed.

We recommend that the builder ensures that all lagging is installed as per **AS2970-2011 Residential Slab and Footings** prior to concrete pour.

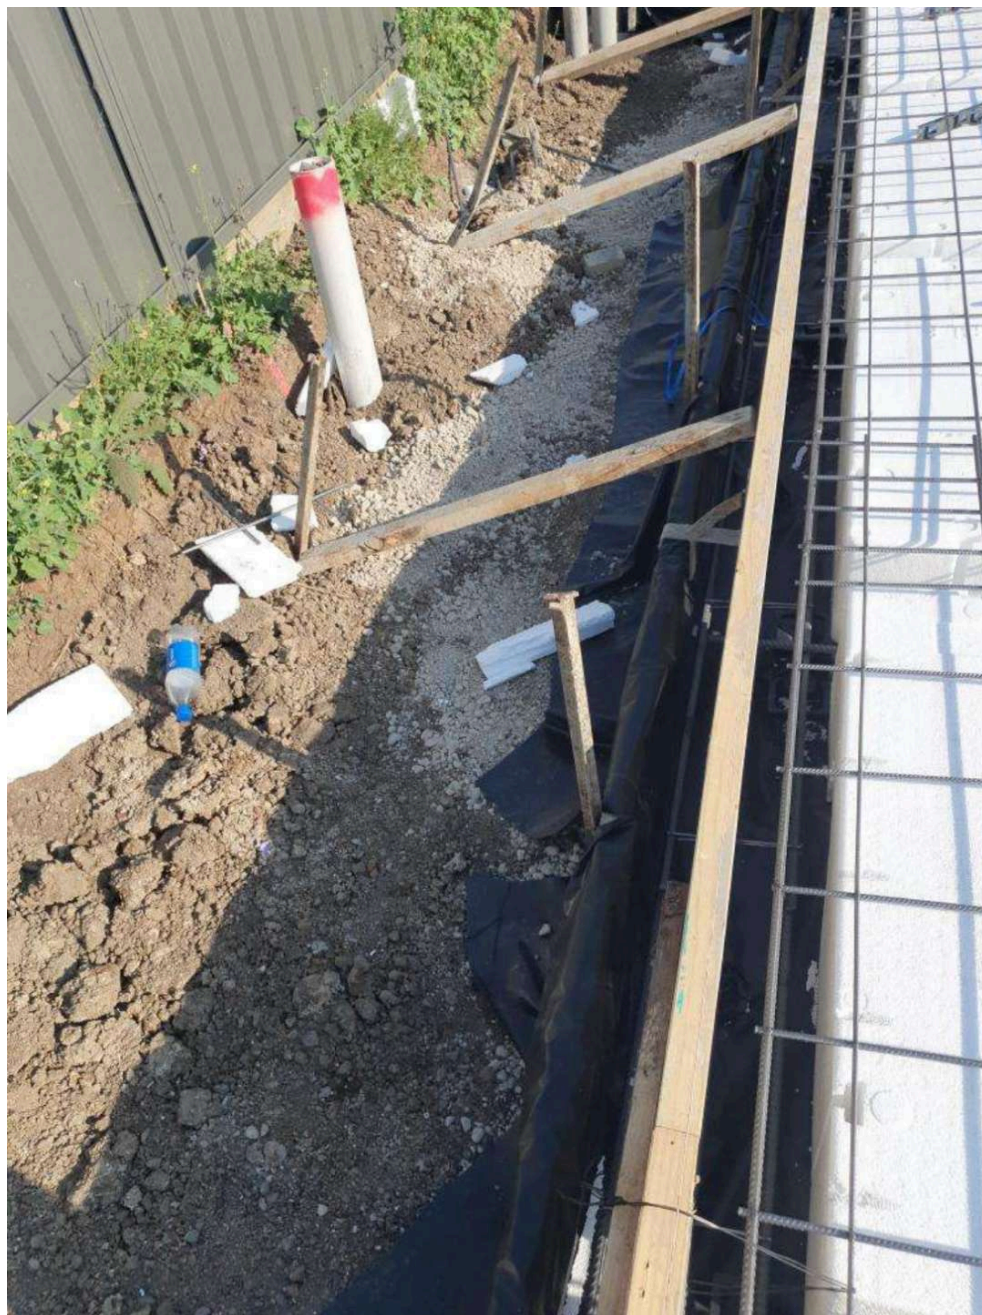
The site preparation has been carried out which will promote water pooling to the external perimeter of the concrete slab.

We recommend that on completion of the pour, that external grading away from the slab occurs to the surrounding soil.

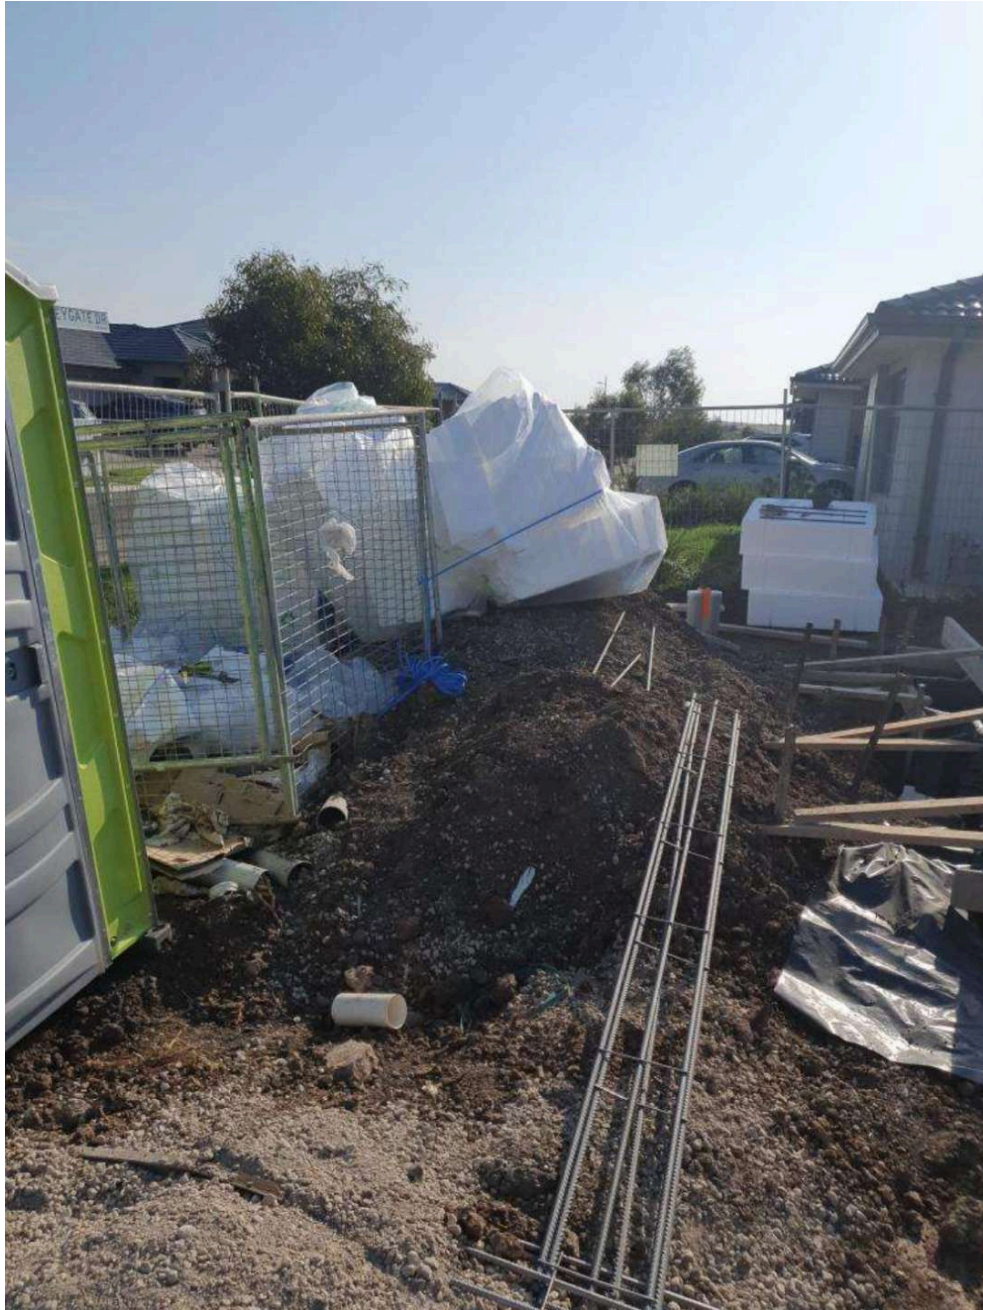
At the time of inspection, excessive spoils and/or rubbish was identified to the site.

We recommend that the area is maintained to allow safe access and movement onsite.
