Lock Up/Pre-Plaster Inspection Report

Inspect365

Inspection Address VICTORIA

Report/Agreement # 2210210847402

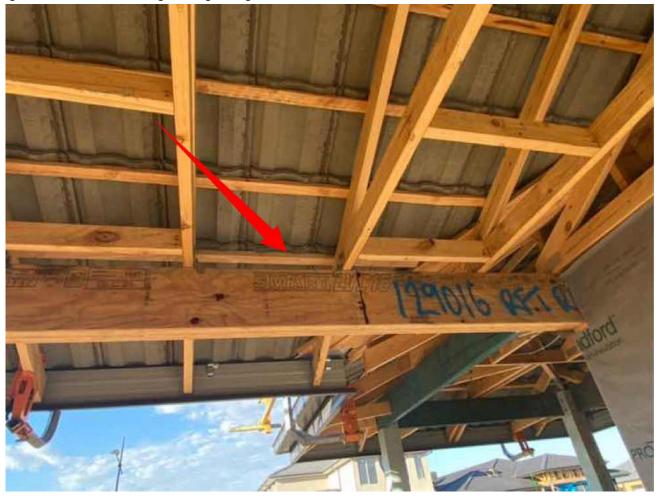
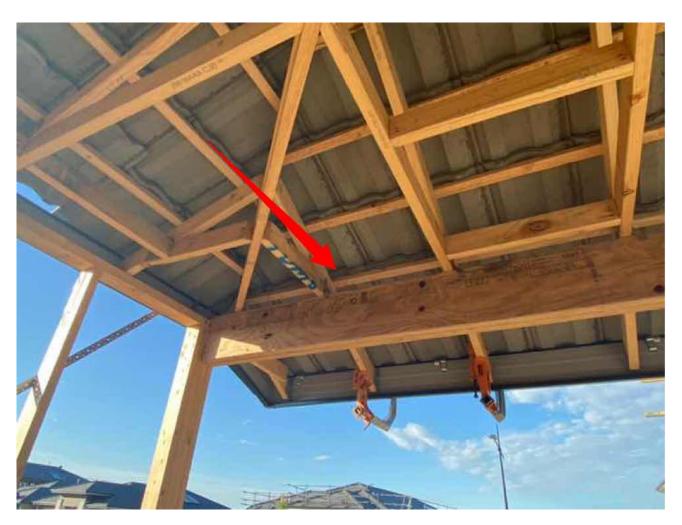
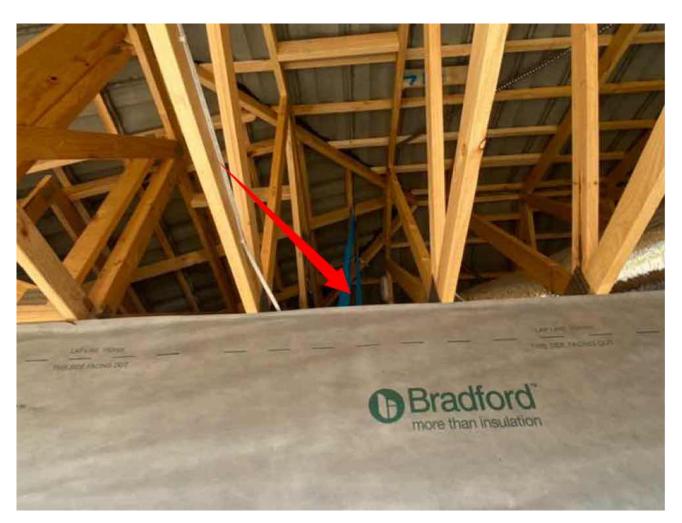
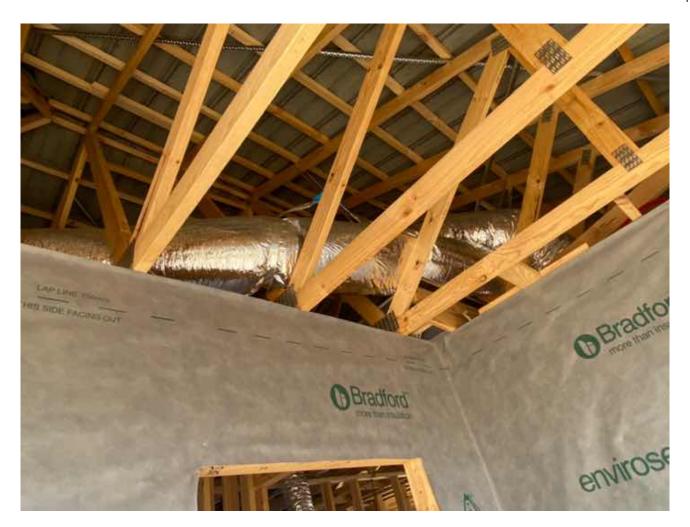
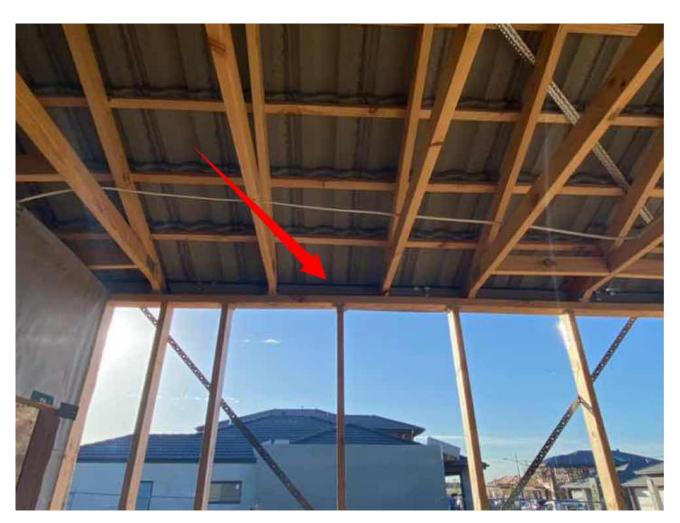
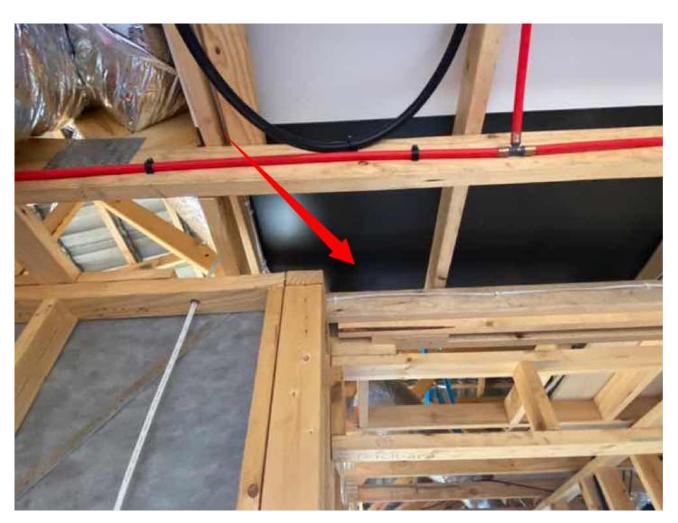
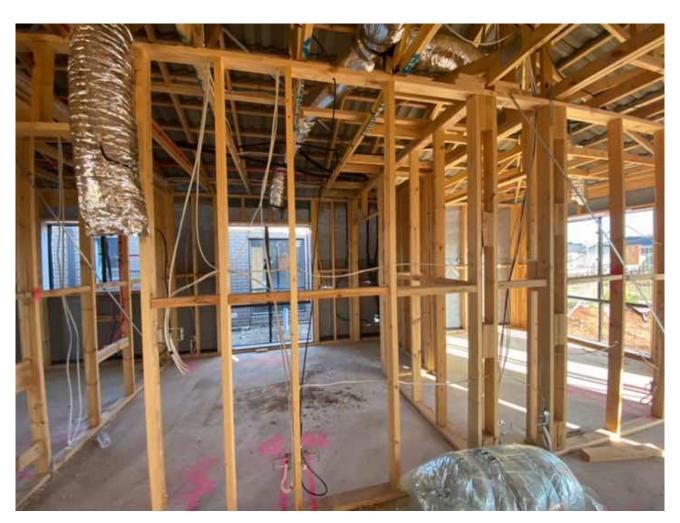
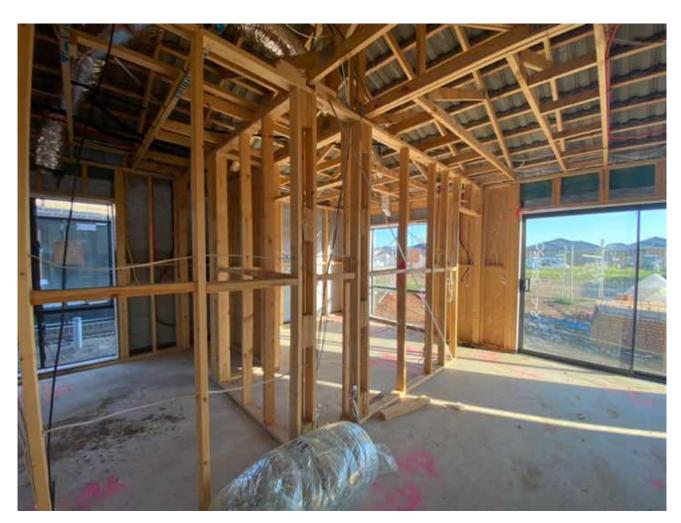
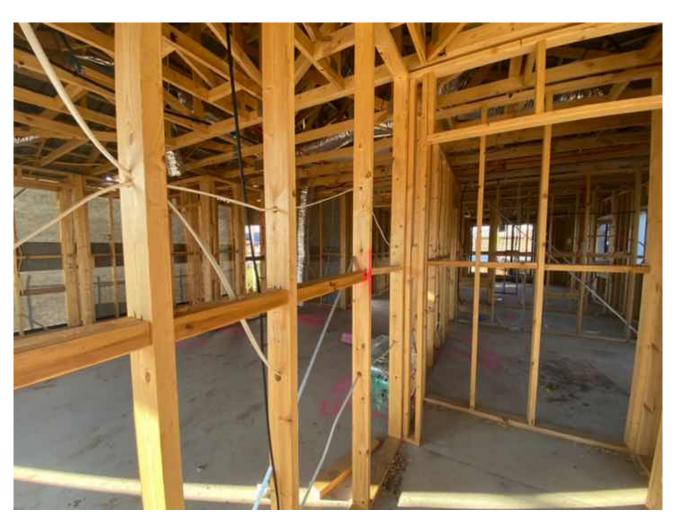
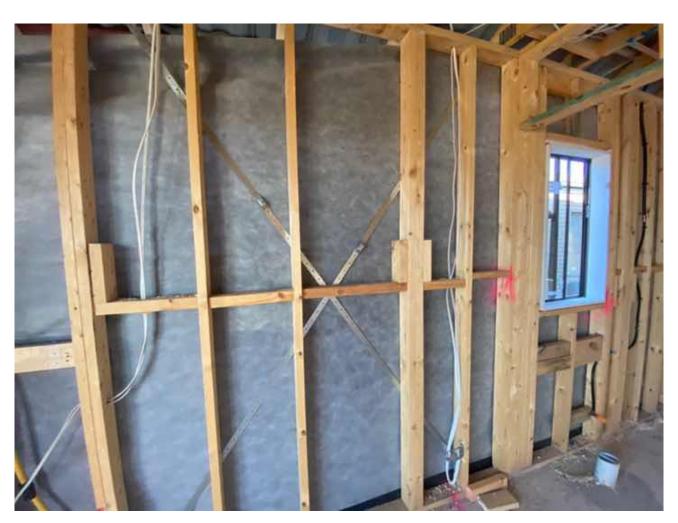
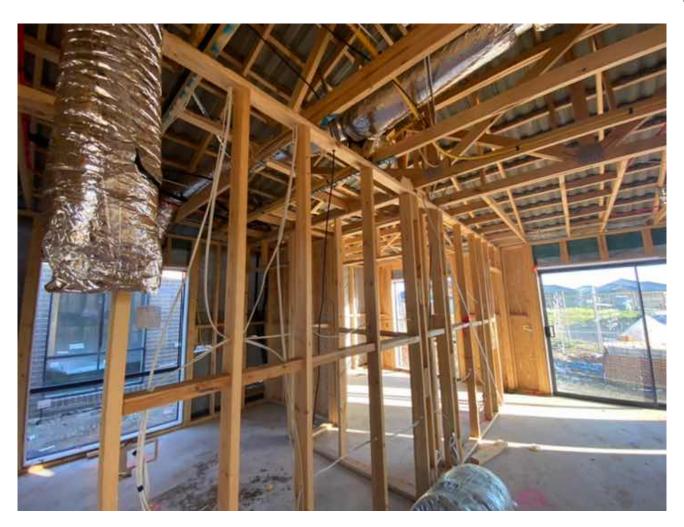
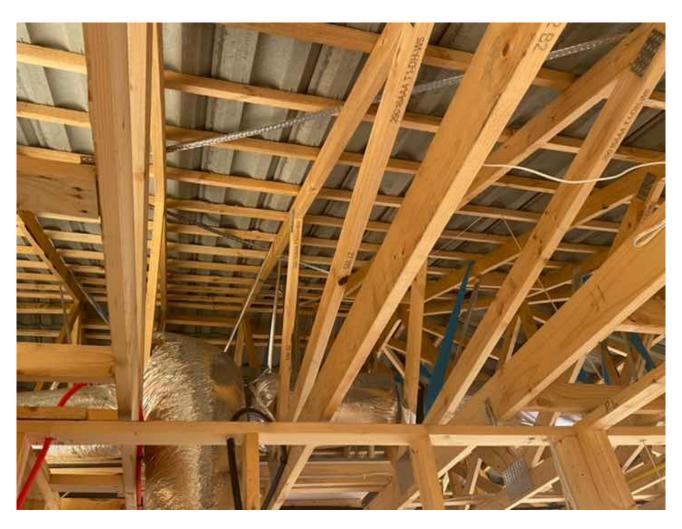
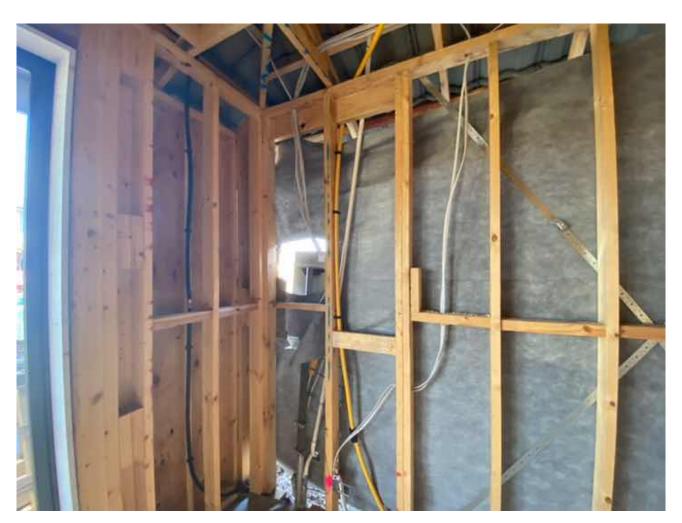
Frame Construction & Fixings

Does Not Conform With Plans.

Various wall and ceiling noggins required, including garage.

No signs of the wall or ceilings being straightened.

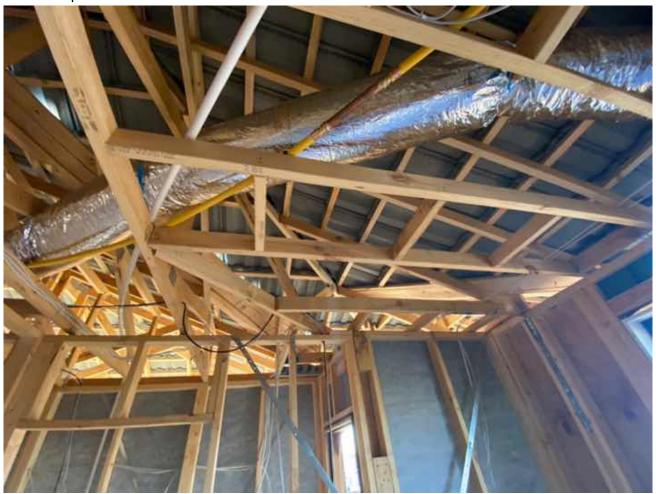
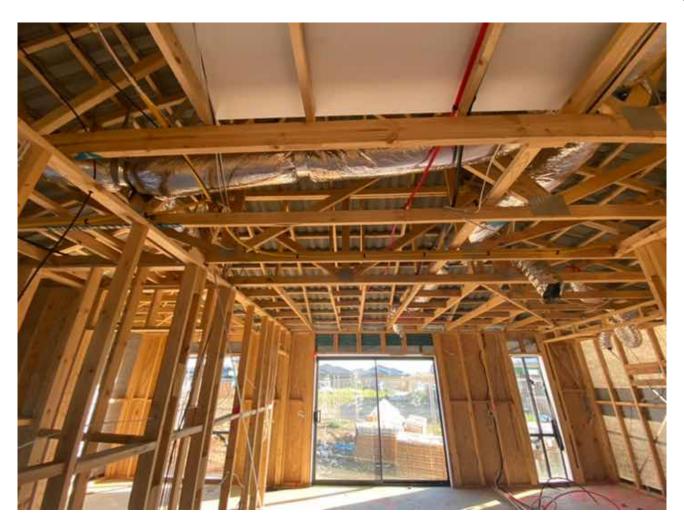
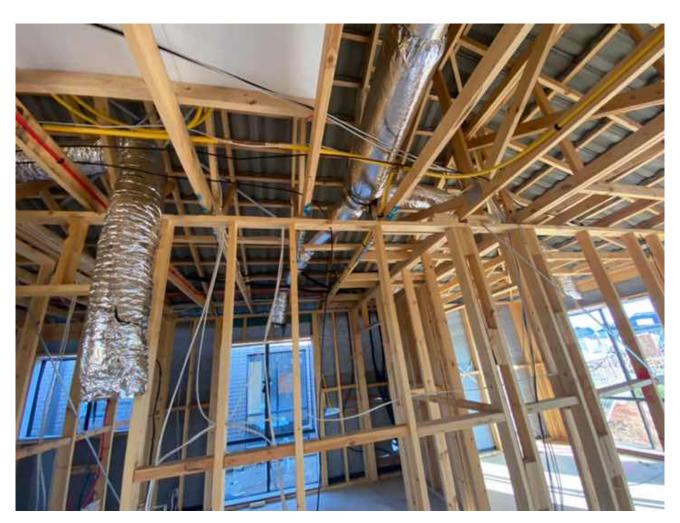
Heating & cooling ducting

Conforms with plans

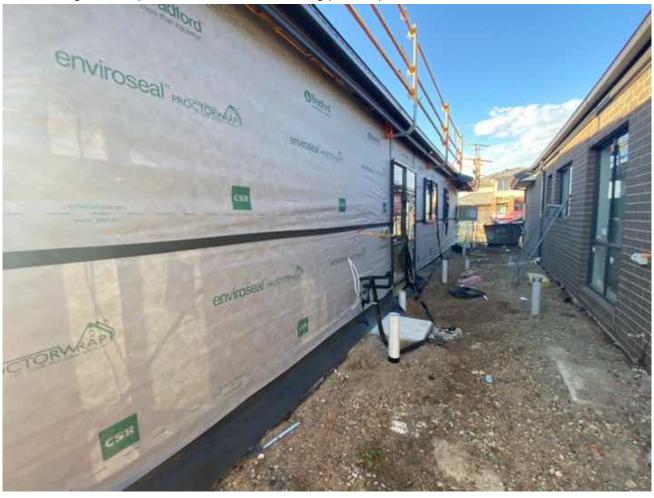
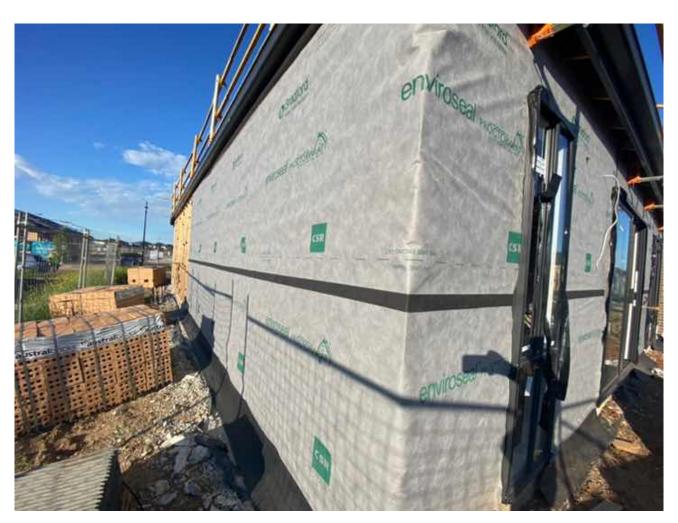
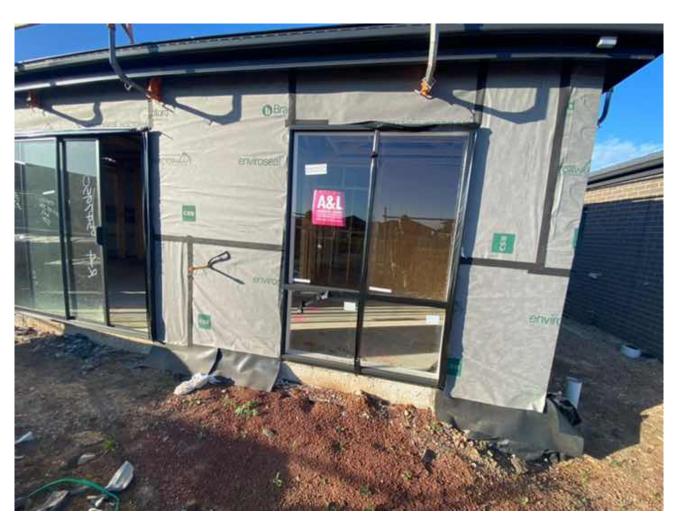
External cladding

Does Not Conform With Plans.

Exterior cladding not completed, recommend installing prior to plaster.

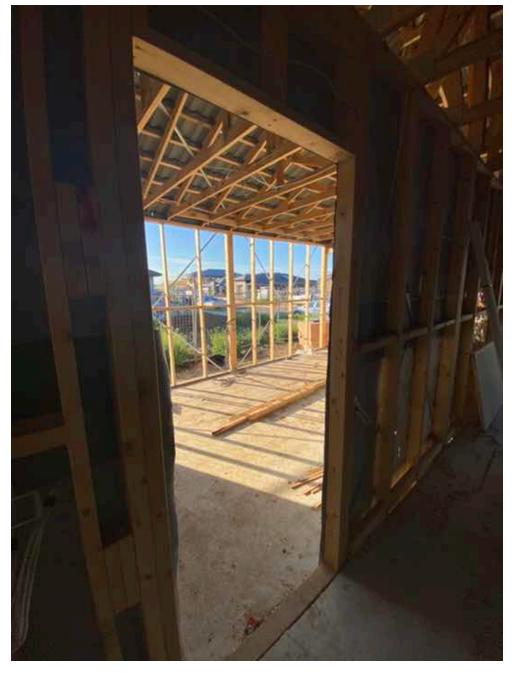
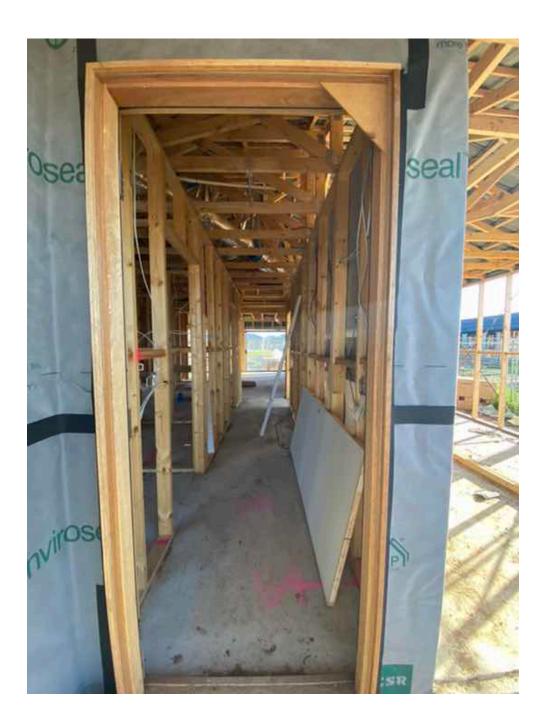
Doors

Does Not Conform With Plans.

Temporary doors not installed.

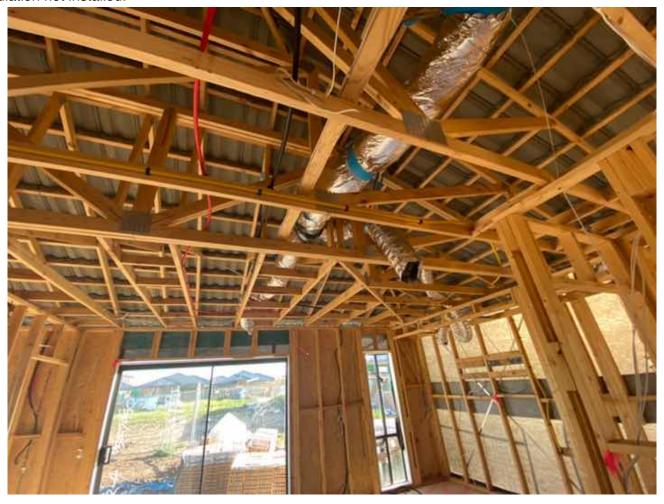
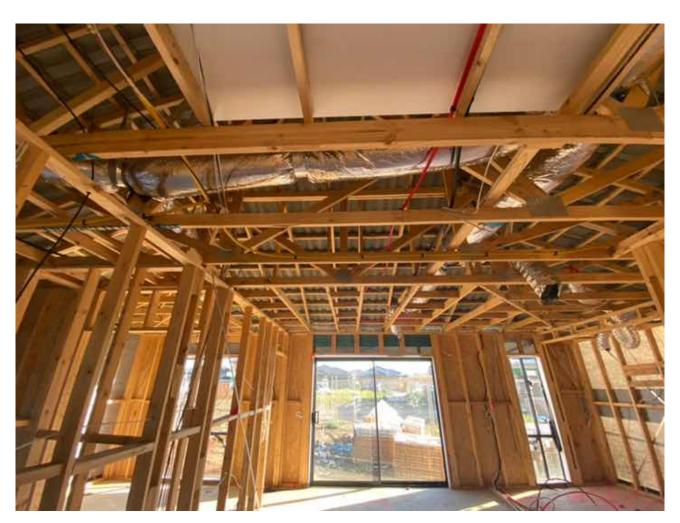
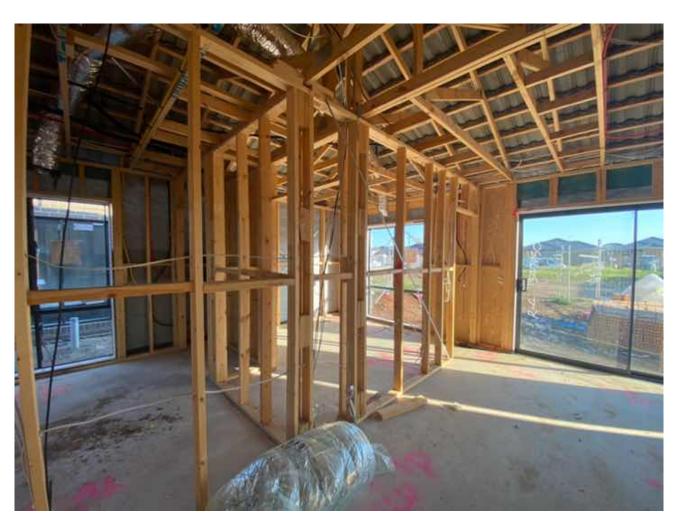
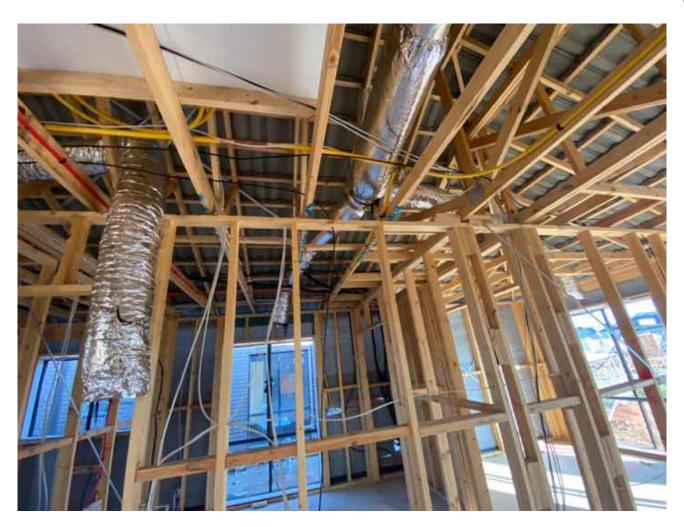
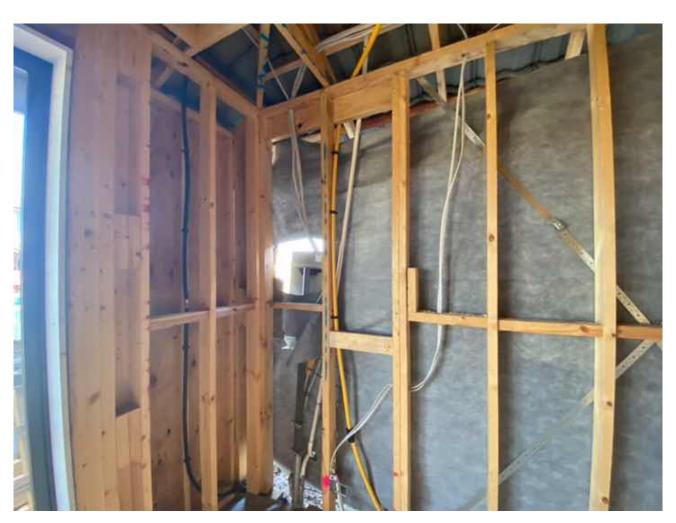
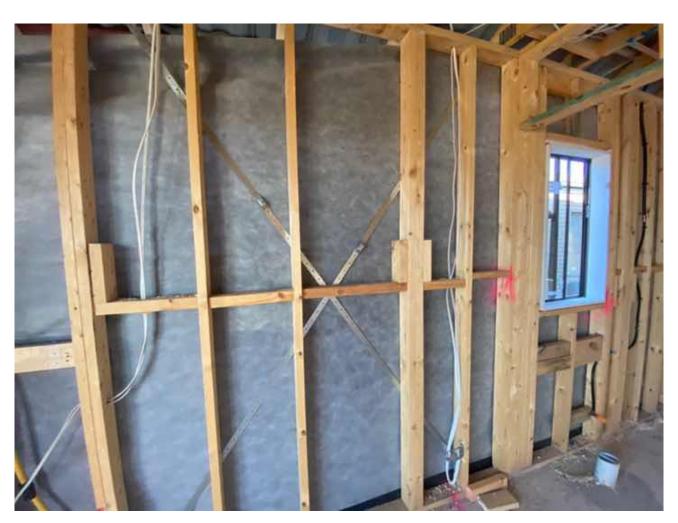
Does Not Conform With Plans.

Insulation not installed.

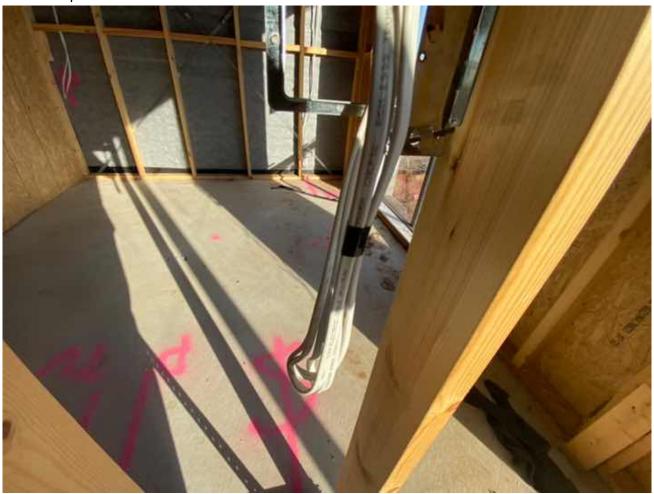
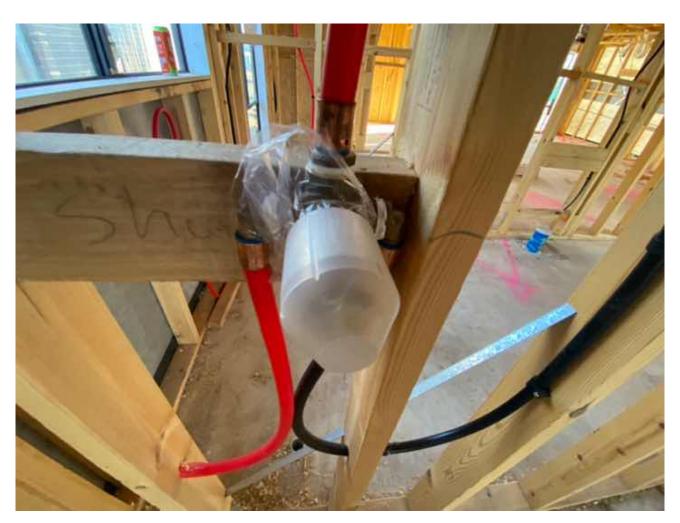
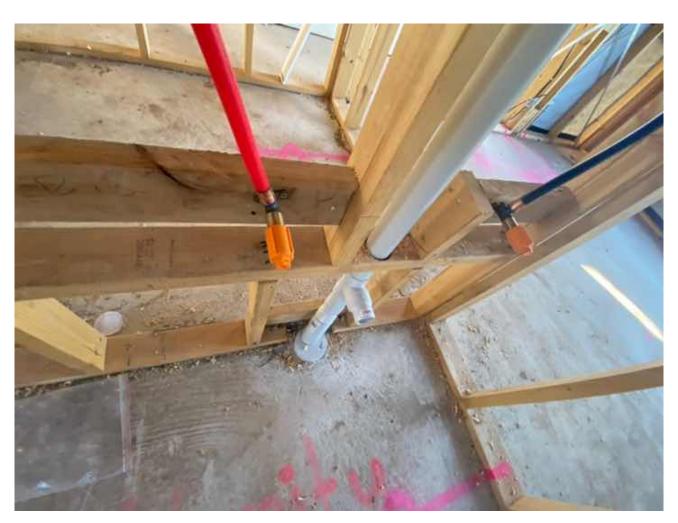
Plumbing & elctrical services

Conforms with plans

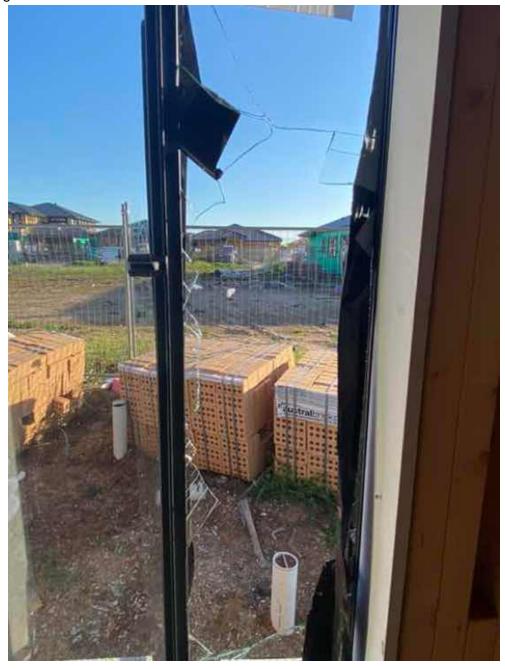
Glazing

Does Not Conform With Plans.

Broken pane of glass.

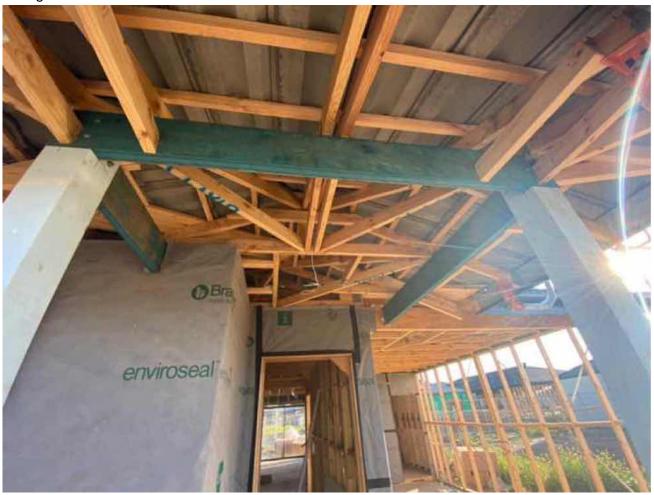
Eave linigs

Does Not Conform With Plans.

Eave linings not installed.
