Post Slab Defect Inspection (No pre-slab carried out)

Inspect365

VICTORIA

Inspection Date: 18 Nov 2021

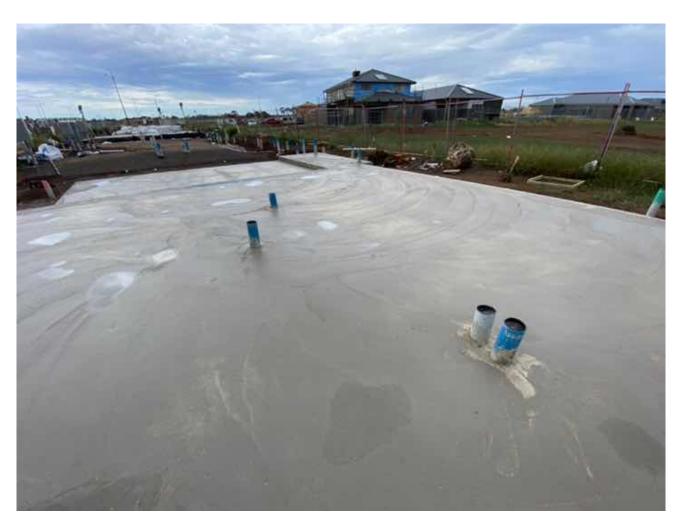
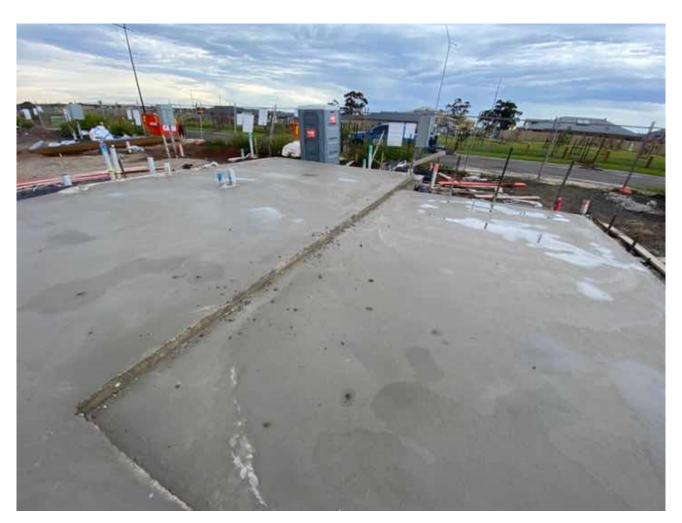
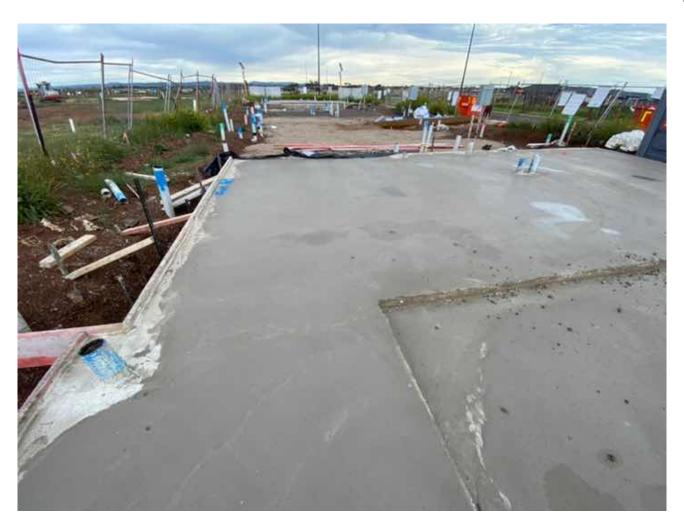
Obstructions and Inaccessible Areas

Concrete slab obstructing waffle pods, steel work and preparation for this stage.

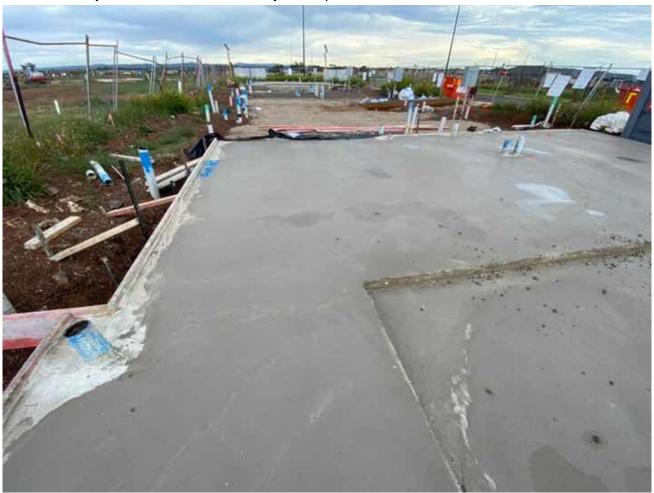
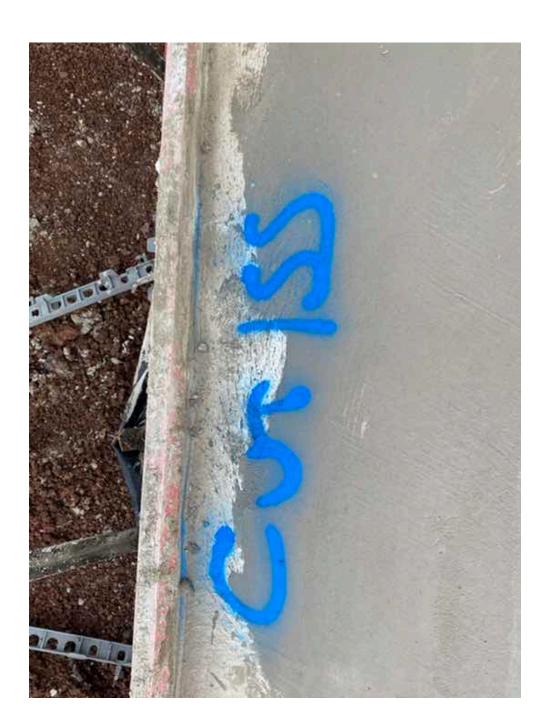
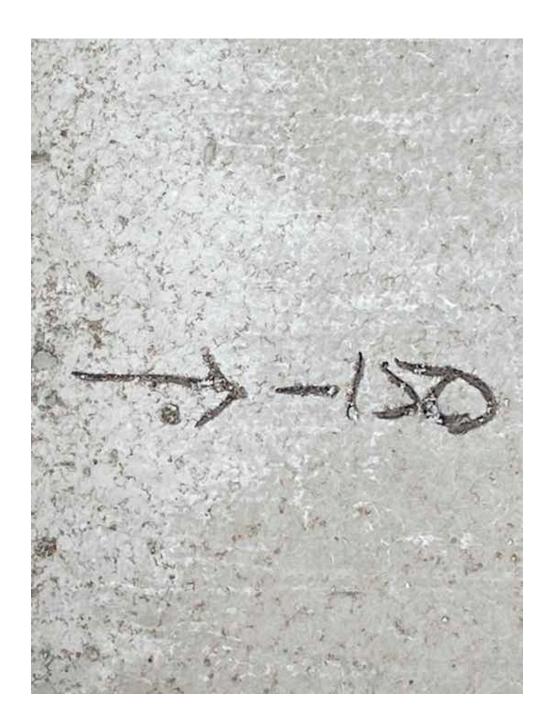
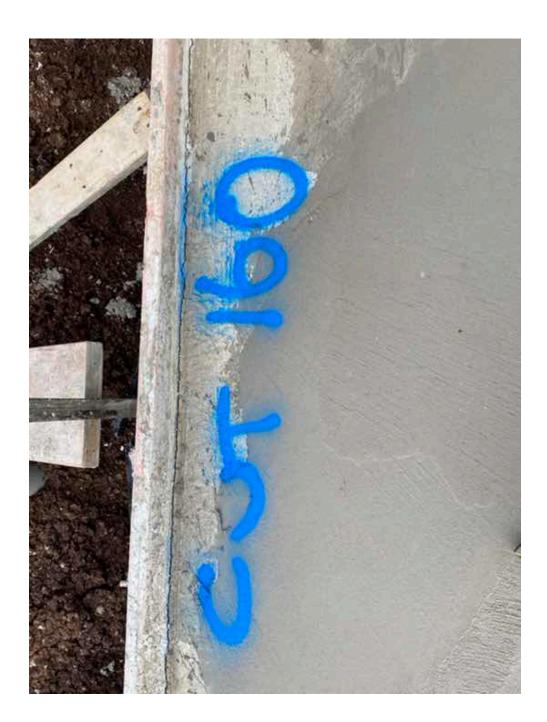
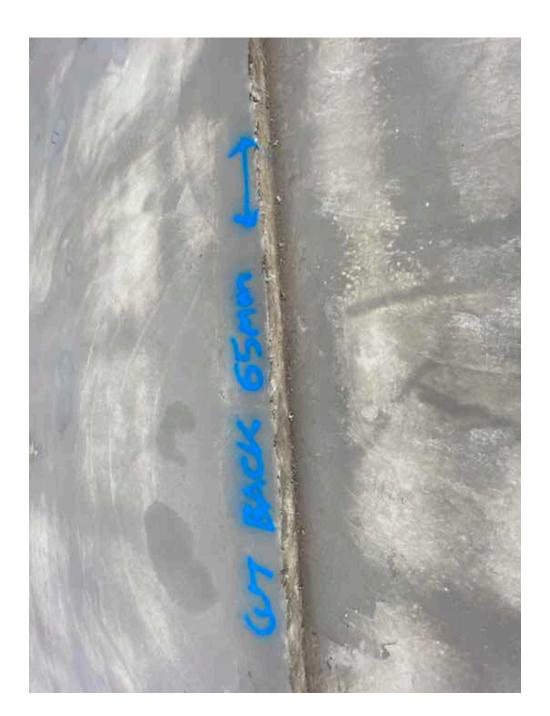
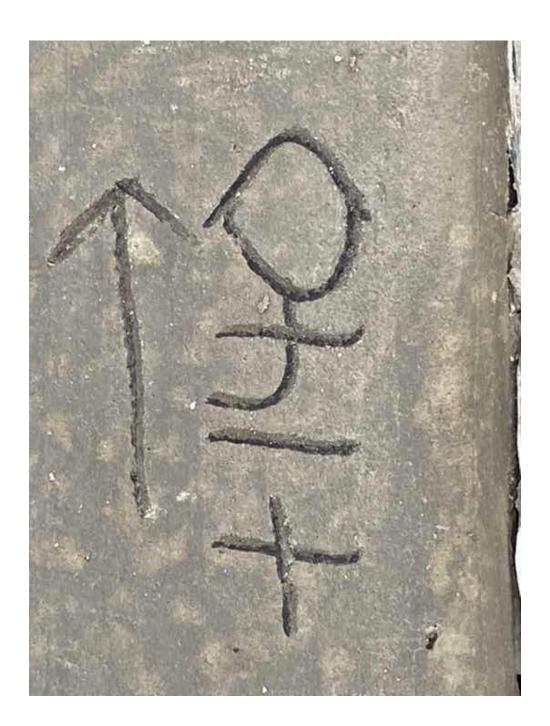
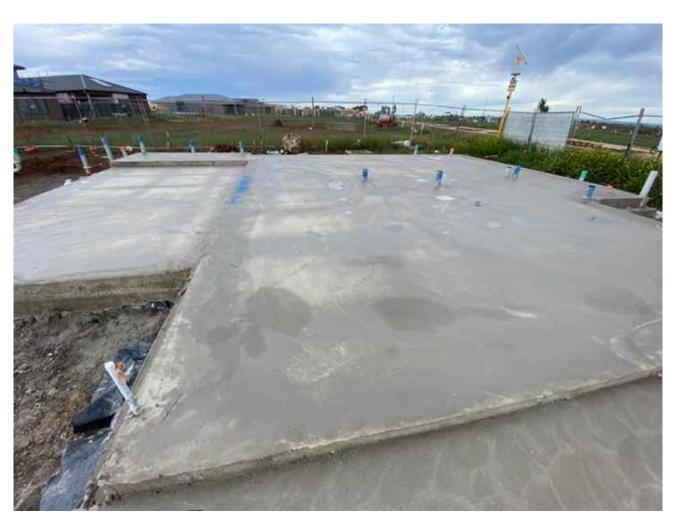
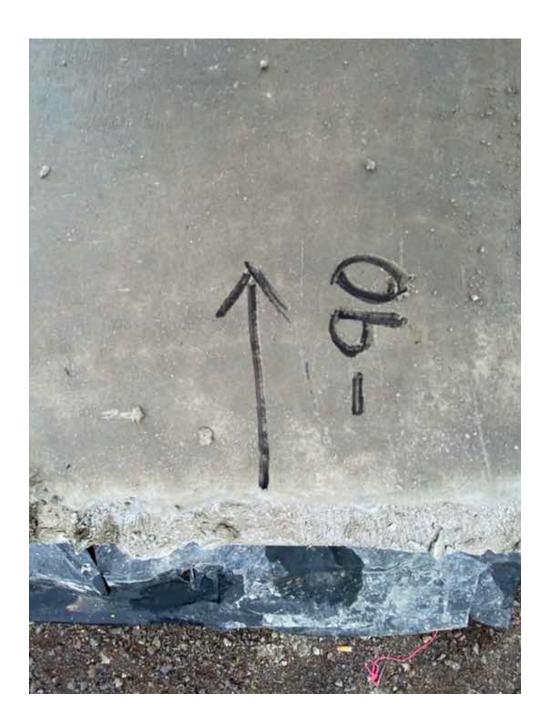
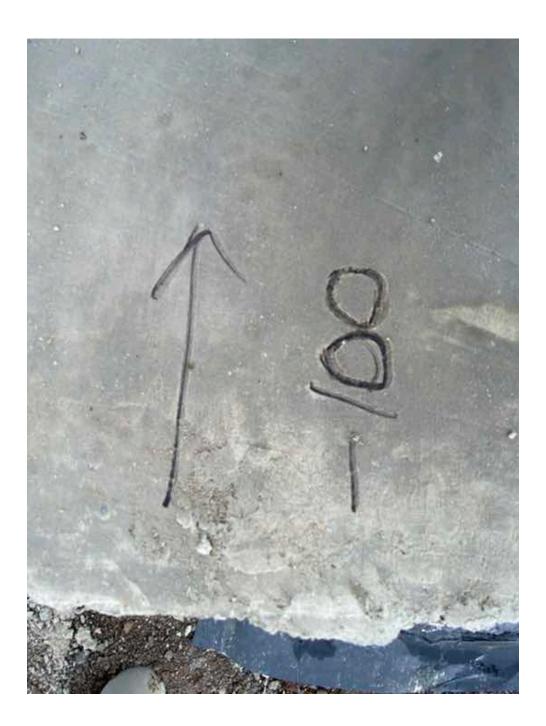
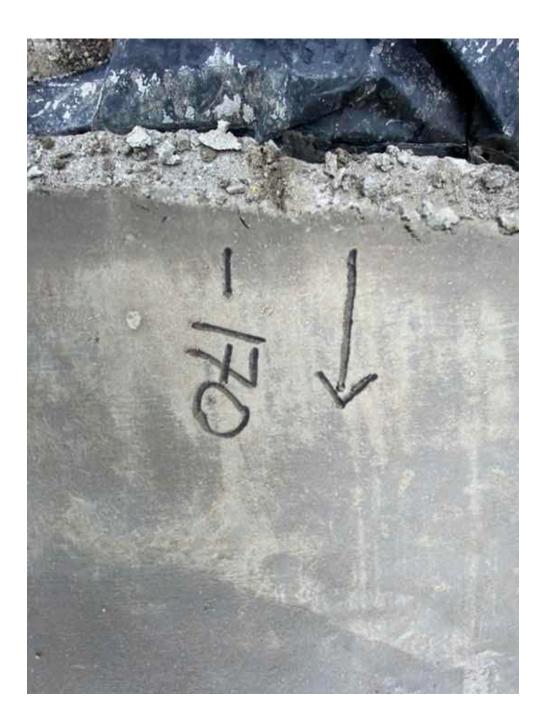
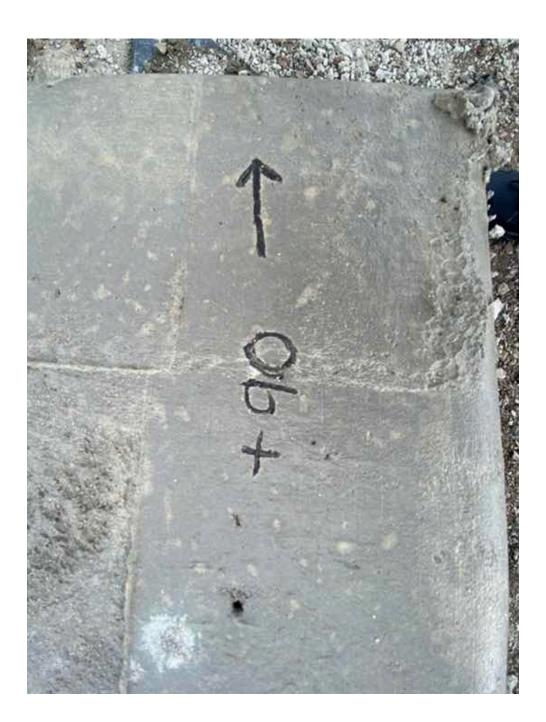
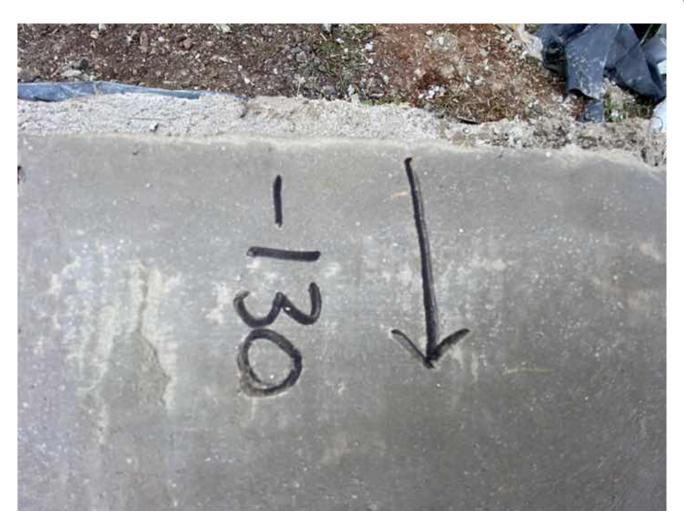
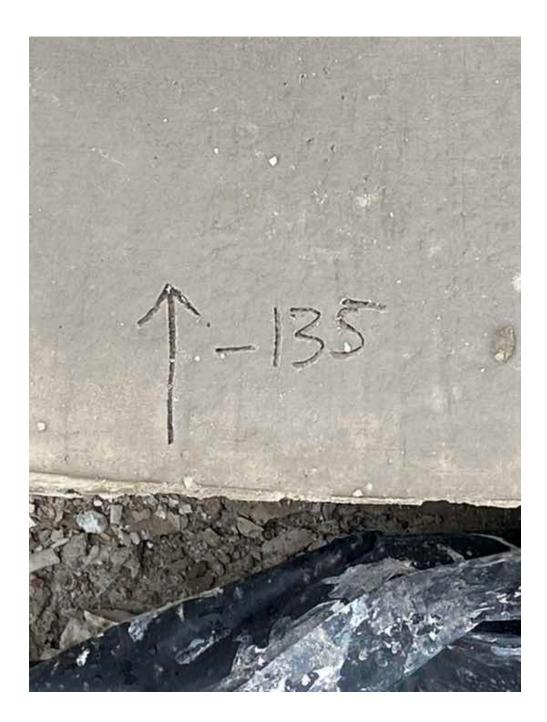
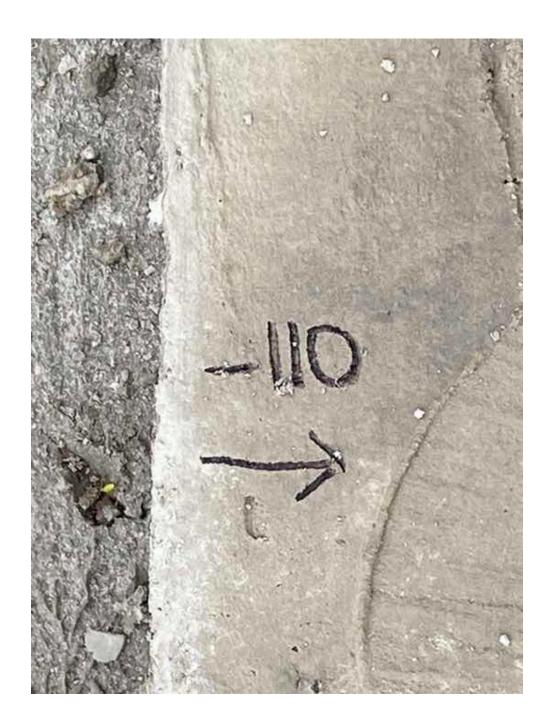
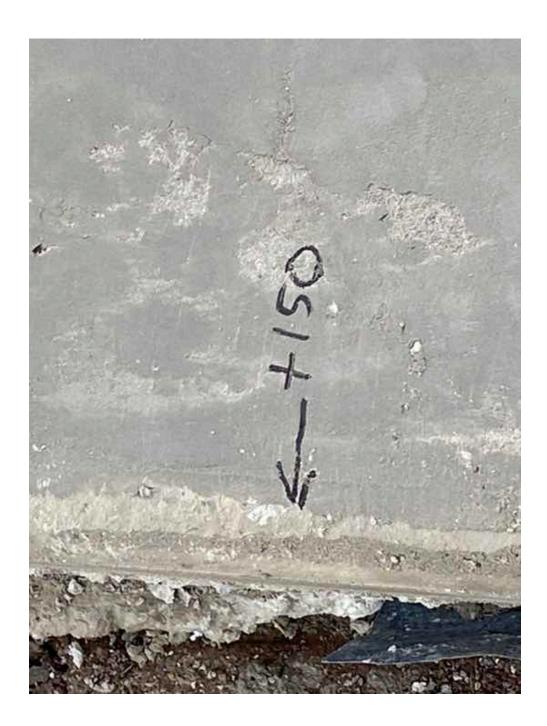
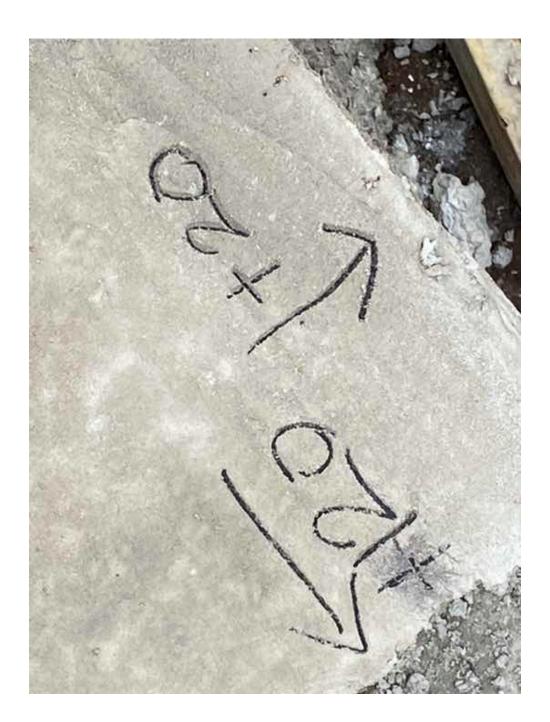
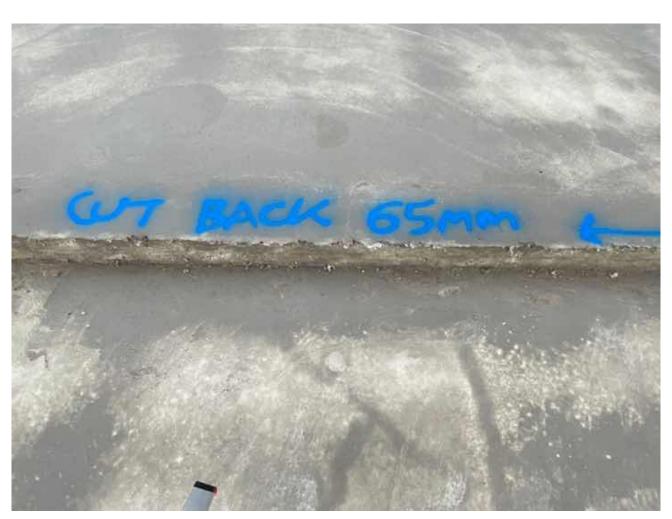
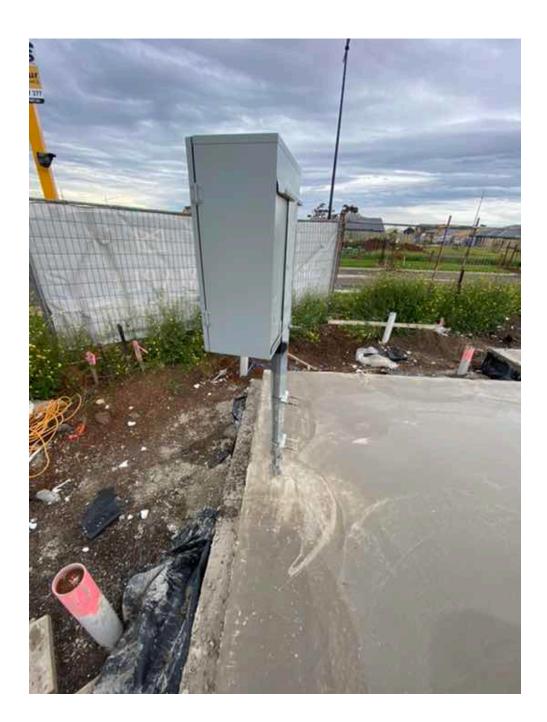
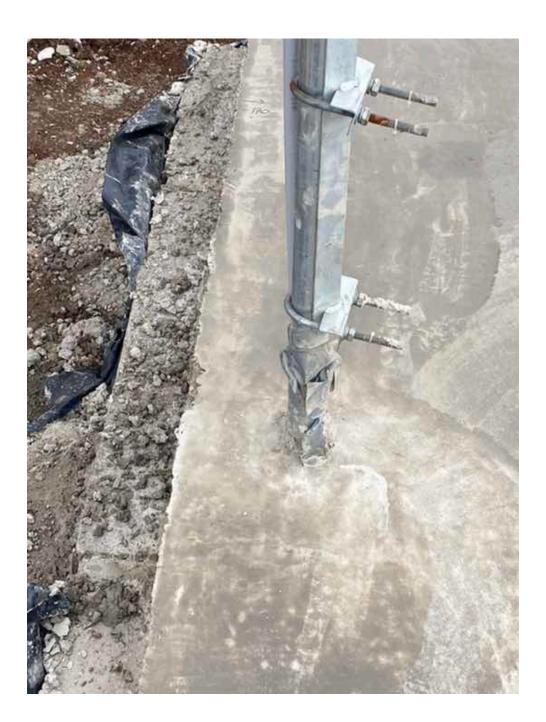
Layout

Does Not Conform With Plans.

At the time of my inspection I noted a large amount of diagrams and measurements marked on the concrete slab, these markings are indicating areas in the slab that need to be cut back or extended, if this is the case I recommend the building surveyor assess to determine if this can be completed without compromising the structural integrity of the slab, steel work and waffle pods.

I mark this as a major defect due to the severity of the problem.
