Waterproof Stage Inspection

Sample, Hillside, VIC, 3037

Fixing and water proofing

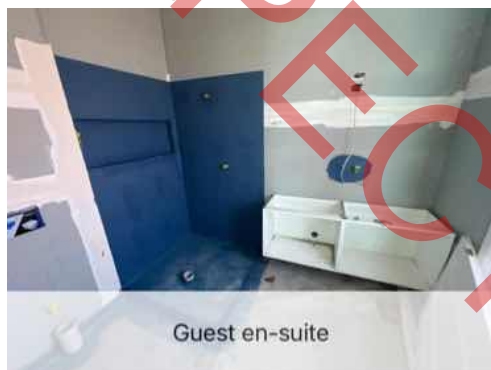
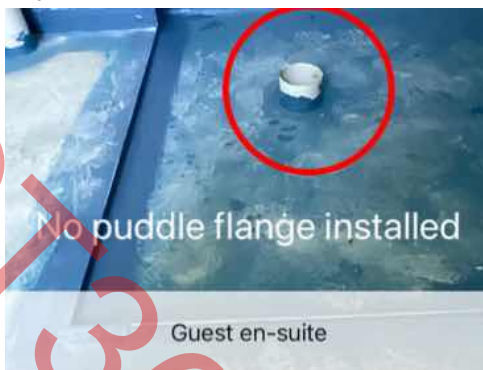
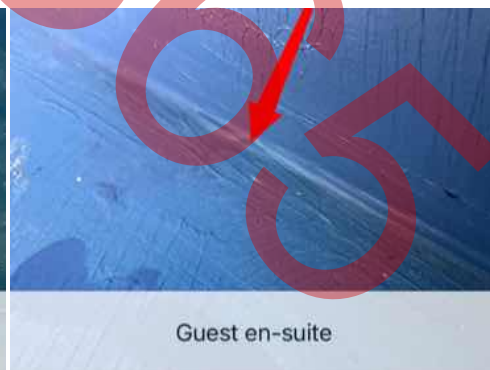
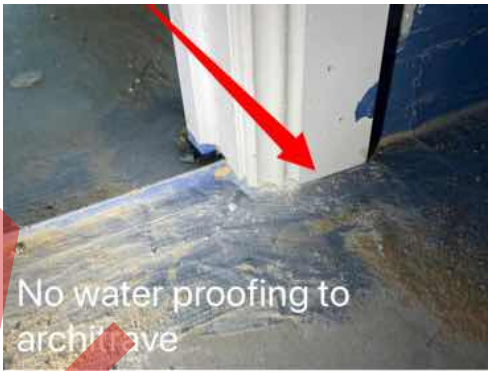
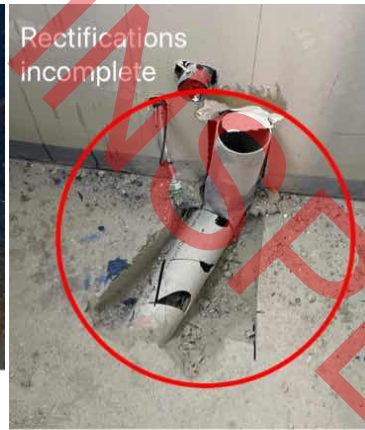
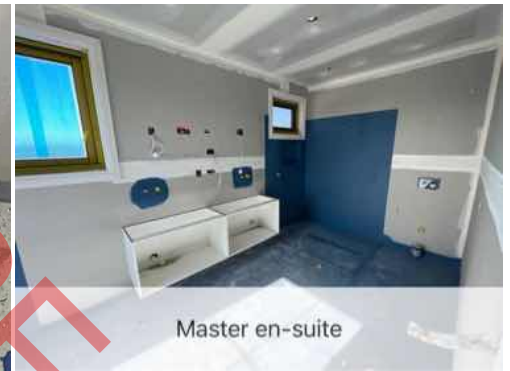
Bath

The door architraves and jambs within the wet areas need to be fully waterproofed around them up to the same height as the top of the door opening waterstop or be cut short to the floor to finish no lower than the top of the door opening waterstop and the waterproofing then needs to be continuous around to the wall to floor junction from the water stop to ensure a continuous seal between the perimeter flashing and the waterstop.

General workmanship is below the Acceptable Standard.

There has been no waterproofing applied above the vessel/sink area - shower window

The puddle flange is not installed.

Recommend adding tape/sealing around penetrations/wall/floor junctions.

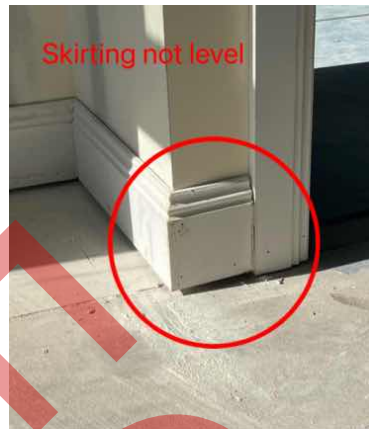
Master bedroom

The skirting is not installed in areas. We understand this will be completed after the installation of floor tiles.

The cabinetry installation is incomplete

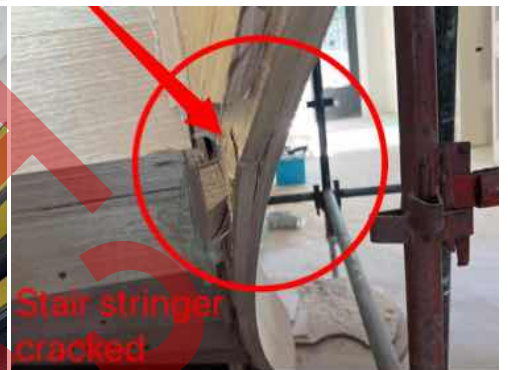
The stair stringer is cracked and may have compromised the structural integrity of the stair case.

Stair stringer cracked

Recommend to seek structural integrity certification for stair stringer from relevant specialist/engineer.
