# Post Completion Defect Inspection Report

**Example, VICTORIA, 3024**

Report/Agreement #              0807210944395

Inspection Date:                  08 Jul 2021

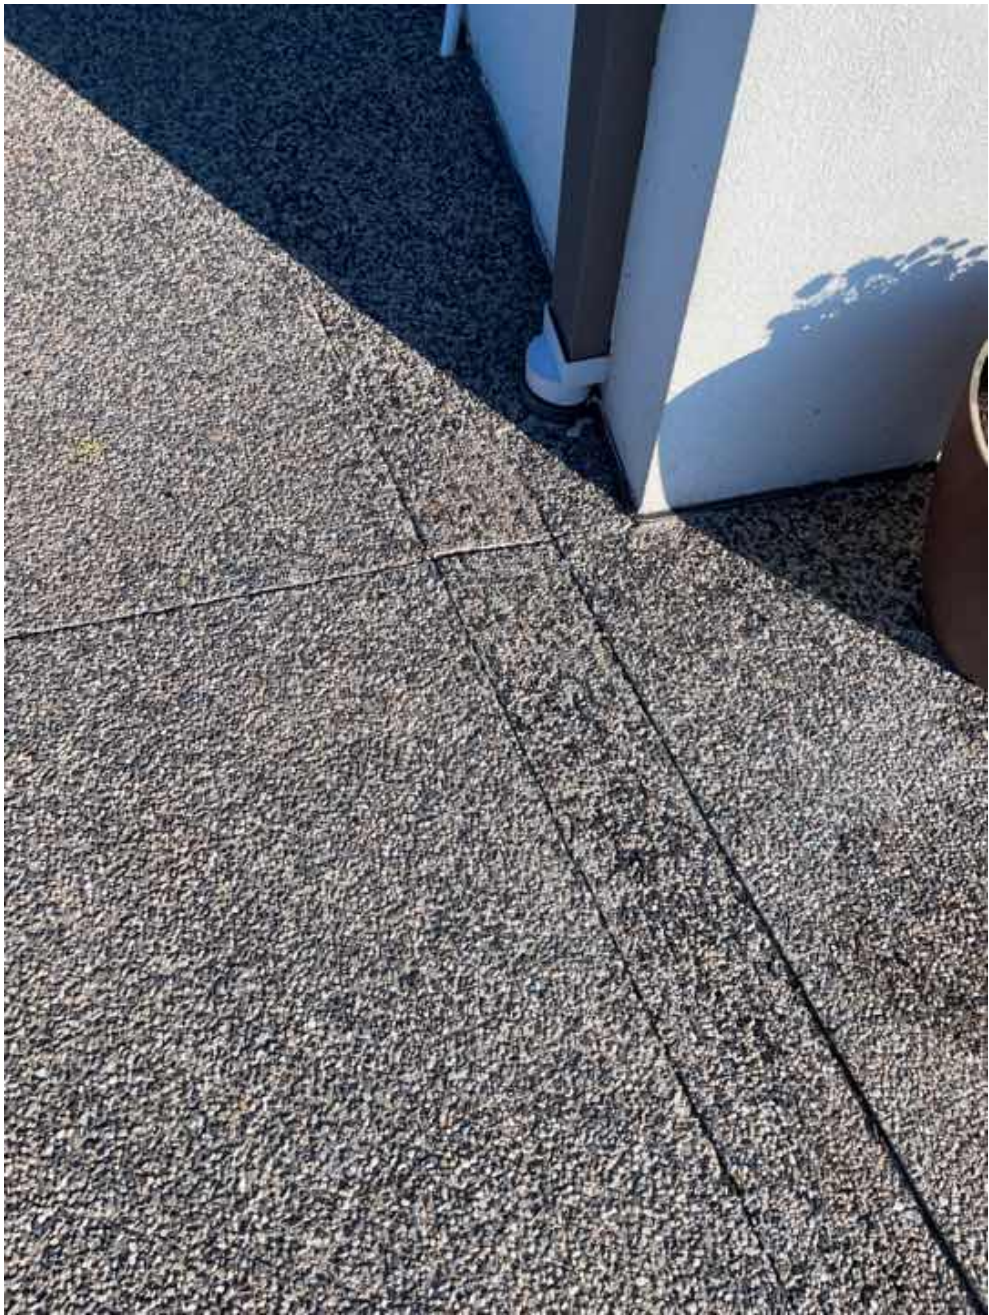
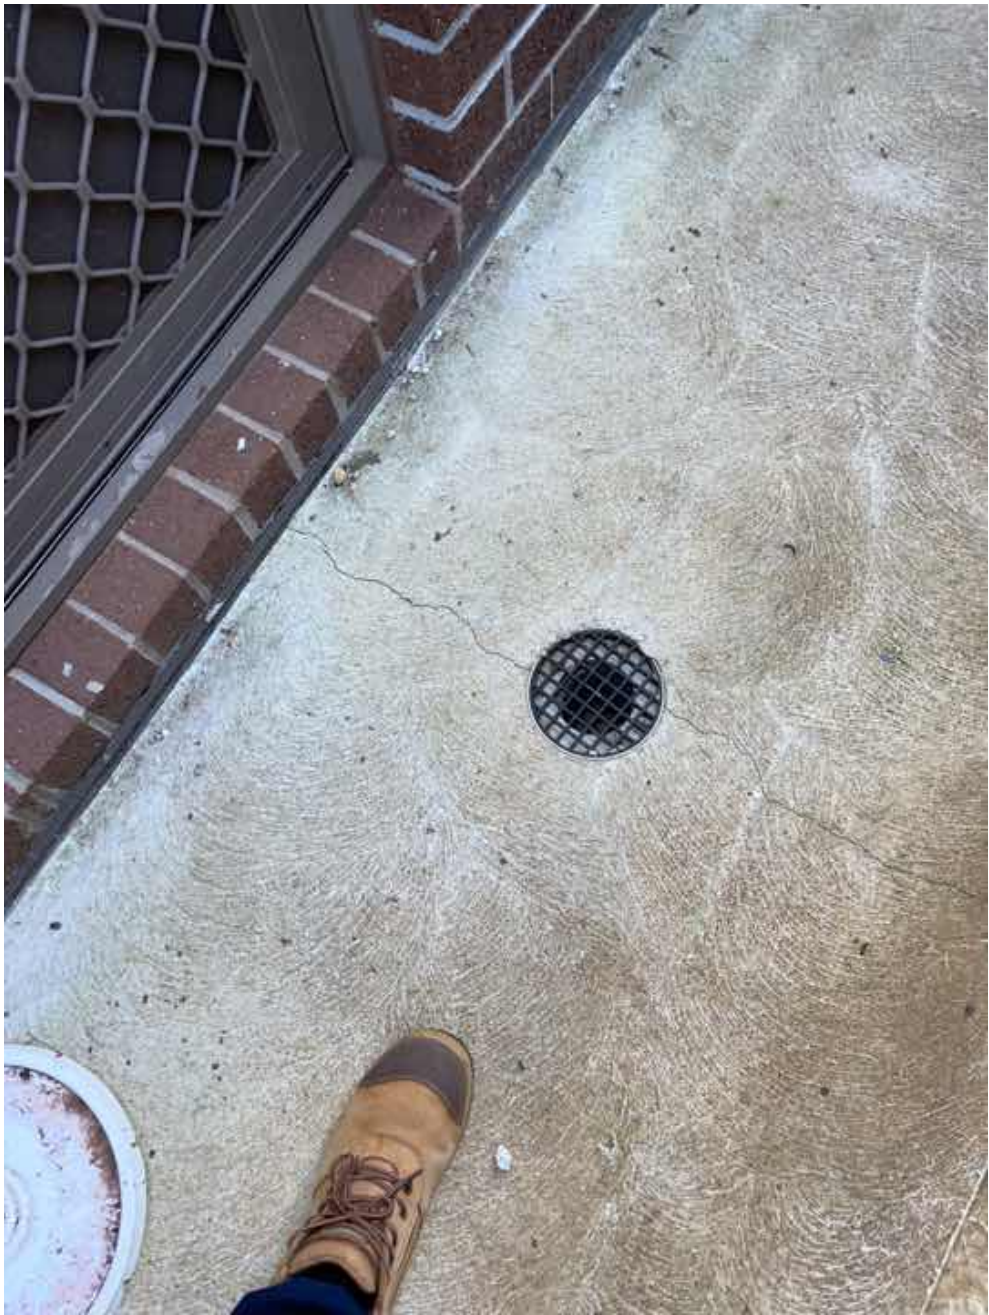
Common cracks and settlement were observed on paths. This may not have any effect on the actual structural integrity of the dwelling itself. Maintenance is recommended. Note: Whilst these cracks appeared to be minor at the time of inspection, we strongly recommend you monitor these cracks and if worsening occurs contact a concreter for further advice.

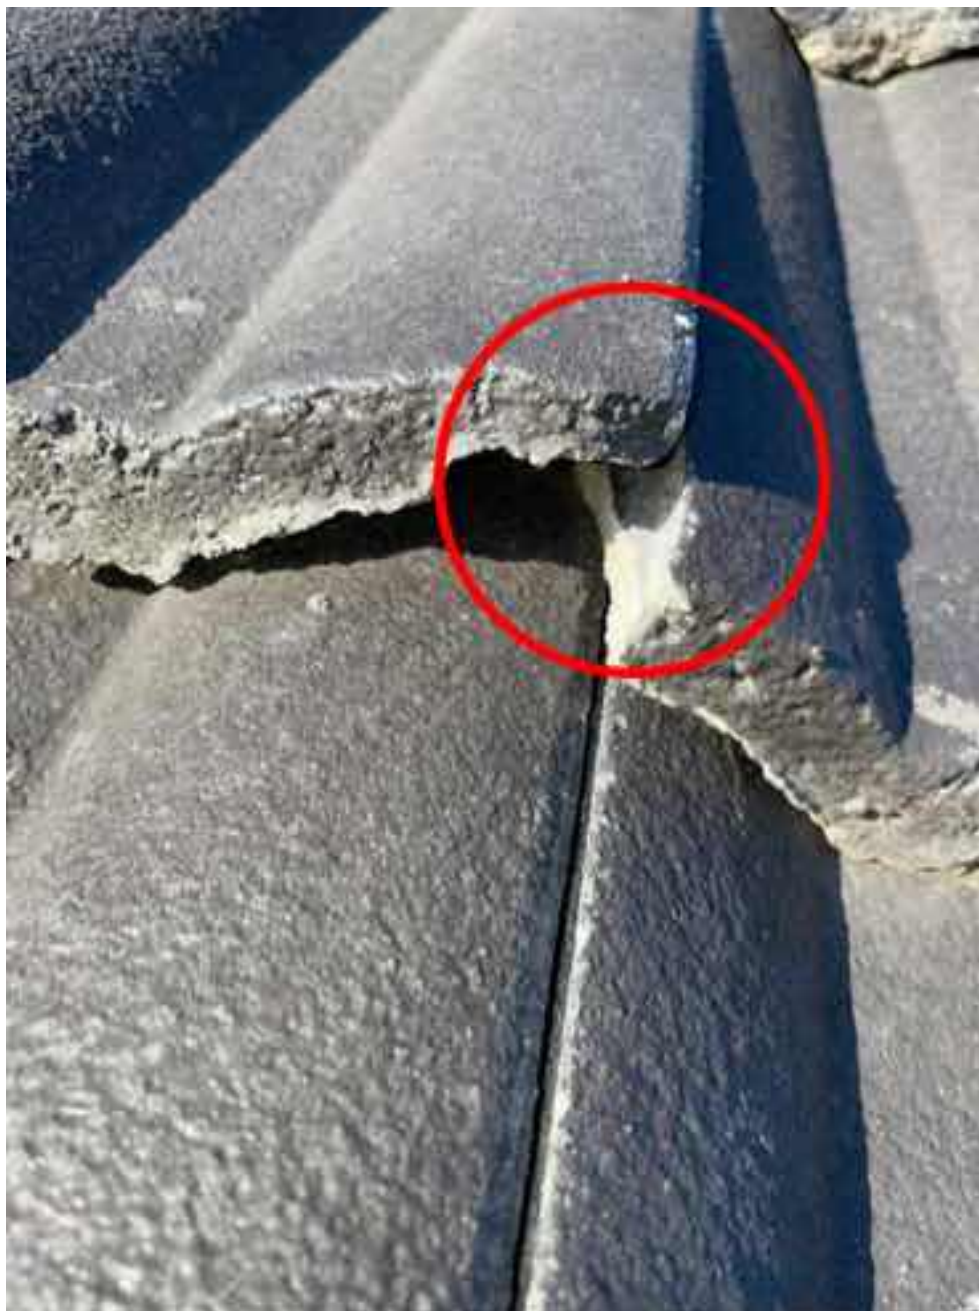
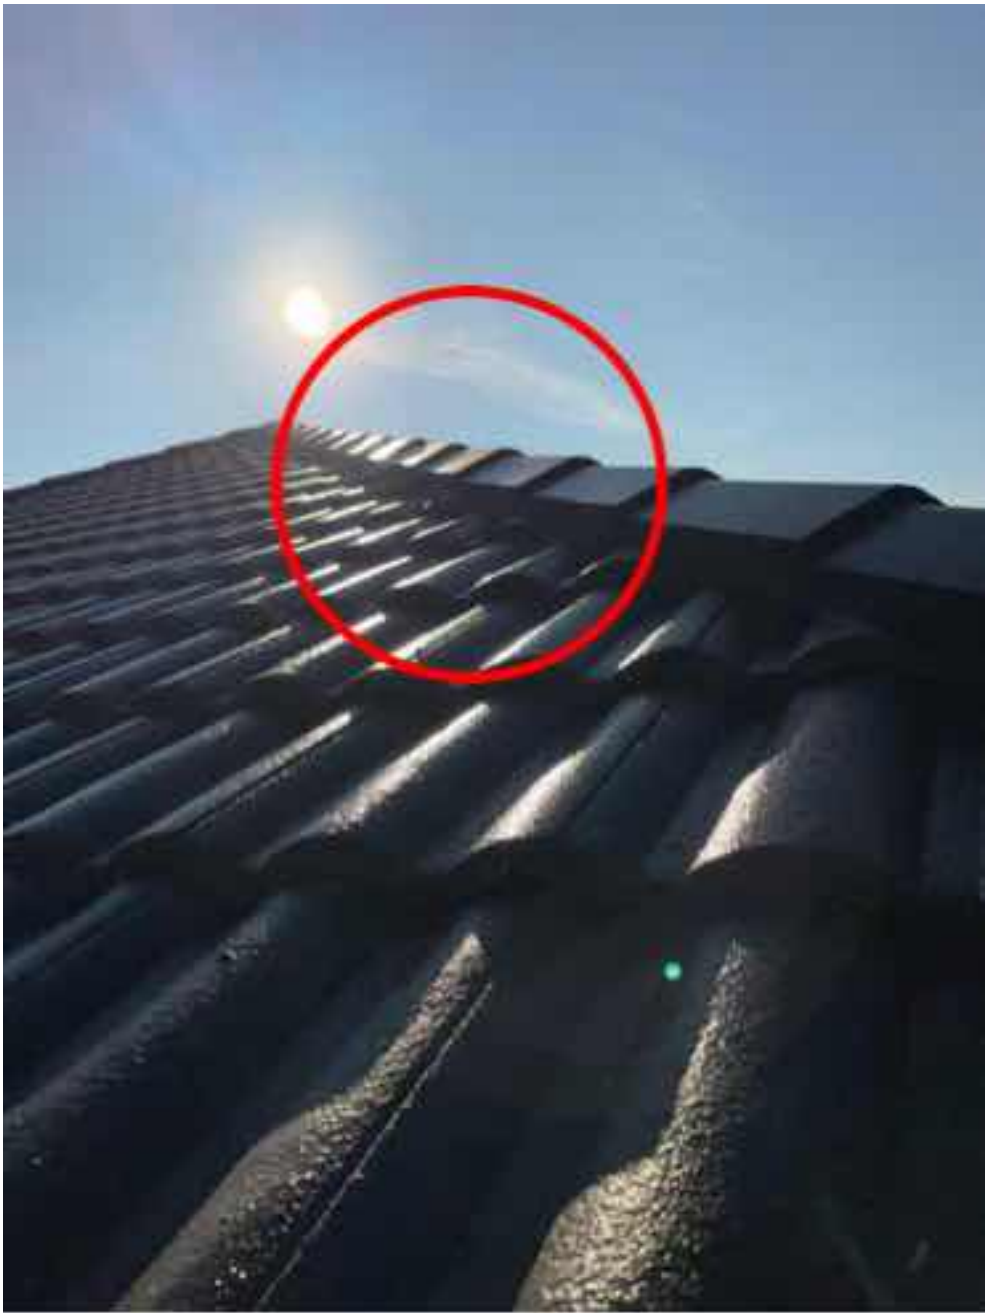
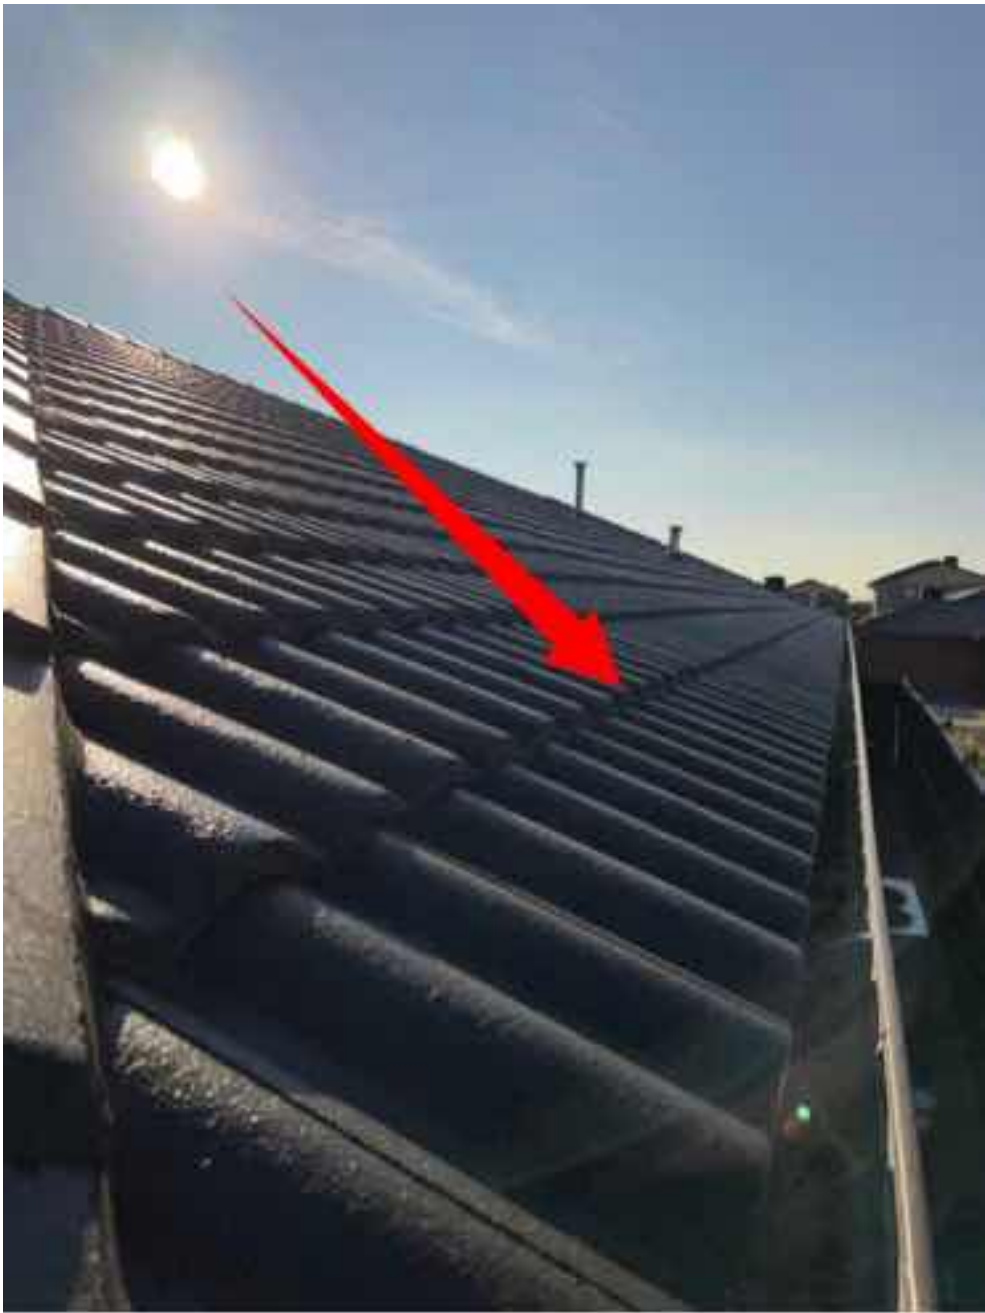
## Roof Clad Condition

Cracked tiles visible - Recommendations: Contact a roof tiler for repairs. This has potential to become a serious issue if repairs aren't carried out due to water ingress into the roof cavity

Tile lift/unevenness visible - Recommendations: Have roofer re-fix. Considered a minor defect but has the potential to become a Major defect if repairs aren't carried out immediately due to water ingress into the roof cavity

Roof line unevenness visible - Recommendations: May be related to some gaining or loosening of the burrup truss. See a carpenter for advice and recommendations. Considered a Minor Defect, however has the potential to be a costly repair.

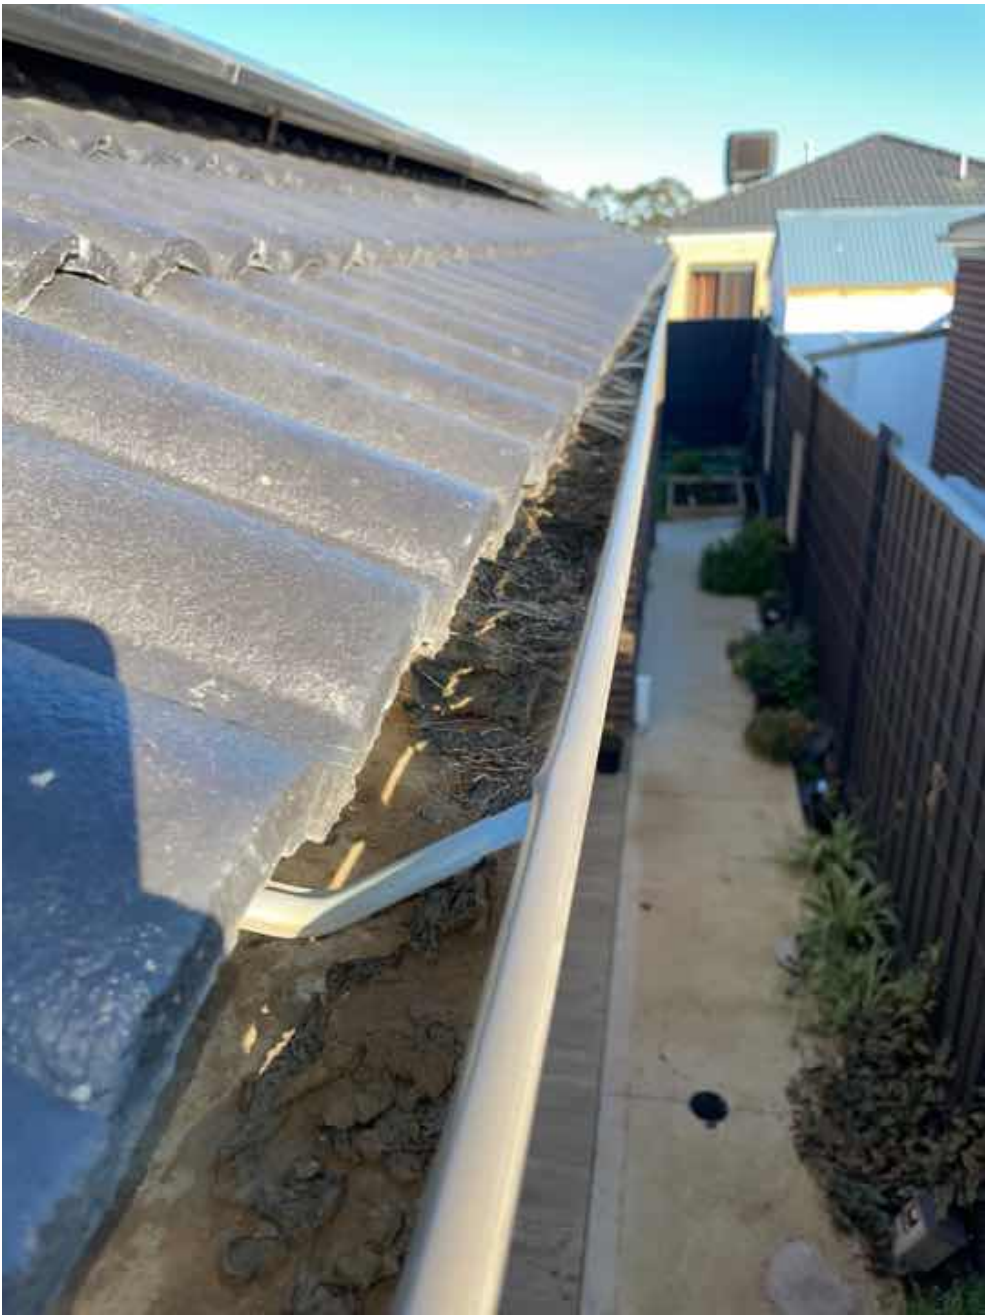
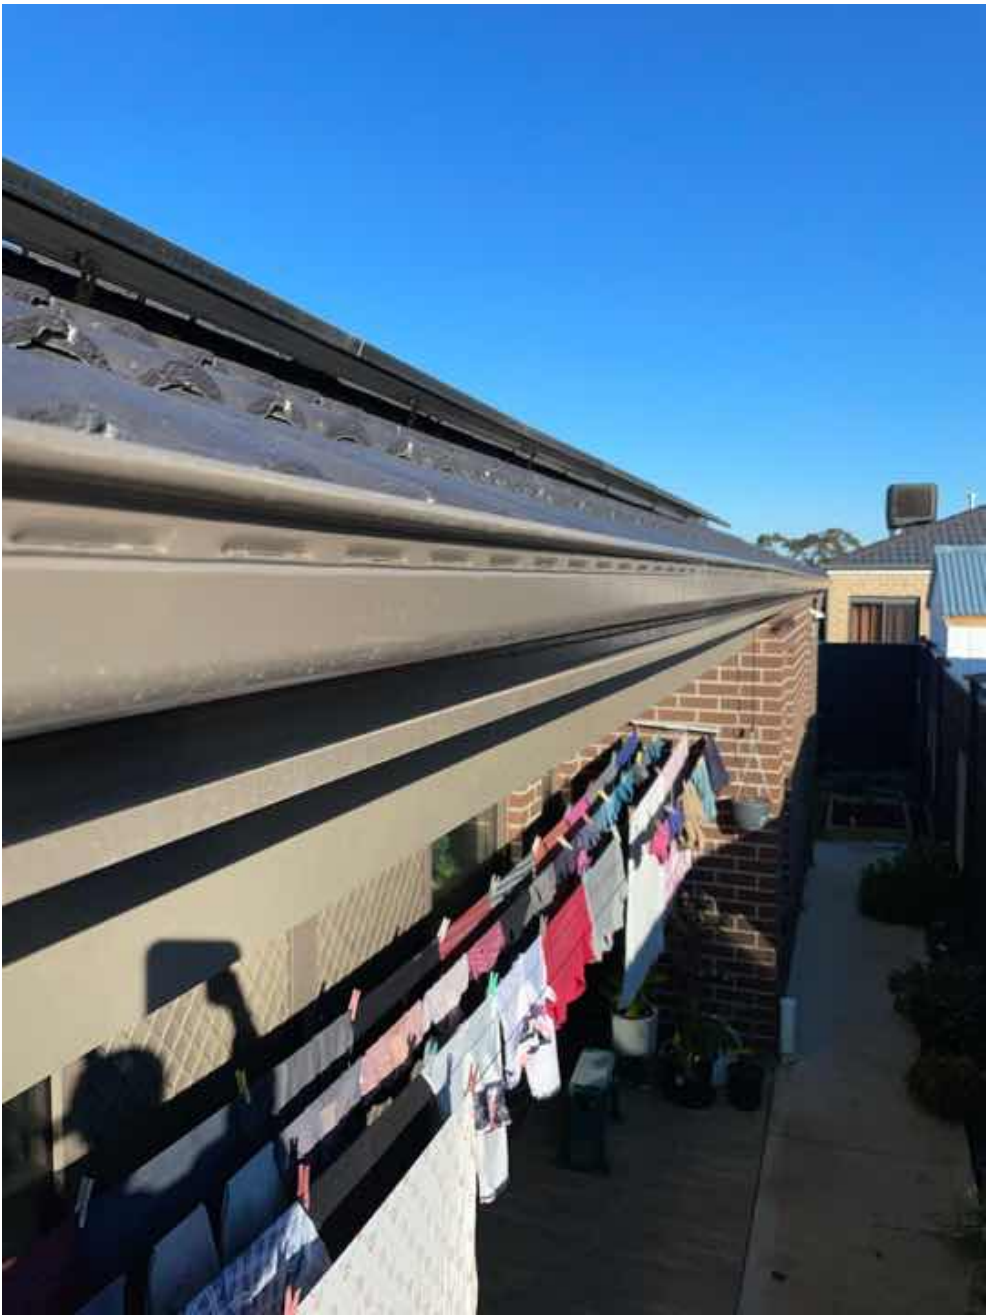
### Gutter Findings

Debris in guttering areas- this requires cleaning out to prevent blocking of down pipes and leaking into eaves and fascia. Recommendations: Have gutters cleaned and assessed by a plumber for adequate fall. Also regularly clean to prevent ponding. Ponding water will contribute to rust.

The gutter fall appears inadequate in areas - Recommendations: A qualified roof plumber should be engaged for repairs and recommendations.

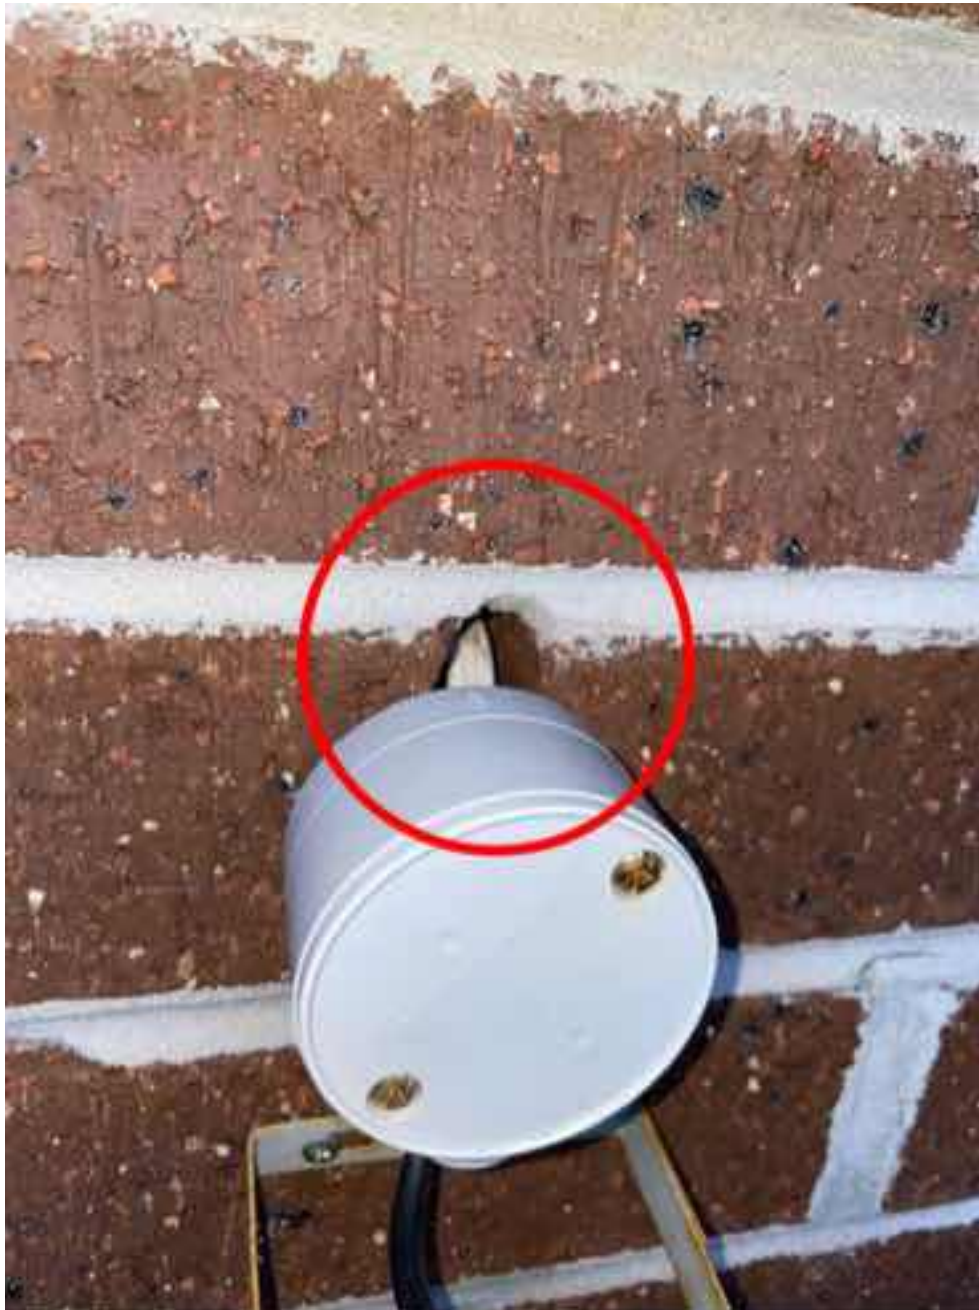
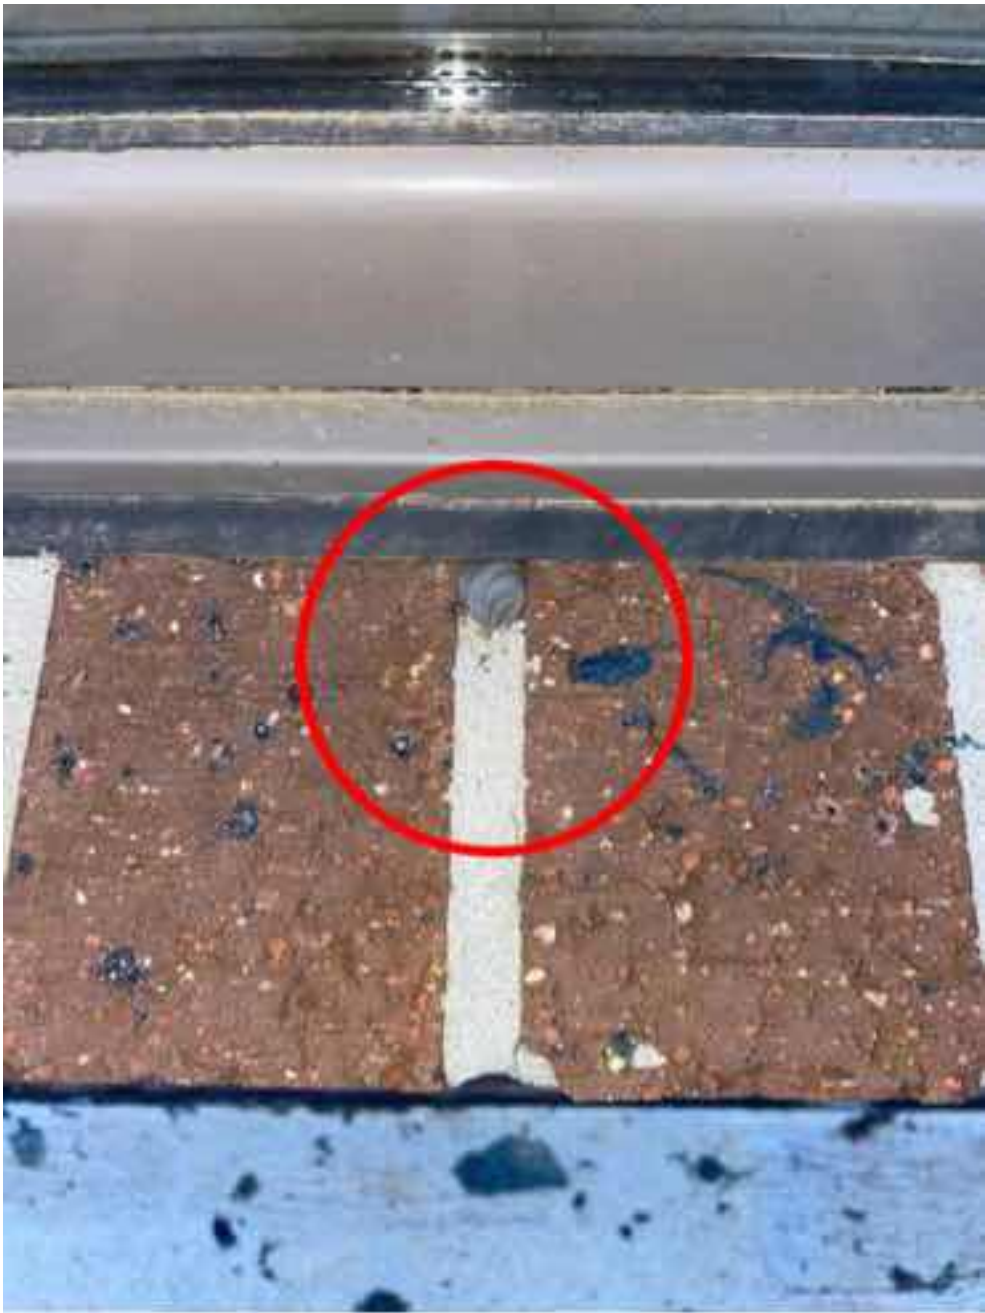
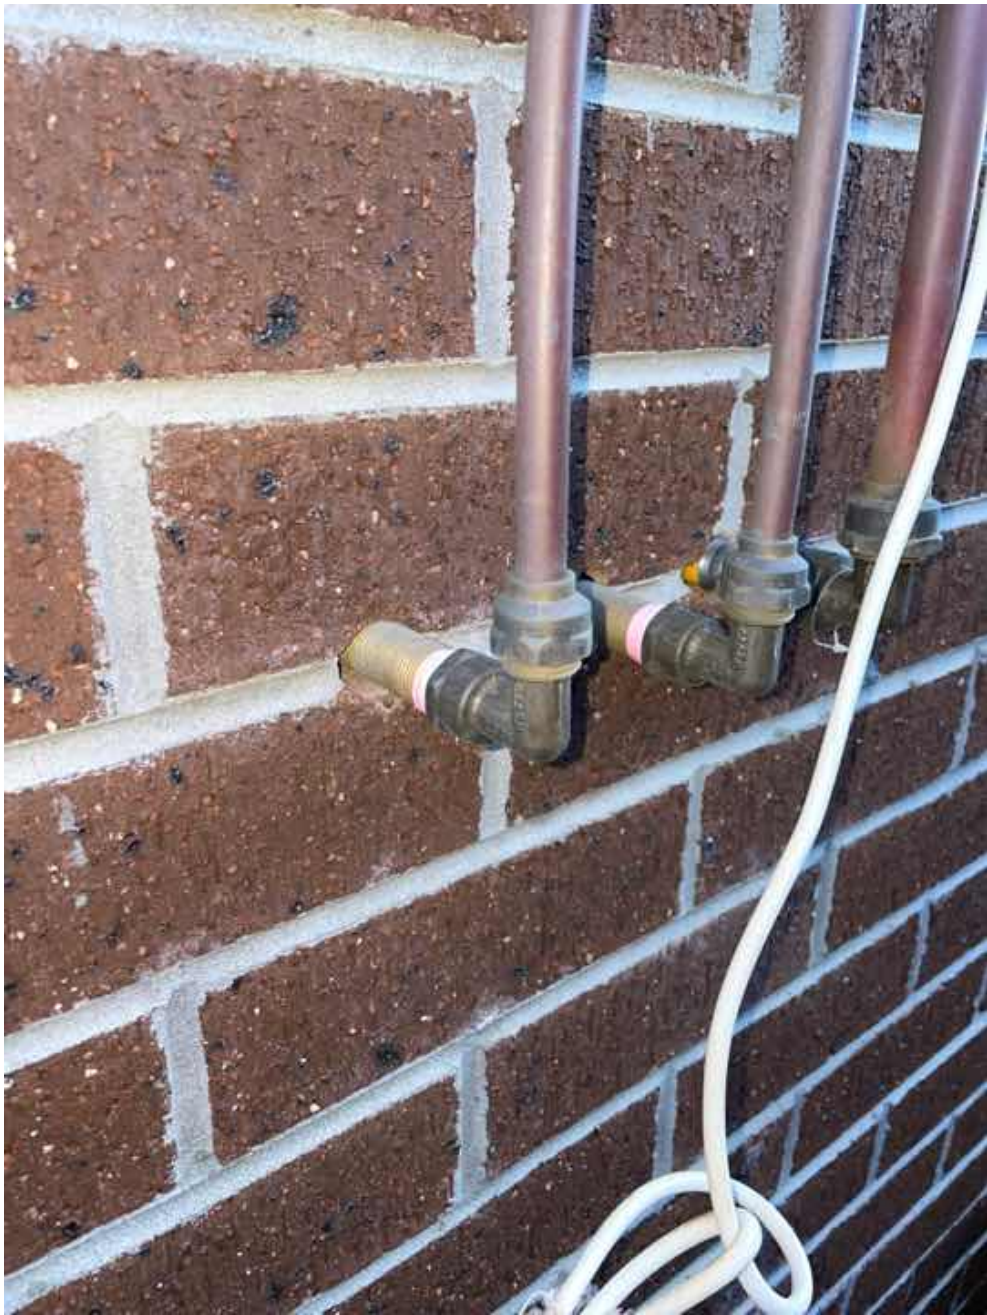
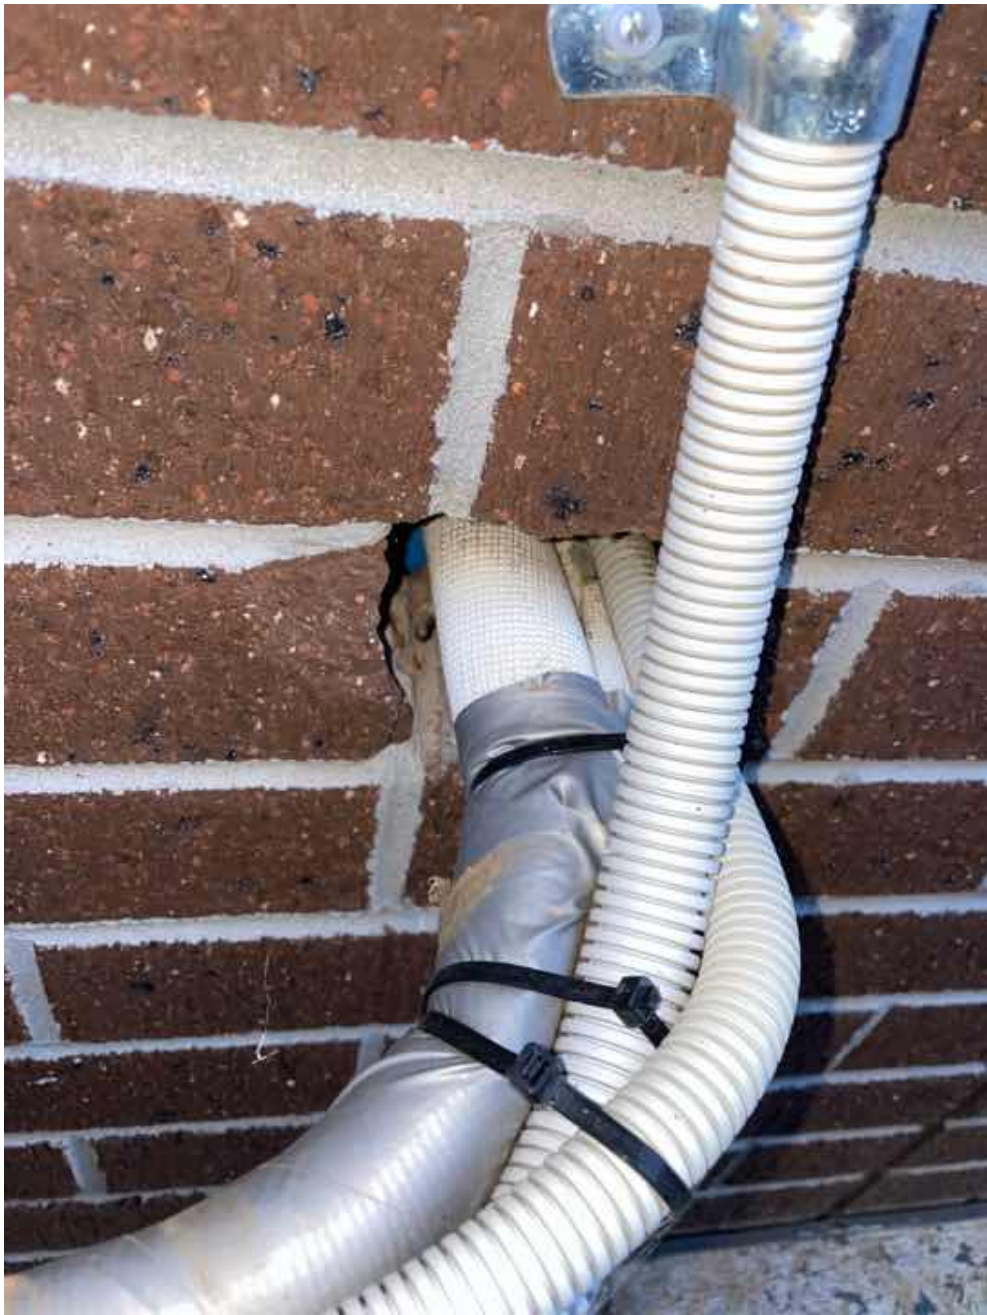
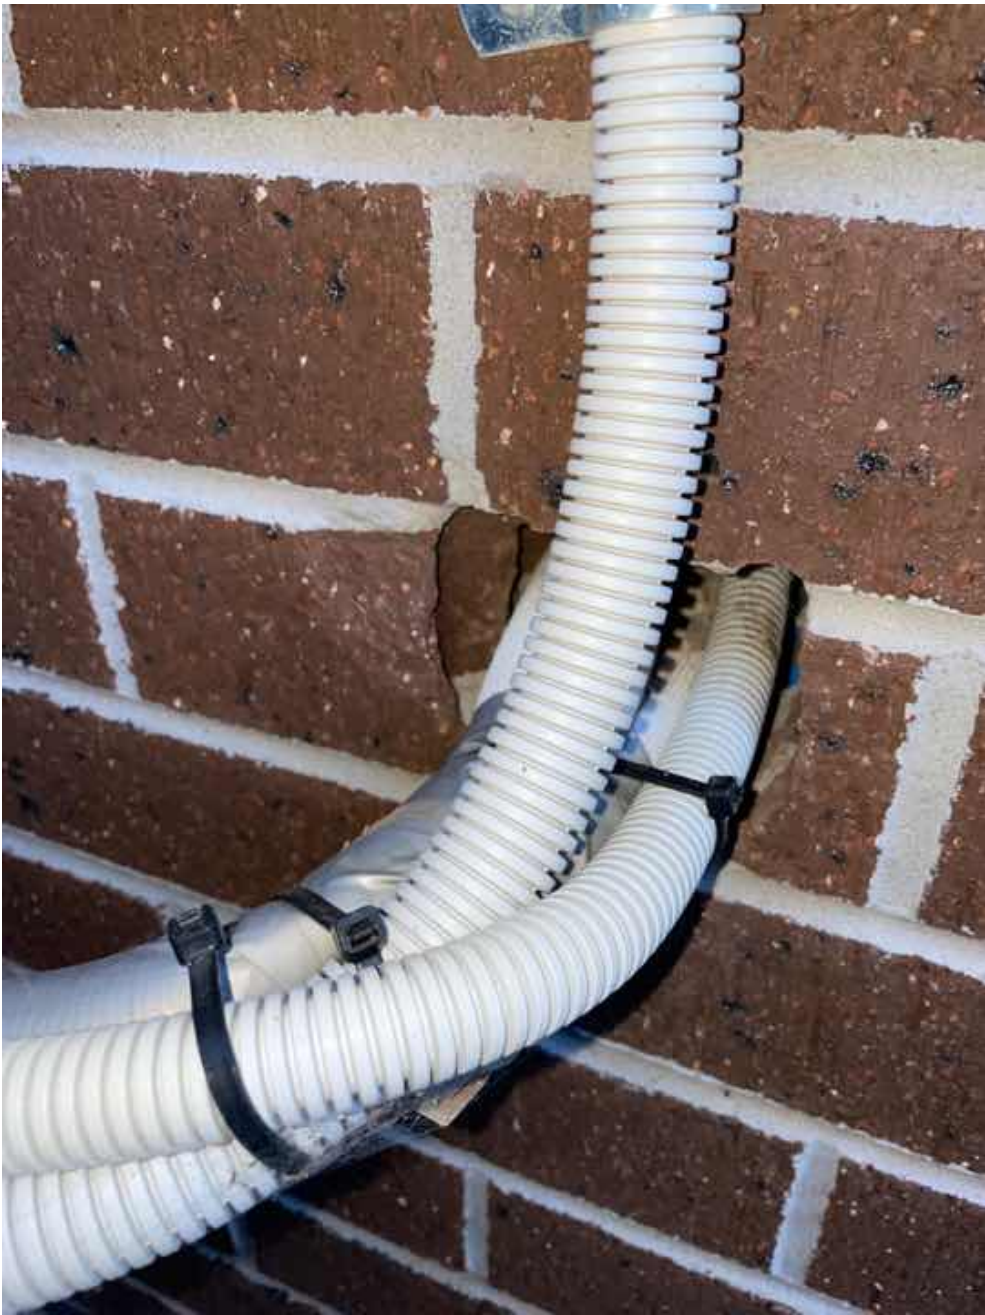
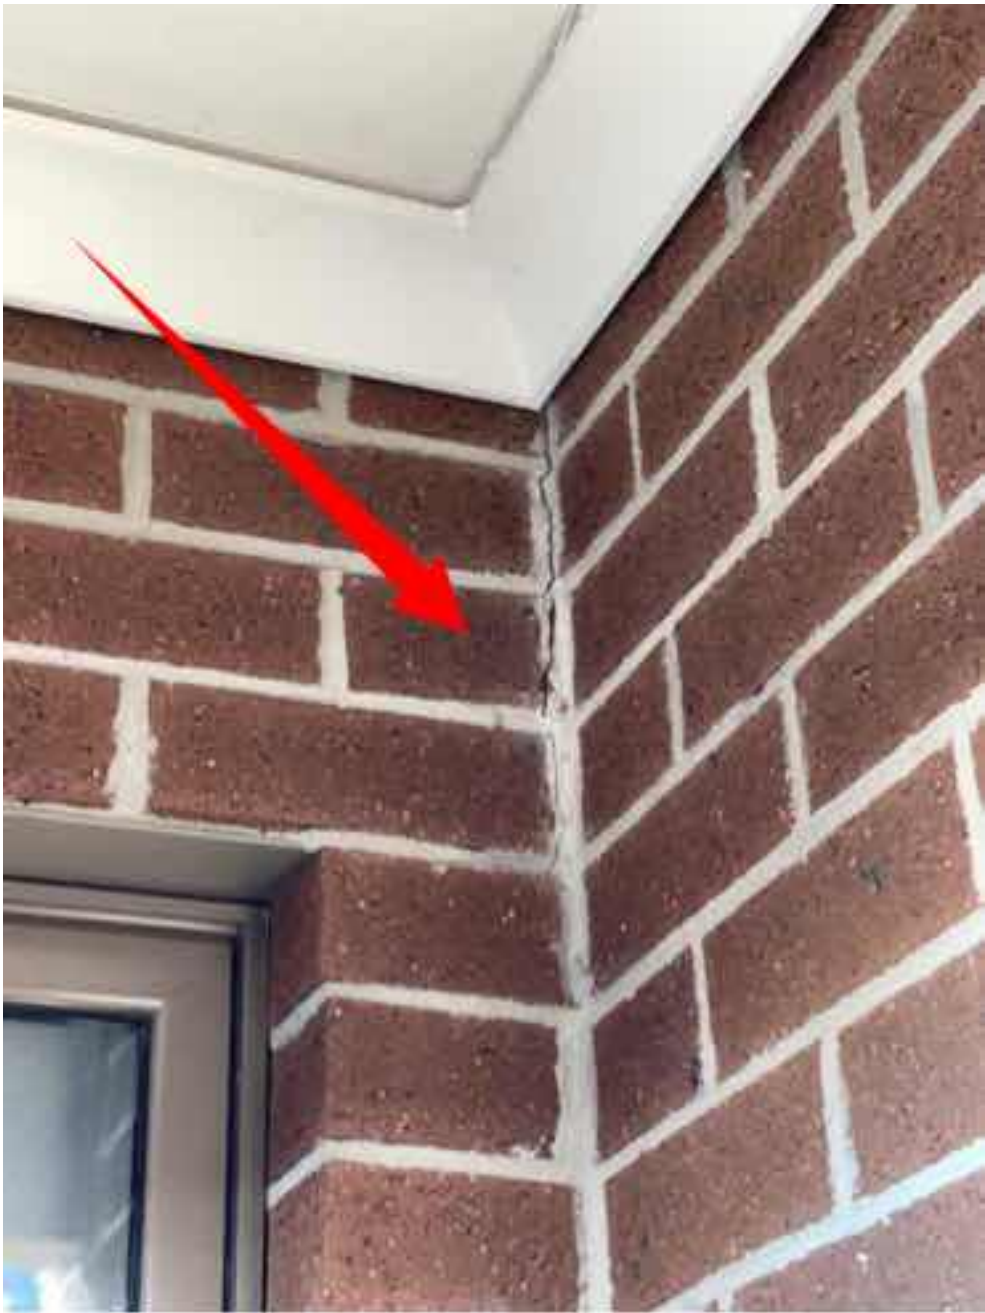
### Cracks noted (Damage Category 3 to 4)

Of areas visible, defects were visible that will require further assessment by a suitably qualified tradesperson in order to prevent further deterioration of the dwelling. Please read below for details.

Possible causes may be foundation movement. Support structure deflection. Thermal movement and moisture uptake or loss, failure under external loads. In the inspectors opinion these cracks require further assessment. A structural engineer should be consulted for further evaluation and advice.

Mortar between the brickwork is eroded. Contact a licensed bricklayer for repairs.

Minor brick damage observed to the brickwork. Have repaired by a licensed brick layer.

Penetration openings observed. I recommend sealing these off so as to avoid vermin and other pest infestation.

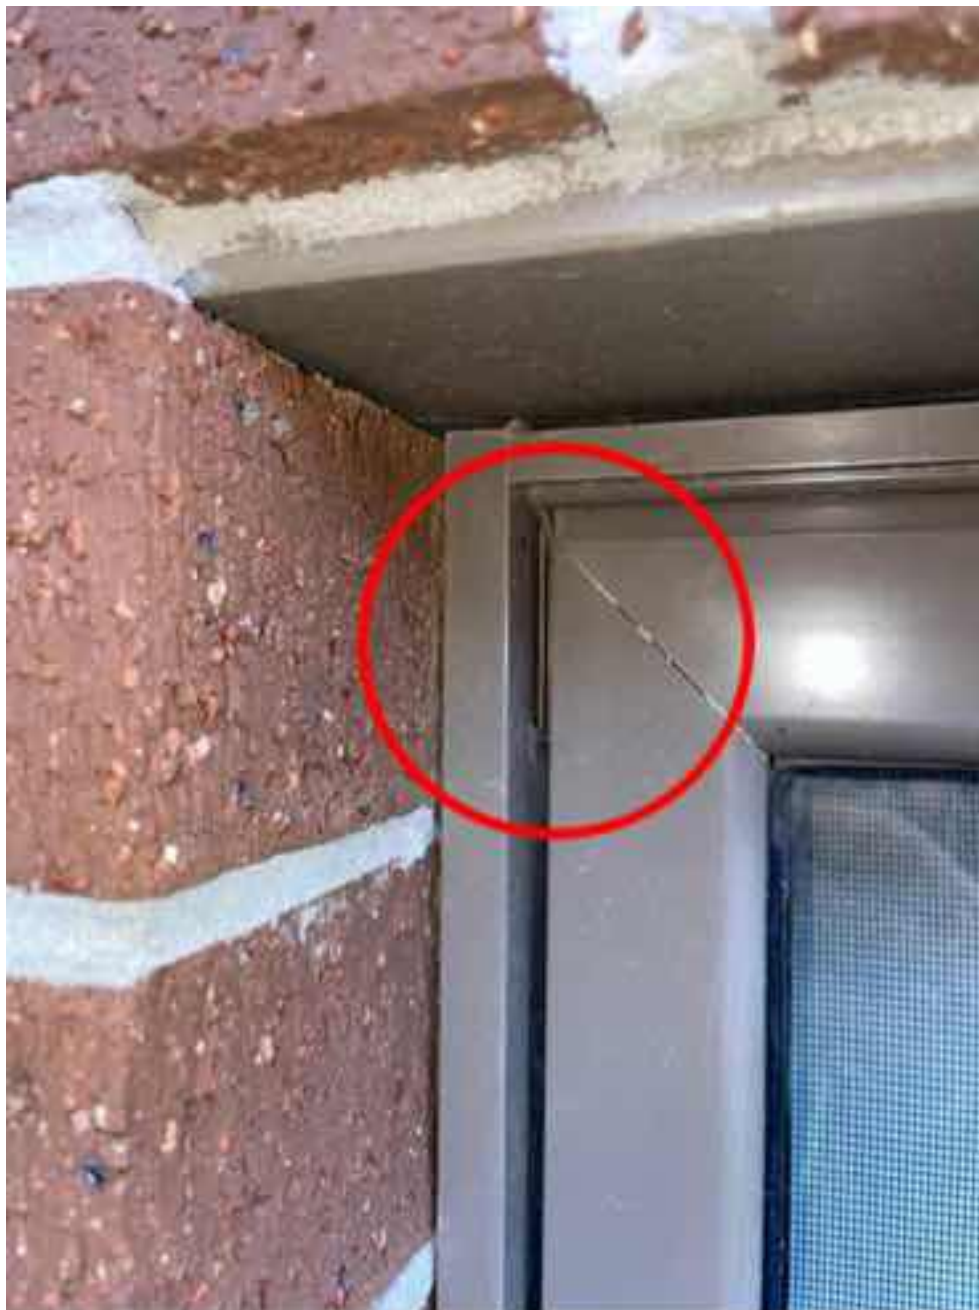
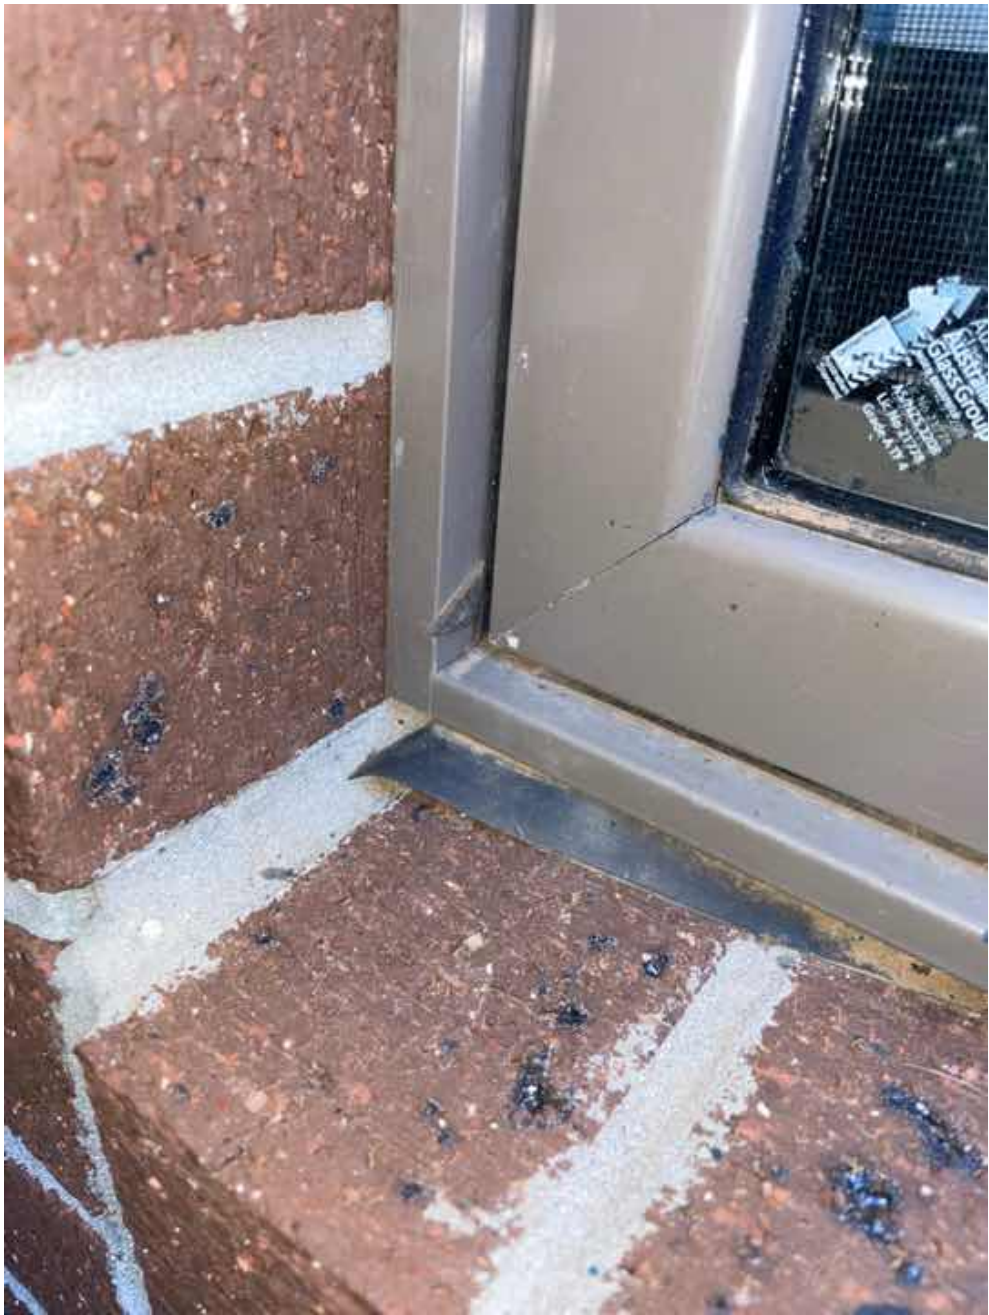
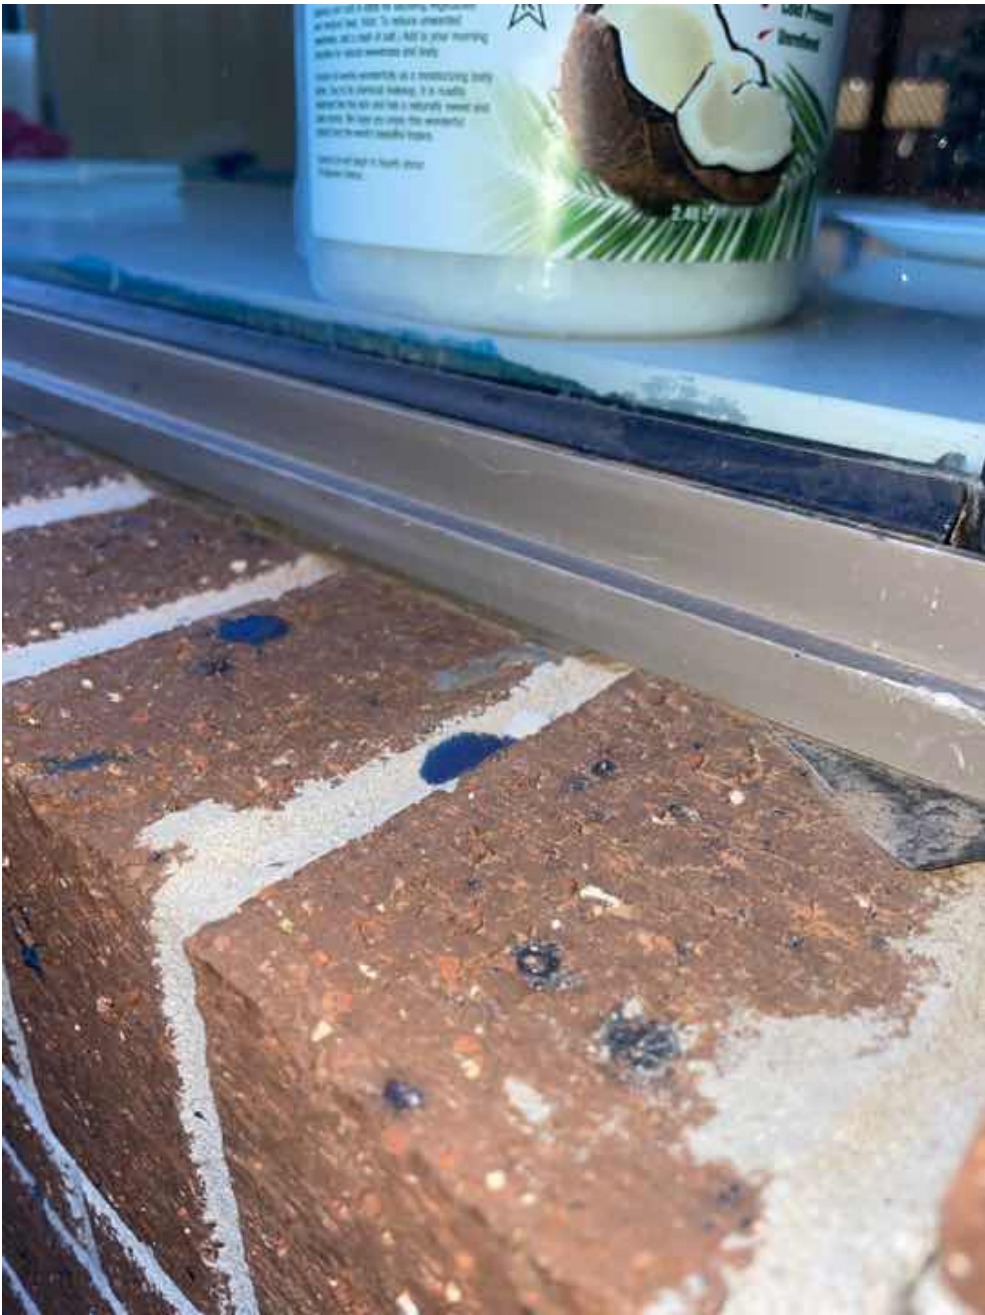
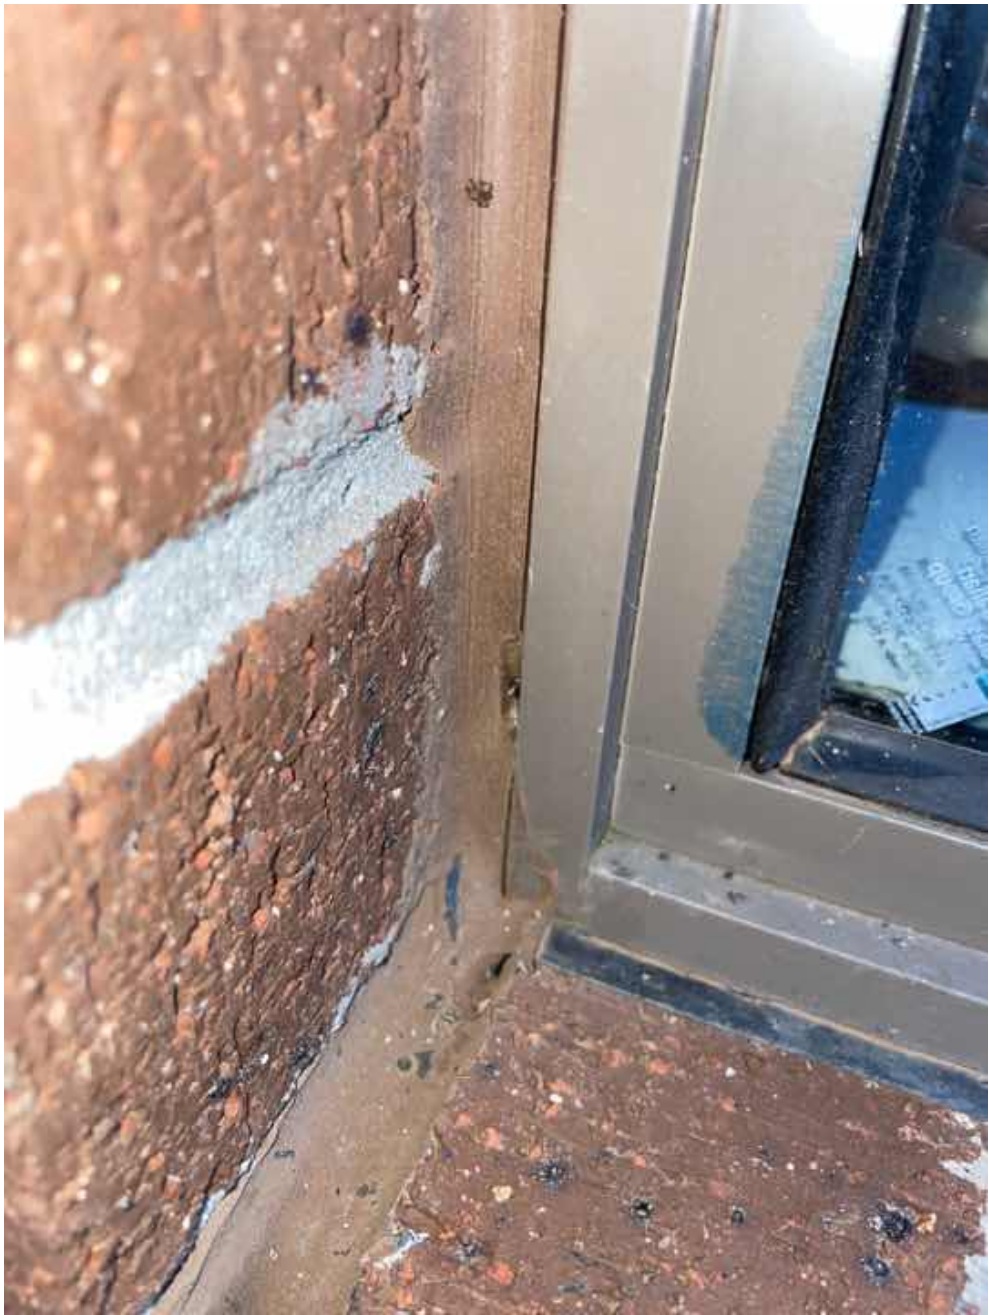
Lintel sagging in sections. This may cause cracking in wall linings above the window - Recommendations: A qualified brick layer should be engaged for repairs and recommendations.

Deterioration of sections of window rubber seals was observed - Recommendations: A qualified glazier should be engaged for advice and recommendations.
