# Post Completion Defect Inspection Report

**Example, VICTORIA, 3024**

Report/Agreement #              0807210944395

Inspection Date:                  08 Jul 2021

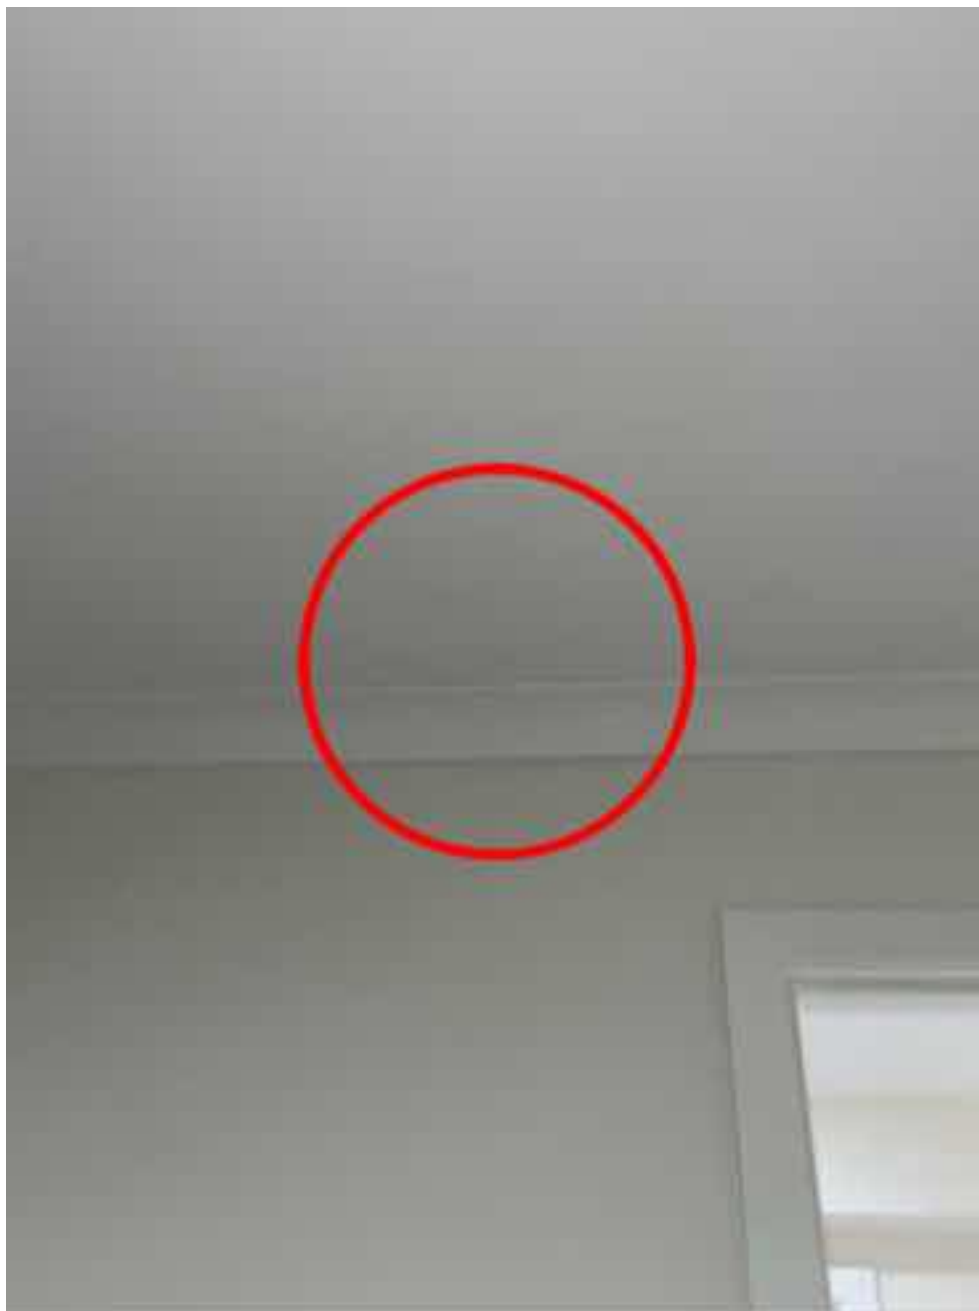
Cornice separation - I recommend you contact a licensed plasterer for repairs.

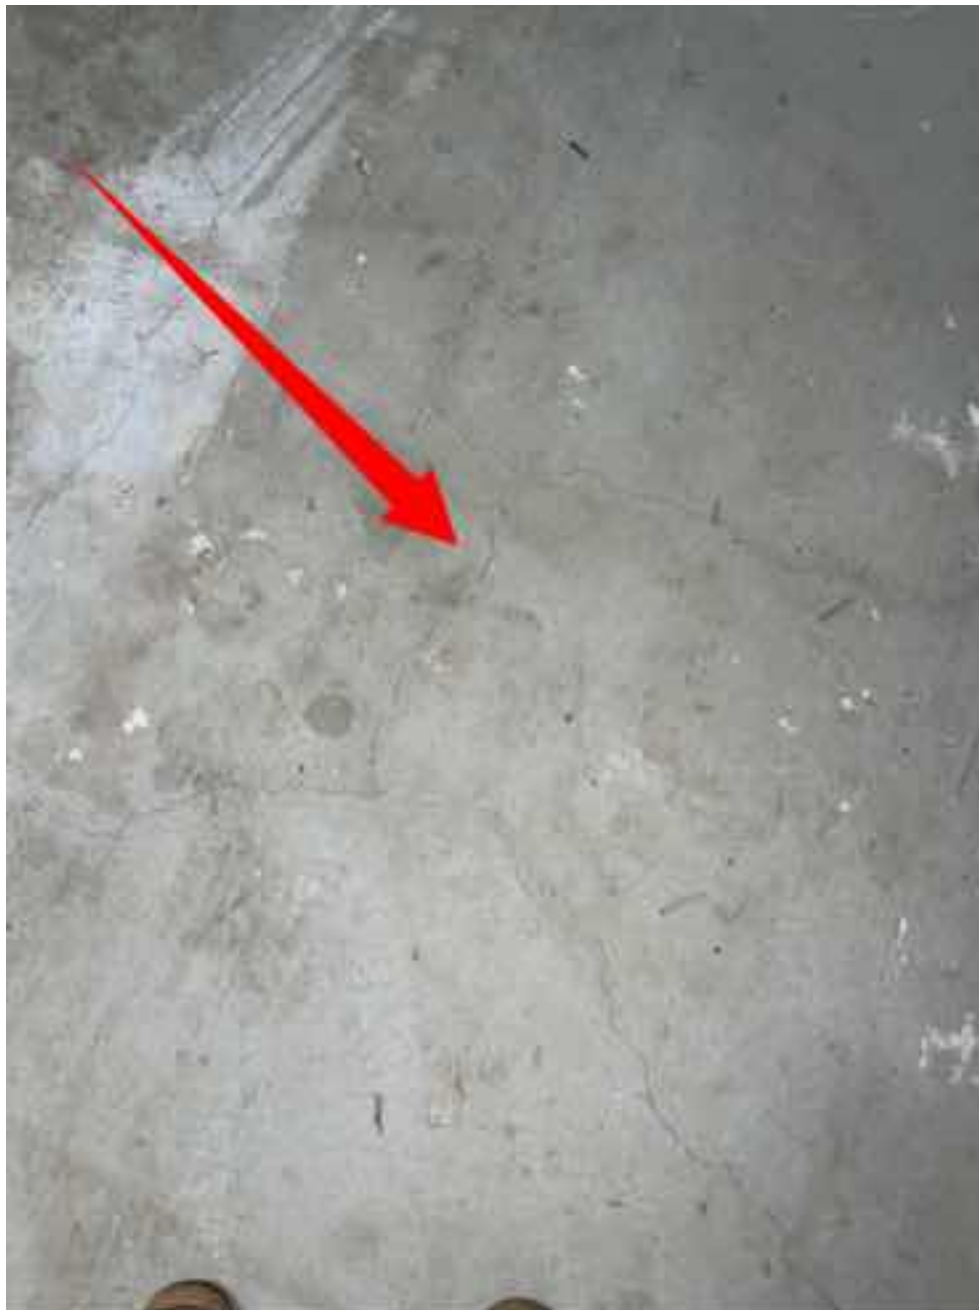
Minor hairline slab cracks - Note. Whilst these cracks appeared to be minor at the time of inspection, we strongly recommend you monitor these cracks and if worsening occurs contact a qualified concreter for further advice.

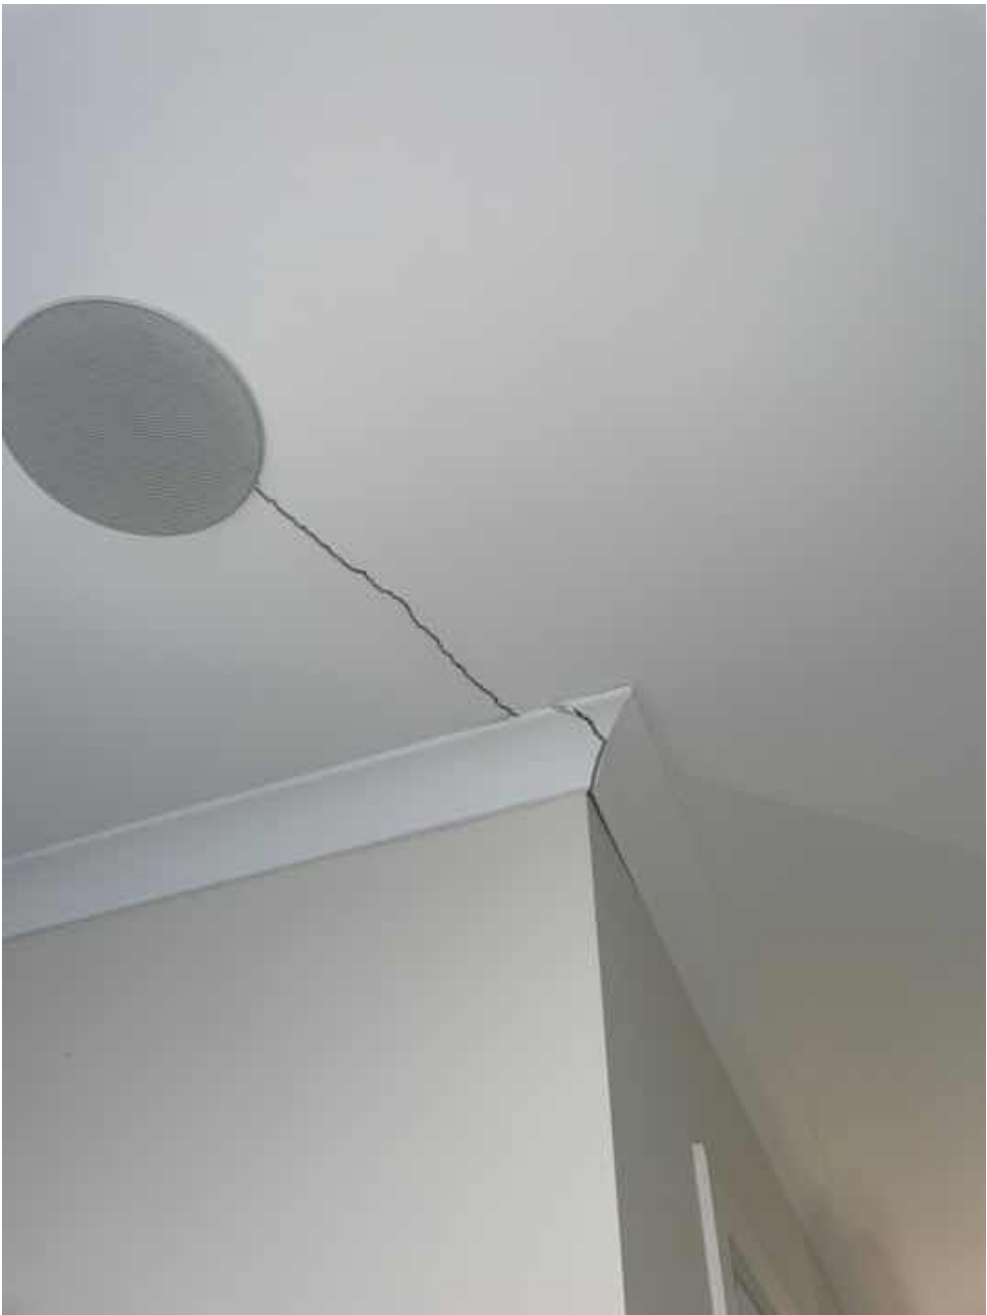
Settlement Cracks Noted . These are typical and generally patch and paint will suffice, however Monitoring these cracks advised for 12 months and if become wider or longer, you will need to contact a structural engineers to assess.

Major Cracks - Excessive, multiple or wide cracking visible. Recommendations: Contact a qualified structural engineer for further advice and recommendations.

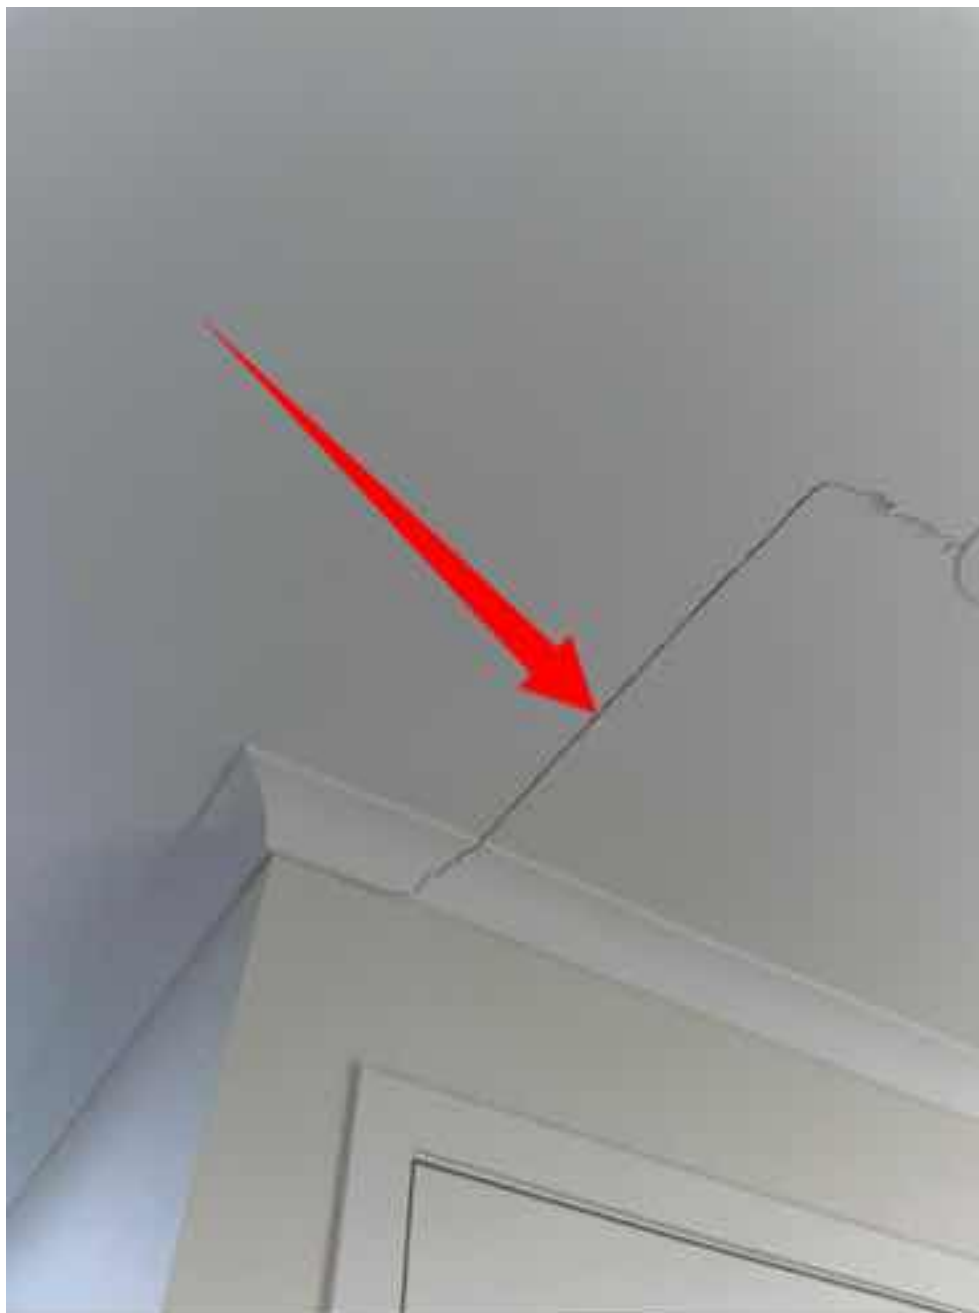
Settlement Cracks Noted . These are typical and generally patch and paint will suffice, however Monitoring these cracks advised for 12 months and if become wider or longer, you will need to contact a structural engineers to assess.

Major Cracks - Excessive, multiple or wide cracking visible. Recommendations: Contact a qualified structural engineer for further advice and recommendations.

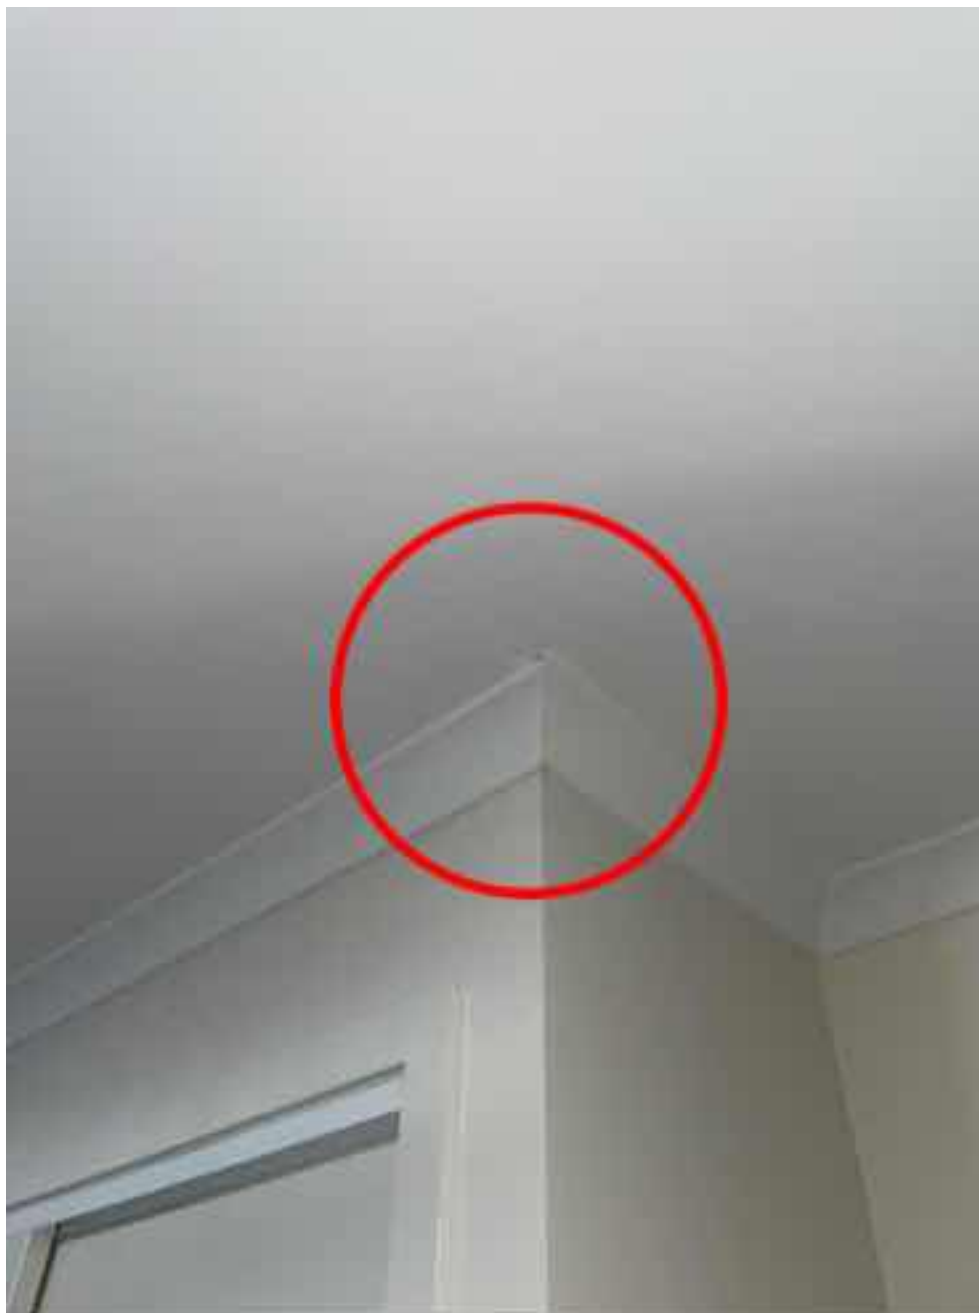
Cornice separation - I recommend you contact a licensed plasterer for repairs.

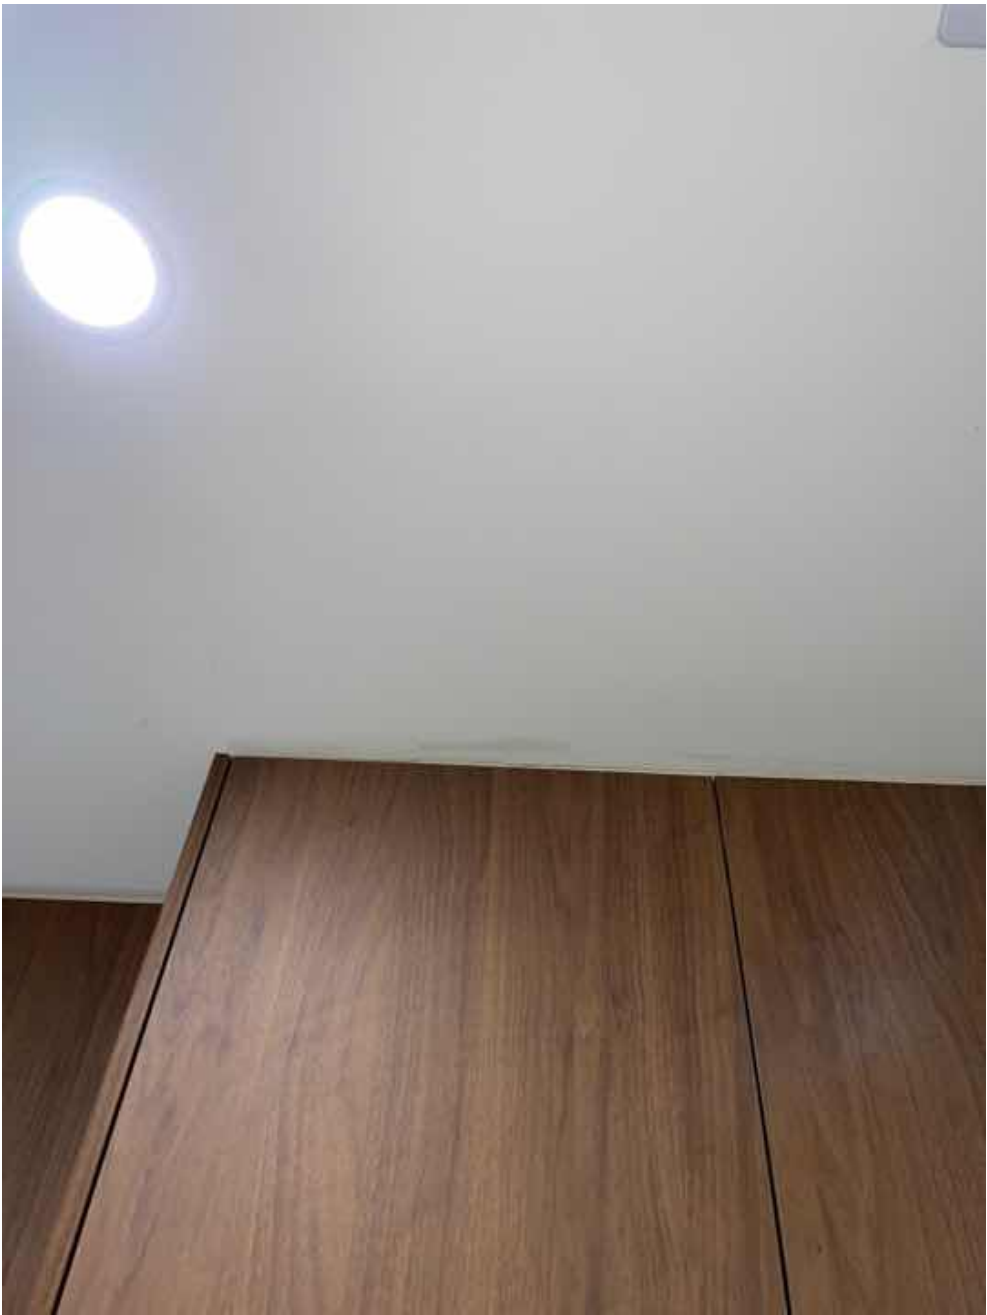
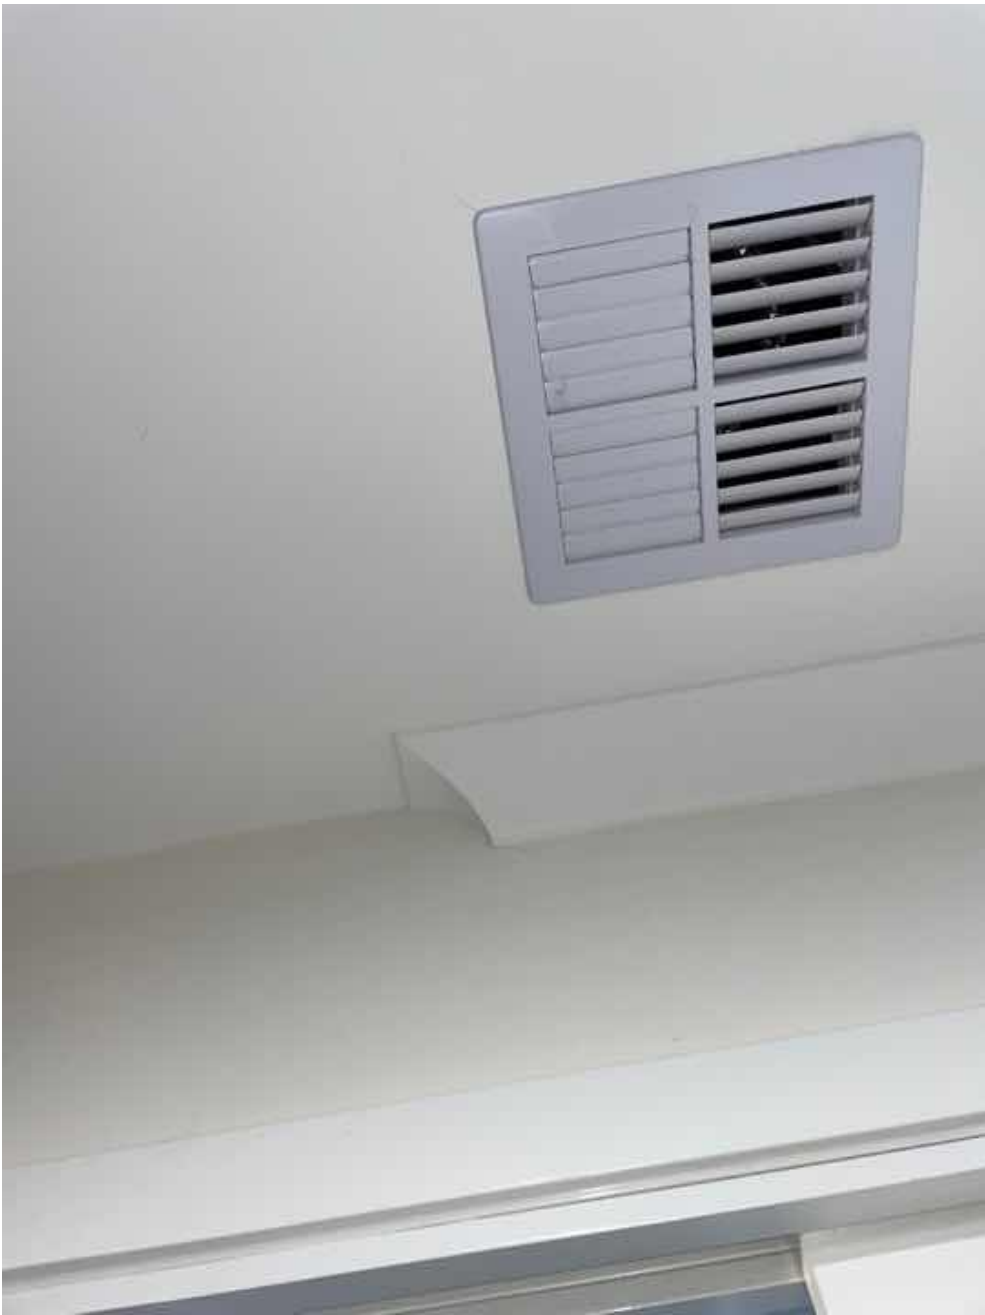
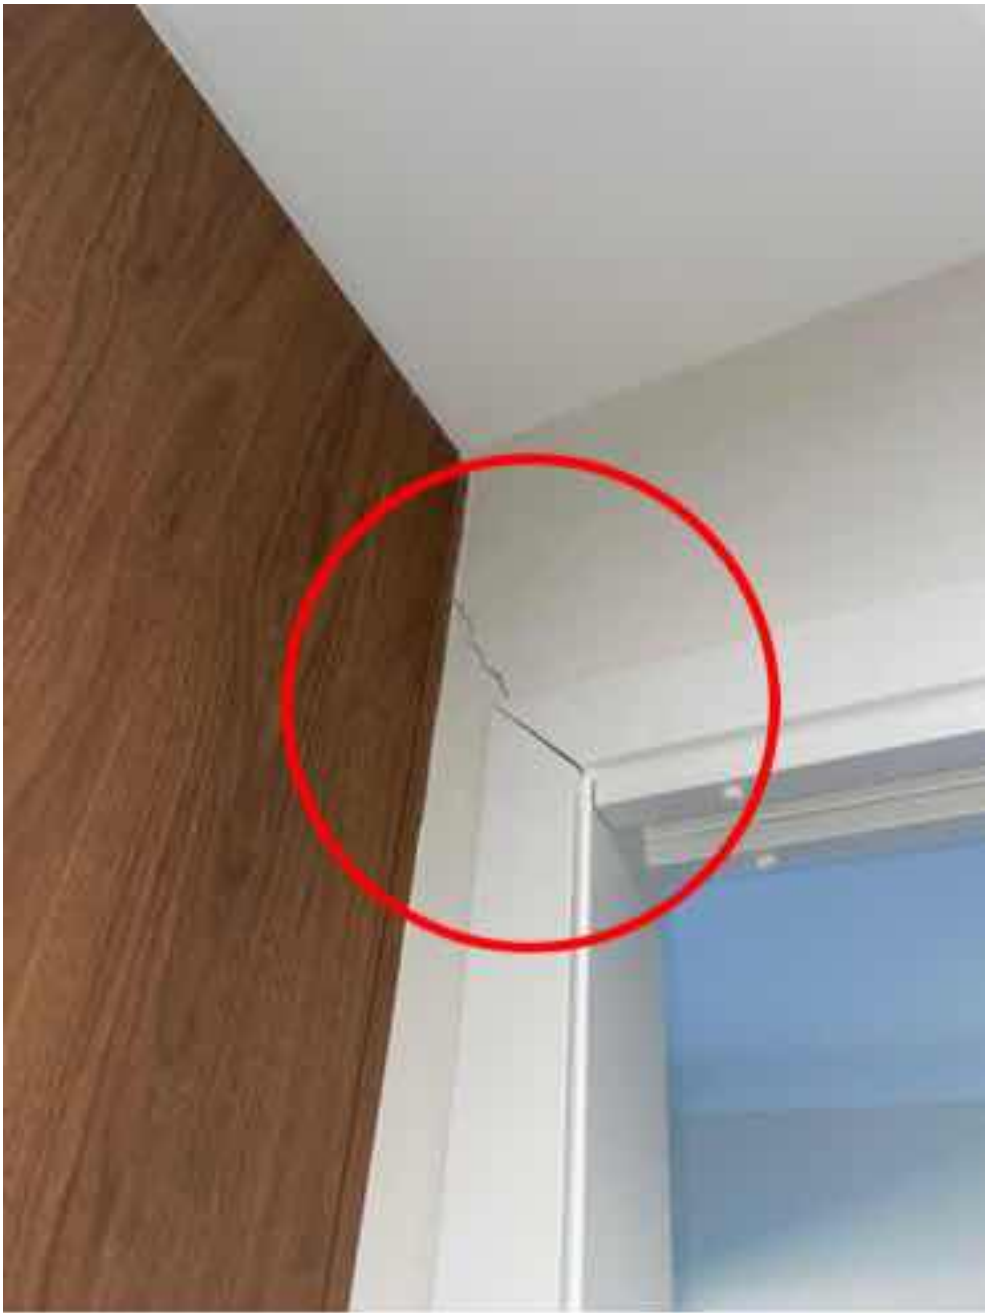
Major Cracks - Excessive, multiple or wide cracking visible. Recommendations: Contact a qualified structural engineer for further advice and recommendations.

Settlement Cracks Noted . These are typical and generally patch and paint will suffice, however Monitoring these cracks advised for 12 months and if become wider or longer, you will need to contact a structural engineers to assess.
