# Building & Timber Pest Inspection Report

**Inspect365**

**VICTORIA, 3087**

Inspection Date:                24 May 2021

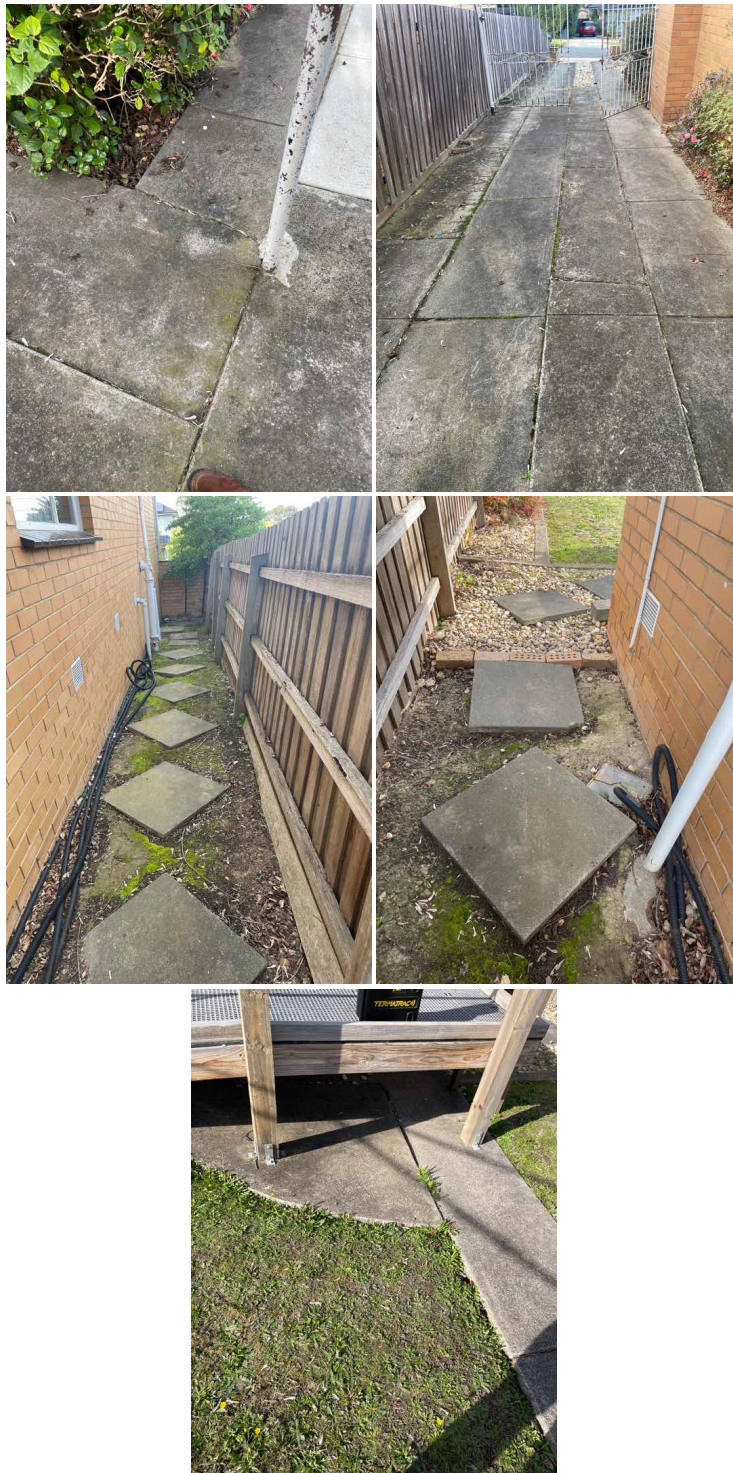
Common cracks and settlement were observed on paths. Whilst these cracks appeared to be typical at the time of inspection, we strongly recommend you monitor these cracks and if worsening occurs contact a concreter for further advice.

Surface raised and settled in some areas. This can cause water ponding. Relaying recommended.

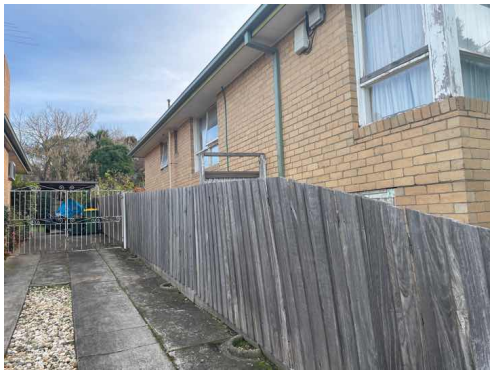
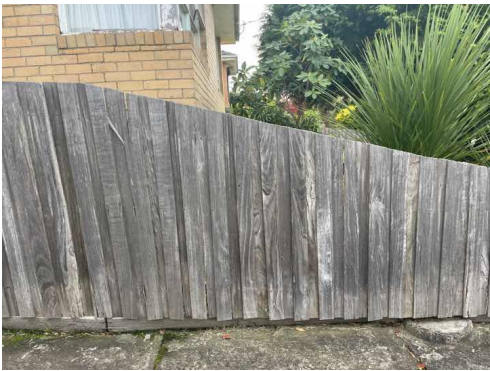
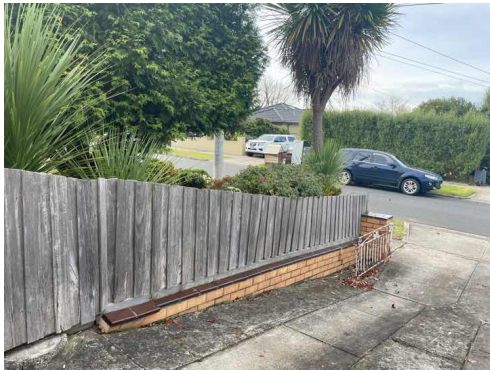
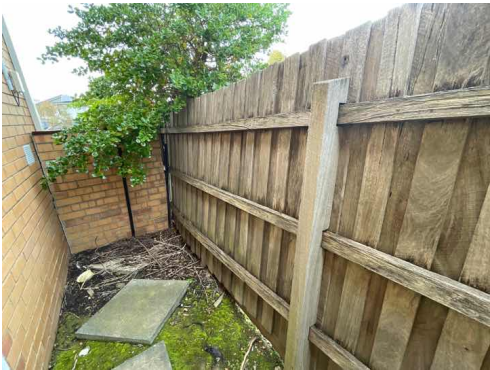
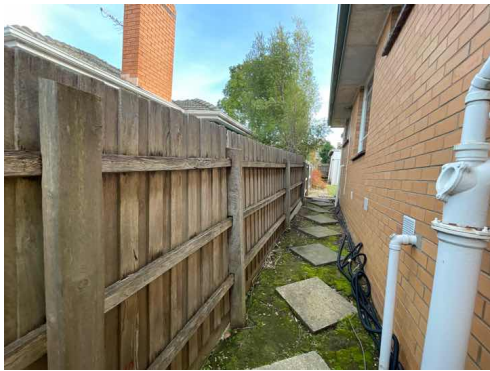
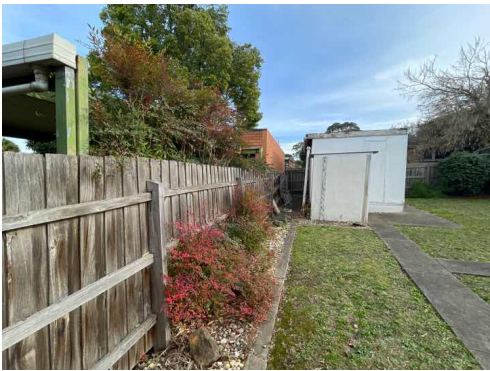
General fence components have rot. Repairs are required by fencing contractor.

Rust noted to fence. Replacement recommended.

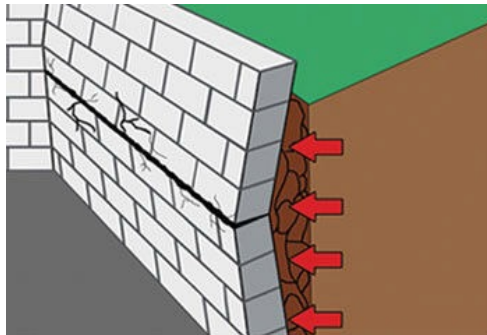
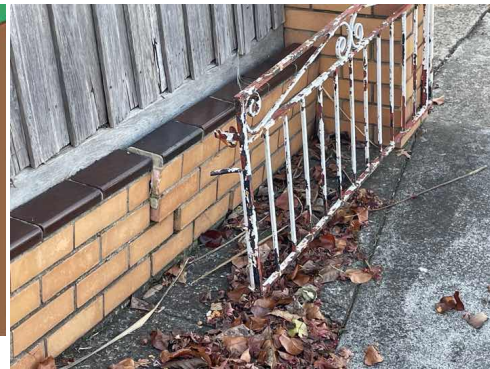
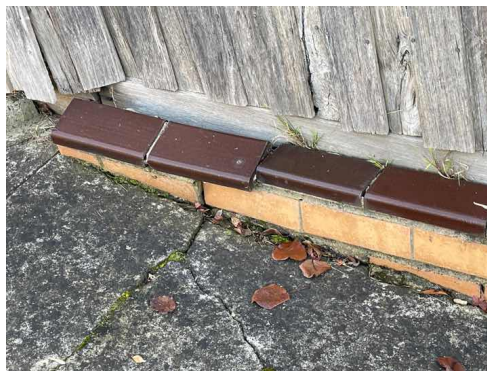
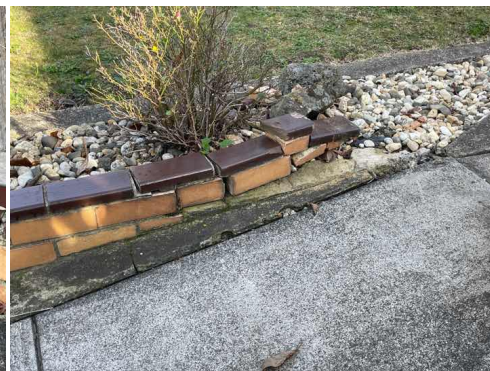
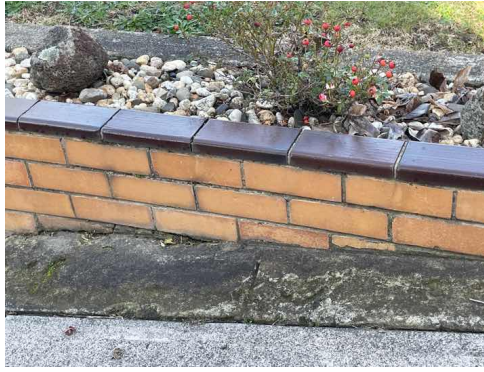
Retaining wall cracking. Normally this occurs if adequate drainage has not been provided (Ag Line) or a poor footing system or a combination of reasons. A qualified brick layer should be engaged for advice and recommendations.

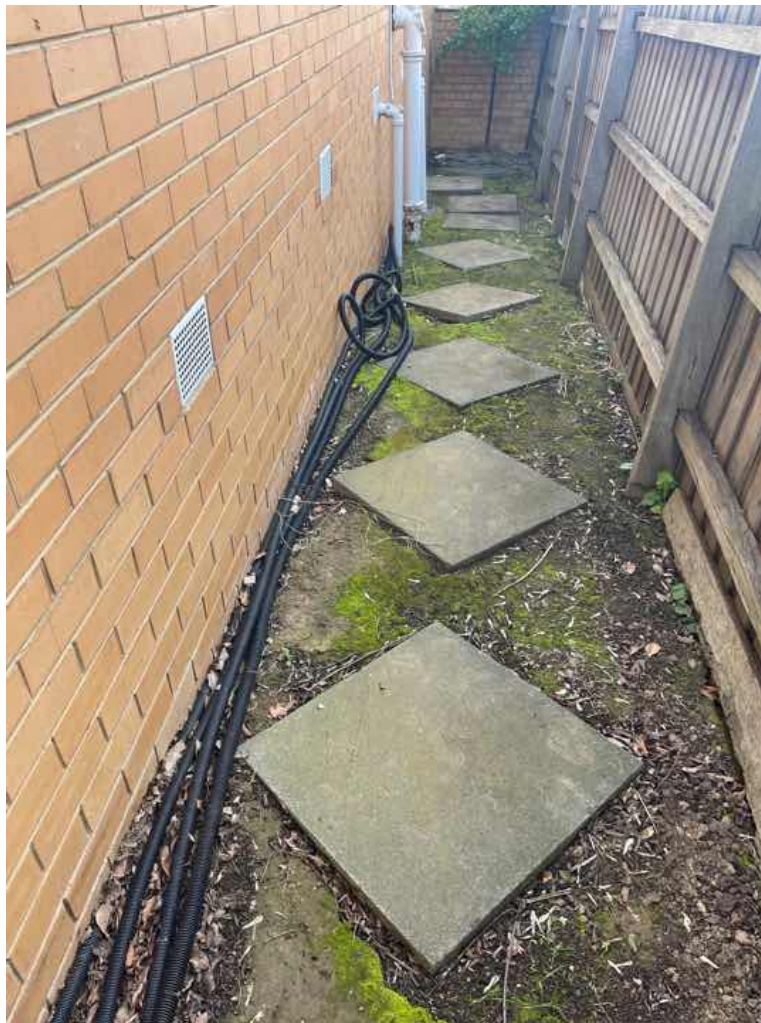
The ground levels along the perimeter walls at the side of the home did not appear to fall away from the property walls sufficiently due to the natural landscape and contour. This will need to be assessed during a period of rainfall and if surface water appears to be entering the sub floor if applicable or ponding against the perimeter walls, engage a plumber or landscaper to assess and rectify as required. All drains should be regularly checked by a plumber and kept clean of debris to allow surface water to be carried away from the dwelling.

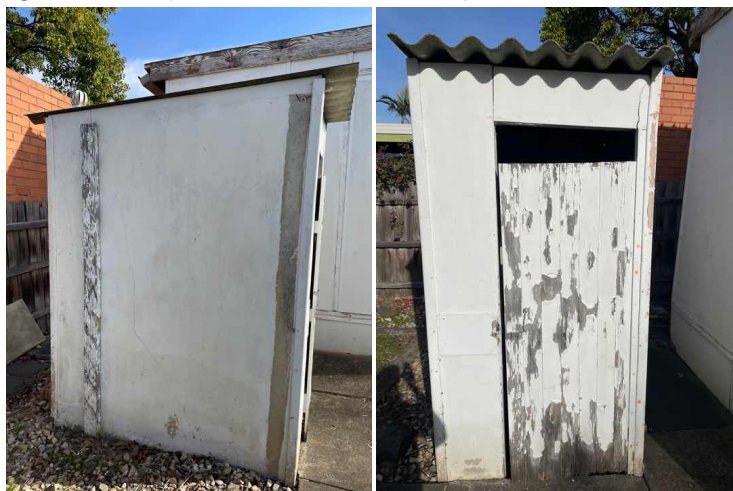
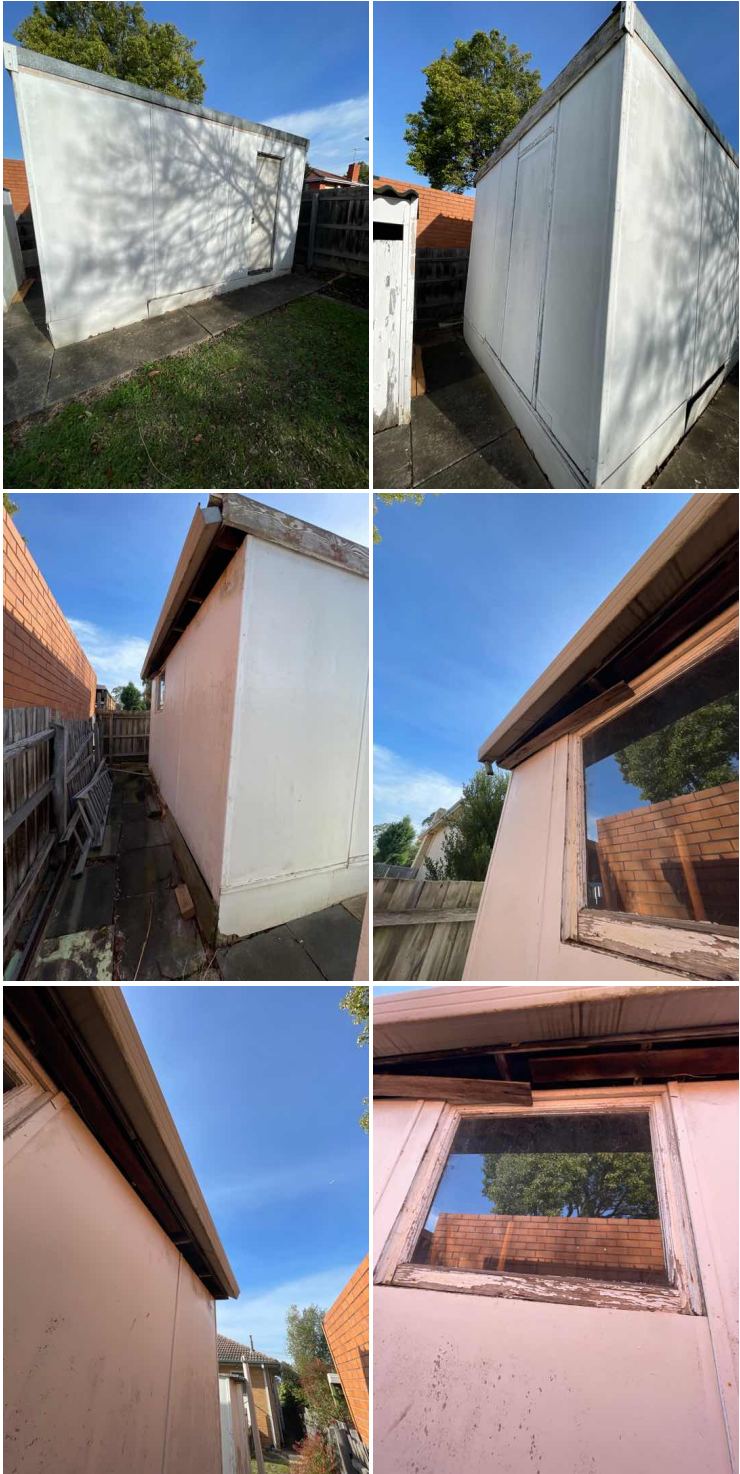
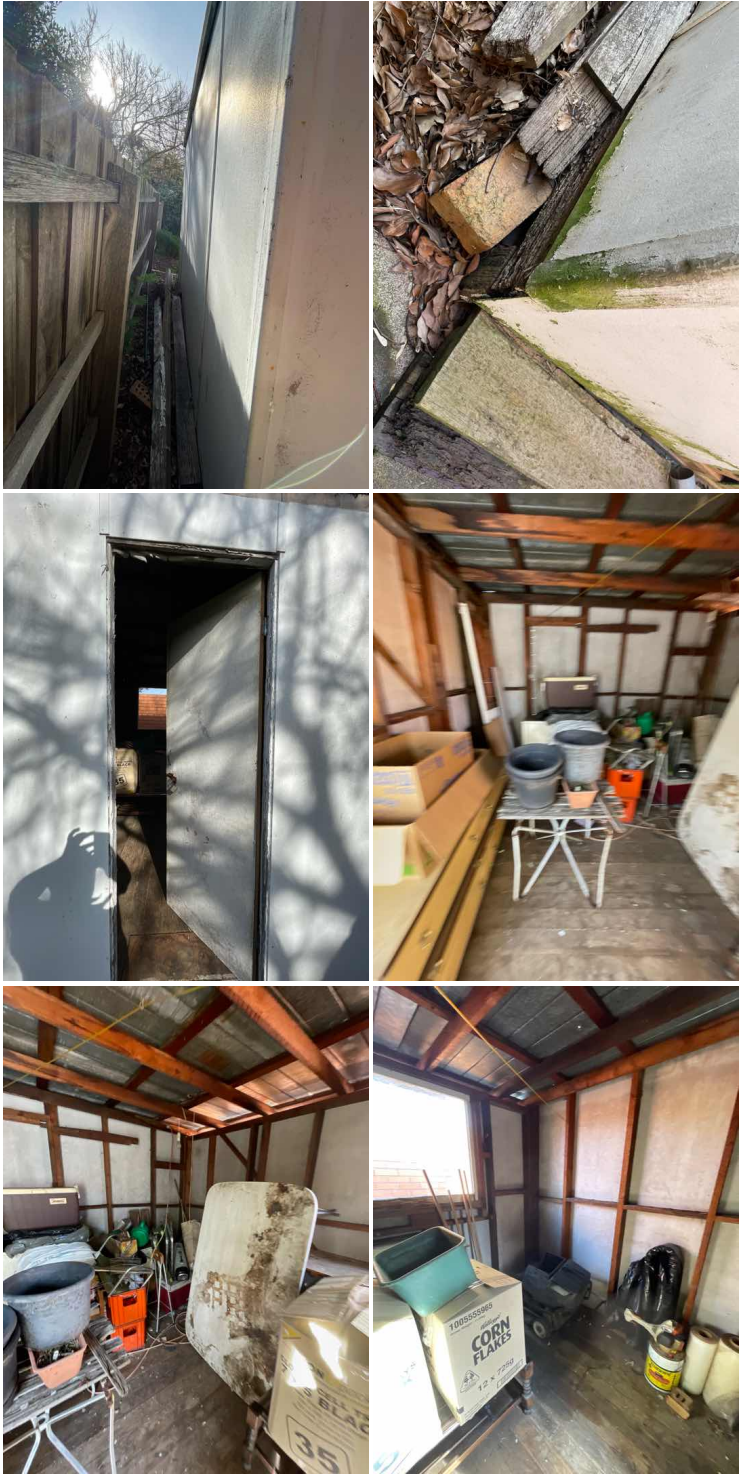
Timber fungal decay in the framing. A qualified carpenter should be engaged for repairs.

Rust developing on cladding noted. Repairs to restrict rust required.

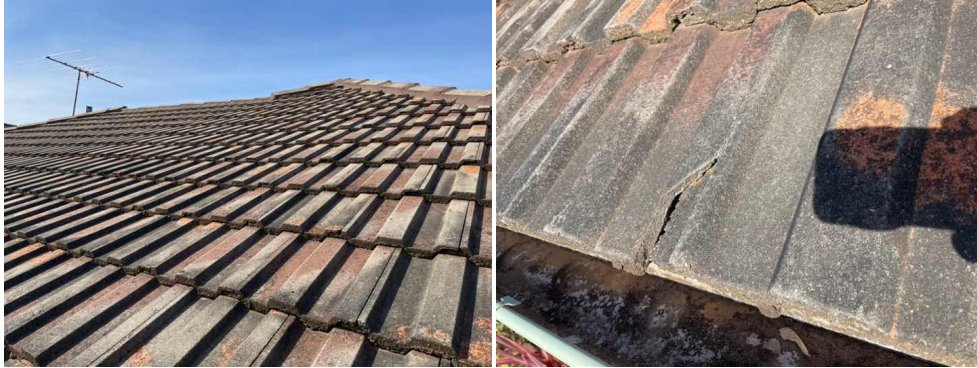
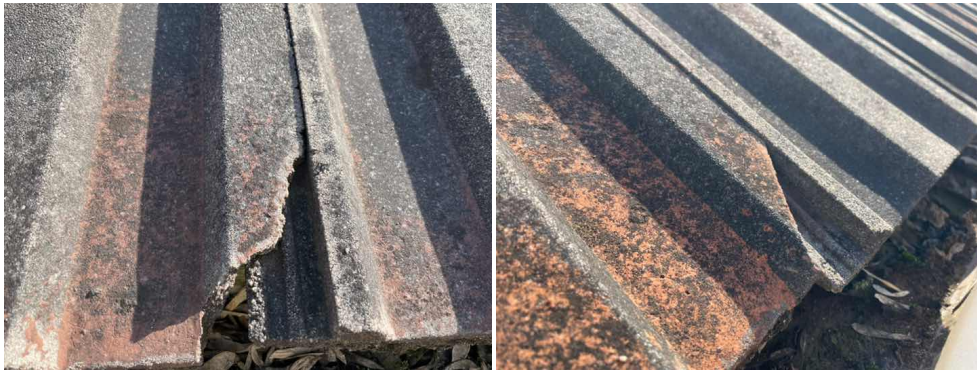
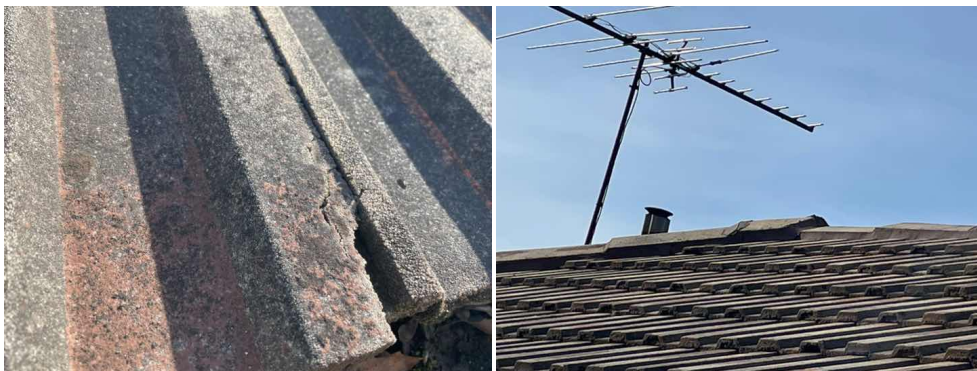
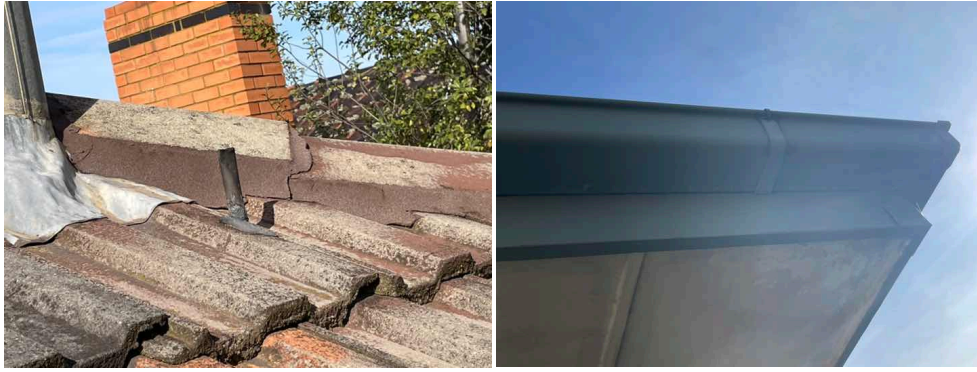
Cracked tile ends visible. A qualified roof tiling contractor should be engaged for advice and recommendations. Considered a minor defect but has the potential to become a Major defect if repairs aren't carried out immediately due to water ingress into the roof cavity.

Roof line unevenness visible. May be related to sag due to age or insufficient support, some gaining or loosening of the burru truss. See a qualified carpenter for advice and recommendations. Considered a minor defect, however has the potential to be a costly repair.

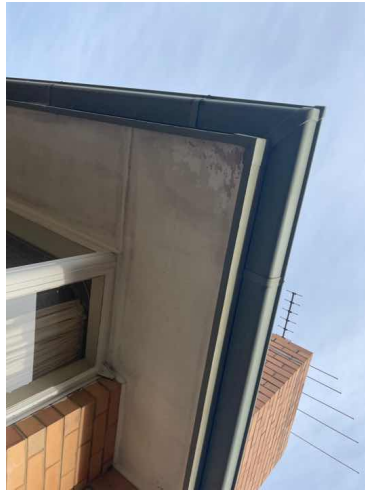
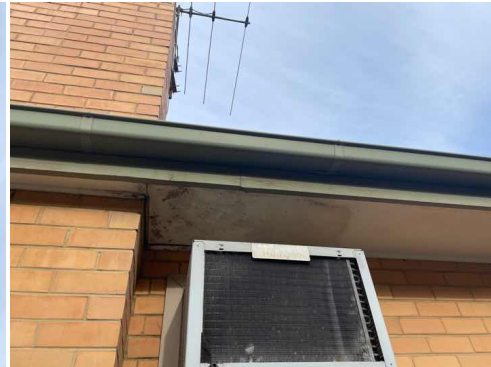
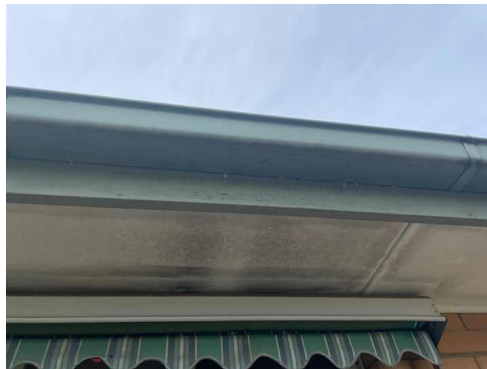
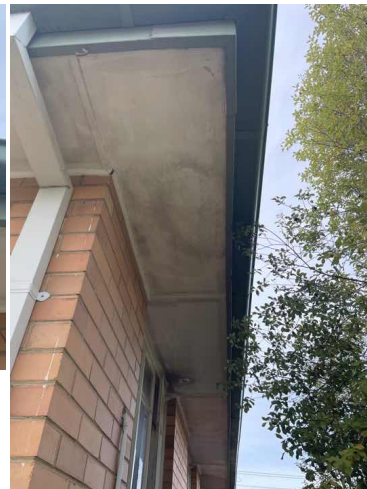
The Mould should be treated and the eaves painted with an anti-Mould paint.

Eave lining stains observed. Normally this occurs due to overflow in blocked gutters or previous leaks. Recommendations. Gutters should be kept clear of debris and eave linings can then be painted or repaired as required.

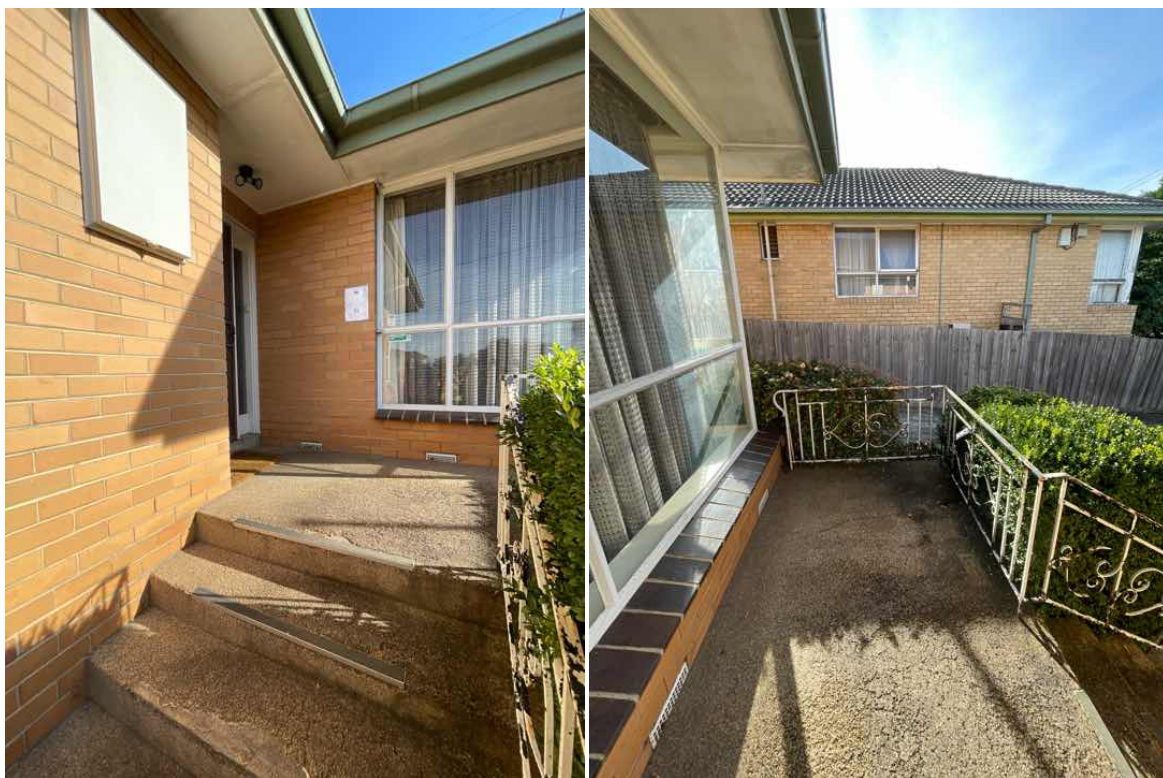
Defects exist to an area or component/s requiring assessment by a specialised field. Please read below for details.

Rust evident on rails / balustrade - Recommendations: A qualified tradesperson should be engaged for repairs

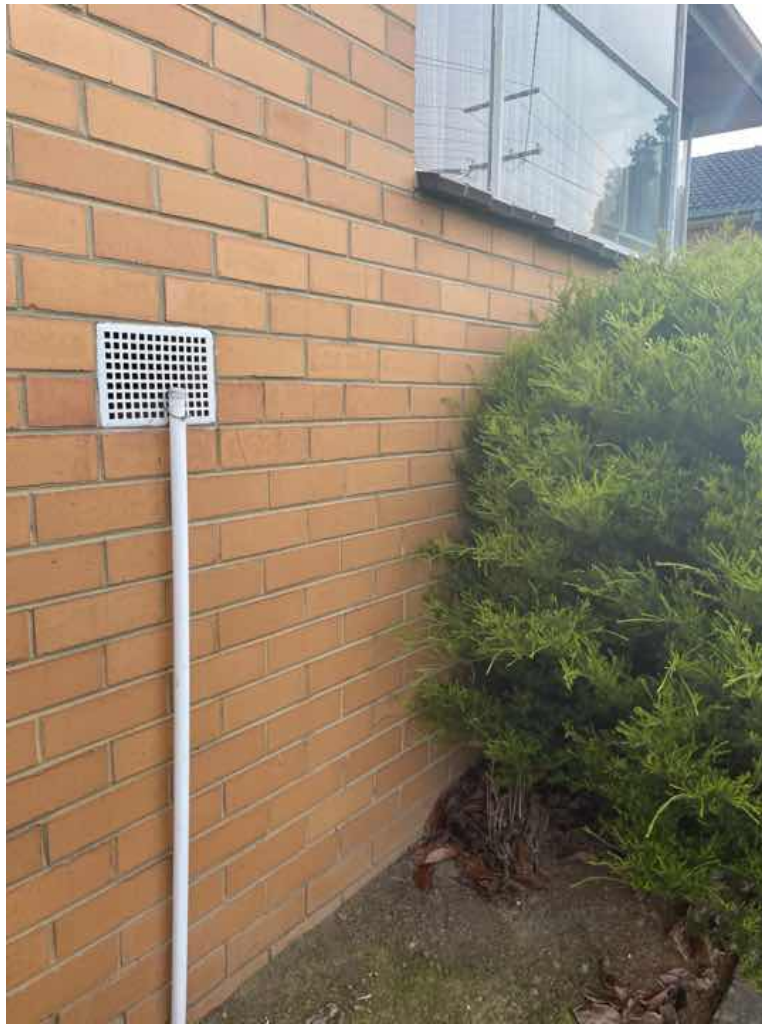
Minor brick damage observed to the brickwork. Have repaired by a qualified brick layer.

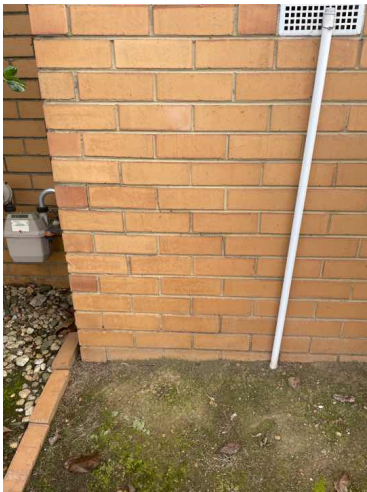
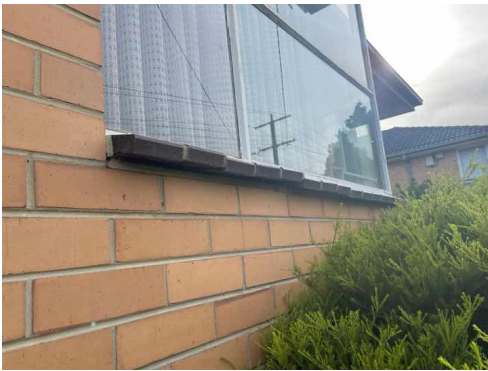
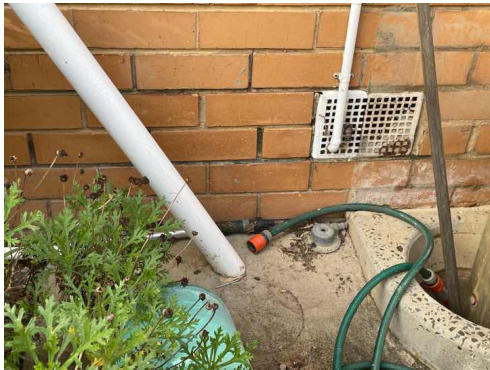
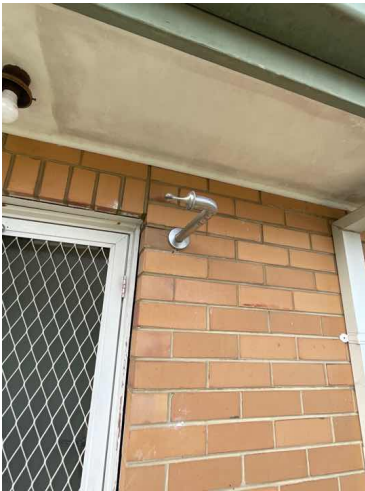
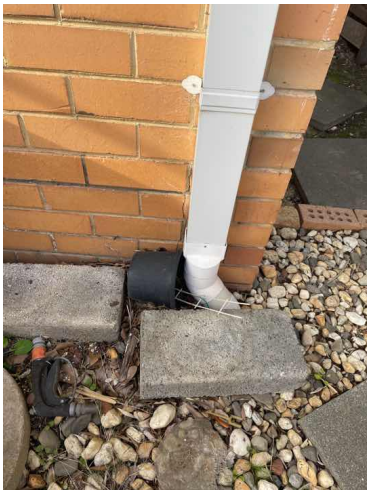
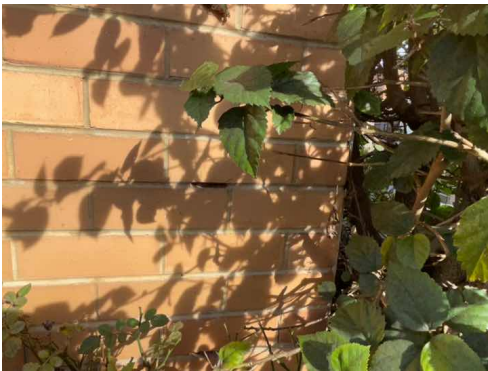
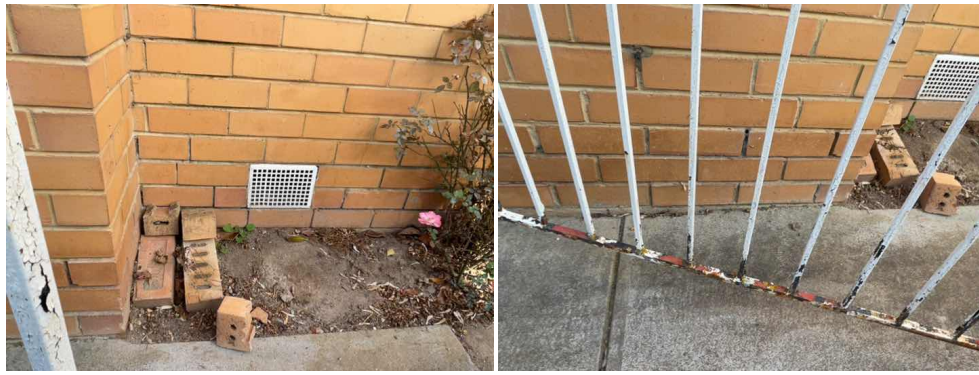
There appears to have been some settlement in the building which has caused some cracking to the walls. These cracks are categorized as 0 to 2. This can also cause some doors to bind or be out of square. In the inspectors opinion these cracks are due to settlement, usually due to ground movement and subsequent movement to building materials can be expected. Any cracks should be monitored and if cracks increase in size, further investigation should be carried out by a structural engineer.

Mortar erosion between the brickwork is eroded. Contact a qualified bricklayer for repairs.

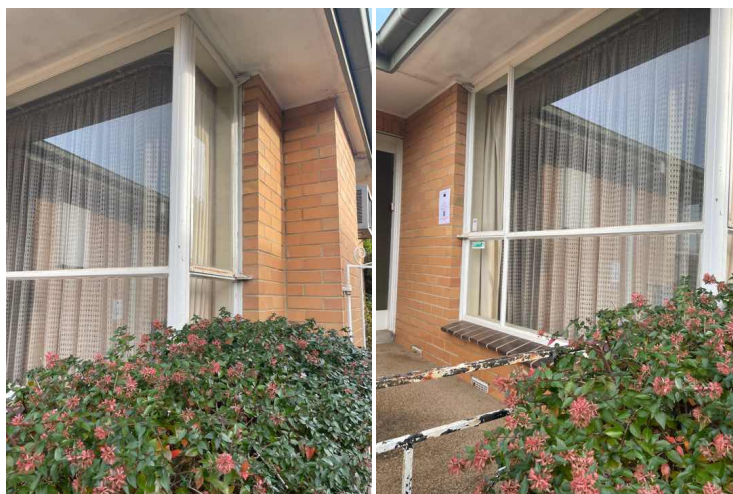
General age/damage has occurred to window components. Recommendations: Restoration work recommended. A qualified carpenter should be engaged for advice and recommendations.

Rust is evident in sections of the homes window framework. Some areas should be repaired. A suitably qualified tradesman should be engaged for advice and recommendations.

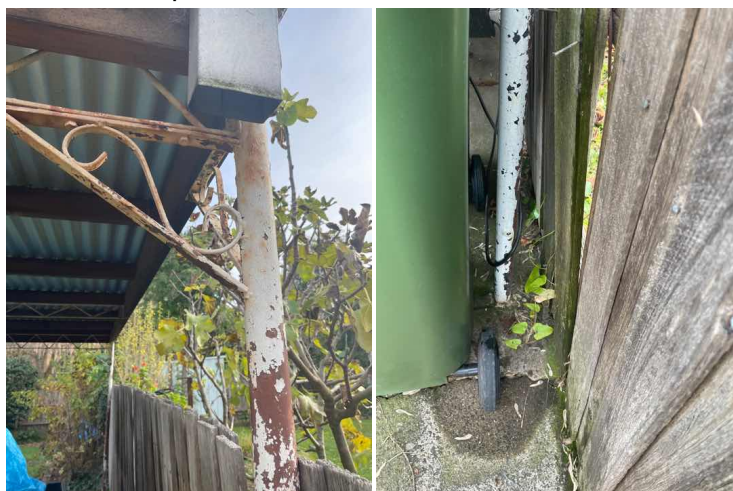
Corrosion noted to the metal frame. Replacement recommended.

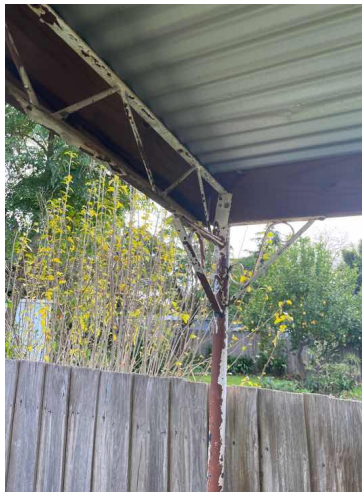
Down pipe is not connected to storm water. Contact a roof plumber for repairs

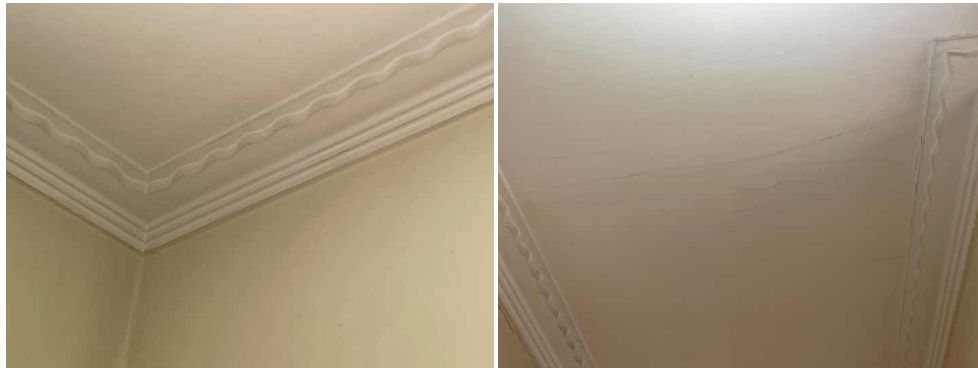
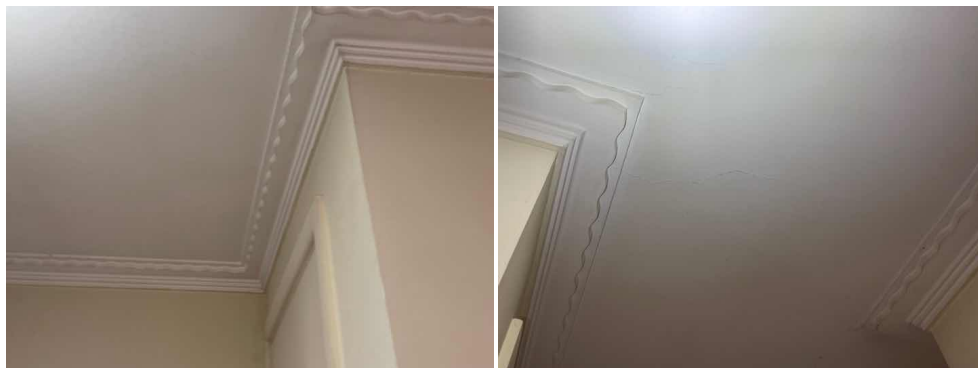
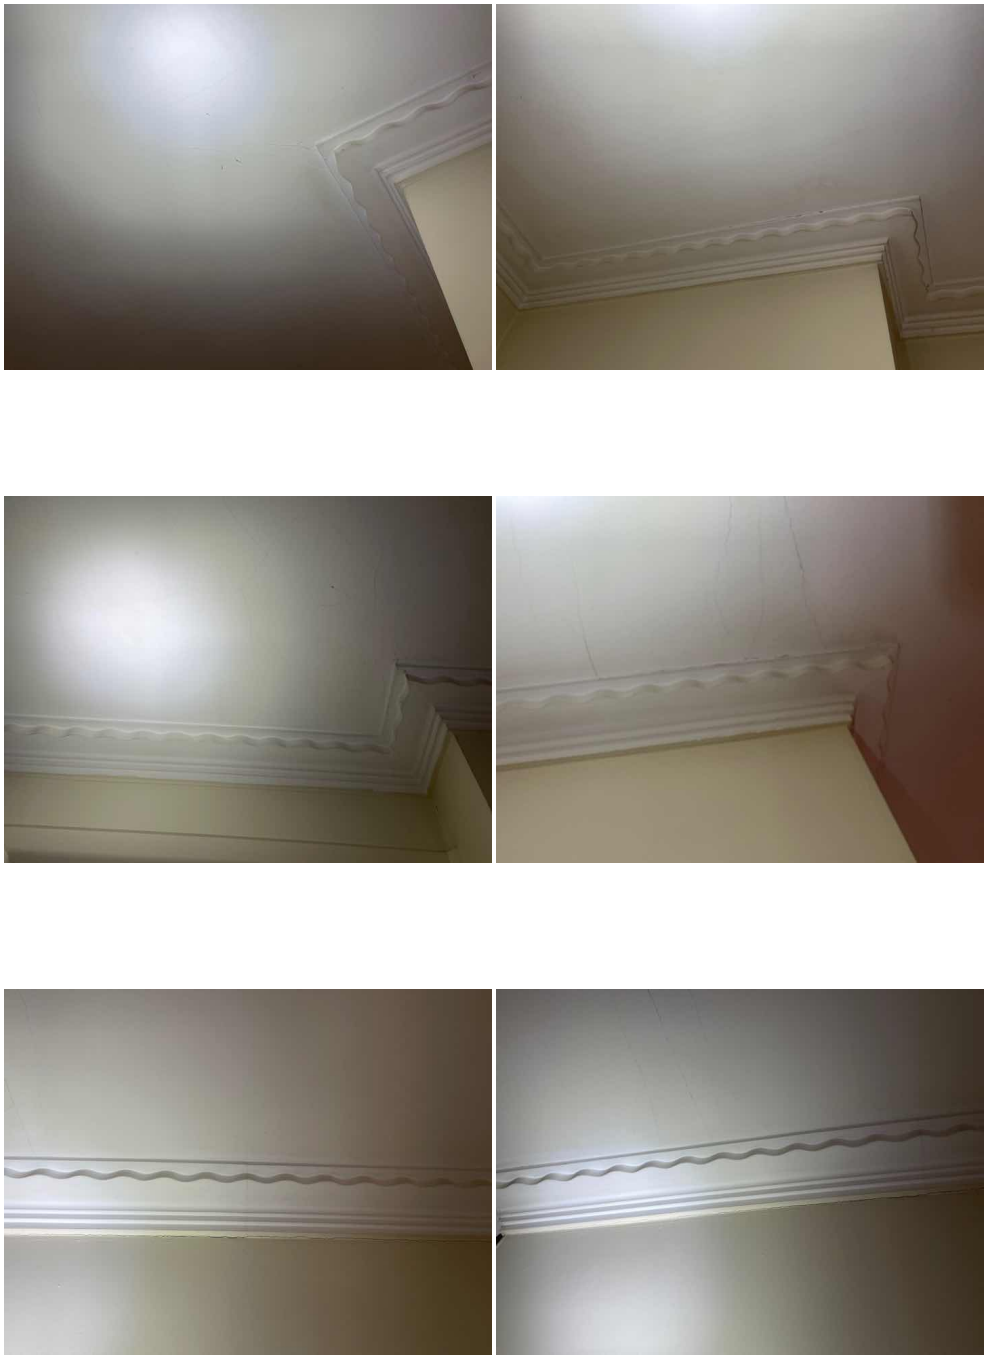
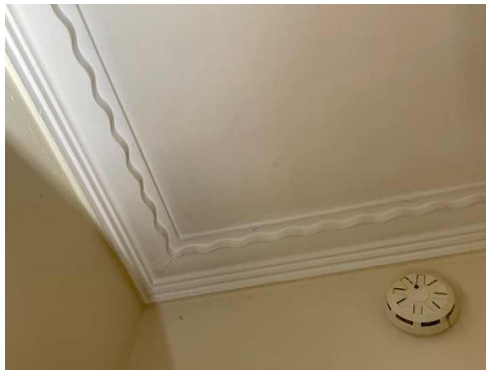
General ageing and/or denting and the like is evident on ceiling linings - Recommendations: A qualified painter should be engaged to assess and repair as required.

Settlement Cracks Noted. These are typical and generally patch and paint will suffice, however monitoring these cracks is advised for 12 months and if they become worse, further investigation by a suitably qualified professional is advised.

Typical cornice separation/detachment observed. I recommend you contact a qualified painter for repairs.

Ceiling stains - No moisture readings obtained. These may have been repaired however you will need to monitor after a prolonged period of rainfall. If leaking persists, a qualified plumber should be engaged for advice and recommendations. All water damaged plaster should be replaced.

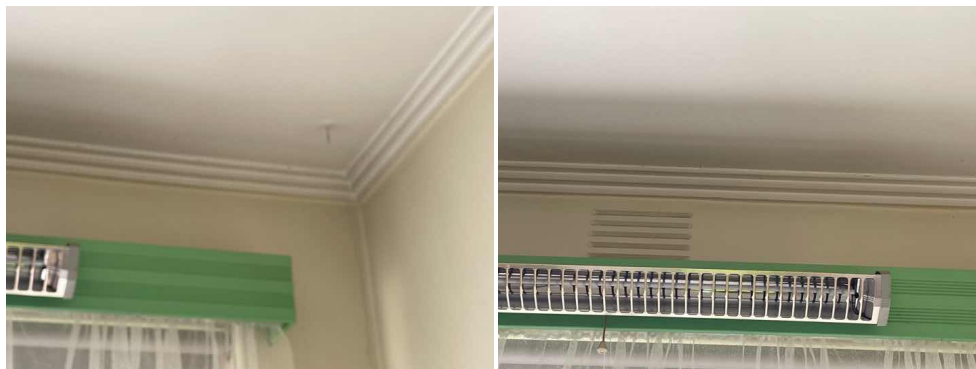
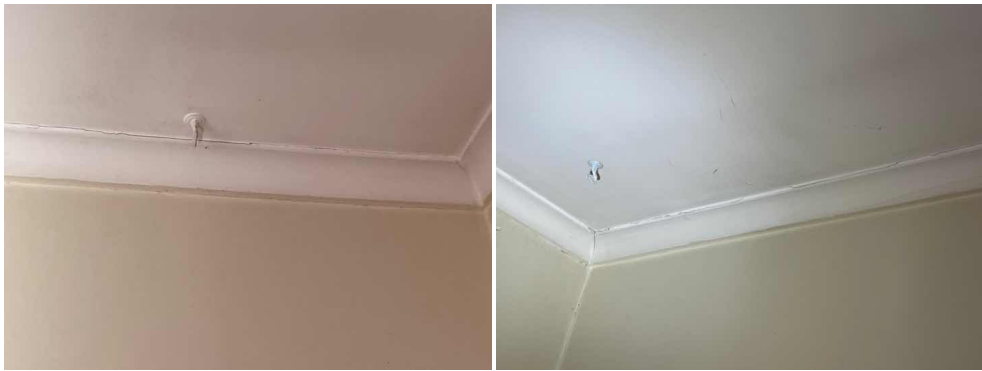
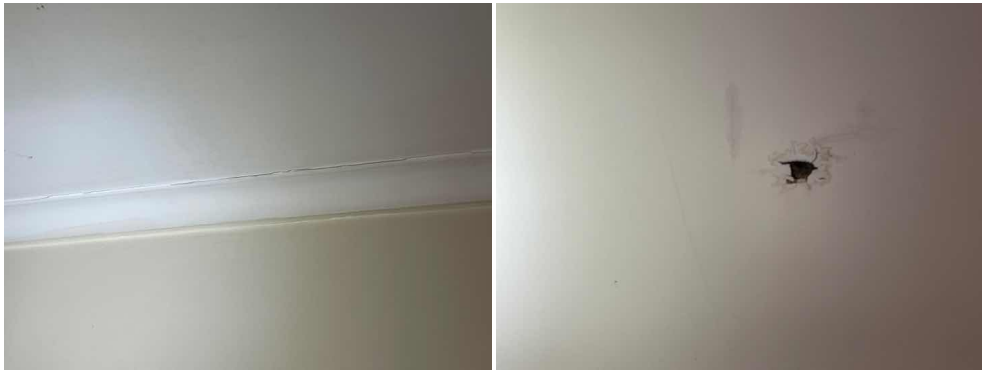
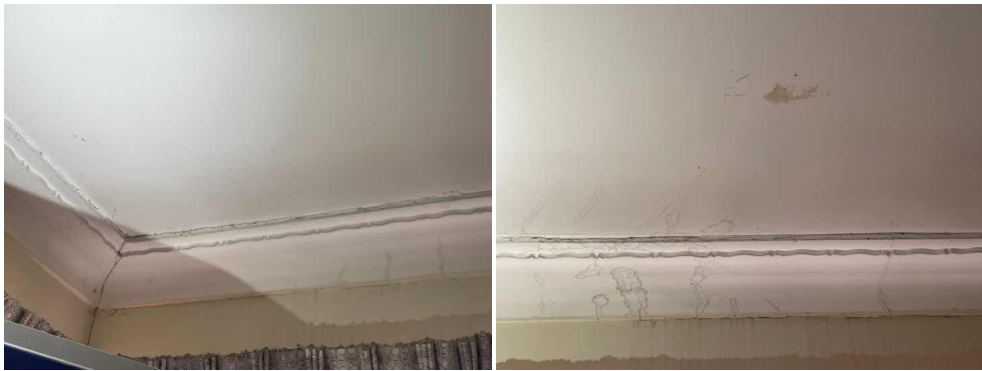
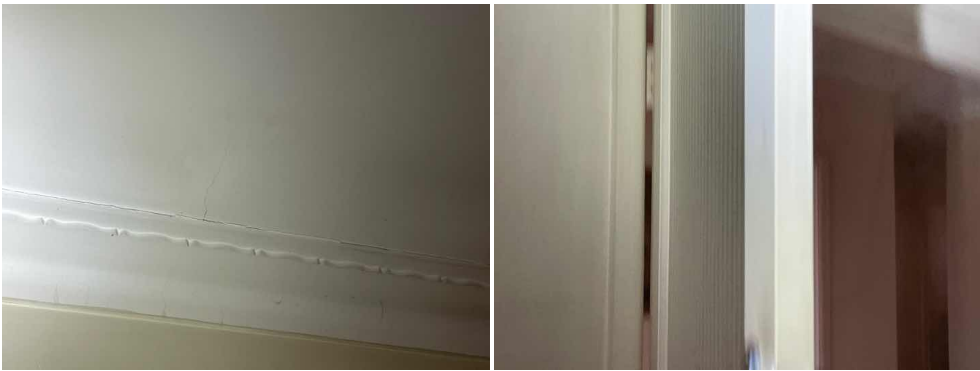
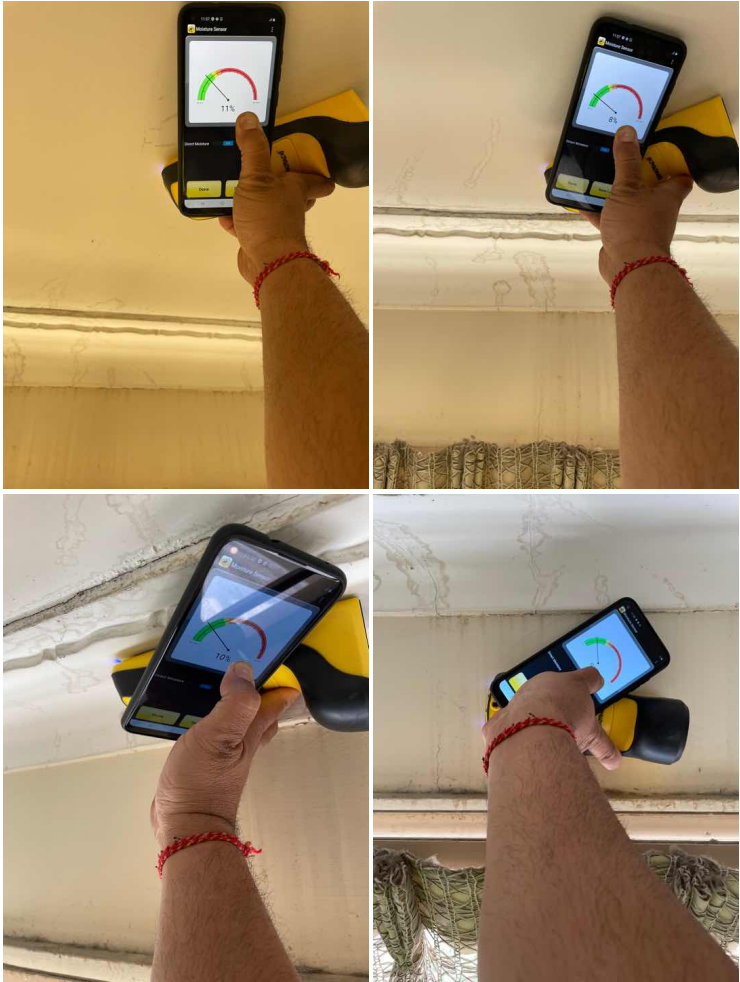
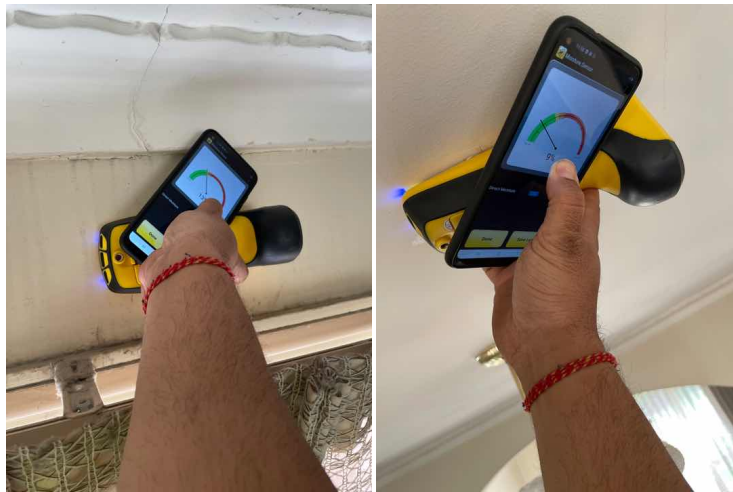
General ageing and/or denting and the like is evident on ceiling linings - Recommendations: A qualified painter should be engaged to assess and repair as required.

Settlement Cracks Noted. These are typical and generally patch and paint will suffice, however monitoring these cracks is advised for 12 months and if they become worse, further investigation by a suitably qualified professional is advised.

Typical cornice separation/detachment observed. I recommend you contact a qualified painter for repairs.

Incomplete patch/paint repairs noted. I recommend you contact a qualified painter for repairs.

Ceiling stains - No moisture readings obtained. These may have been repaired however you will need to monitor after a prolonged period of rainfall. If leaking persists, a qualified plumber should be engaged for advice and recommendations. All water damaged plaster should be replaced.

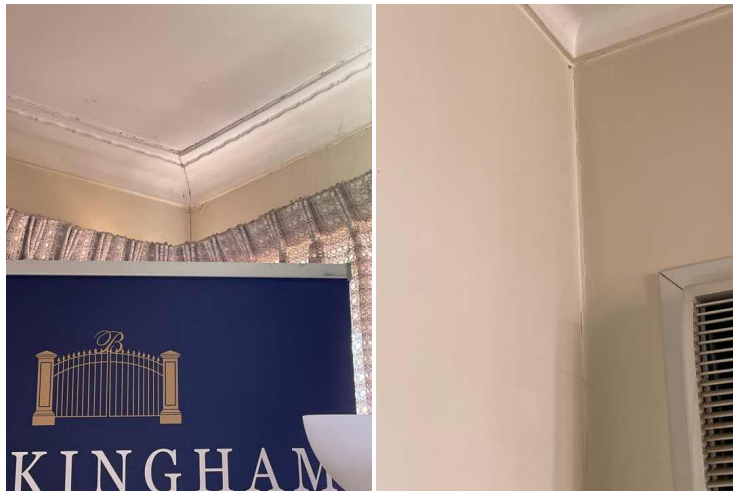
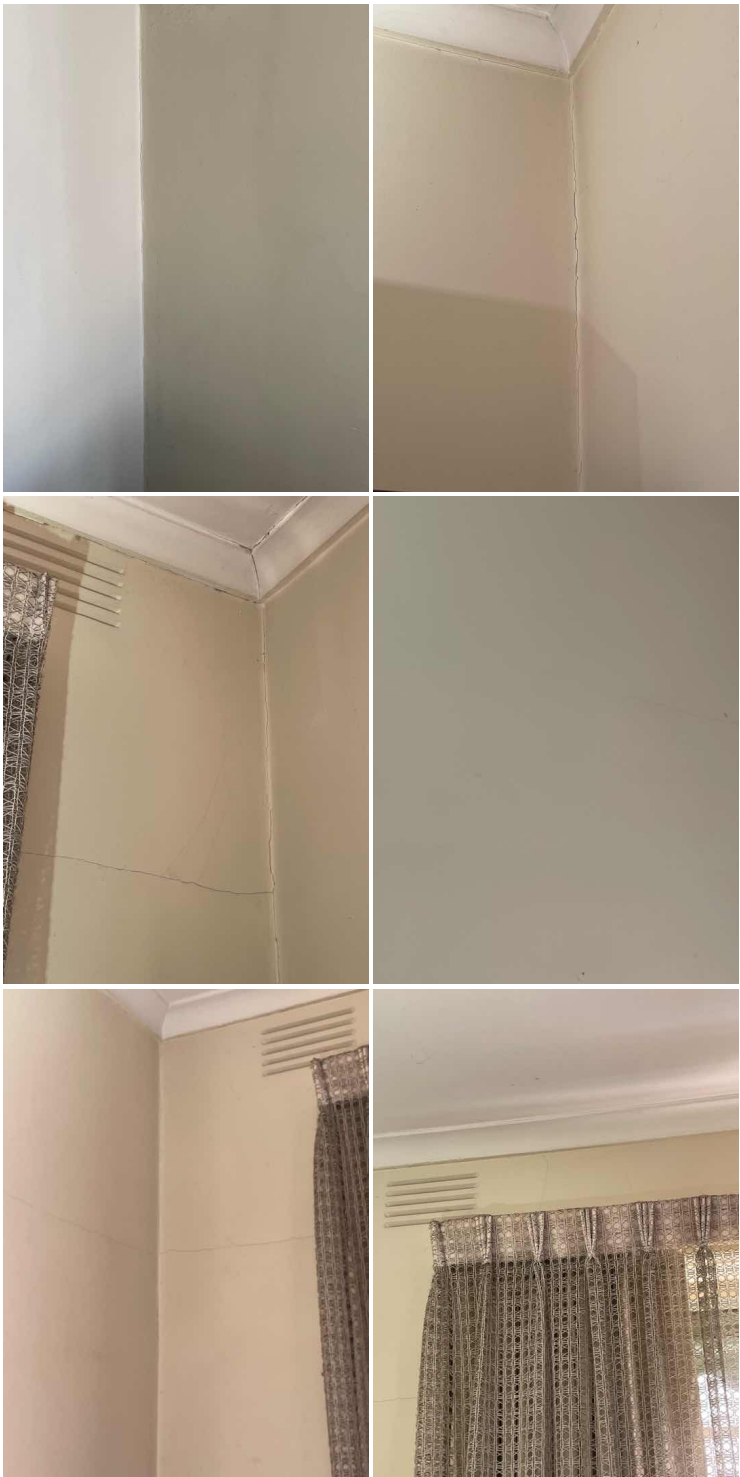
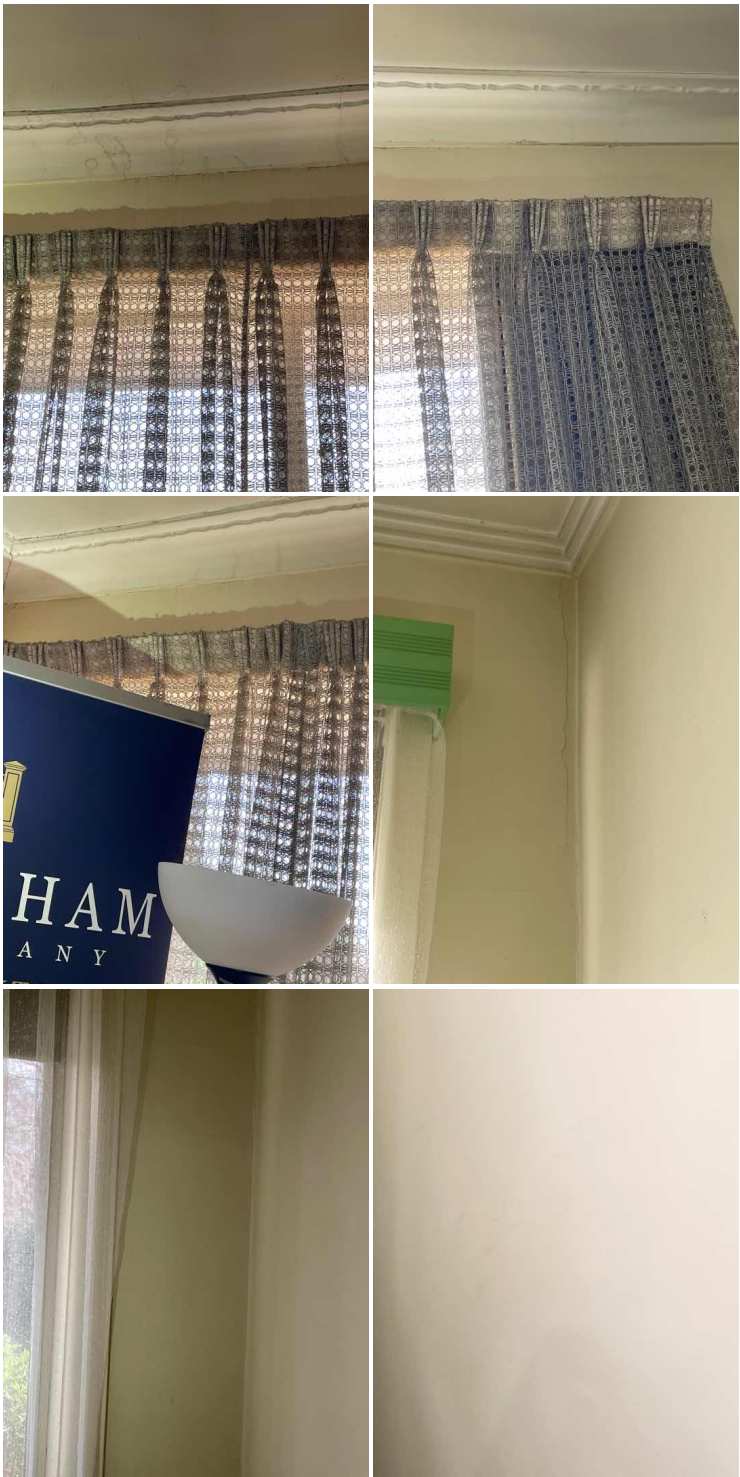
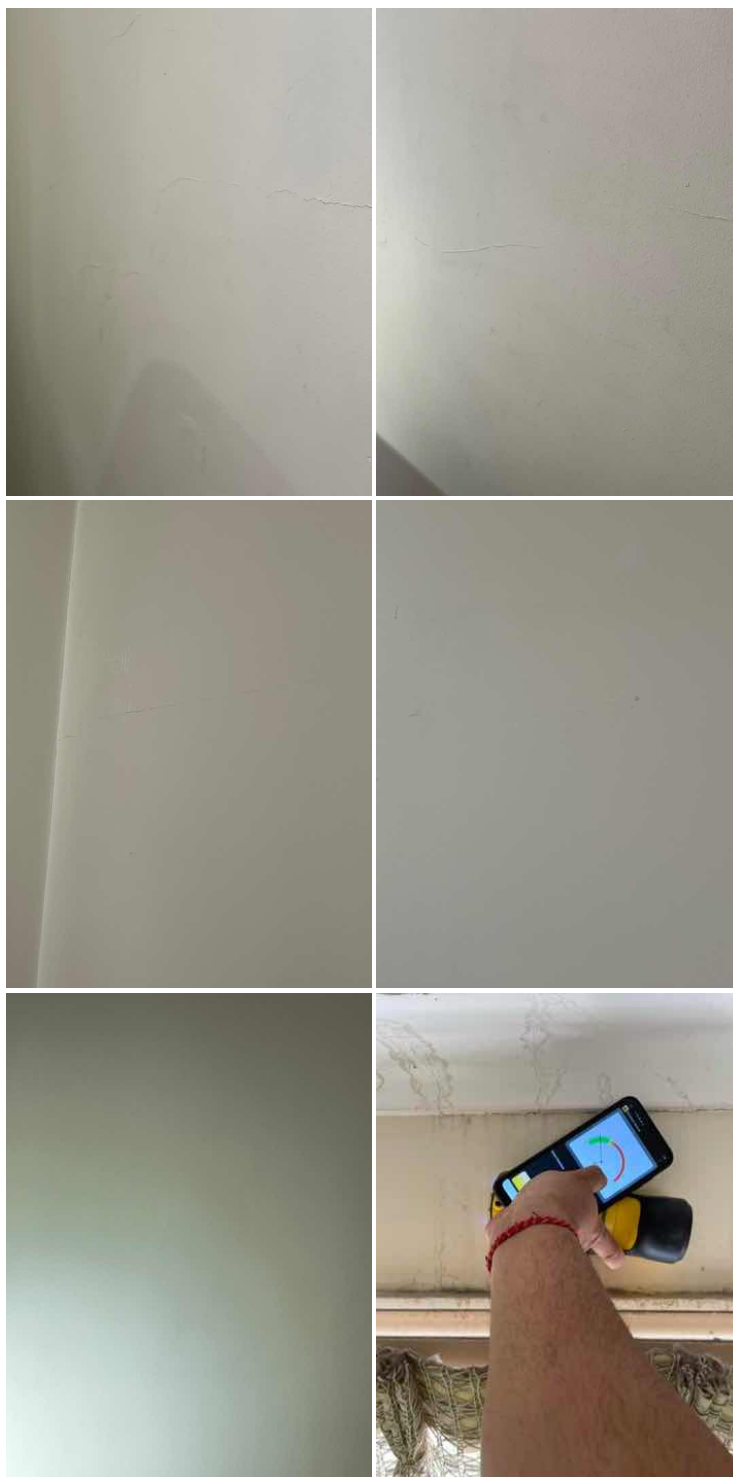
General ageing and/or denting and the like is evident on wall linings - Recommendations: A qualified painter should be engaged to assess and repair as required.

Settlement Cracks Noted. These are typical and generally patch and paint will suffice, however we recommend you monitor these cracks and if they become wider or longer, you will need to contact a structural engineers to assess.

Patched wall cracks visible - Recommendations: Engage a plasterer to assess for further advice and repairs - I am unable to guarantee that these patched areas will not re-open in the future. If further opening occurs the affected areas may require re-assessment by a suitably qualified contractor.

Wall stains observed - No abnormal moisture readings obtained. Recommendations: These may have been repaired, however, you will need to monitor this area and if further staining or flaking appears contact a qualified plumber for further investigation.
