# Building & Timber Pest Inspection Report

**Inspect365**

**VICTORIA, 3087**

Inspection Date:                24 May 2021

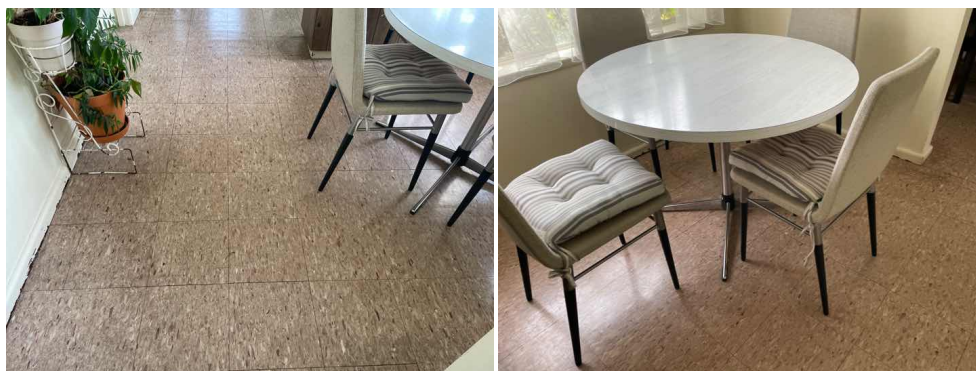
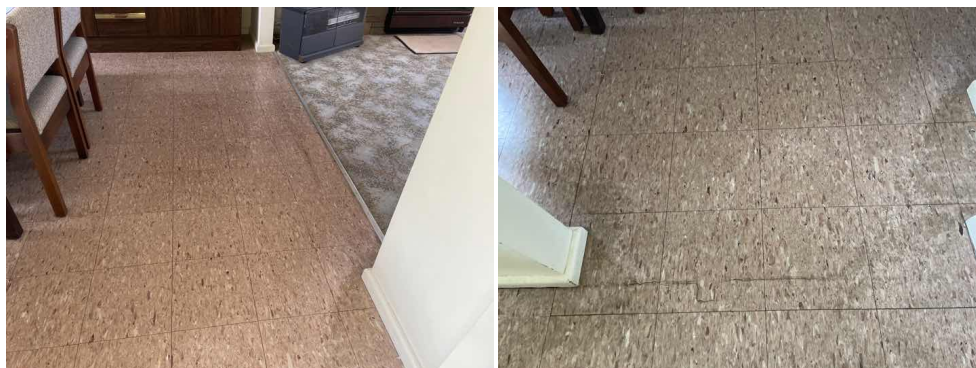
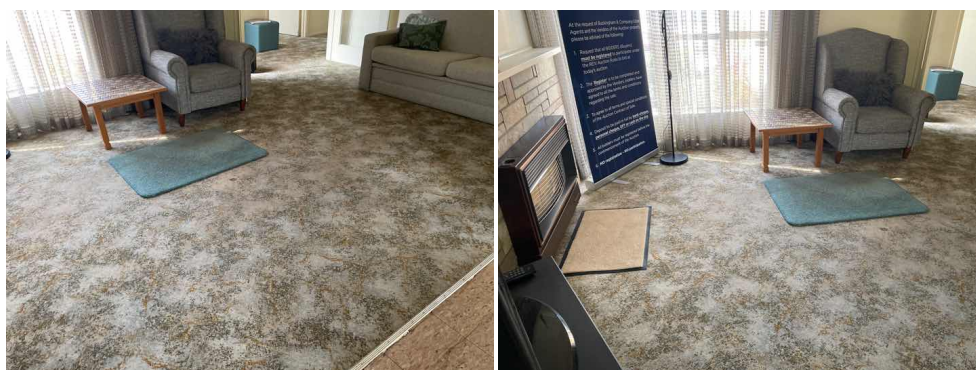
General carpet deterioration. Replacement may be required A qualified carpet layer should be engaged.

Stains observed - Steam cleaning may rectify stained areas but they appear entrenched.

Unevenness visible in floor. Possibly due to poor workmanship or excessive movement/settlement. A qualified carpenter should be engaged for advice and recommendations re levelling.

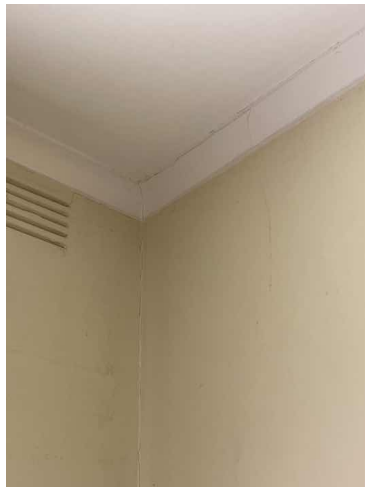
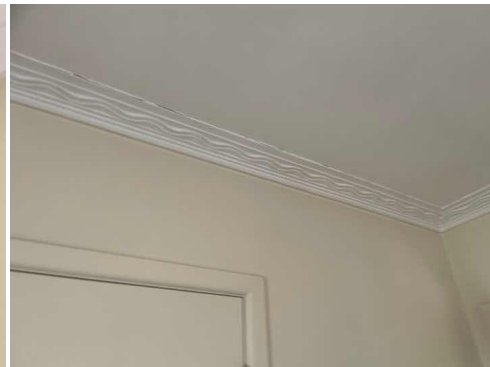
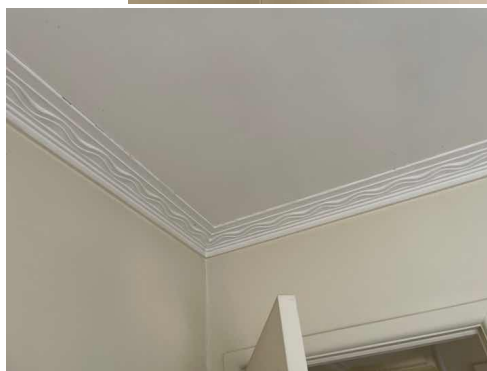
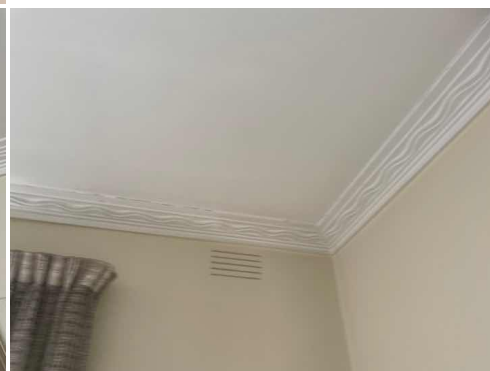
General ageing and/or denting and the like is evident on ceiling linings - Recommendations: A qualified painter should be engaged to assess and repair as required.

Typical cornice separation/detachment observed. I recommend you contact a qualified painter for repairs. Ceiling paint flake/deterioration is evident. Recommendations: General maintenance/painting as required. Ceiling stains - Moisture readings obtained. In the absence of rain It's difficult to ascertain with certainty the location of the leak. A qualified roofer/roofing plumber should be engaged for advice and recommendations. All water damaged plaster should be replaced.

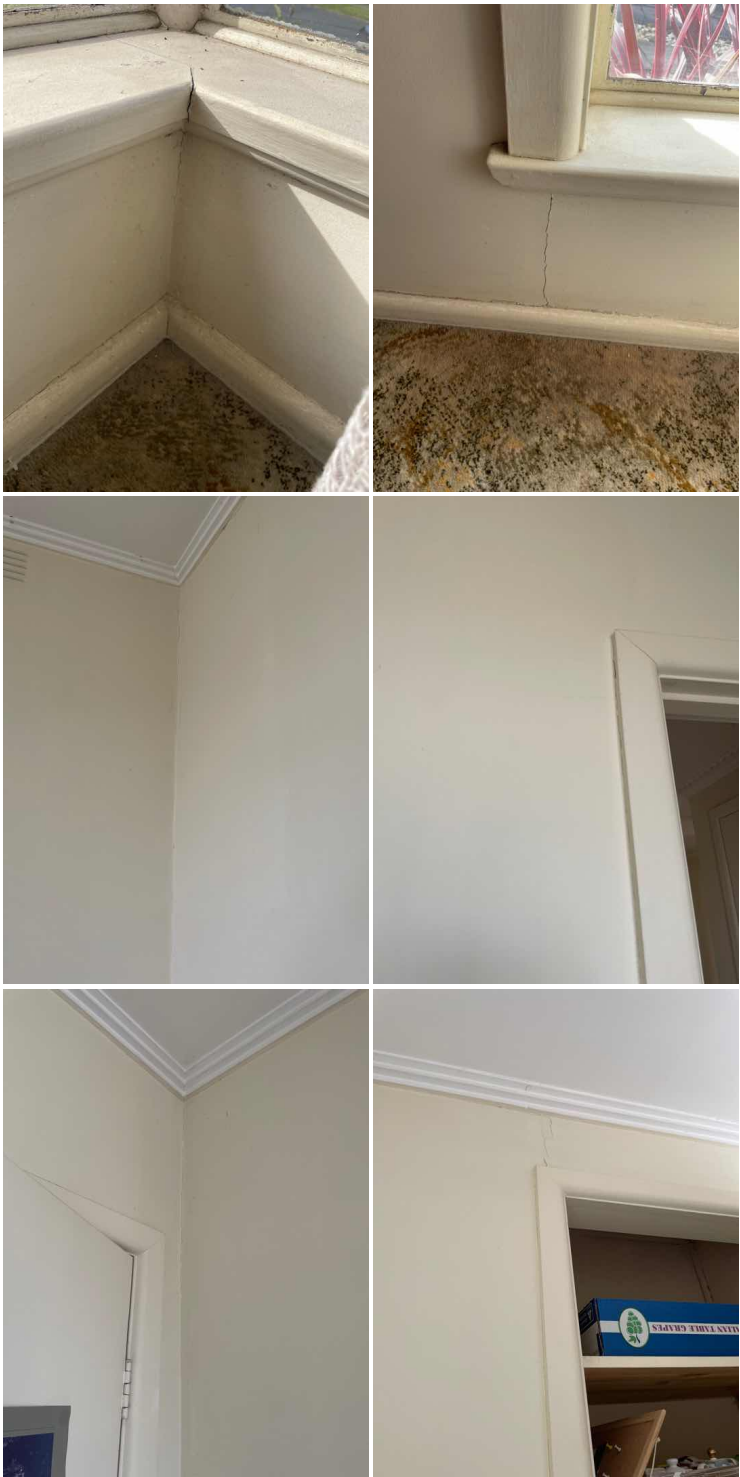
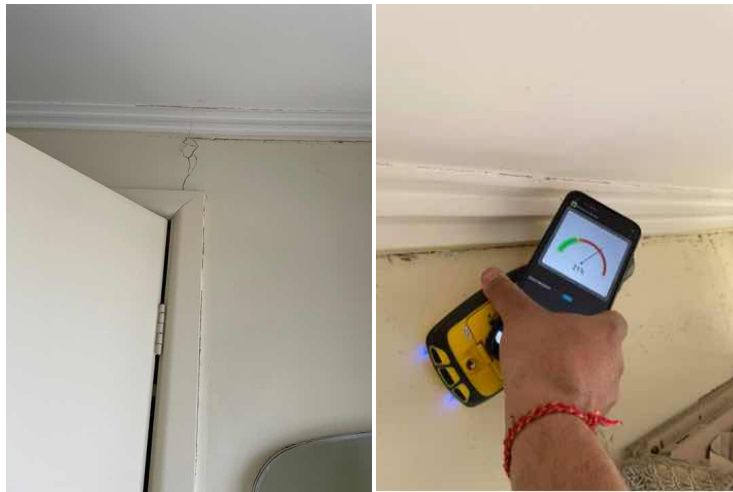
General ageing and/or denting and the like is evident on wall linings - Recommendations: A qualified painter should be engaged to assess and repair as required.

Settlement Cracks Noted. These are typical and generally patch and paint will suffice, however we recommend monitor these cracks and if become wider or longer, you will need to contact a structural engineers to assess.

Patched wall cracks visible - Recommendations: Engage a plasterer to assess for further advice and repairs - I am unable to guarantee that these patched areas will not re-open in the future. If further opening occurs the affected areas may require re-assessment by a suitably qualified contractor.

Wall stains observed - High moisture readings obtained. It is in the opinion of the inspector that the backfilling of the eaves and blocked gutters have contributed to the problem. This must be investigated further as there was no access to the roof void at the time of inspection. Recommendations: Contact licensed tradesperson for further assessment advice and repairs

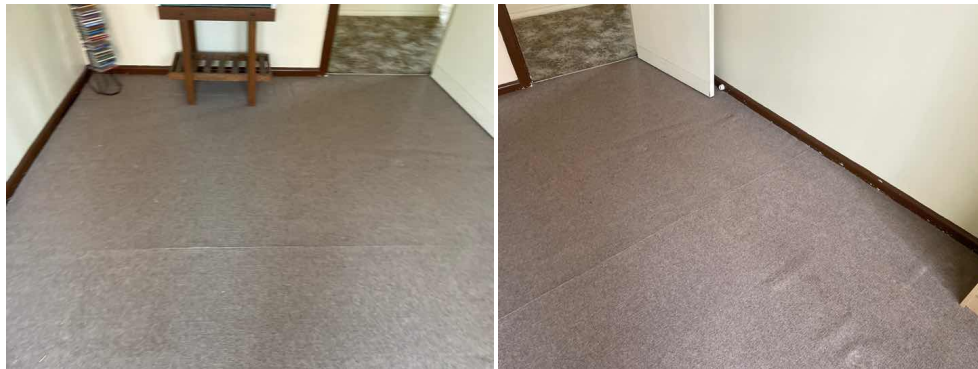
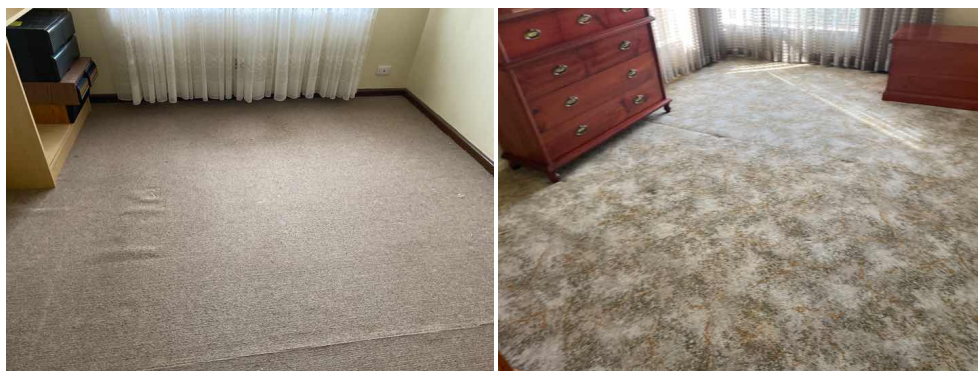
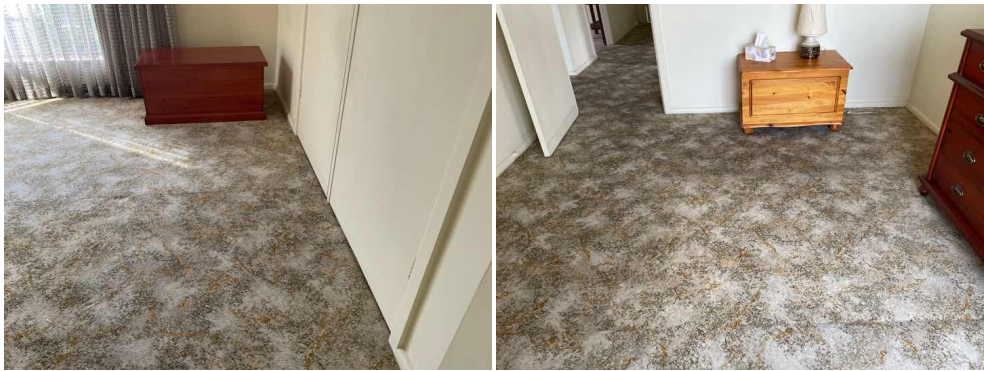
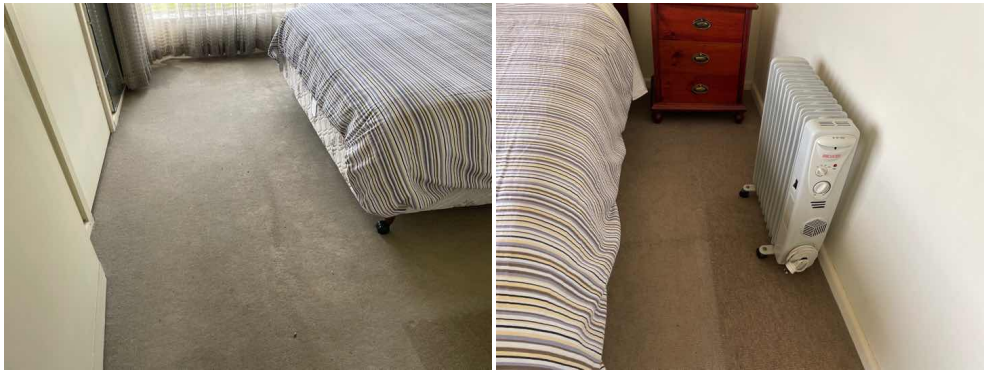
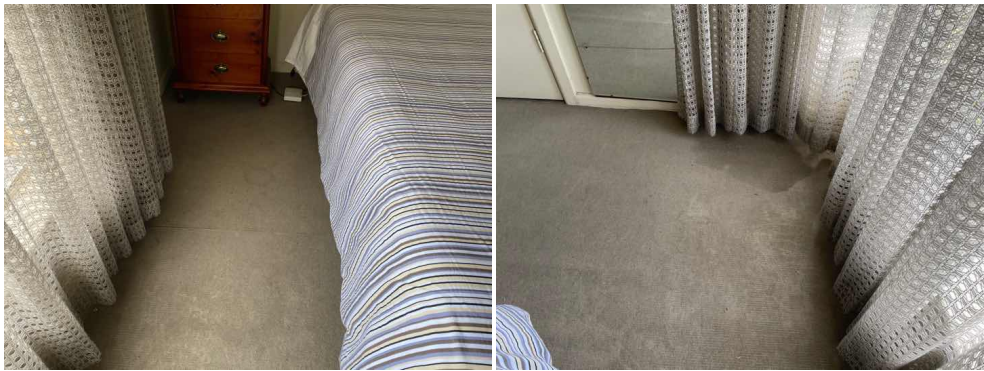
General age wear deterioration - The window frame/components showed evidence of ageing and wear. General maintenance works required.

General carpet deterioration. Replacement may be required A qualified carpet layer should be engaged.

The floorboards underneath the carpets are in satisfactory condition and may be polished as an alternative.

Stains observed - Steam cleaning may rectify stained areas but they appear entrenched.

Unevenness visible in floor. Possibly due to poor workmanship or excessive movement/settlement. A qualified carpenter should be engaged for advice and recommendations re levelling.

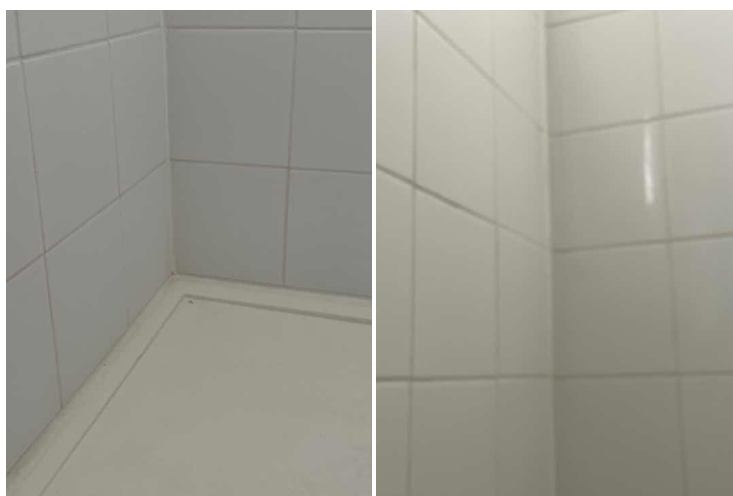
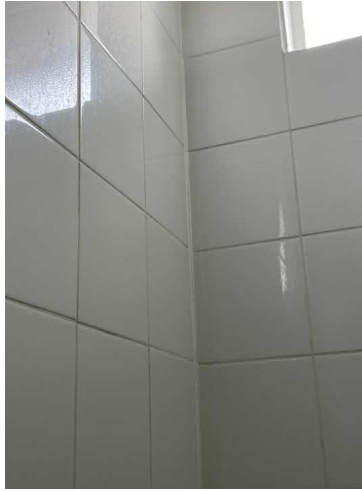
Tile grout deterioration to tiles to the shower area. Re-grout / seal. A qualified tiler should be engaged recommendations and repairs as water may seep in causing rot and creating conducive conditions termites.

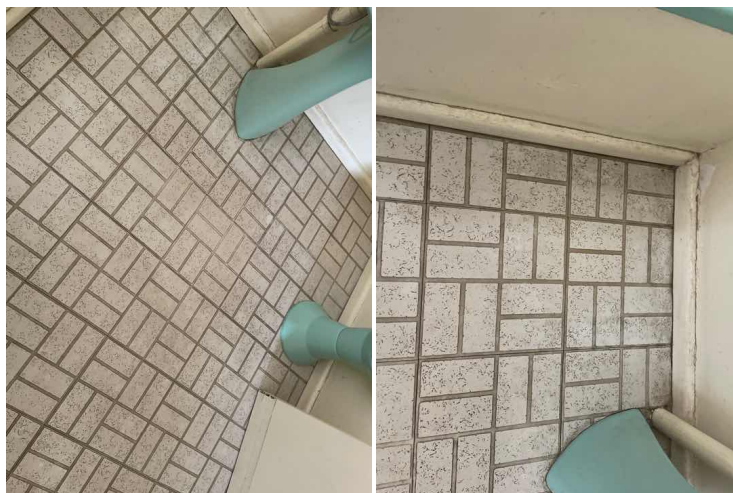
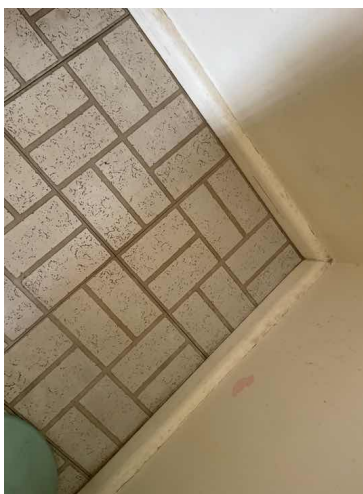
General ageing and/or denting and/or wear and/or previous wall patching and the like is evident on wall linings - Recommendations: A qualified painter should be engaged to assess and repair as required.

Settlement Cracks Noted . These are typical and generally patch and paint will suffice, however Monitoring these cracks advised for 12 months and if become wider or longer, you will need to contact a structural engineers to assess.

Patched wall cracks visible. Engage a plasterer to assess for further advice and repairs - I am unable to guarantee that these patched areas will not re-open in the future. If further opening occurs the affected areas may require re-assessment by a suitably qualified contractor.

Deteriorated grout noted. This should be repaired as this will lead to water ingress under the tiles causing uplifting and possible water penetration.

Unevenness visible in floor. Possibly due to poor workmanship or excessive movement/settlement. A qualified carpenter should be engaged for advice and recommendations re levelling.

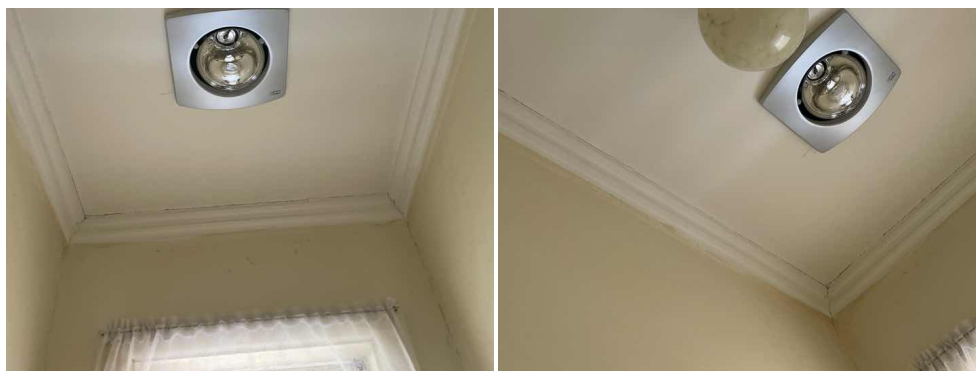
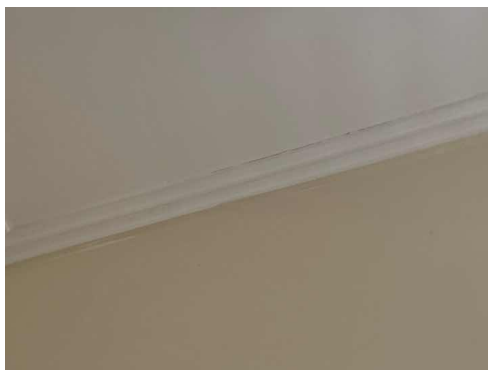
General ageing and/or denting and/or wear and/or previous patching and the like is evident on ceiling linings - Recommendations: A qualified painter should be engaged to assess and repair as required.

Cornice separation. I recommend you contact a licensed plasterer for repairs.

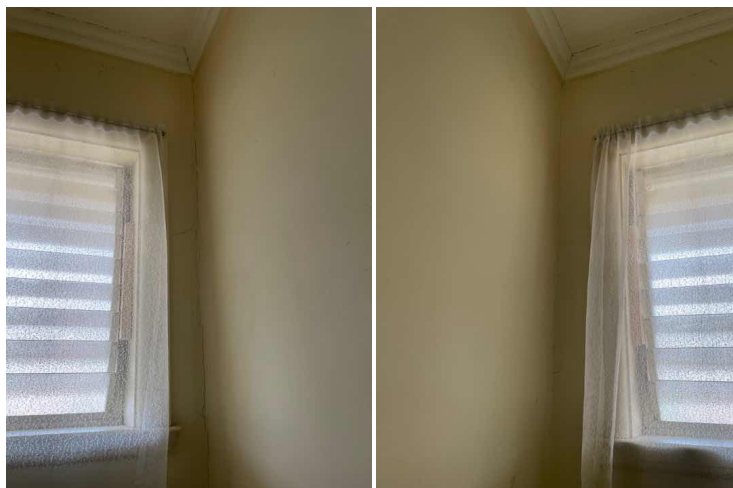
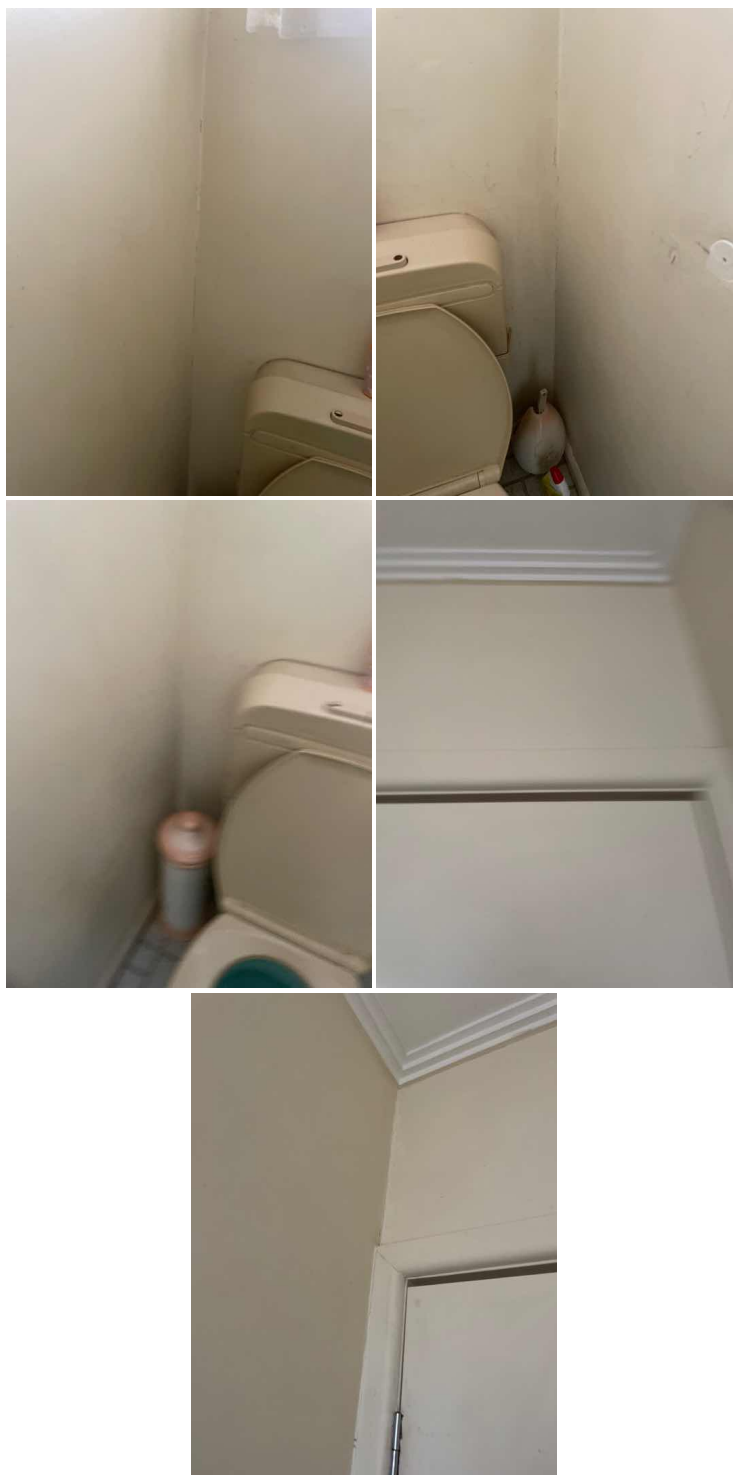
General ageing and/or denting and/or wear and/or previous wall patching and the like is evident on wall linings - Recommendations: A qualified painter should be engaged to assess and repair as required.

Settlement Cracks Noted . These are typical and generally patch and paint will suffice, however Monitoring these cracks advised for 12 months and if become wider or longer, you will need to contact a structural engineers to assess.

Patched wall cracks visible. Engage a plasterer to assess for further advice and repairs - I am unable to guarantee that these patched areas will not re-open in the future. If further opening occurs the affected areas may require re-assessment by a suitably qualified contractor.

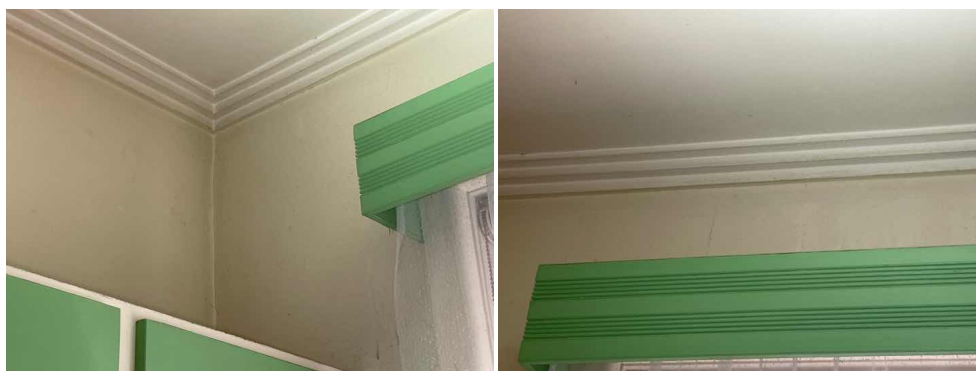
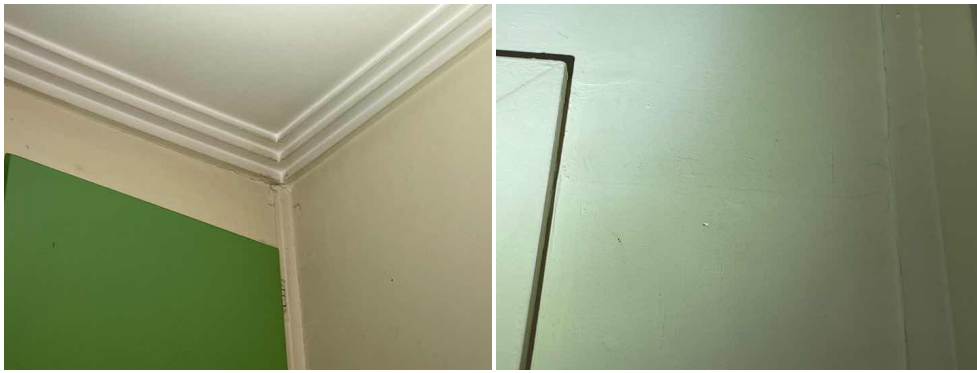
General ageing and/or denting and/or wear and/or previous wall patching and the like is evident on wall linings - Recommendations: A qualified painter should be engaged to assess and repair as required.

Settlement Cracks Noted . These are typical and generally patch and paint will suffice, however Monitoring these cracks advised for 12 months and if become wider or longer, you will need to contact a structural engineers to assess.

Patched wall cracks visible - Recommendations: Engage a plasterer to assess for further advice and repairs - I am unable to guarantee that these patched areas will not re-open in the future. If further opening occurs the affected areas may require re-assessment by a qualified carpenter.

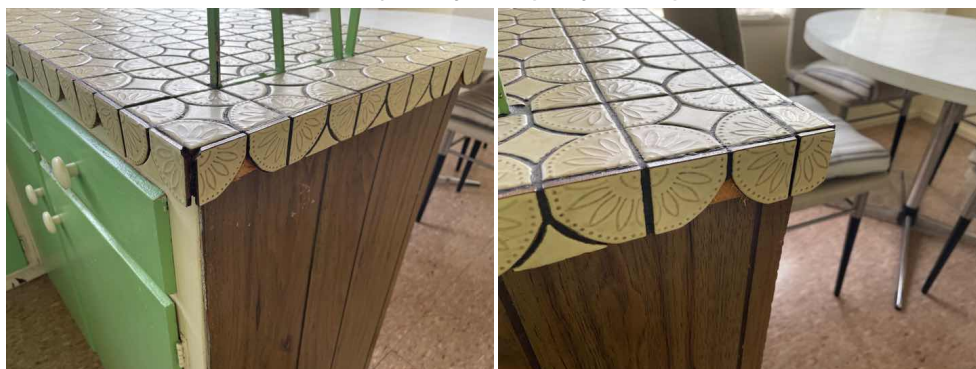
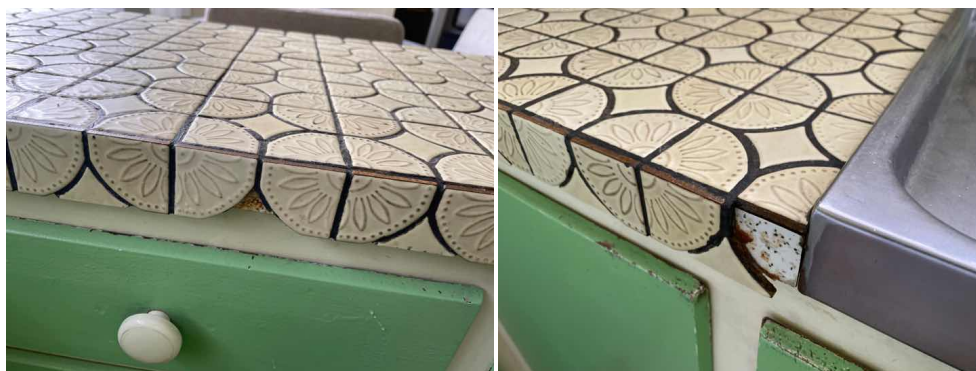
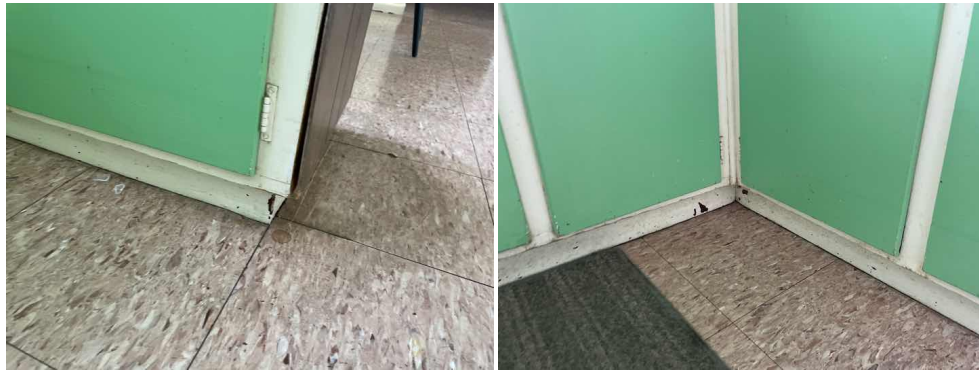
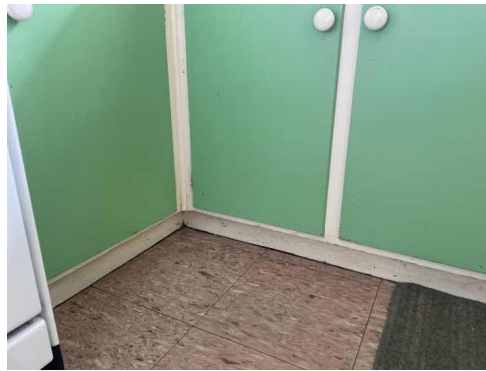
Splash back grout deteriorated. Repairs by qualified tiler is recommended.

Splash back tile cracking visible. Repairs by qualified tiler is recommended.

There is a leak from the tap head. Have checked by a plumber

The tap / tap head is loose. Might be as simple as tightening or a replacement maybe required. A qualified plumber should be engaged for assessment and recommendations.

Damage was noted to the bench top tiles, contact a joinery company for repairs

Damage was noted to the cabinets, contact a joinery company for repairs

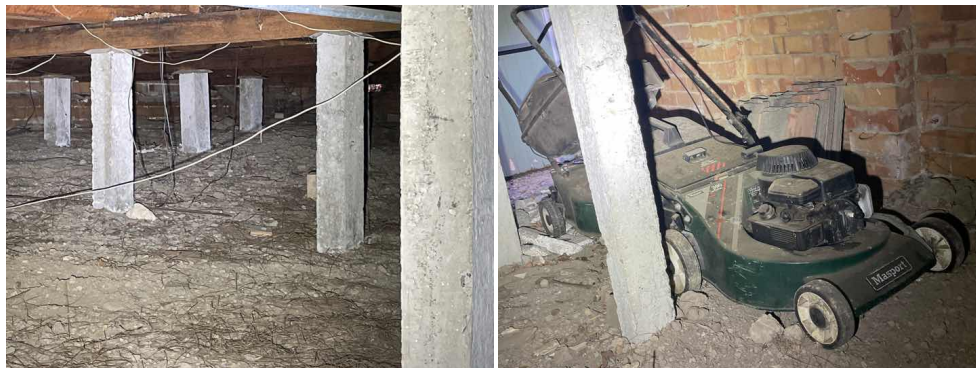
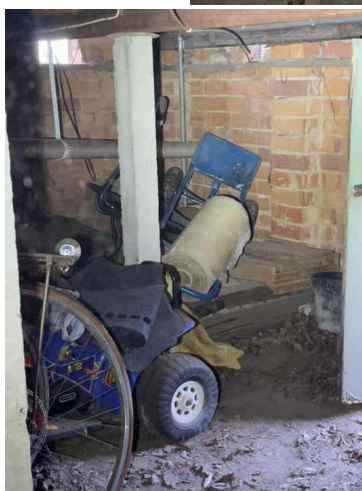
Inability to safely enter through the man hole without causing damage or injury to the inspector due to the access door being mostly above the cabinets thus preventing safe placement of the ladder to gain entry into the roof void. I would recommend relocating the access door to an area with adequate clearance to be able to safely enter without causing injury or damage.

Low access restricted full visual inspection.

Stored items restricted visual inspection.

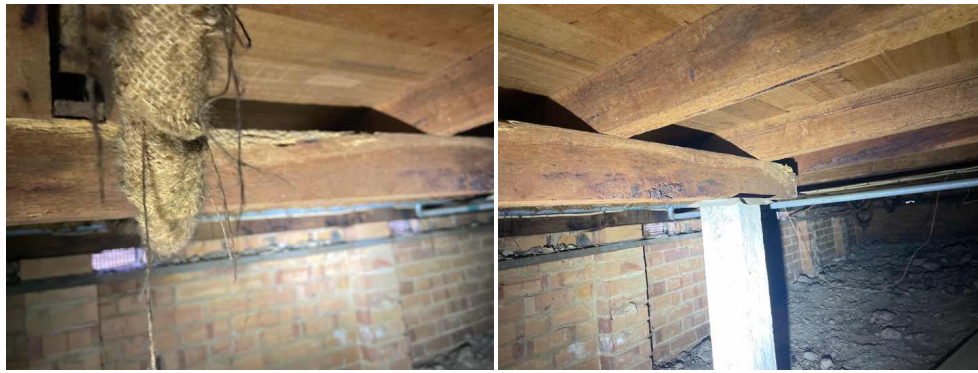
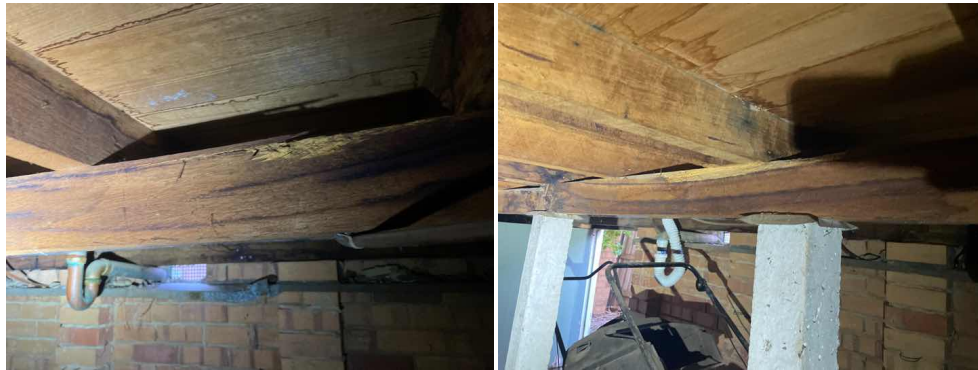
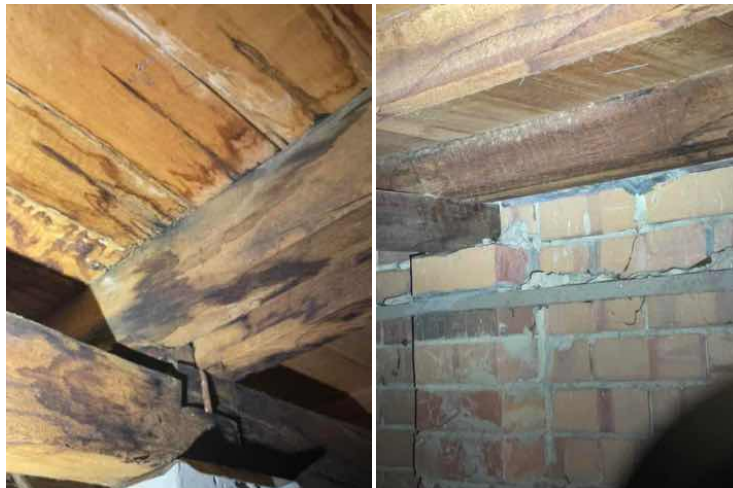
Borer damage to the bearer was observed. Engage a qualified carpenter to assess and make recommendations. Old leak stains evident in subfloor timber may have been fixed

Recommendations: contact licensed carpenter to assess for repairs and advice

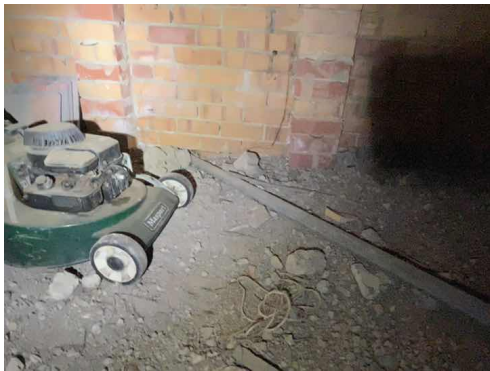
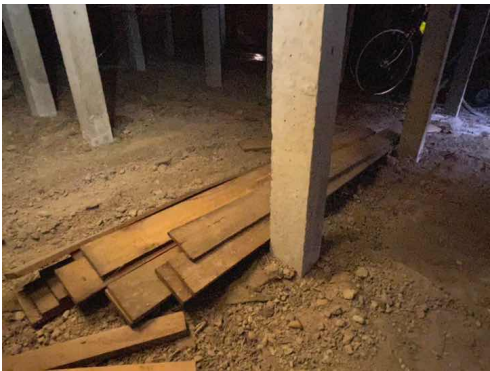
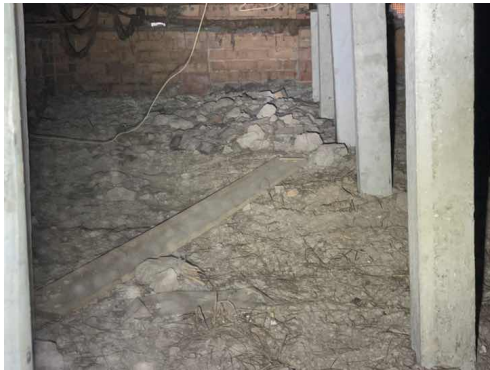
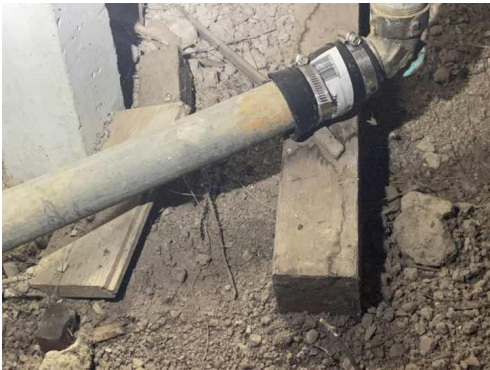
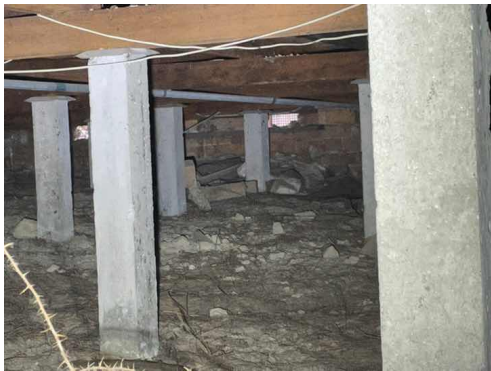
### Subfloor Cleanliness

There was debris and other material in the subfloor, we recommend cleaning these to aid with ventilation and reduce the likely hood of rodents and pests.

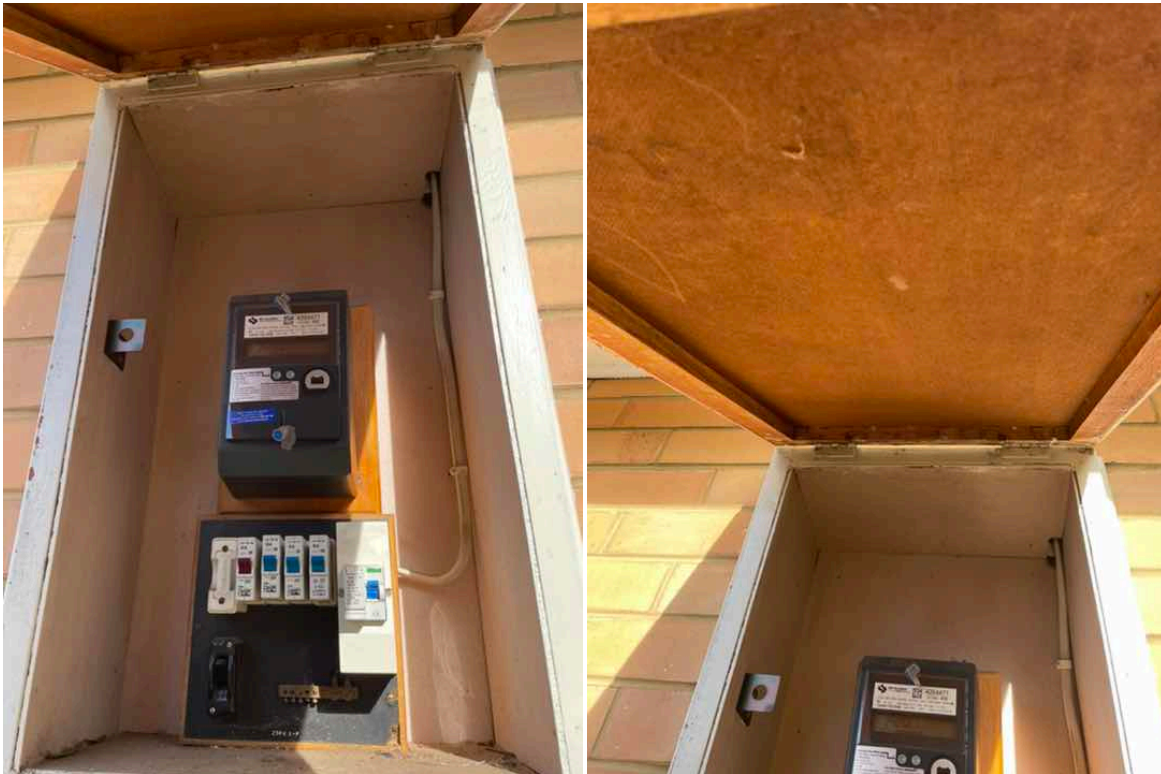
#### **Was a Treatment Notice Found**

No, a durable notice was not found during the inspection.

This firm can give no assurances with regard to work that may have been previously performed by other firms. You should obtain copies of all paperwork and make your own inquiries as to the quality of the treatment, when it was carried out and warranty information. In most cases you should arrange for a treatment in accord with Australian Standard 3660 to be carried out to reduce the risk of further attack.

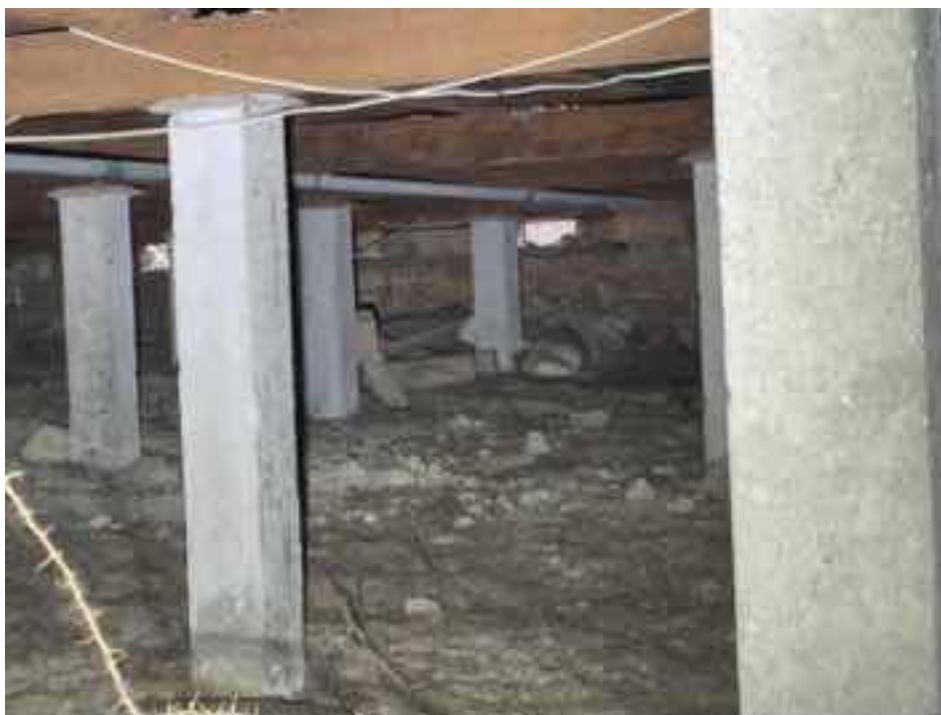
#### **The Termite Shields Appear To Be**

The ant capping is generally considered adequate.
