Building Defect Inspection

Sample , Epping, VIC

Report/Agreement # 100124023859311
 Inspection Date: 10 Jan 2024
 Inspection Time: 02:38 pm

Pest And Building Inspection

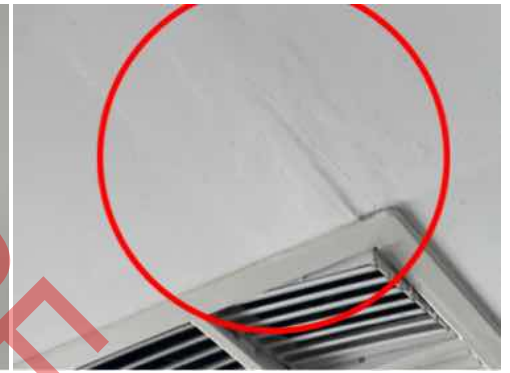
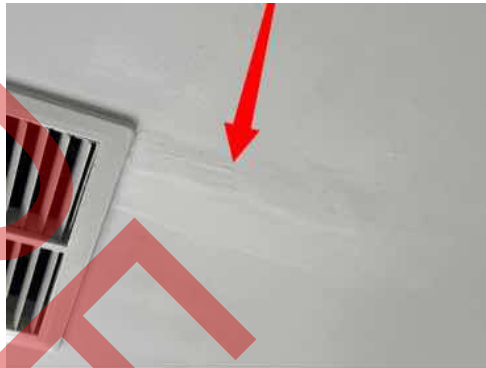
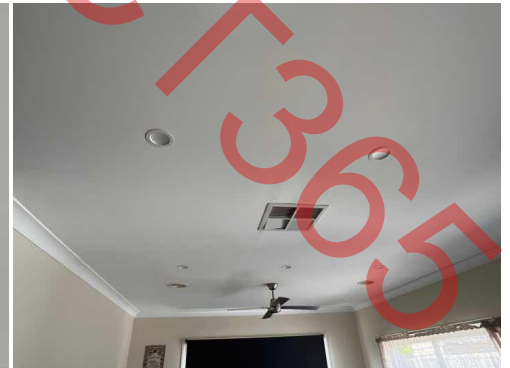
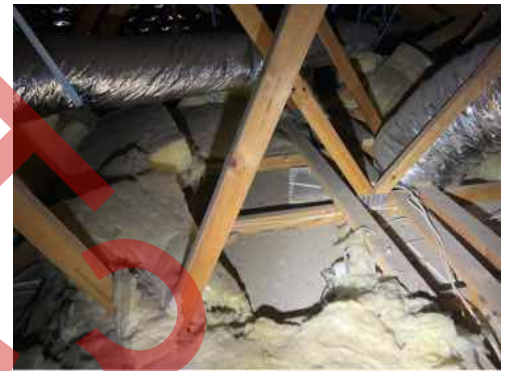
Hallway/passage

Cracking along sheet joint

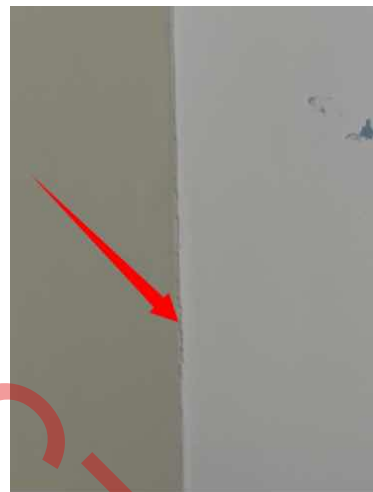
Settlement Cracks Noted . These are typical and generally patch and paint will suffice, however Monitoring these cracks advised for 12 months and if become wider or longer, you will need to contact a structural engineers to assess.
