Building & Timber Pest Inspection Report

Inspect365

Sample St, Melbourne , VIC, 3000

Report/Agreement # 220124021820381
Inspection Date: 22 Jan 2024
Inspection Time: 02:18 pm

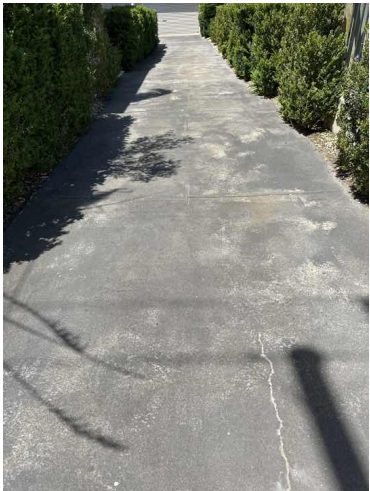
Driveway Condition

Common cracks & settlement were observed on the driveway. Maintenance is recommended. Note: Whilst these cracks appeared to be minor at the time of inspection, we strongly recommend you monitor these cracks and if worsening occurs contact a concreter for further advice.

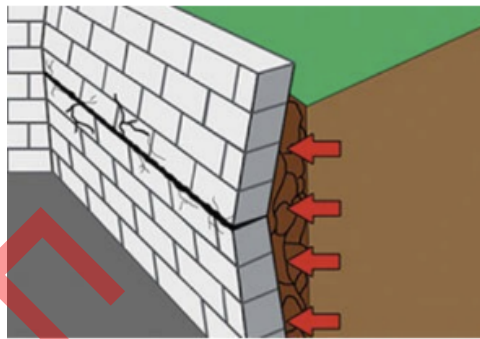
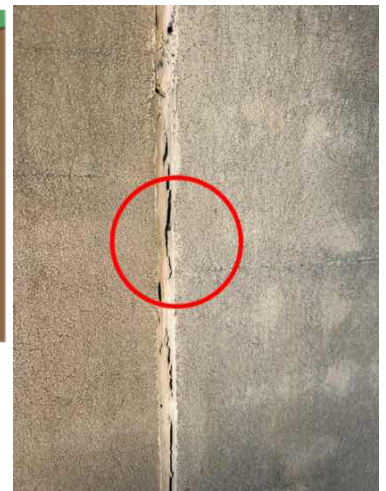
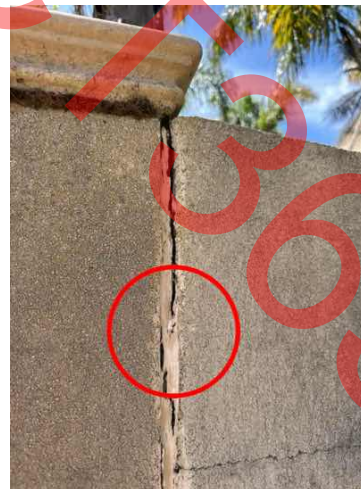
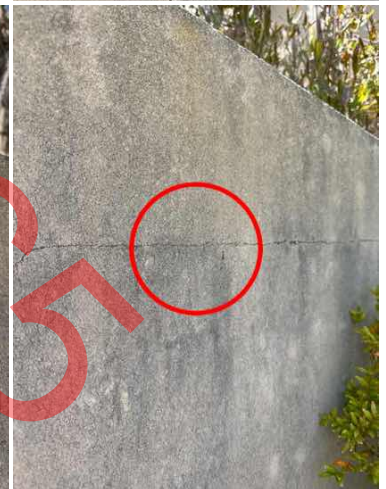
Overall Condition

Retaining wall cracking - Recommendations:
A qualified brick layer should be engaged for
advice and recommendations.

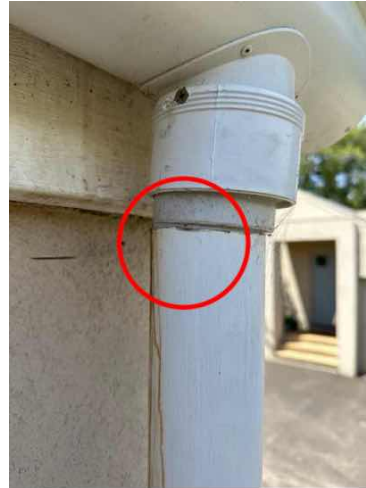
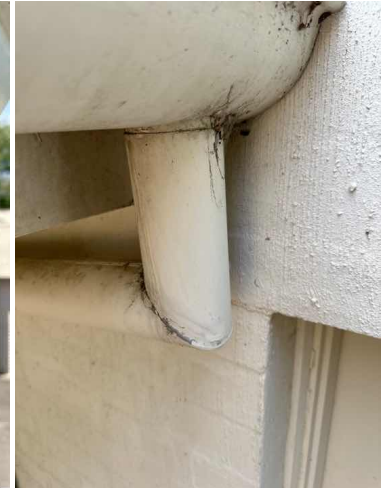
Leaking down pipe joins visible. This can be conducive to termite infestation and cause water damage to cladding over time. Recommendations: A qualified roof plumber should be engaged to repair.

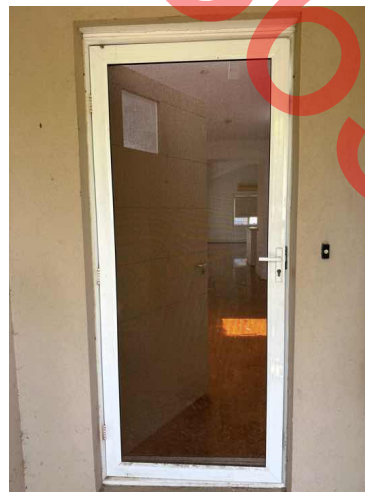
Door frames are damaged. A carpenter or a builder should be consulted for repairs.

The laundry door is weathered and deteriorated. Repair or replacement recommended

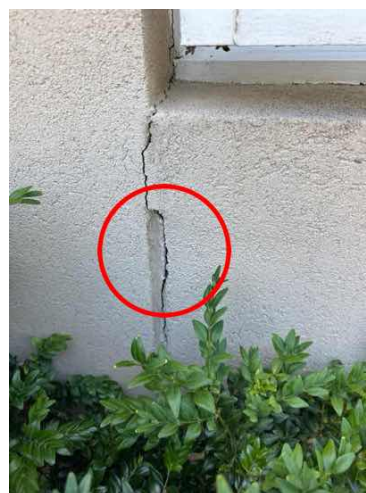
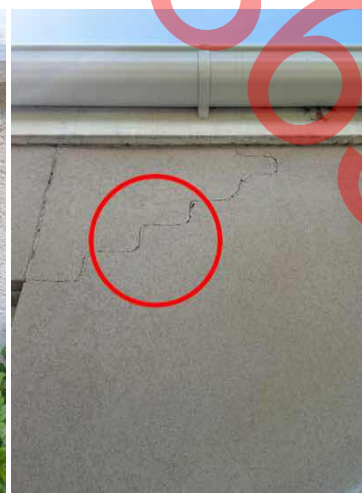
Condition

There appears to have been some settlement in the building which has caused some cracking to the walls. These cracks are categorized as 0 to 2. This can also cause some doors to bind or be out of square. In the inspectors opinion these cracks are due to settlement, usually due to ground movement and subsequent movement to building materials can be expected. Any cracks should be monitored and if cracks increase in size.

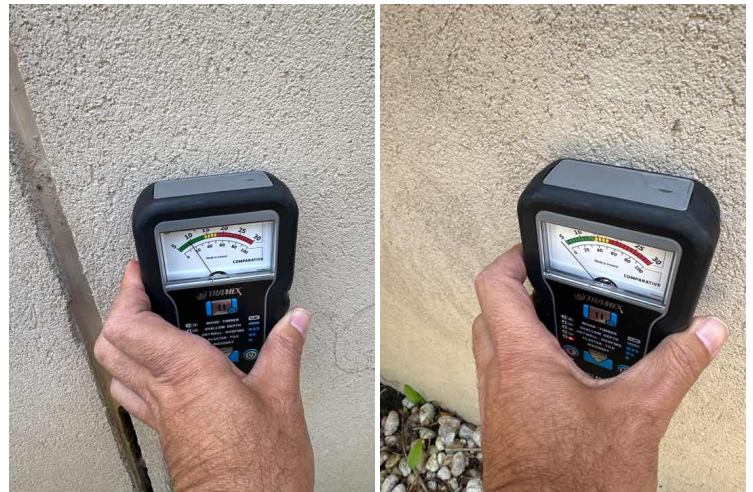
Damp Proof Course

A damp proof course is not visible or could not be visually identified. This may cause rising damp issues. Contact a damp proof course specialist to further investigate and make recommendation.

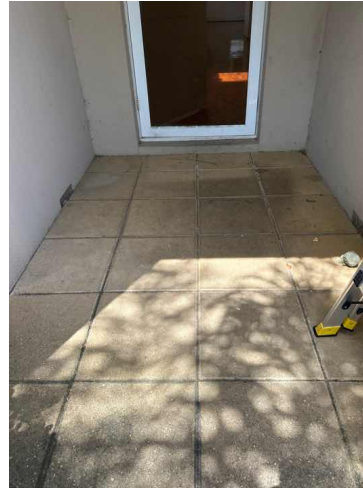
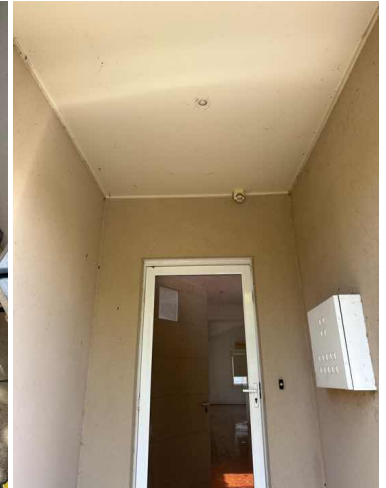
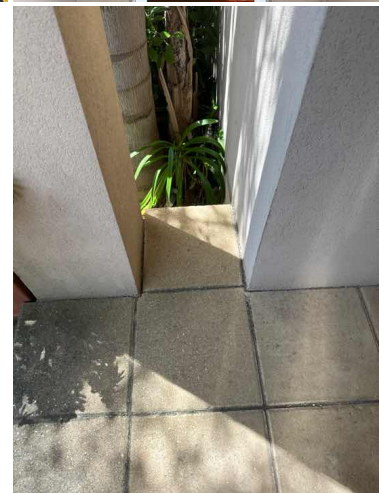
Ceiling Lining Condition

Ceiling lining join cracks. Contact a licensed plasterer for repairs.

Ceiling paint flake/deterioration is evident.
Recommendations: General maintenance/painting as required.

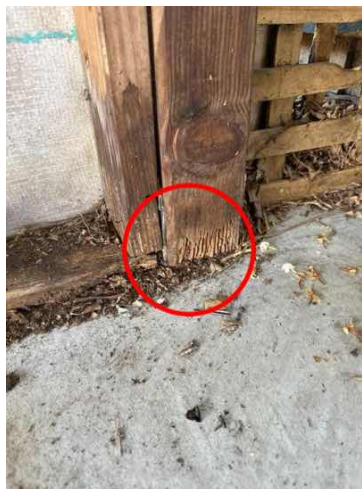
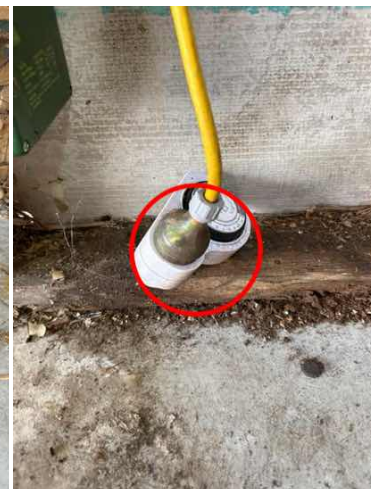
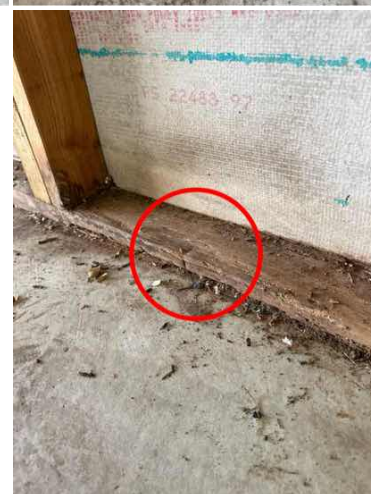
Internal Wall Findings(1)

General ageing and/or denting and/or wear and/or previous wall patching and the like is evident on wall linings - Recommendations: A qualified painter should be engaged to assess and repair as required.

Cracks noted. Possible causes may be foundation movement. Support structure deflection. Thermal movement and moisture uptake or loss, failure under external loads.

It is in my professional opinion that this is general settlement and caulking of the joint will suffice.

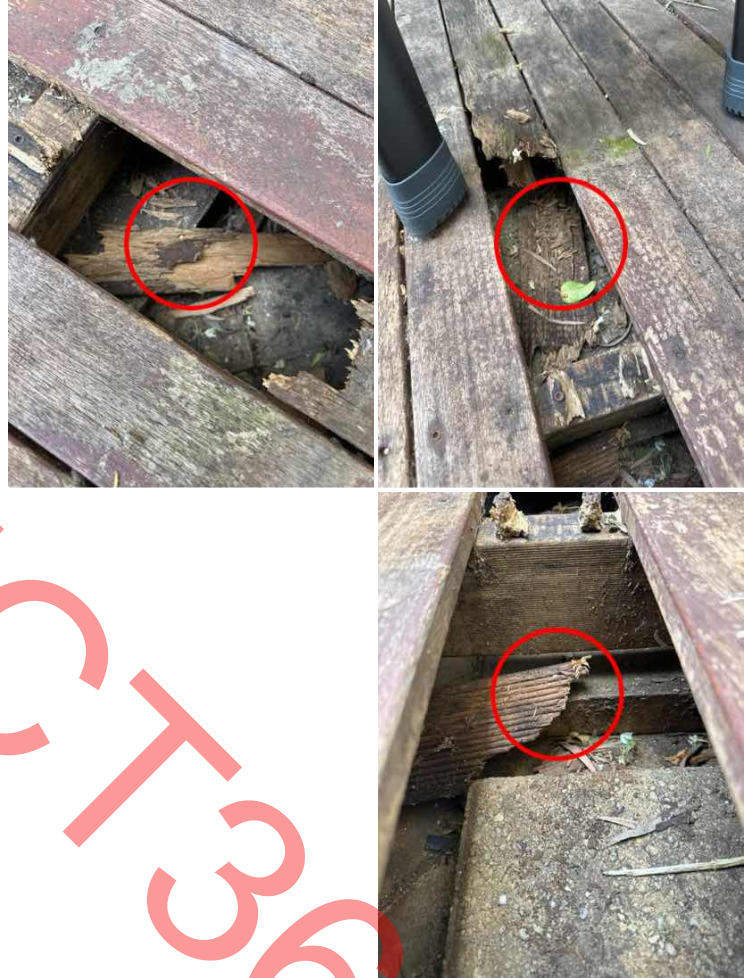
Decking Timber

Decking board surfaces are weathered - Recommendations: We recommend cleaning and maintenance as needed.

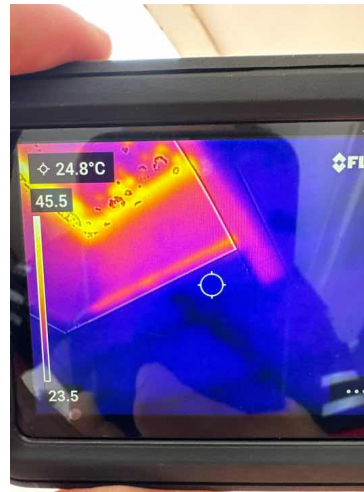
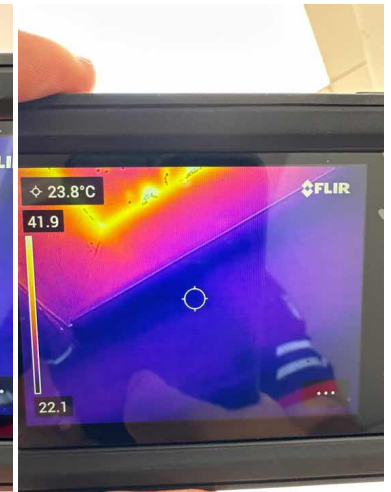
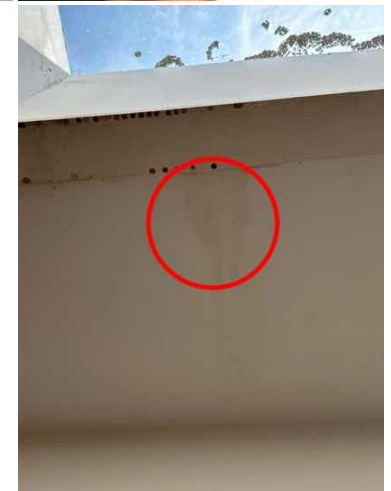
Walls

Impact damage noted. Contact a licensed plasterer for repairs.

Incomplete Patch/Paint repairs noted. Call a licensed painter for repairs

Skirting board damage. Possibly bath/shower recess leak related. Recommendations: Have bathroom/shower assessed by a plumber for leaks and maintenance / replace skirting boards as required.

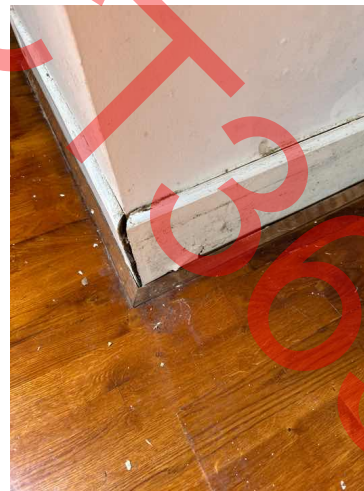
Flooring

Stained timber flooring - This is normally due some water penetration. This will not be able to be removed and options include replacement, staining all the boards dark or lining same to cover. Recommendations: A qualified carpenter should be engaged for advice and recommendations.

Skirt Moisture Damage/Swelling observed.
Replacement recommended.

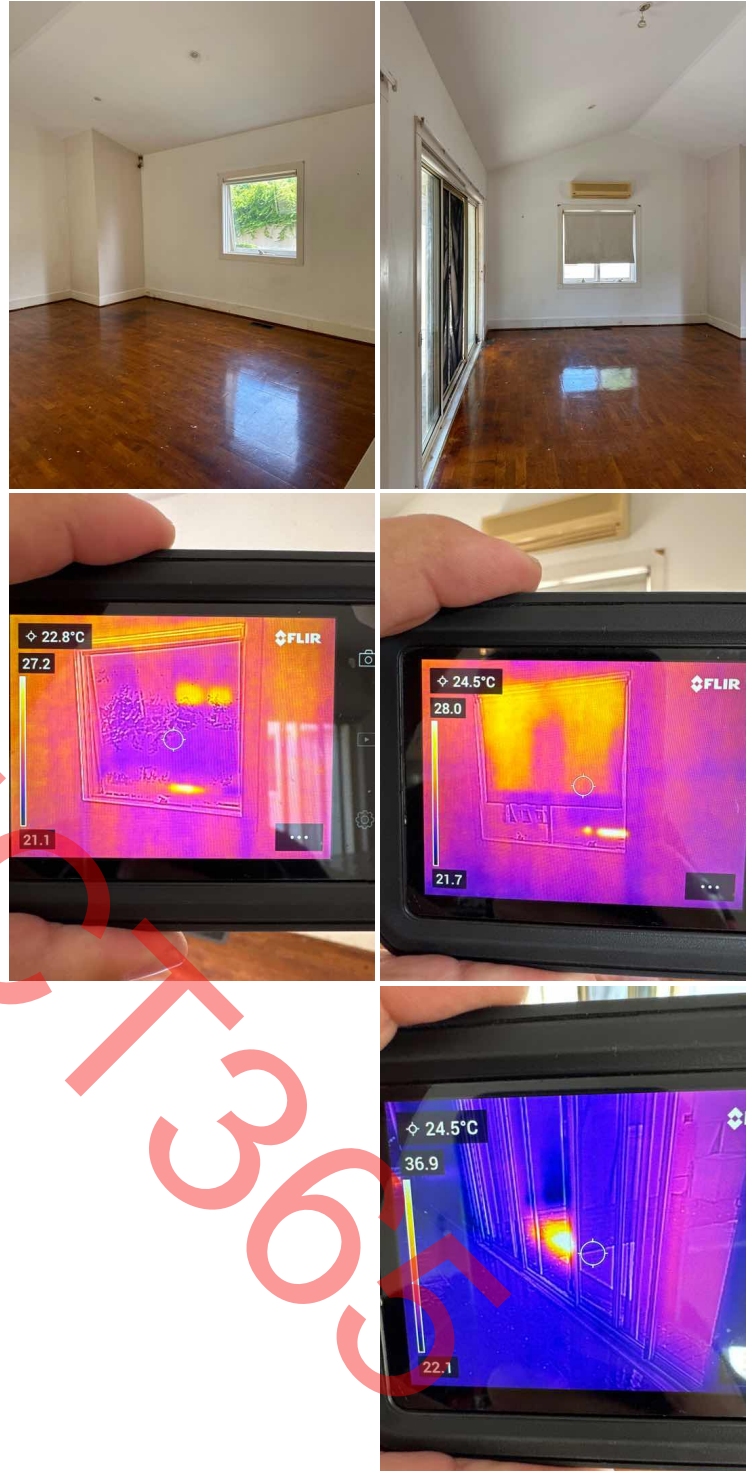
Mould growth noted . Due to health risks we strongly recommend that a expert in the field of mould treatment be engaged for further advise and recommendations

Ceiling paint flake/deterioration is evident.
Recommendations: General maintenance / painting as required.

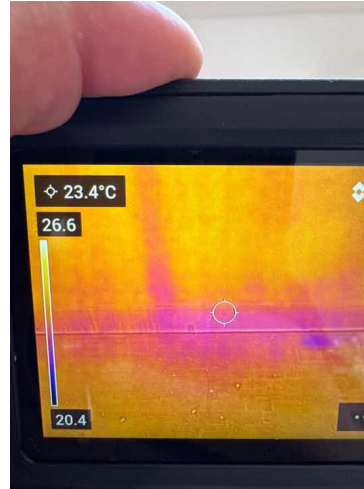
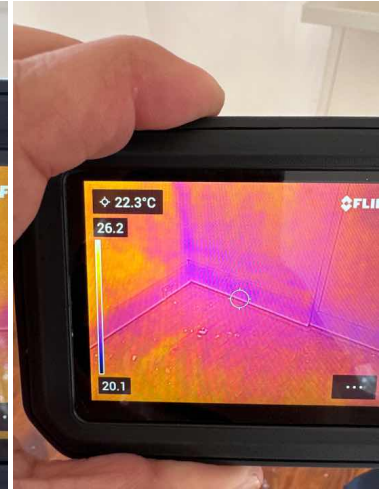
High moisture readings detected. There was no evidence of paint flake, Recommendations: Accurate diagnosis of the cause and extent of the damp problem is very important and should be assessed prior to purchasing the dwelling as can be quite costly if a damp proof course has to be reinstated.

Skirting board damage/deterioration -

Wall stains observed - No abnormal moisture readings obtained. Recommendations: These may have been repaired, however, you will need to monitor this area and if further staining or flaking appears contact a licensed plumber for further investigation.

Recommendations: A qualified carpenter should be engaged to replace.

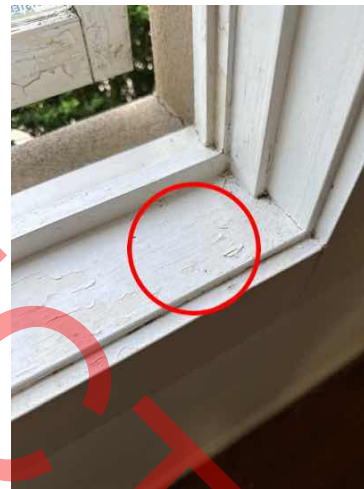
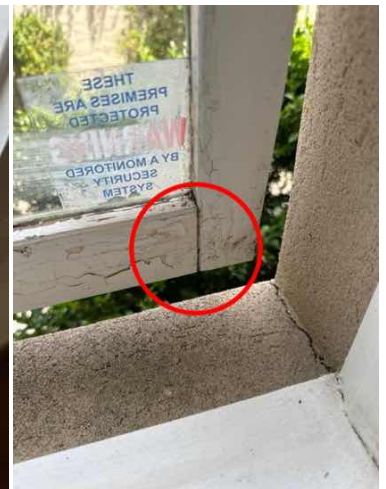
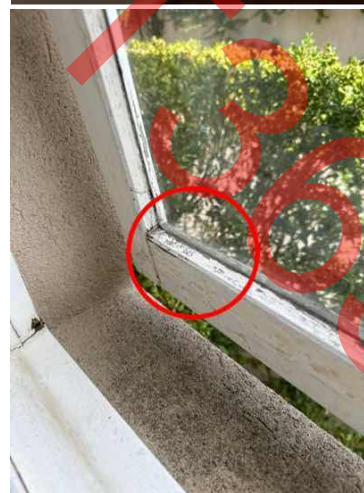
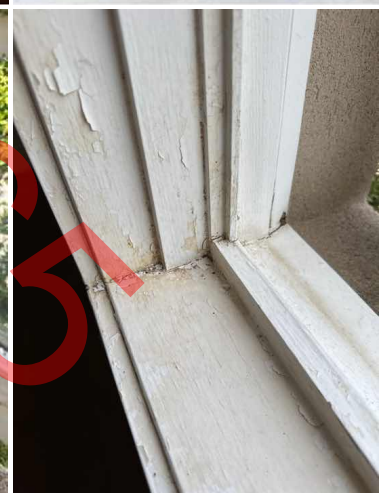
Windows

General age wear deterioration - The window frame/components showed evidence of ageing and wear. Recommendations: General maintenance works required.

Moisture damage and high moisture readings recorded. Possible water ingress. Or condensation. Contact a glazier for repairs.

Timber fungal decay on window frames.

Recommendations: A qualified carpenter should be engaged for advice and recommendations.

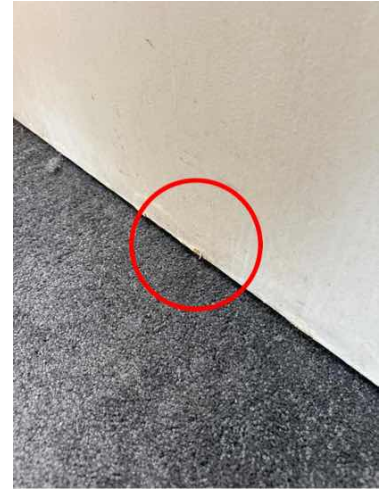
Mould growth noted . Due to health risks we strongly recommend that a expert in the field of mould treatment be engaged for further advise and recommendations

Ceiling stains - Moisture readings obtained. In the absence of rain It's difficult to ascertain with certainty the location of the leak. Recommendations: A qualified roofer should be engaged for advice and recommendations. All water damaged plaster should be replaced by a qualified plasterer.

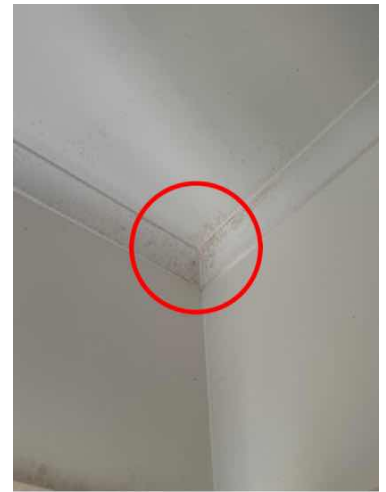
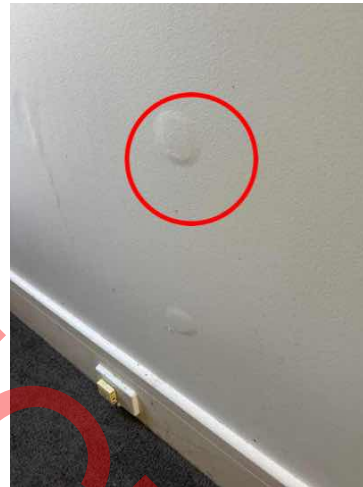
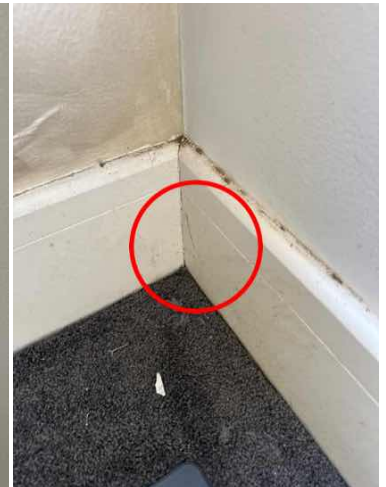
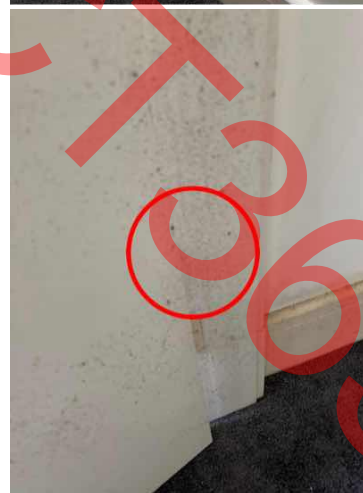
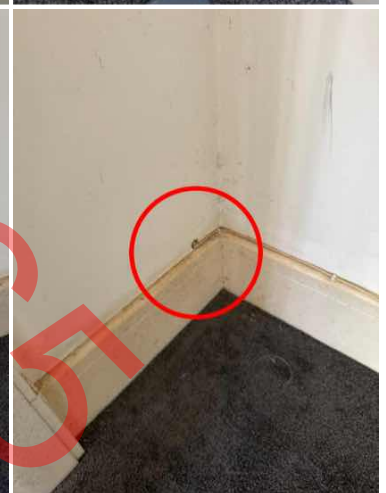
General ageing and/or denting and the like is evident on wall linings - Recommendations: A qualified painter should be engaged to assess and repair as required.

Incomplete Patch/Paint repairs noted. Call a licensed painter for repairs

Skirting board damage/deterioration -

Wall stains observed - No abnormal moisture readings obtained. Recommendations: These may have been repaired, however, you will need to monitor this area and if further staining or flaking appears contact a licensed plumber for further investigation.

Recommendations: A qualified carpenter should be engaged to replace.

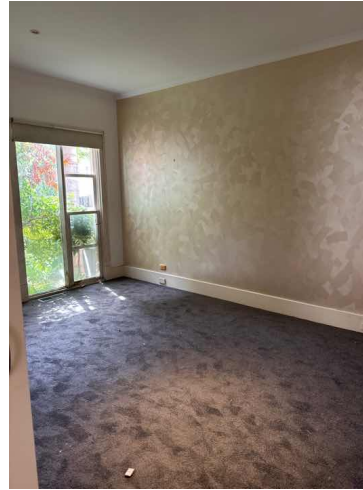
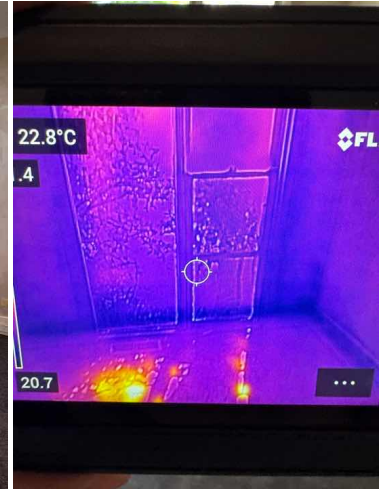
Door

Impact damage to door observed. Repairs / Replacement recommended

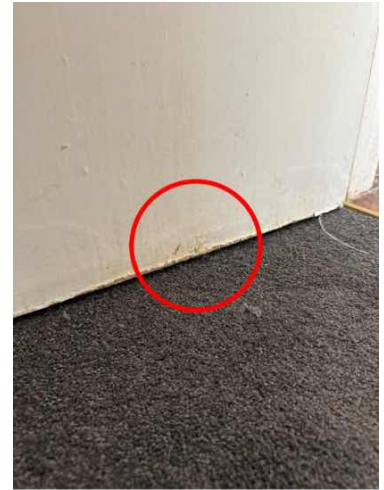
Walls

General ageing and/or denting and the like is evident on wall linings - Recommendations: A qualified painter should be engaged to assess and repair as required.

Settlement Cracks Noted. These are typical and generally patch and paint will suffice, however we recommend monitor for 12 months.

High moisture readings detected. There was no evidence of paint flake , Recommendations: Accurate diagnosis of the cause and extent of the damp problem is very important and should be assessed prior to purchasing the dwelling as can be quite costly if a damp proof course has to be reinstated.

High moisture levels detected indication rising damp. Contact a damp proof and ventilation specialist for repairs and advice. We recommend getting a quote prior to a decision to purchase as this can be very expensive to rectify.

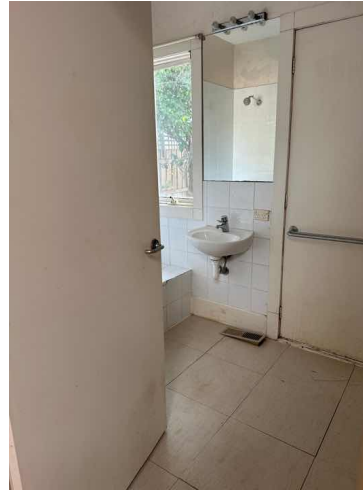
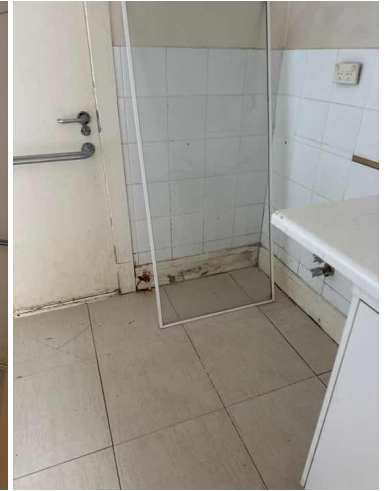
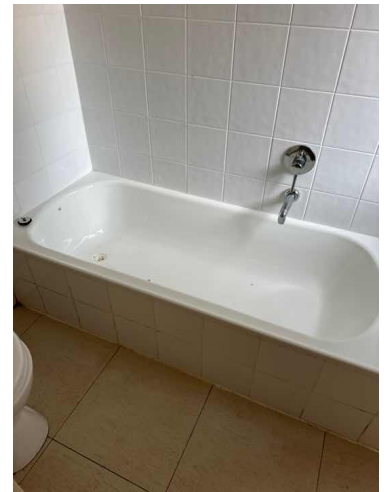
Door / frame deterioration - General age/damage has occurred to door frame, face or components. Recommendations: A qualified carpenter should be engaged for advice and recommendations.

Rot observed to the door frame .This may be related to the shower recess due to being near the door. Recommendations: I advise re-sealing the shower recess junctions by a qualified by damp proofing contractor.

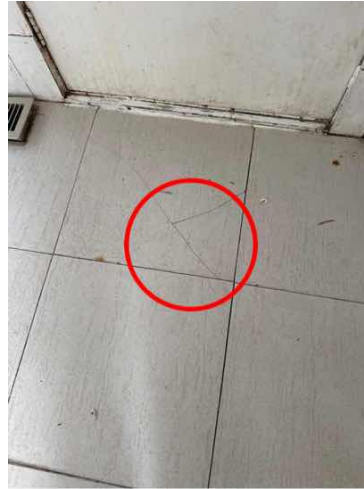
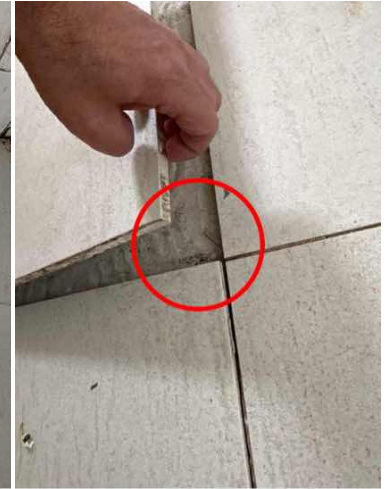
Drummy tiles noted. This needs to be repaired at the earliest as this has the potential to lead to many related issues such as damp, water ingress to other areas and cracked tiles. Contact a licensed tiler for repairs and recommendation

Cracked tile/s noted. This can cause extensive floor and floor frame damage and is conducive to termite infestation if water is leaking through the cavity. A qualified tiler should be engaged for advice and recommendations.

Deteriorated grout noted. This should be repaired as this will lead to water ingress under the tiles causing uplifting and possible water penetration.

There are loose/delaminating tiles. As this is a wet area these should be repaired as soon as possible by a licensed tiler and waterproofing specialist.

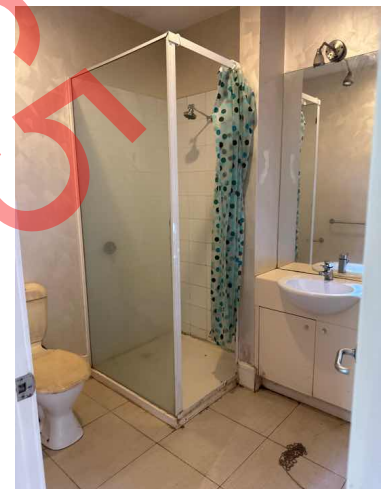
Moisture damage was noted to the ceiling lining though no abnormal moisture readings detected at the time of inspection, however this does not mean that you should rule out an active leak. Monitor for leaks and contact a licensed plumber and plasterer for repairs as required.

Mould spores noted to ceiling. This is a health hazard. See ventilation section

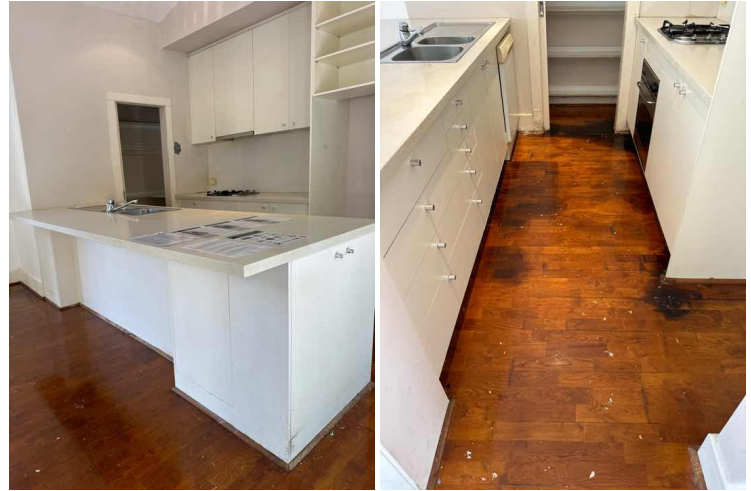
Kitchen and Meals Area

General age/damage has occurred to kitchen and components. Recommendations: A qualified cabinet maker and plumber should be engaged for advice and recommendations regarding renovations

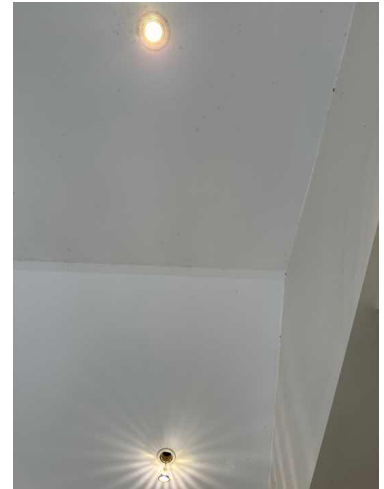
General ageing and/or denting and/or wear and/or previous wall patching and the like is evident on ceiling linings - Recommendations: A qualified painter should be engaged to assess and repair as required.

Ceiling stains - No moisture readings obtained from same. Recommendations: These may have been repaired, however, you will need to monitor after a prolonged period of rainfall - If leaking persists, a qualified plumber should be engaged for advice and recommendations. Essentially, it is preferable to have all water damaged plaster replaced by a qualified plasterer due to potential detachment or collapse.

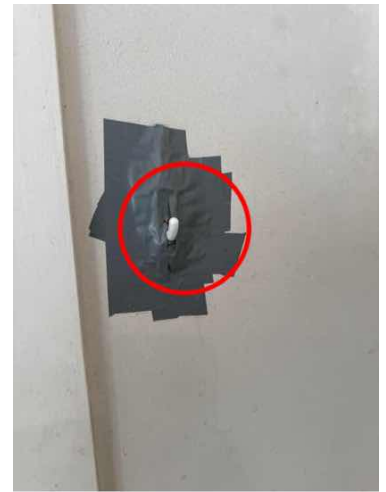
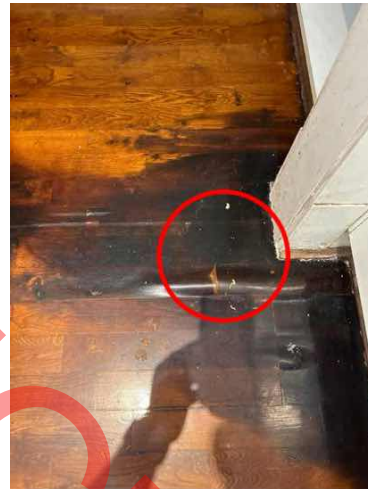
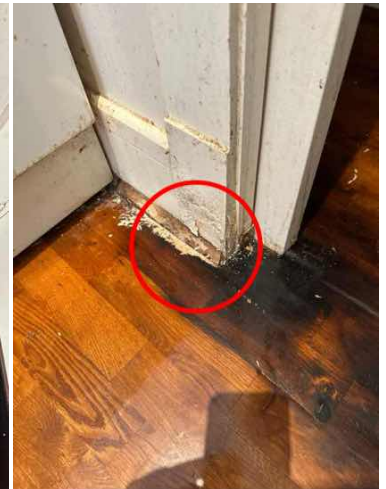
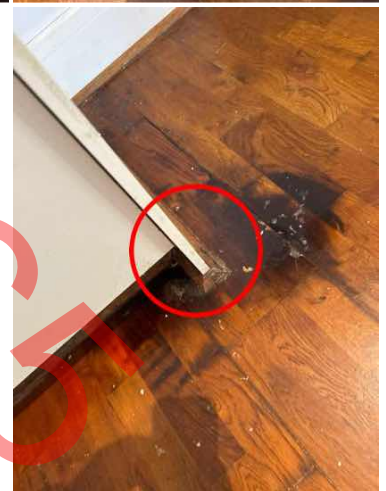
Decay noted to the timber floor. It is strongly recommended that all affected timbers be replaced. This presents a Safety Hazard. Contact a licensed carpenter for repairs.

Skirting boards are water damaged and should be replaced.

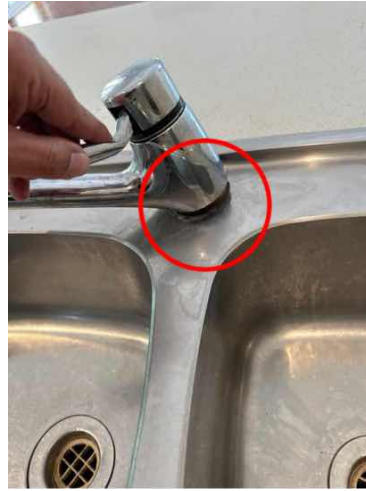
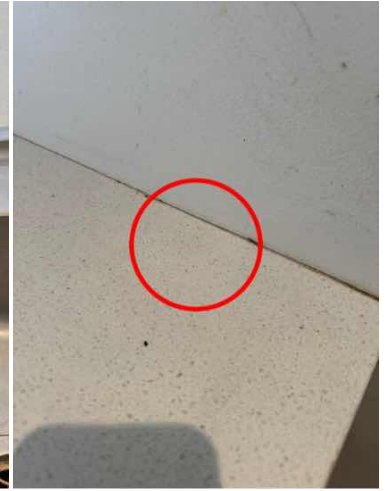
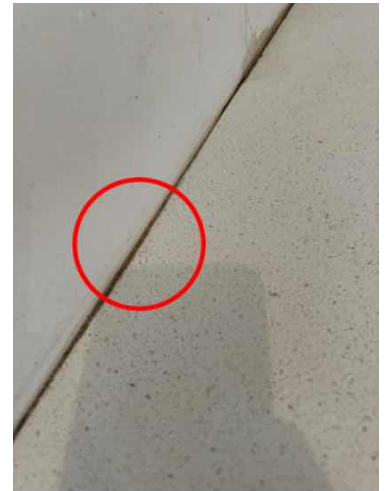
Sink and Taps

Bench top and splash back junction sealing deteriorated - Recommendations: Re-sealing by a plumber or general maintenance contractor is recommended to prevent water access behind the bench.

The tap / tap head is leaking . A qualified plumber should be engaged for repairs.

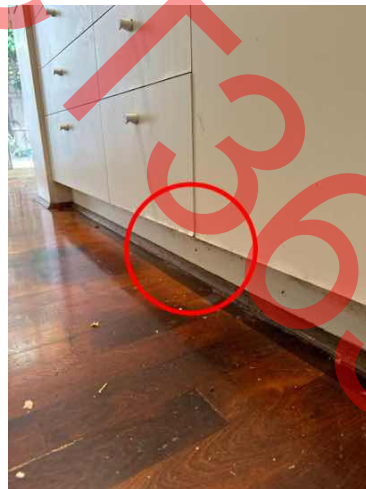
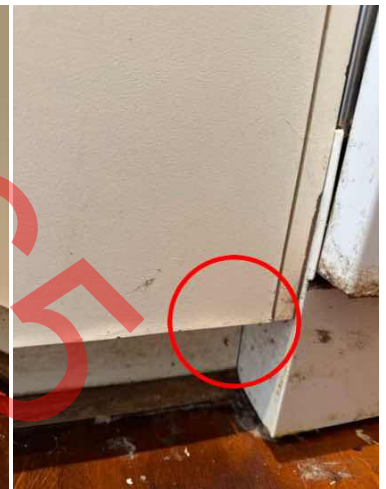
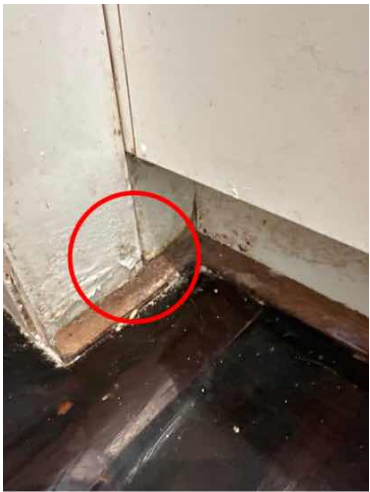
Cupboards And Bench Tops

Water damage to cabinet observed. Replacement required. Contact a cabinet maker for repairs.

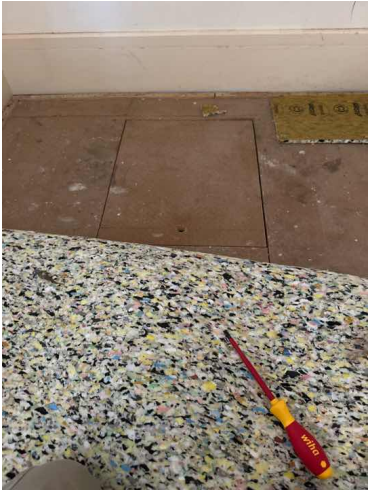
The sub floor could not be inspected due to access door being too small to enter. In accordance with AS4349 the minimum requirement is 500 mm x 400mm access manhole. I recommend installing a larger access door to allow for safe and reasonable entry without potential to cause damage or injury.

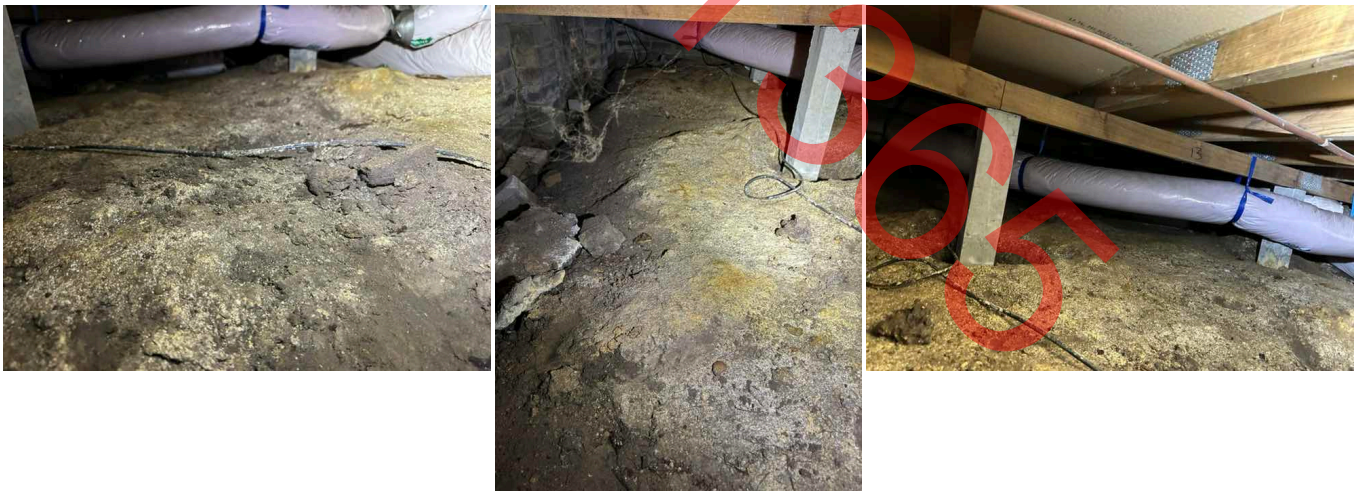
General Condition

Subfloor was not entered and viewed from outside due to potentially toxic mold presenting a health hazard to the inspector.

Yellow mold forms after an extended period of moisture presence in the sub-floor. This could be due to insufficient point of egress for ground water or a potential leak.

Further invasive inspection recommended.

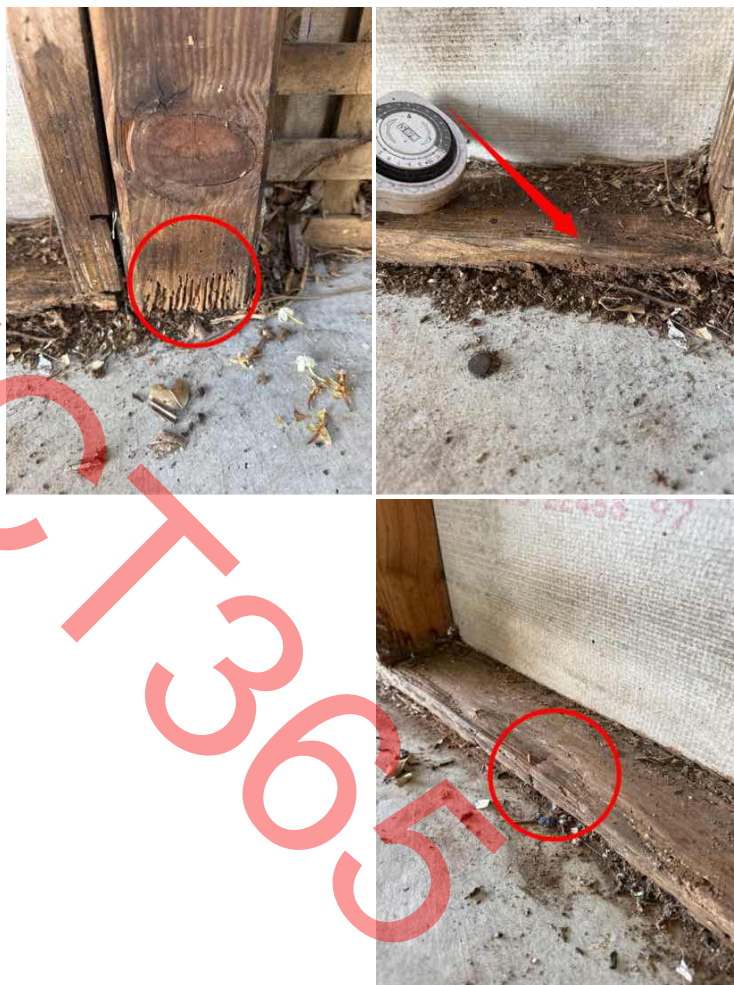
Yes, termite damage was found in the following

To garage timber/s

Where evidence of termite activity was found in the grounds then the risk to buildings is very high. A treatment to eradicate the termites and to protect the building(s) should be carried out. Where the evidence of termite workings was found in the grounds or the building(s) then the risk of a further attack is very high.

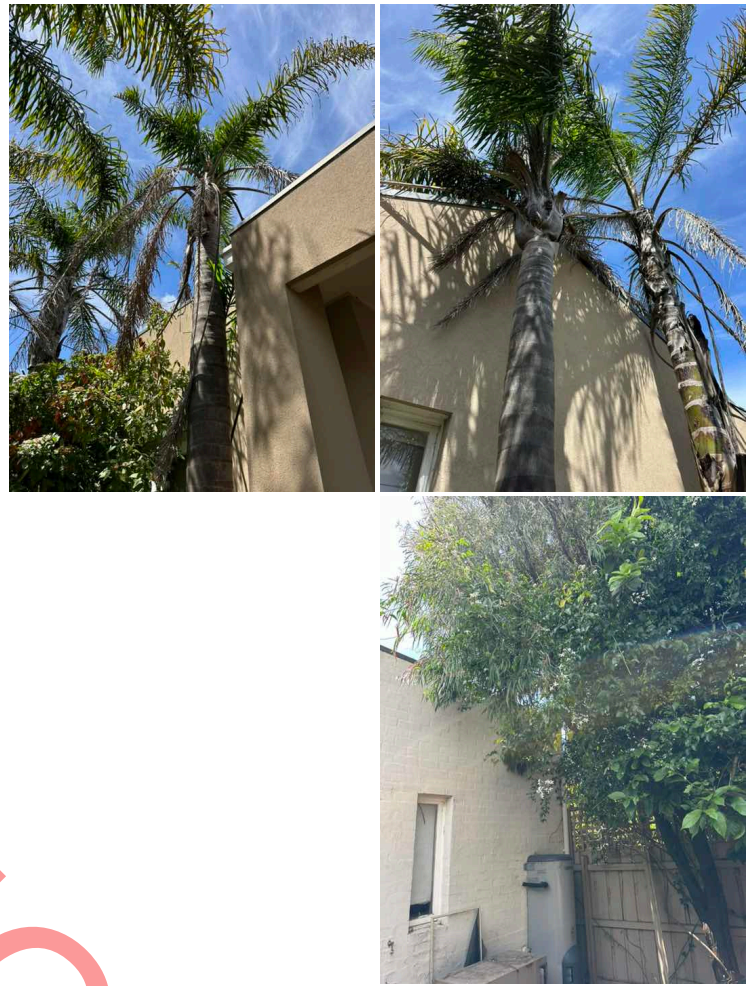
Are Trees Close to Home

Trees are in close proximity to the dwelling and within the termite foraging area. These are a favorable influence for termite infestation and i recommend you liaise with the neighbours to have the trees regularly checked and if in your site, organise regular inspections for termite infestation.
