Waterproof Stage Inspection

Sample, Hillside, VIC, 3037

Fixing and water proofing

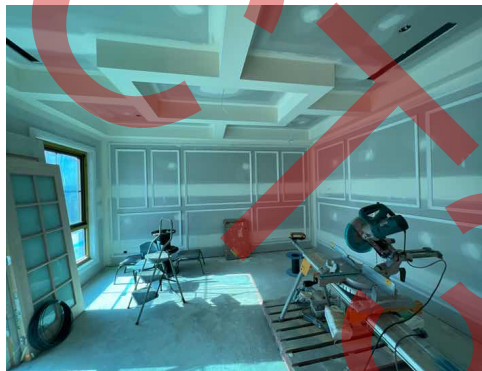
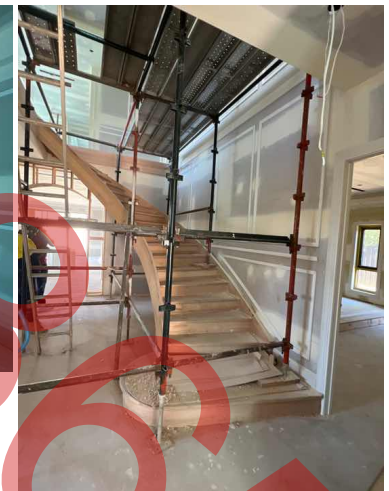
The stair treads are squeaky.

The stair stringer is cracked and may have compromised the structural integrity of the stair case.

Recommend to seek structural integrity certification for stair stringer from relevant specialist/engineer.

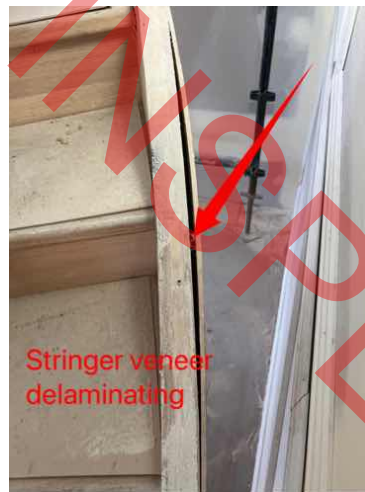
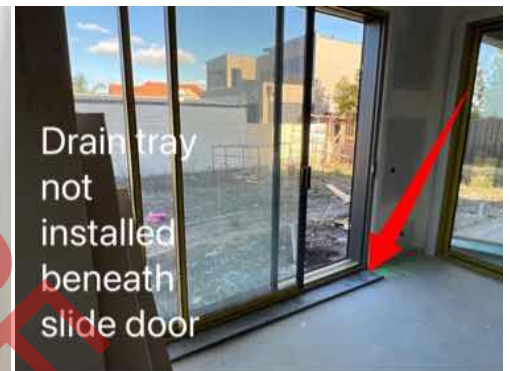
Stair stringer cracked
